Federal SP 32-14

Inspection DOC# 675200326

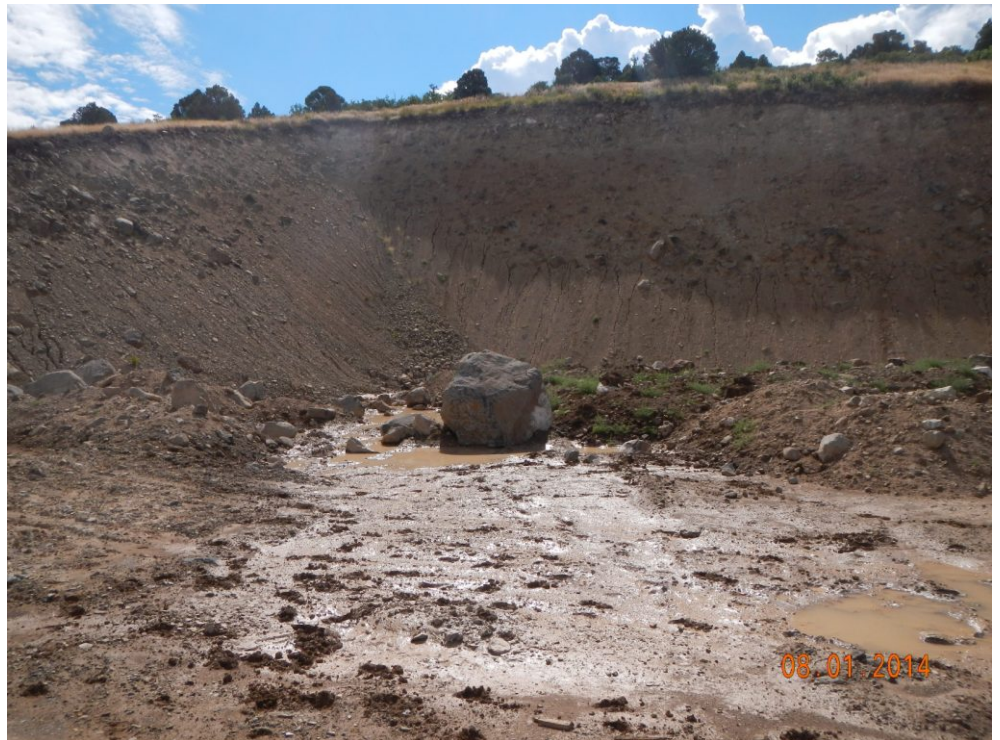
Erosion in SE corner of
fill slope.

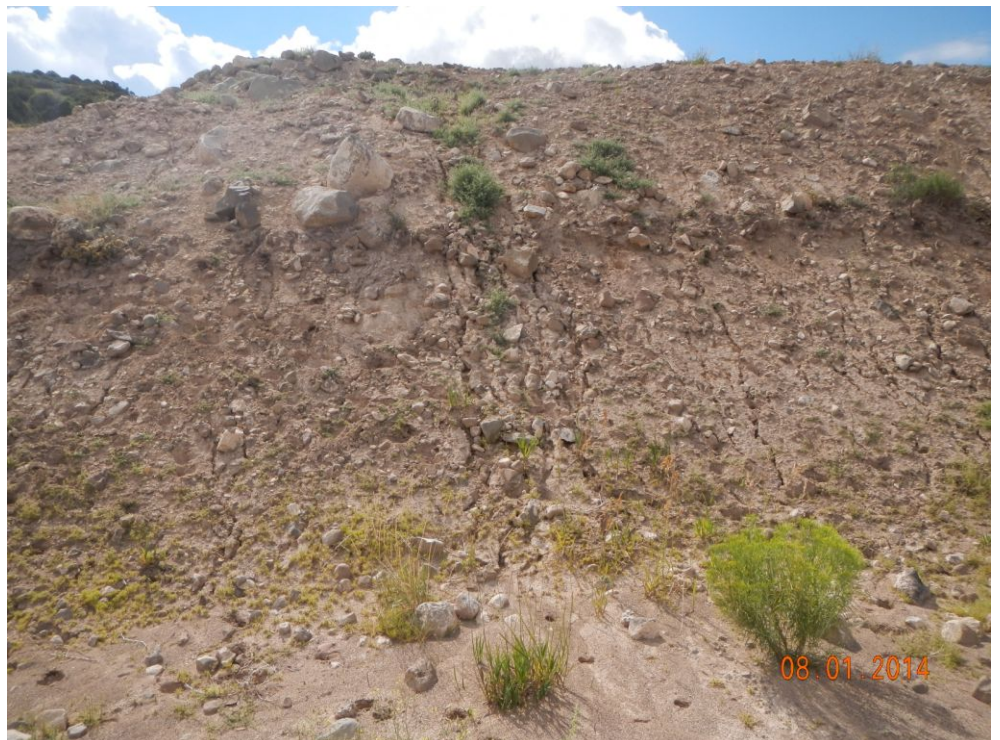
Erosion and rilling
behind separators.

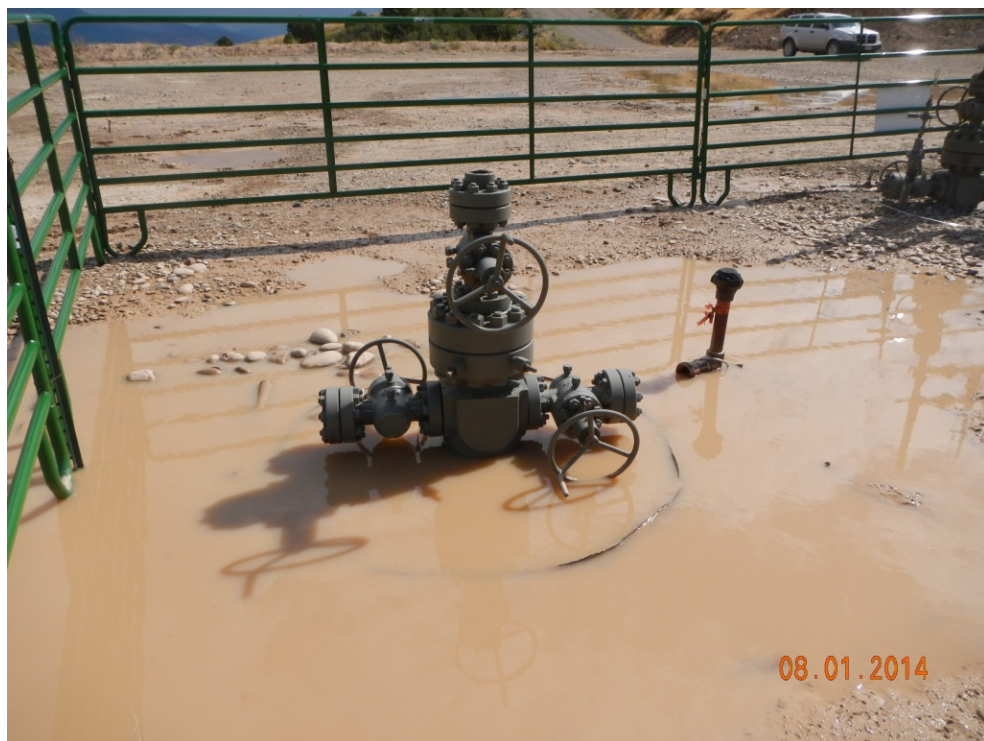
Well API # 05-045-19704

Still in XX status.
