Site Photos (05-001-09529) 7/25/14

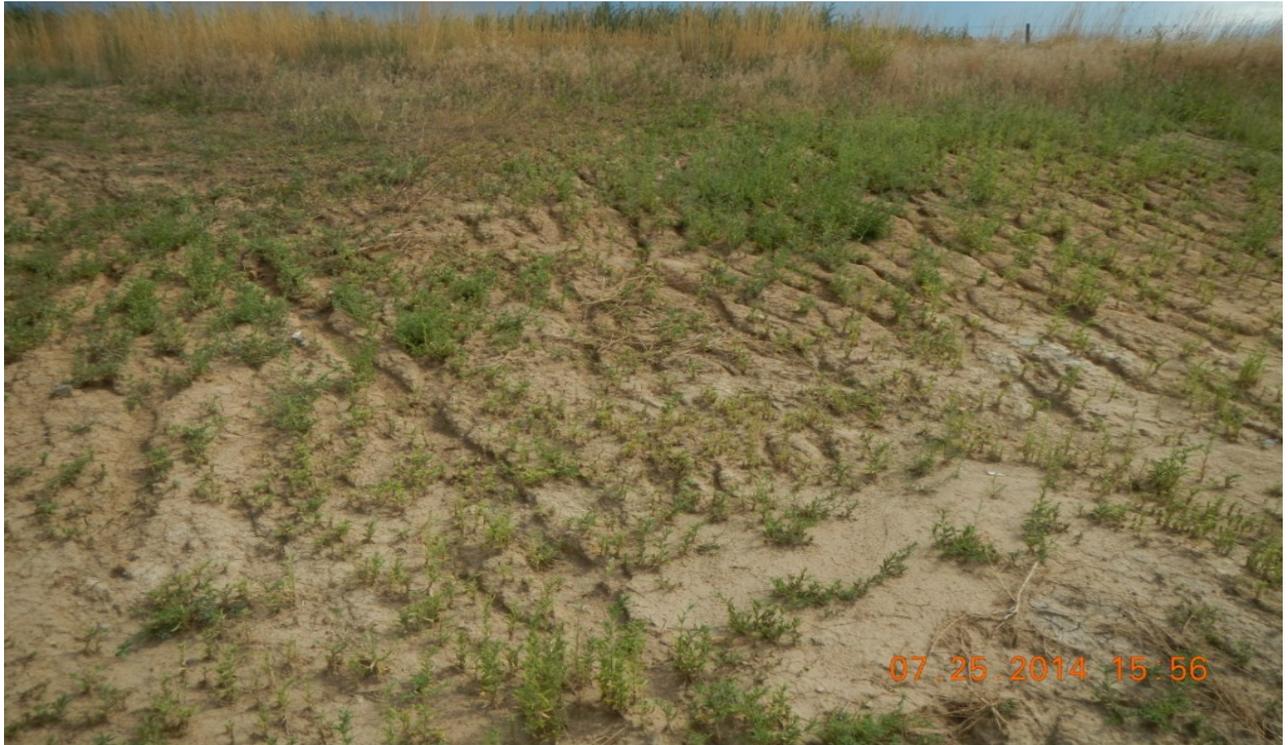
Erosion on south side of location

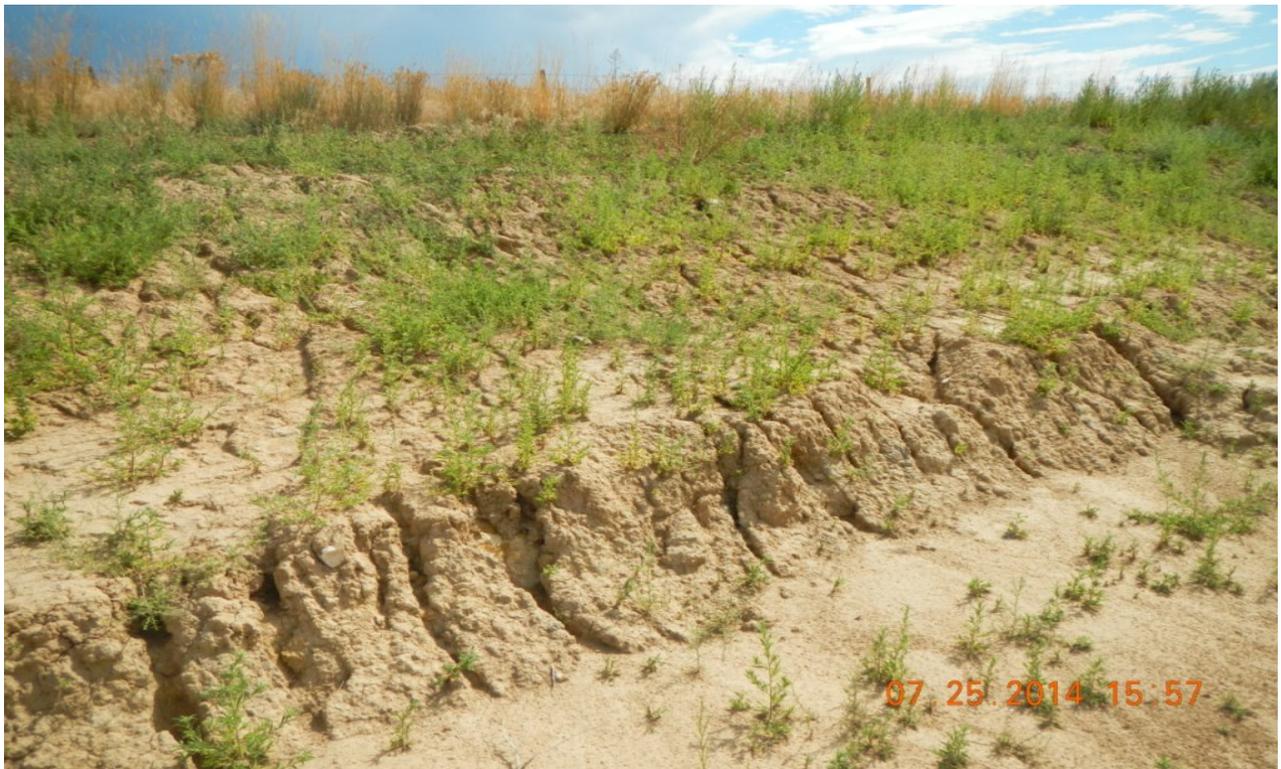
Rill formation along south side of location

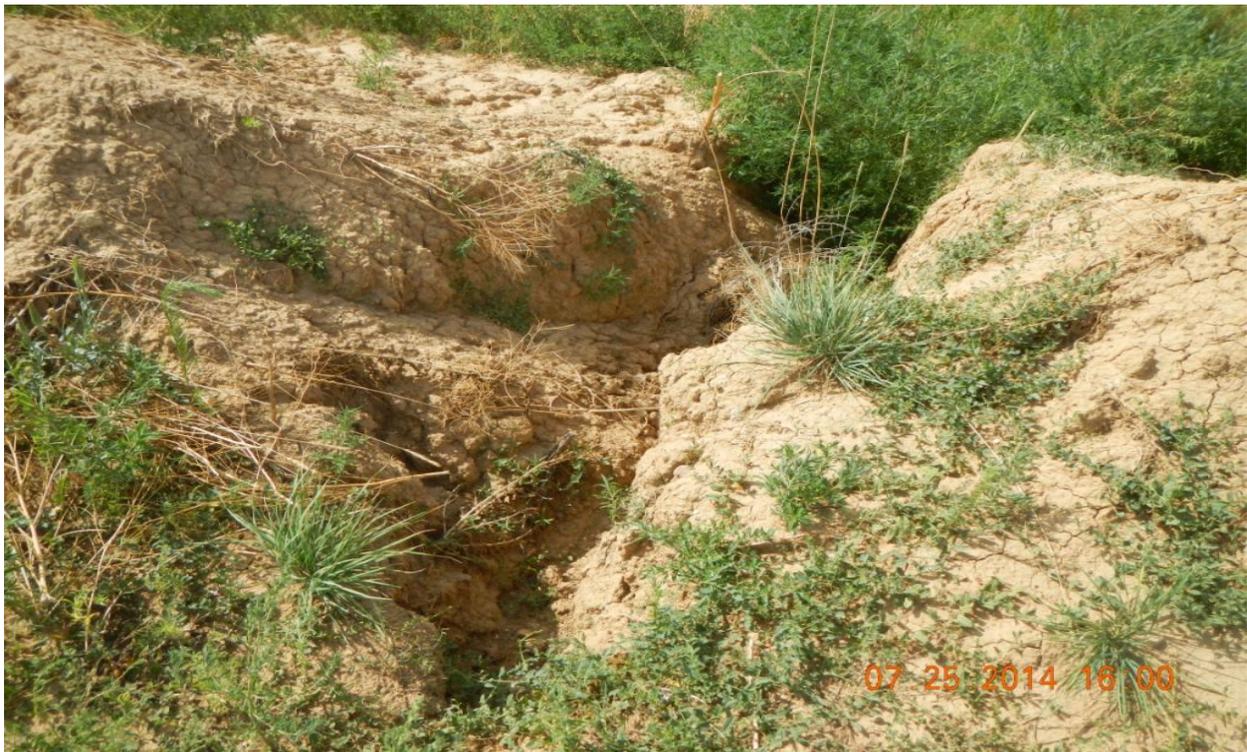
Severe cut in bank on North side of location.

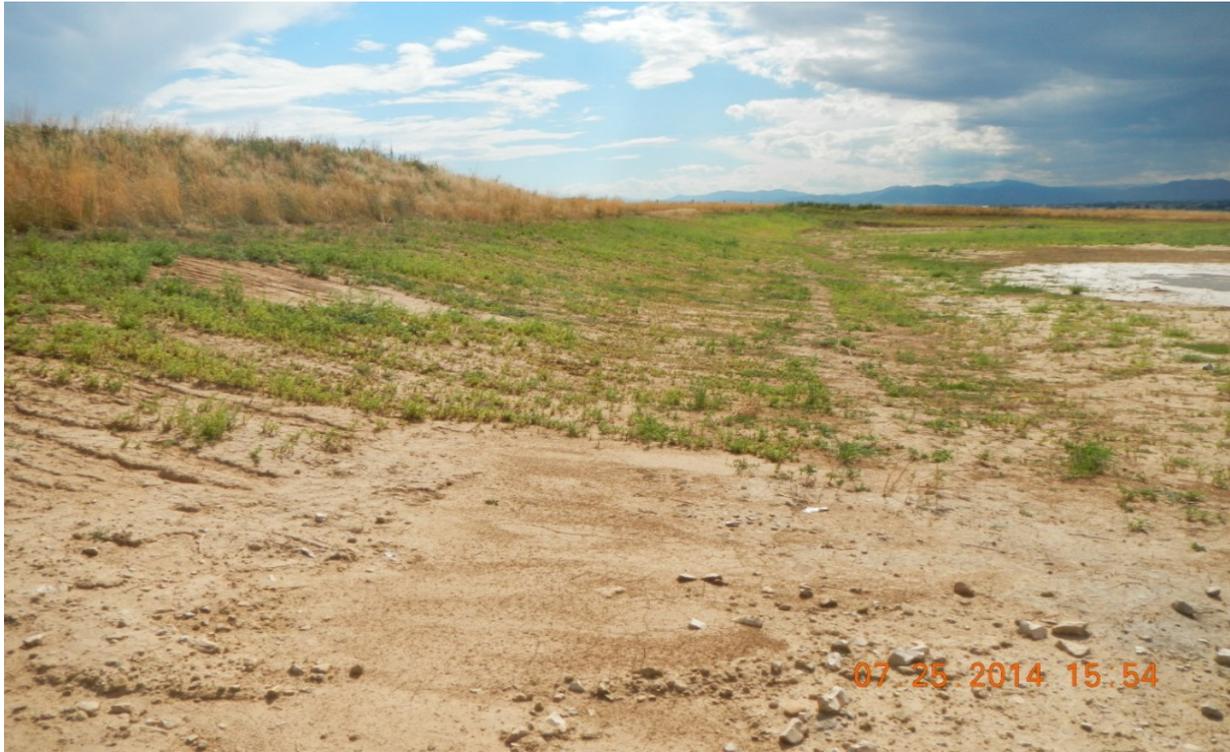
Weed growth around perimeter of location.

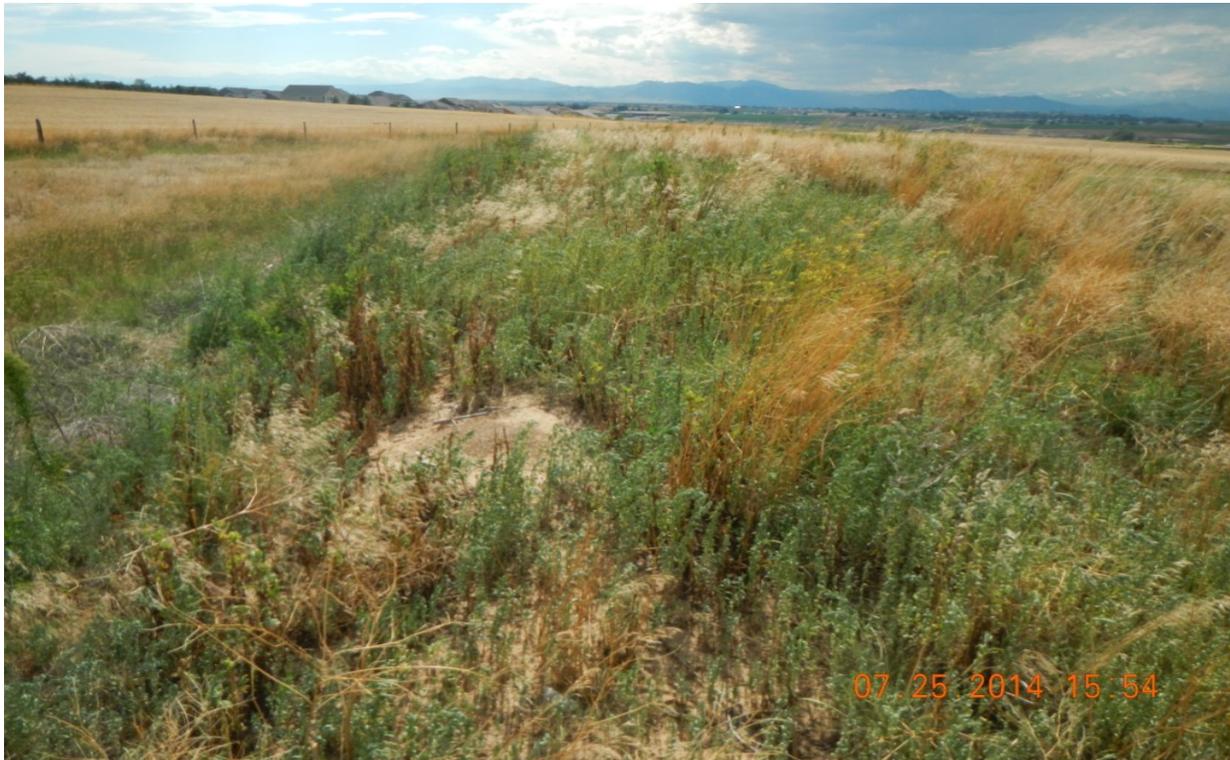
Weed growth along the soil stockpile.

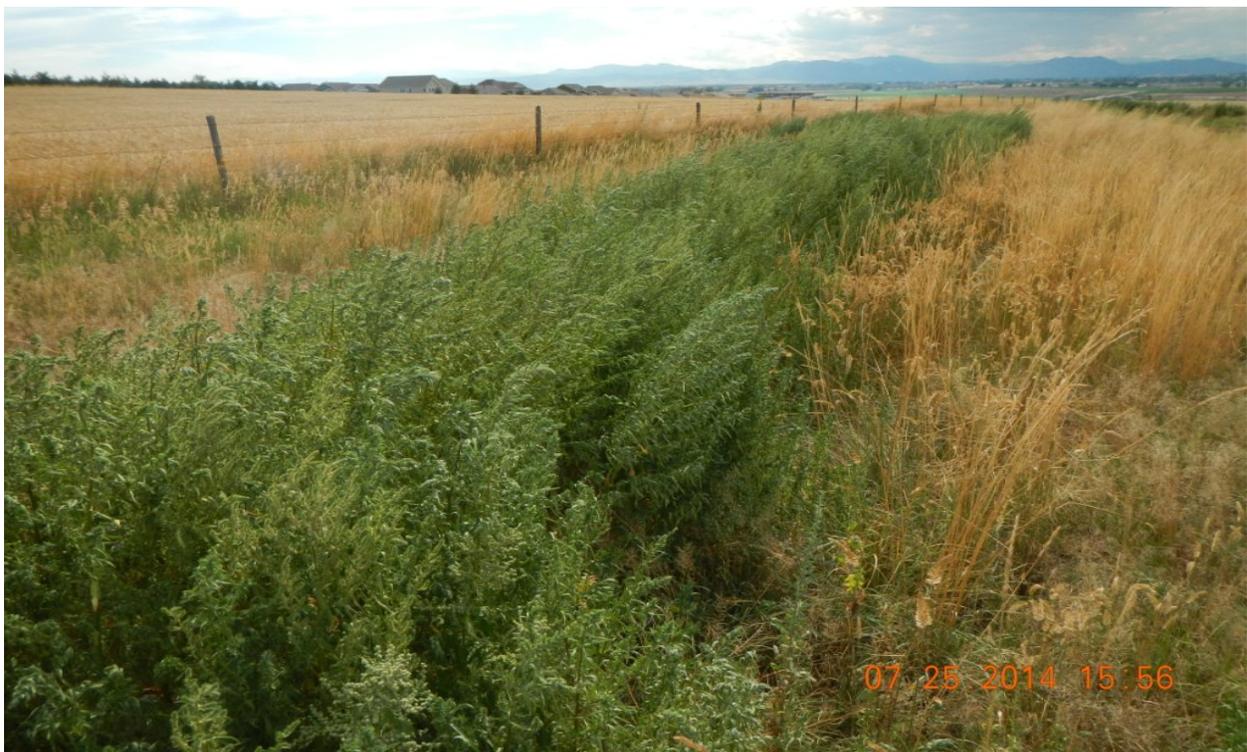
Tall weed growth on south side of location.

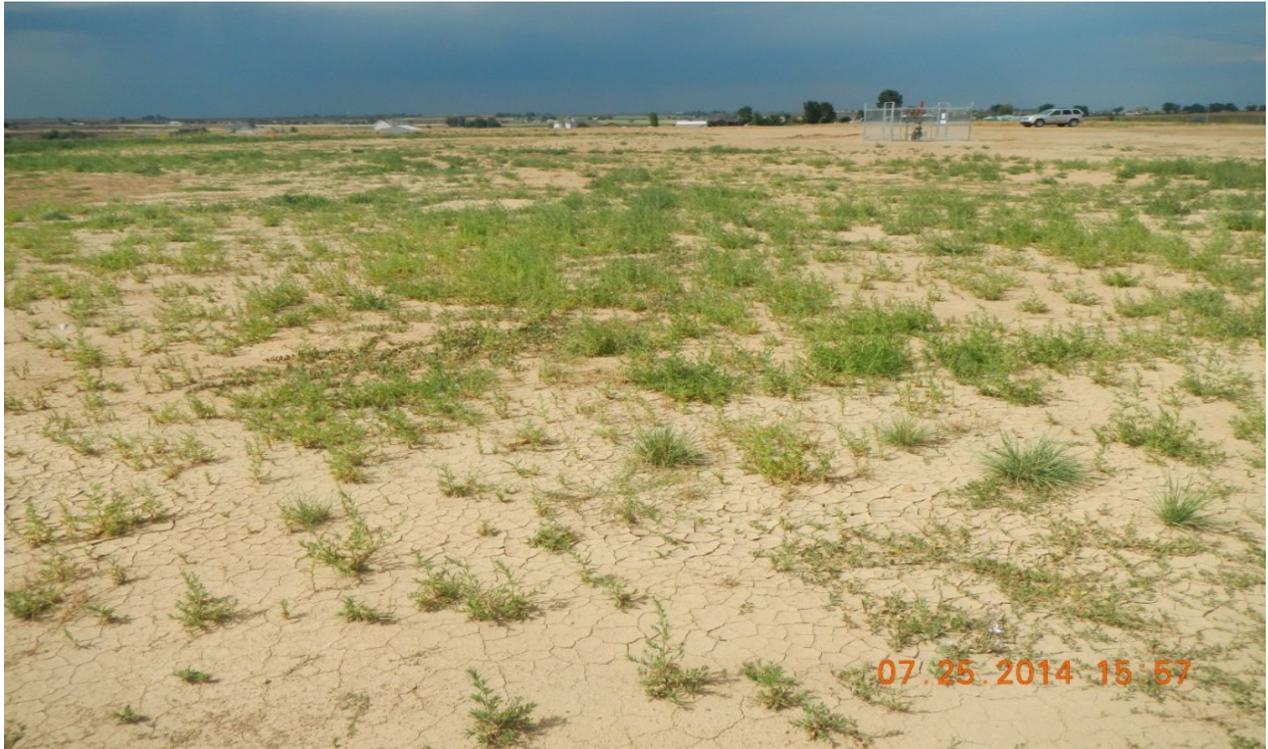
Weed growth on well pad.

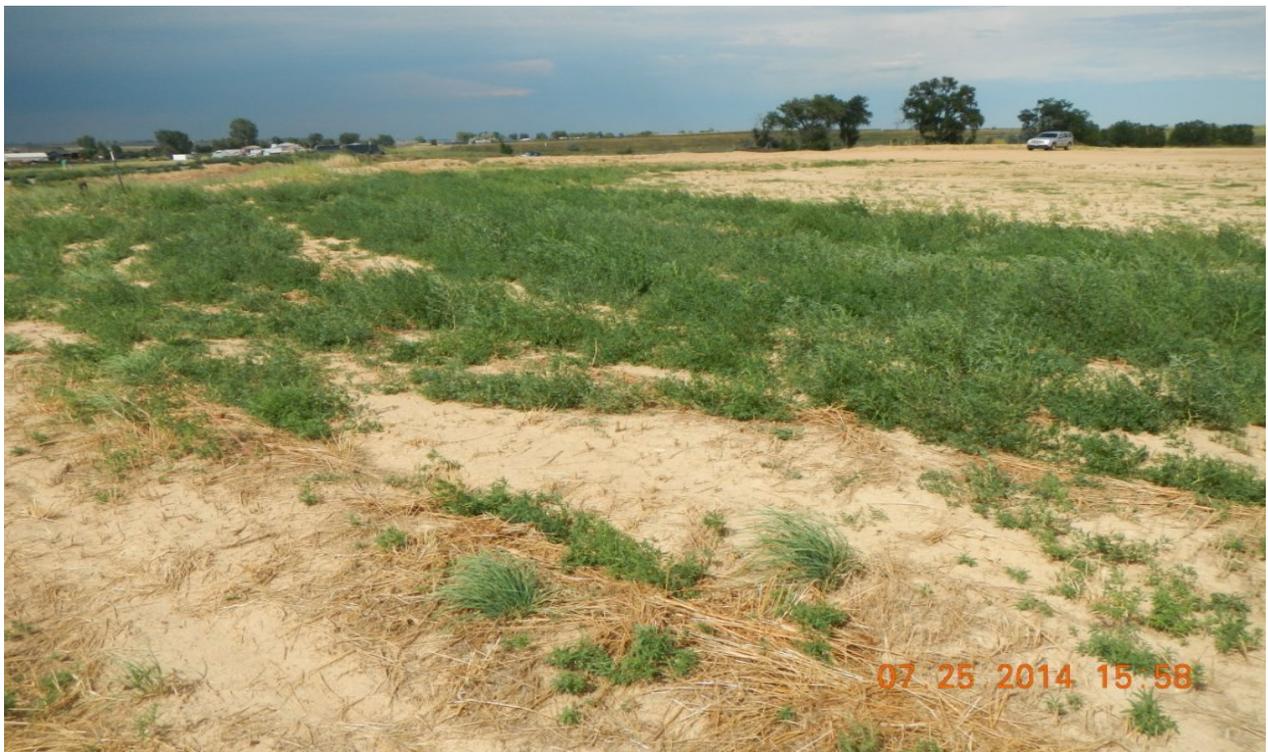
Weed growth on well pad.

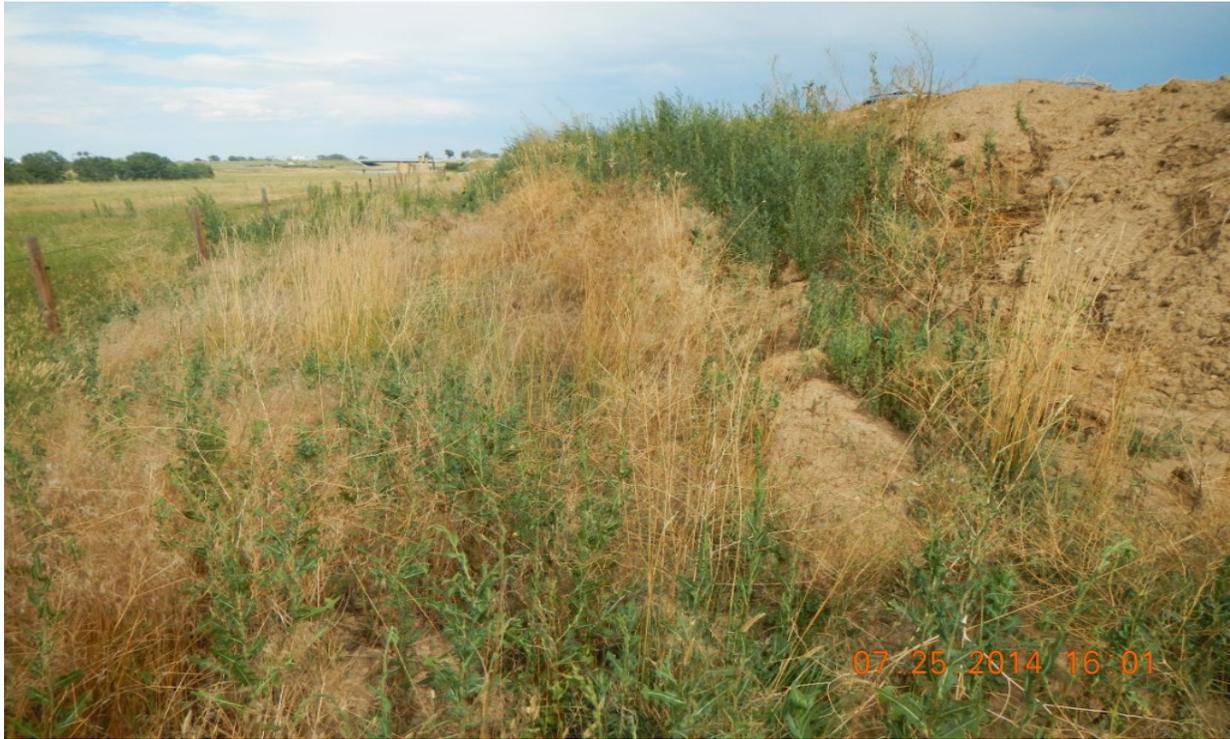
Weed growth around North side of location.

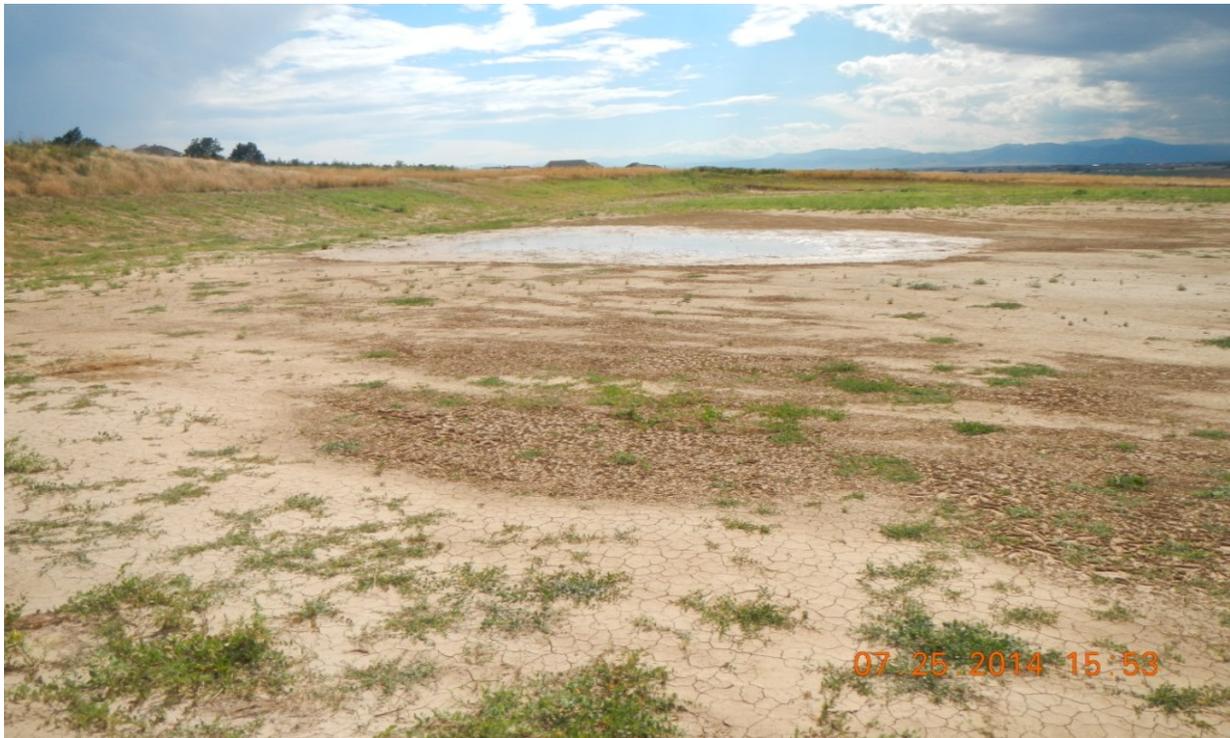
Ponding occurring on well pad.
