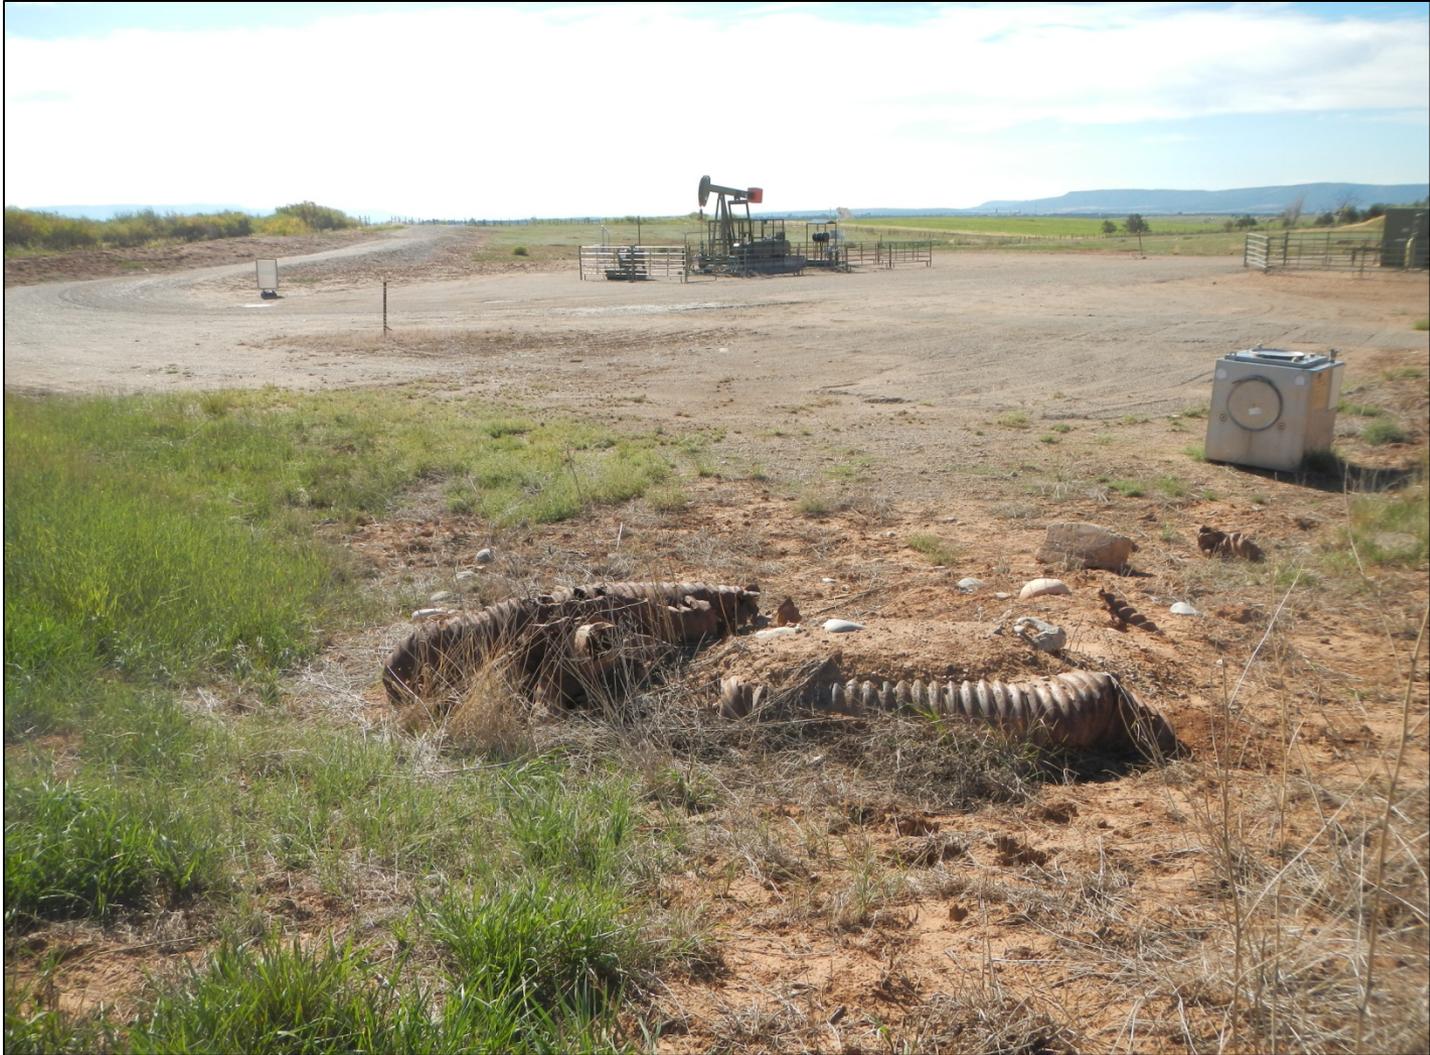
Photo 1. View of unused Tol-pac, damaged culvert, and debris in northwestern corner of well pad.

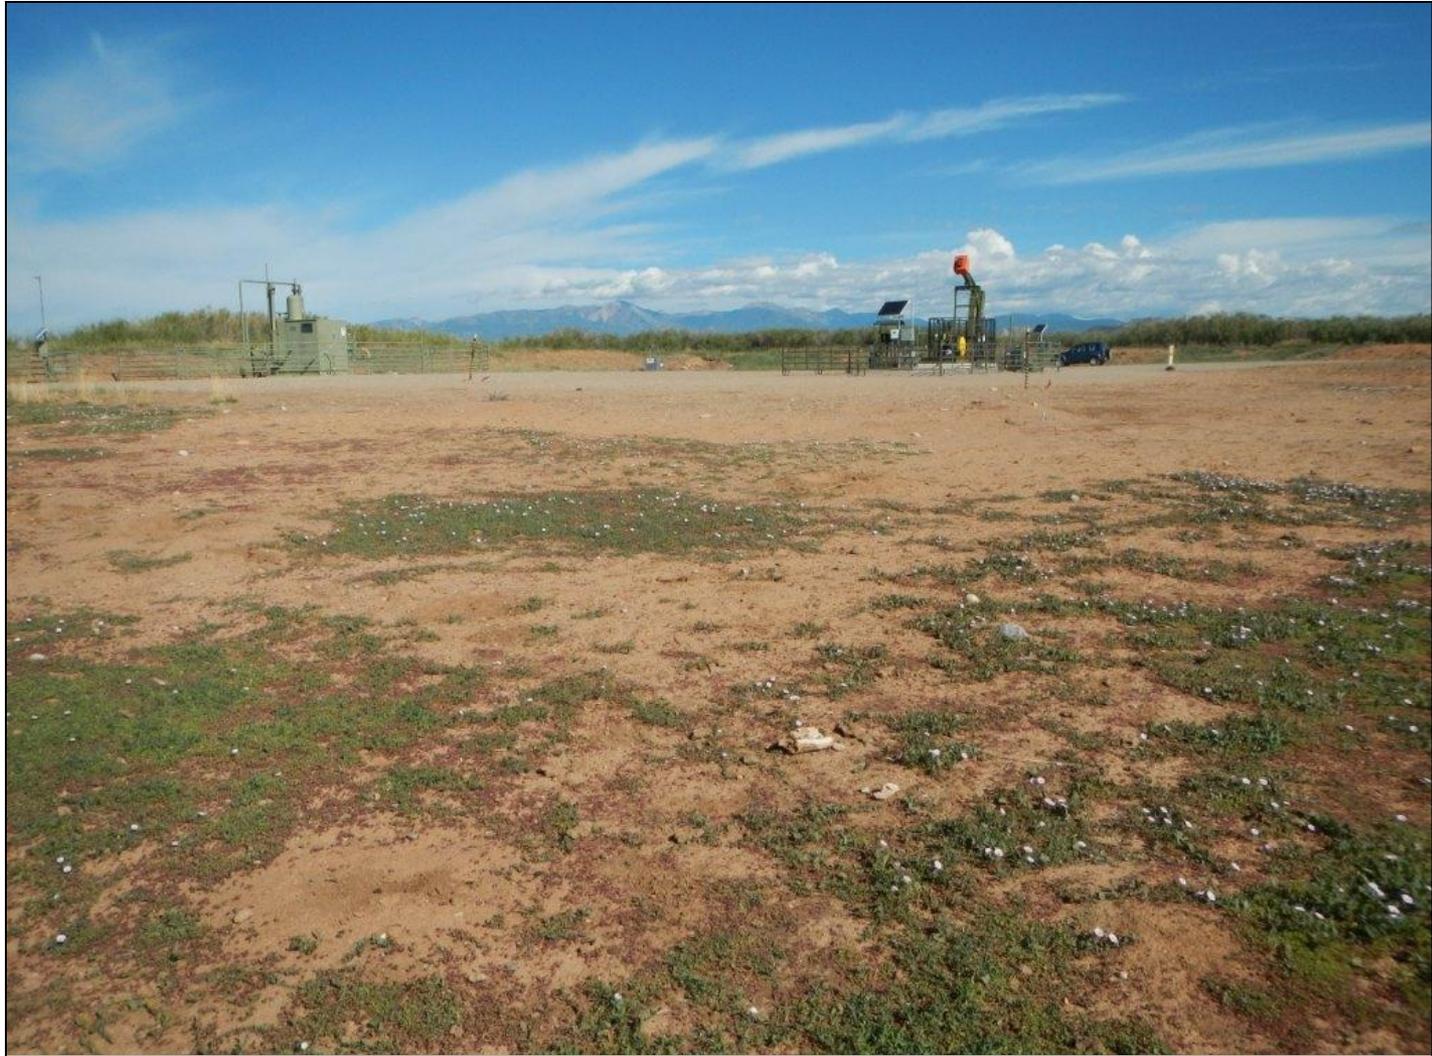
Photo 2. View of poor revegetation in interim reclamation area from southeastern corner of project area facing center. Vegetation is largely field bindweed (*Convolvulus arvensis*).

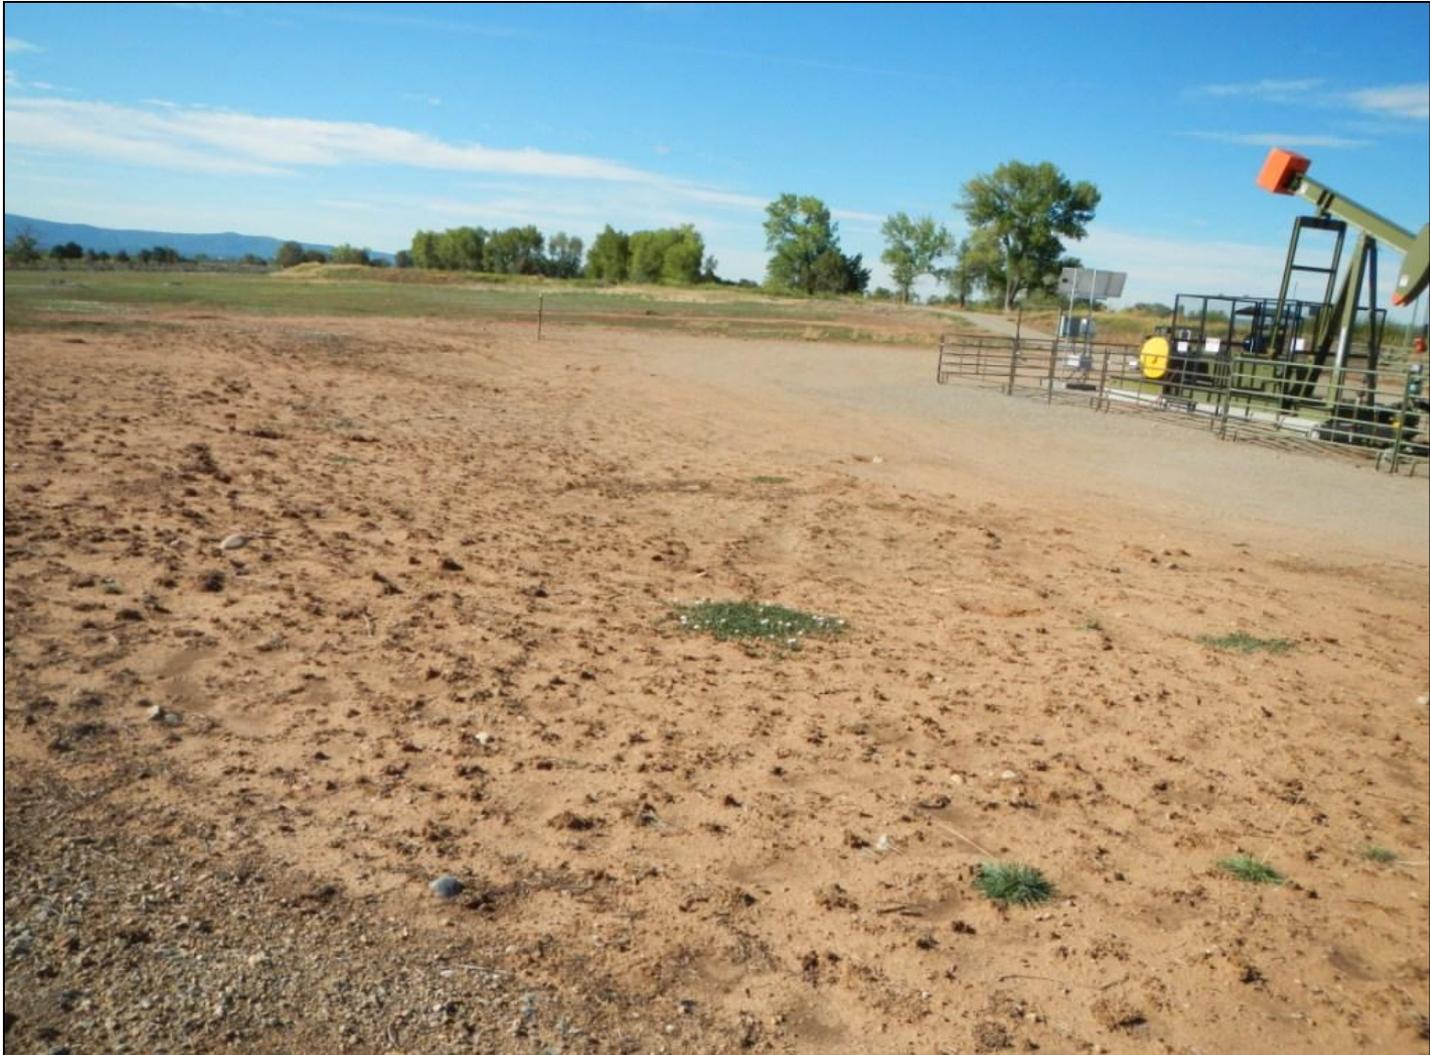
Photo 3. View of interim reclamation area from approximate northeastern corner of well pad facing southward. Run-on from unvegetated interim reclamation area onto well pad can be seen.
