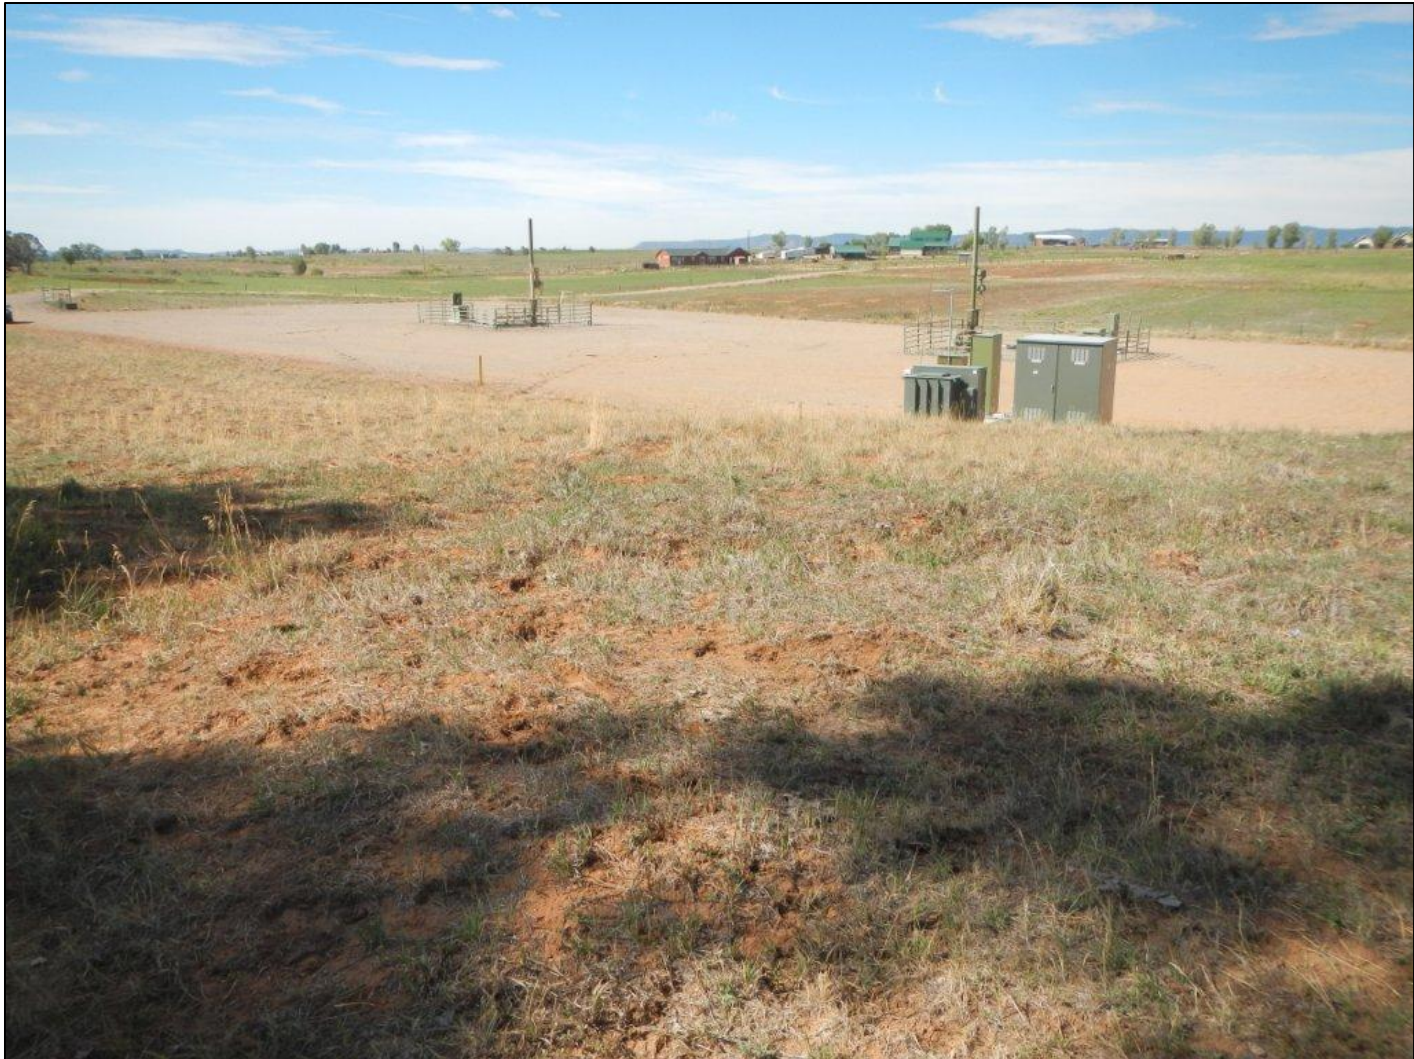
Photo 1. View from northeastern corner of project area toward center.  
Note sufficient grass cover within interim reclamation area.

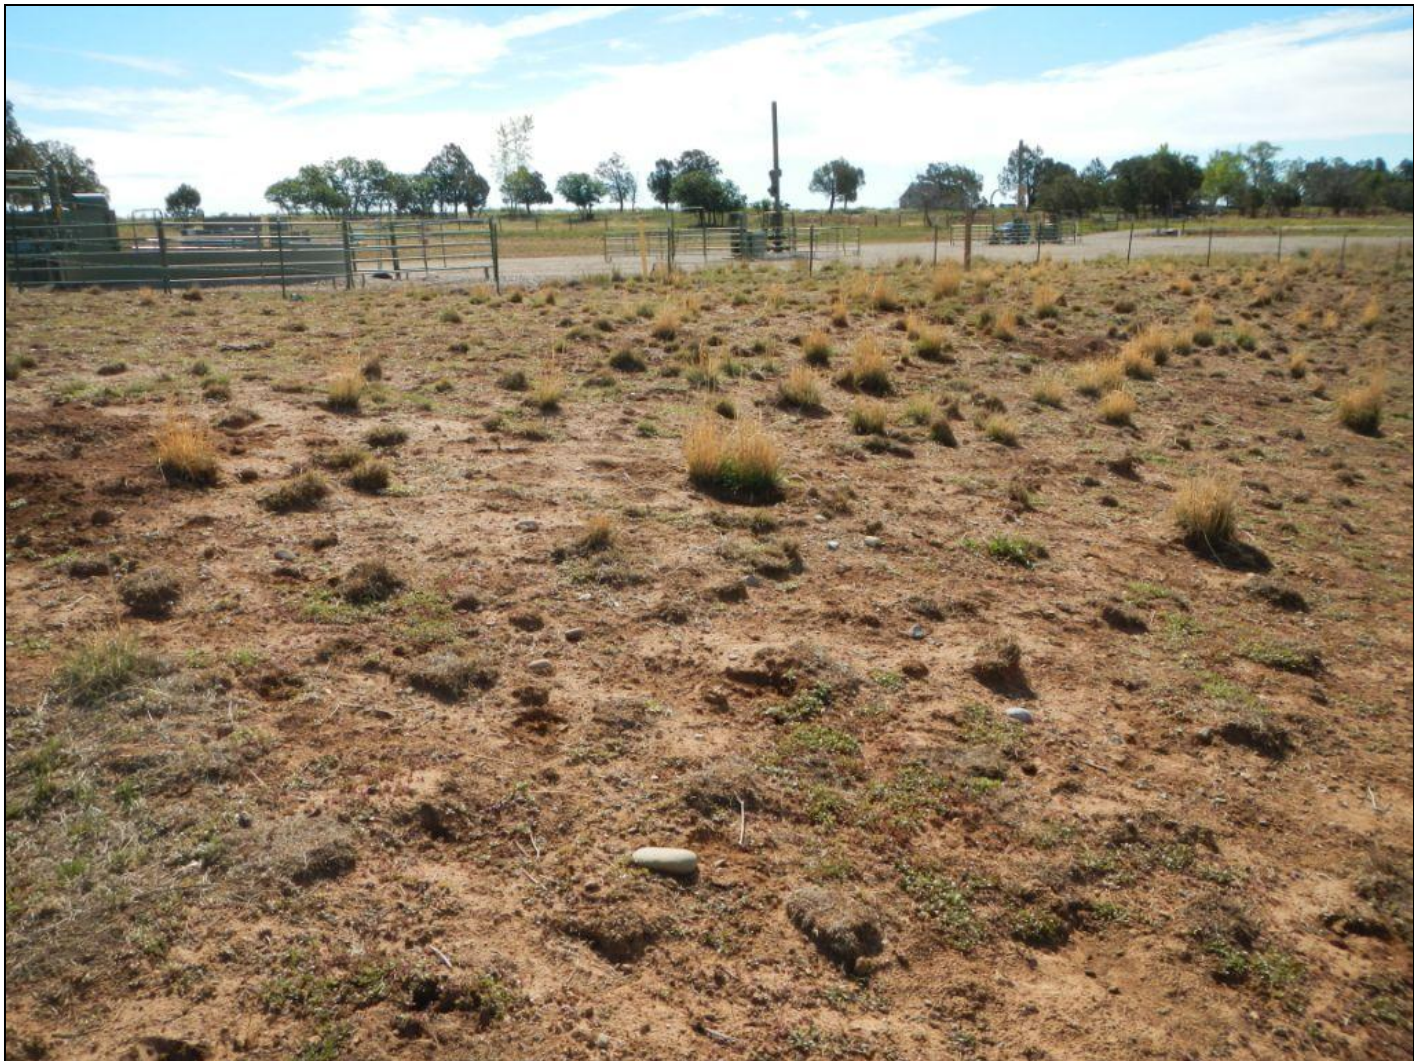
Photo 2. View from southwestern corner of project area toward center.  
Note sparse cover within interim reclamation area.

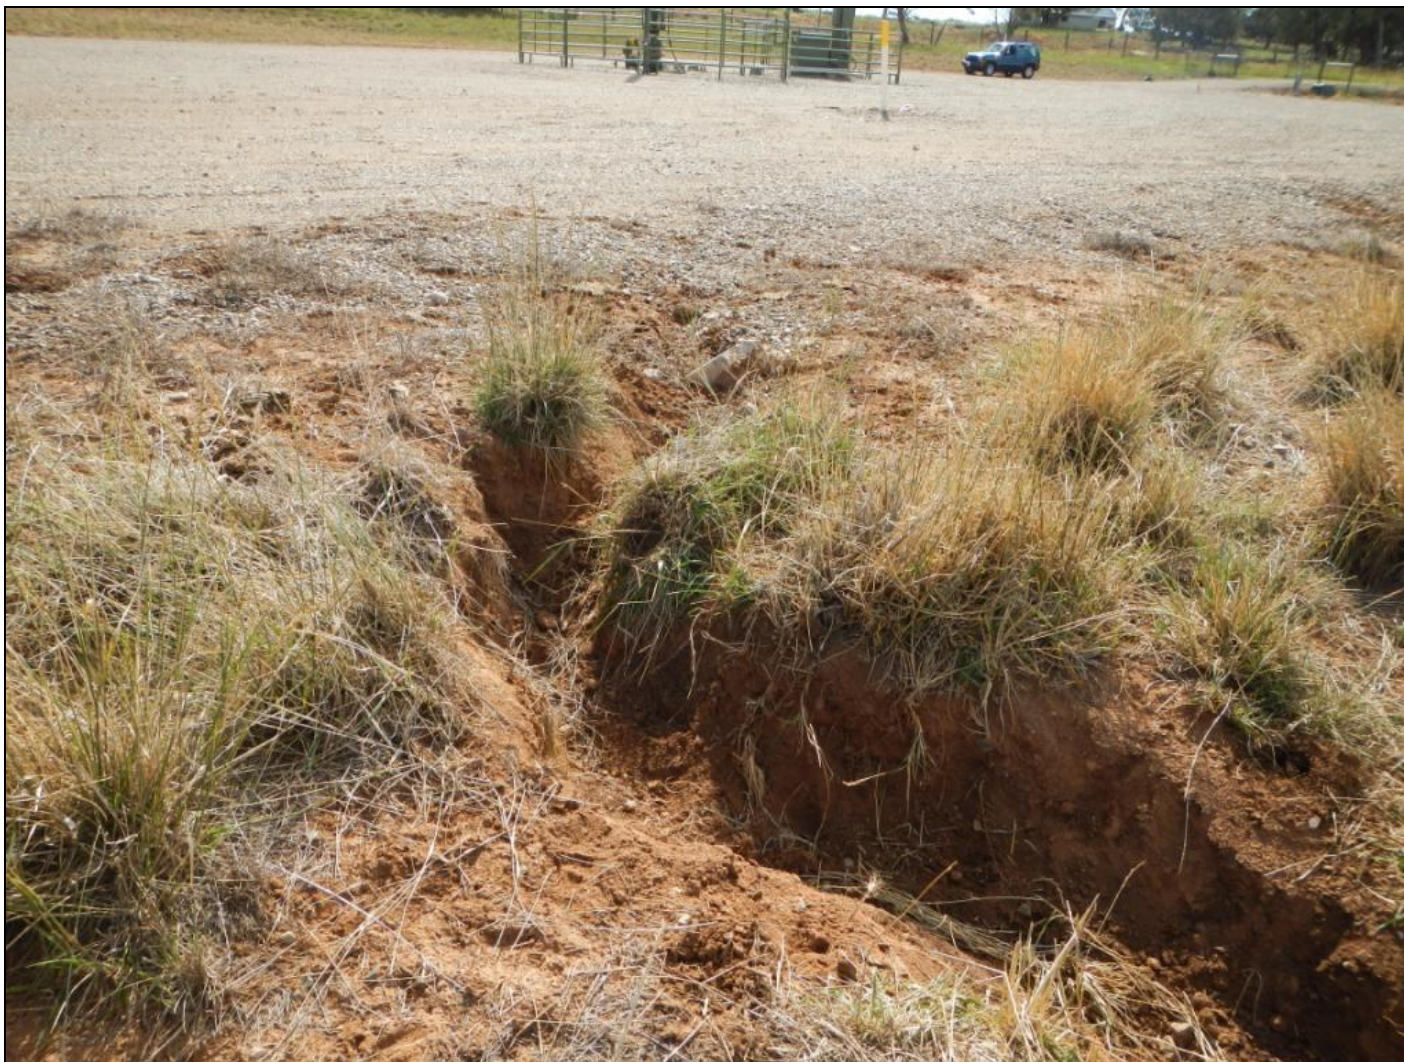
Photo 3. View of erosive feature on the western edge of the well pad.
