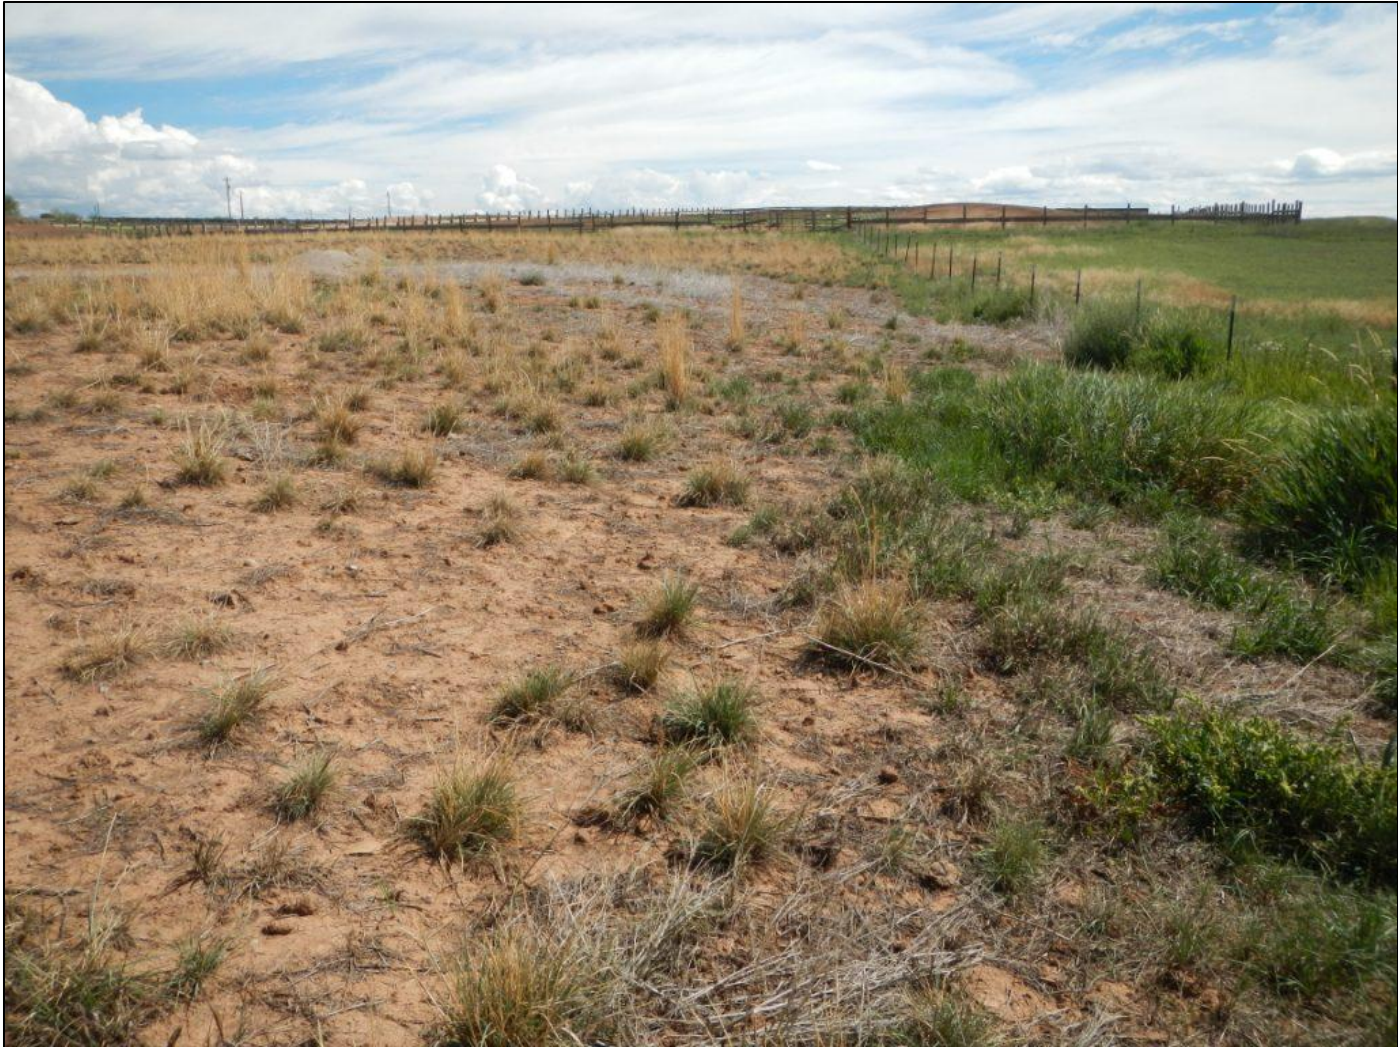
Photo 1. View of southern portion of interim reclamation area facing eastward with areas that are revegetated sufficiently and areas that are not revegetated sufficiently.

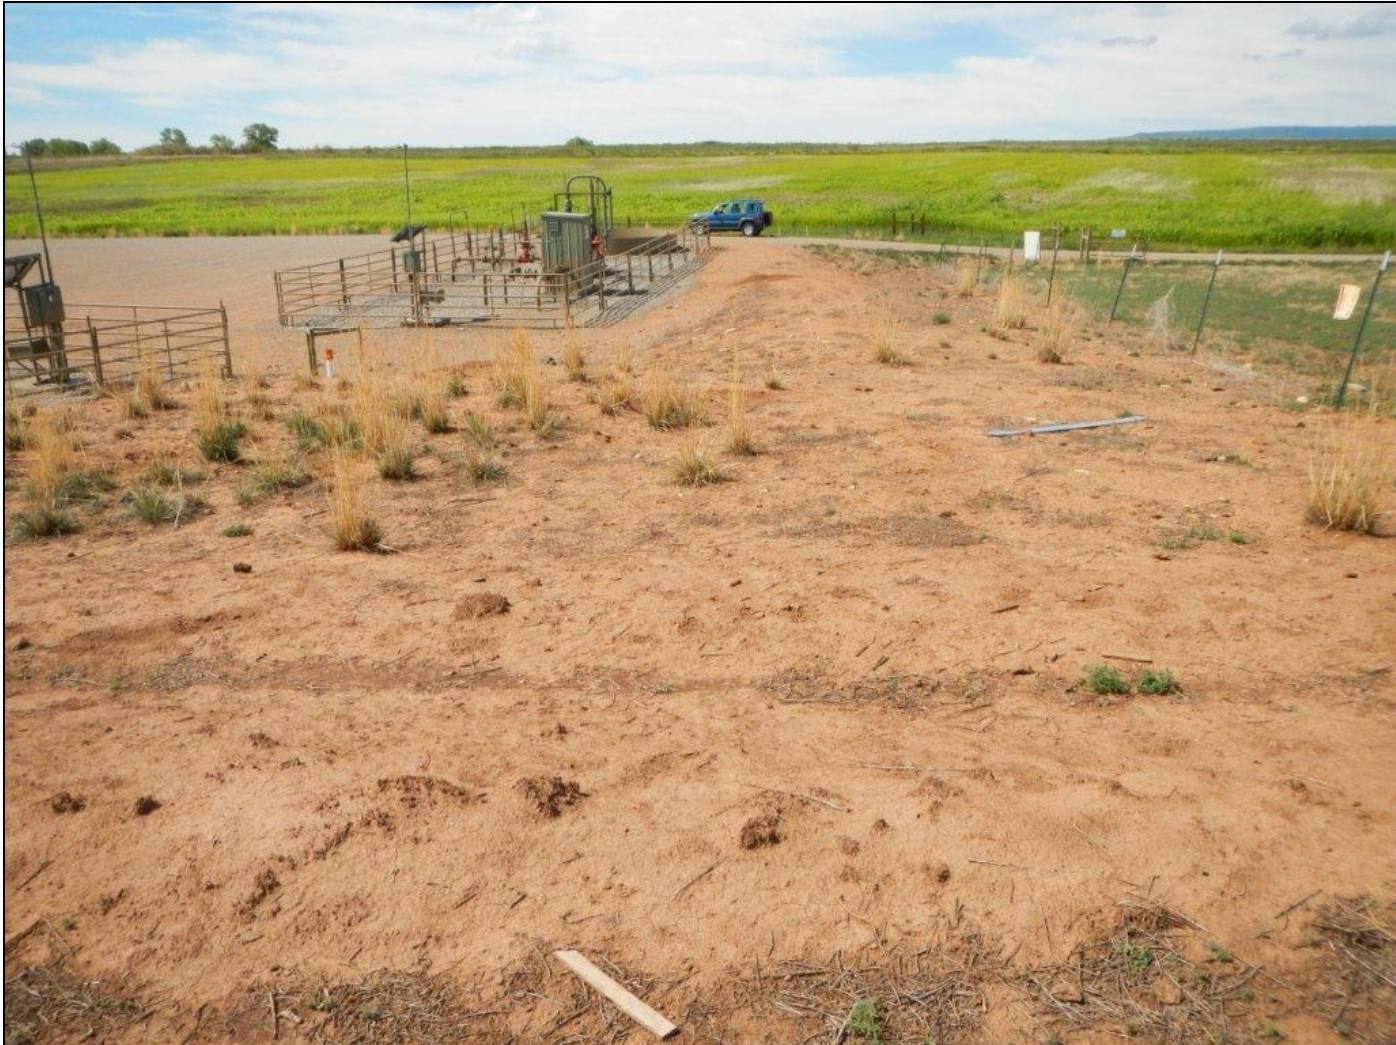
Photo 2. View of northern portion of interim reclamation area facing westward with a small area that is sufficiently revegetated and the majority of the area not sufficiently revegetated.

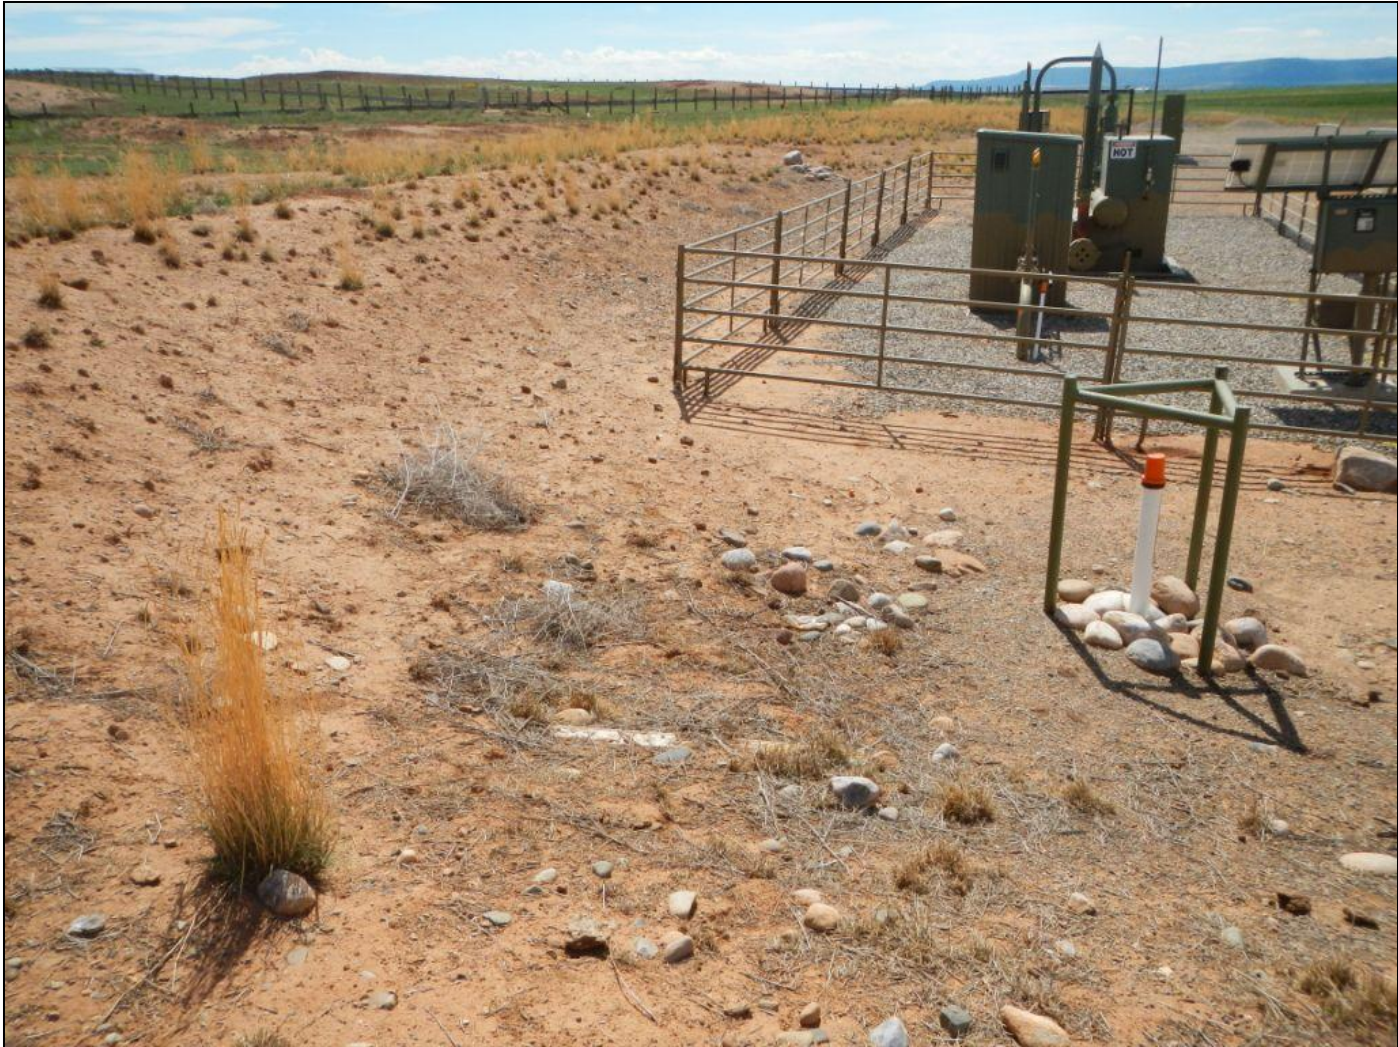
Photo 3. View of sediment that has discharged off of the interim reclamation area slopes onto the working area in the northeastern corner of the well pad.

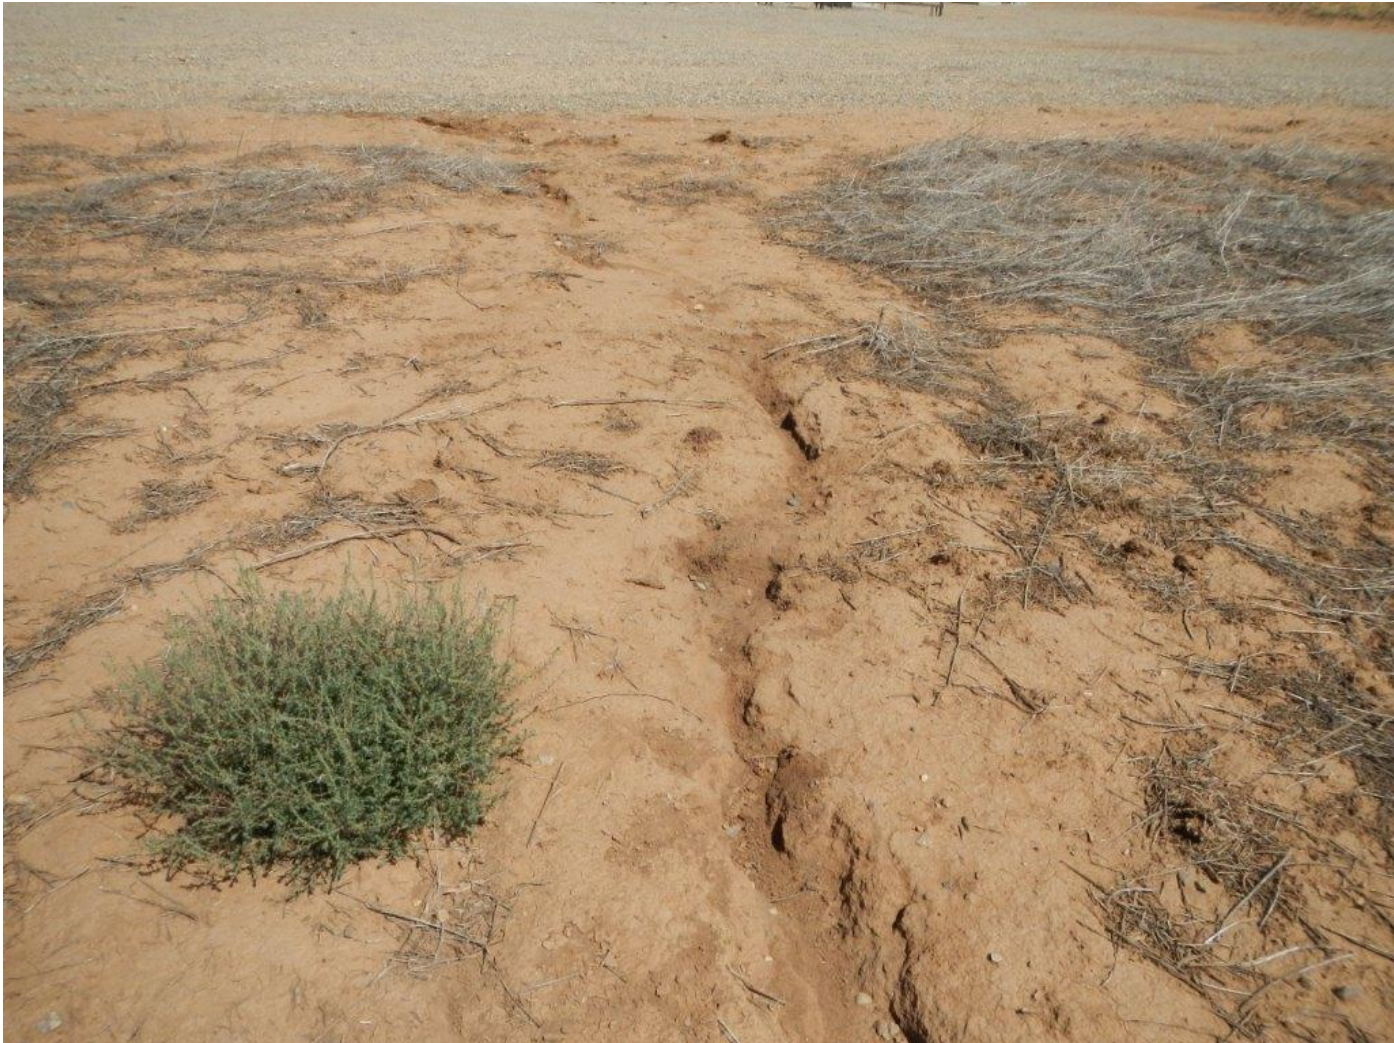
Photo 4. View of rill erosion from southern edge of working area onto the interim reclamation area.
