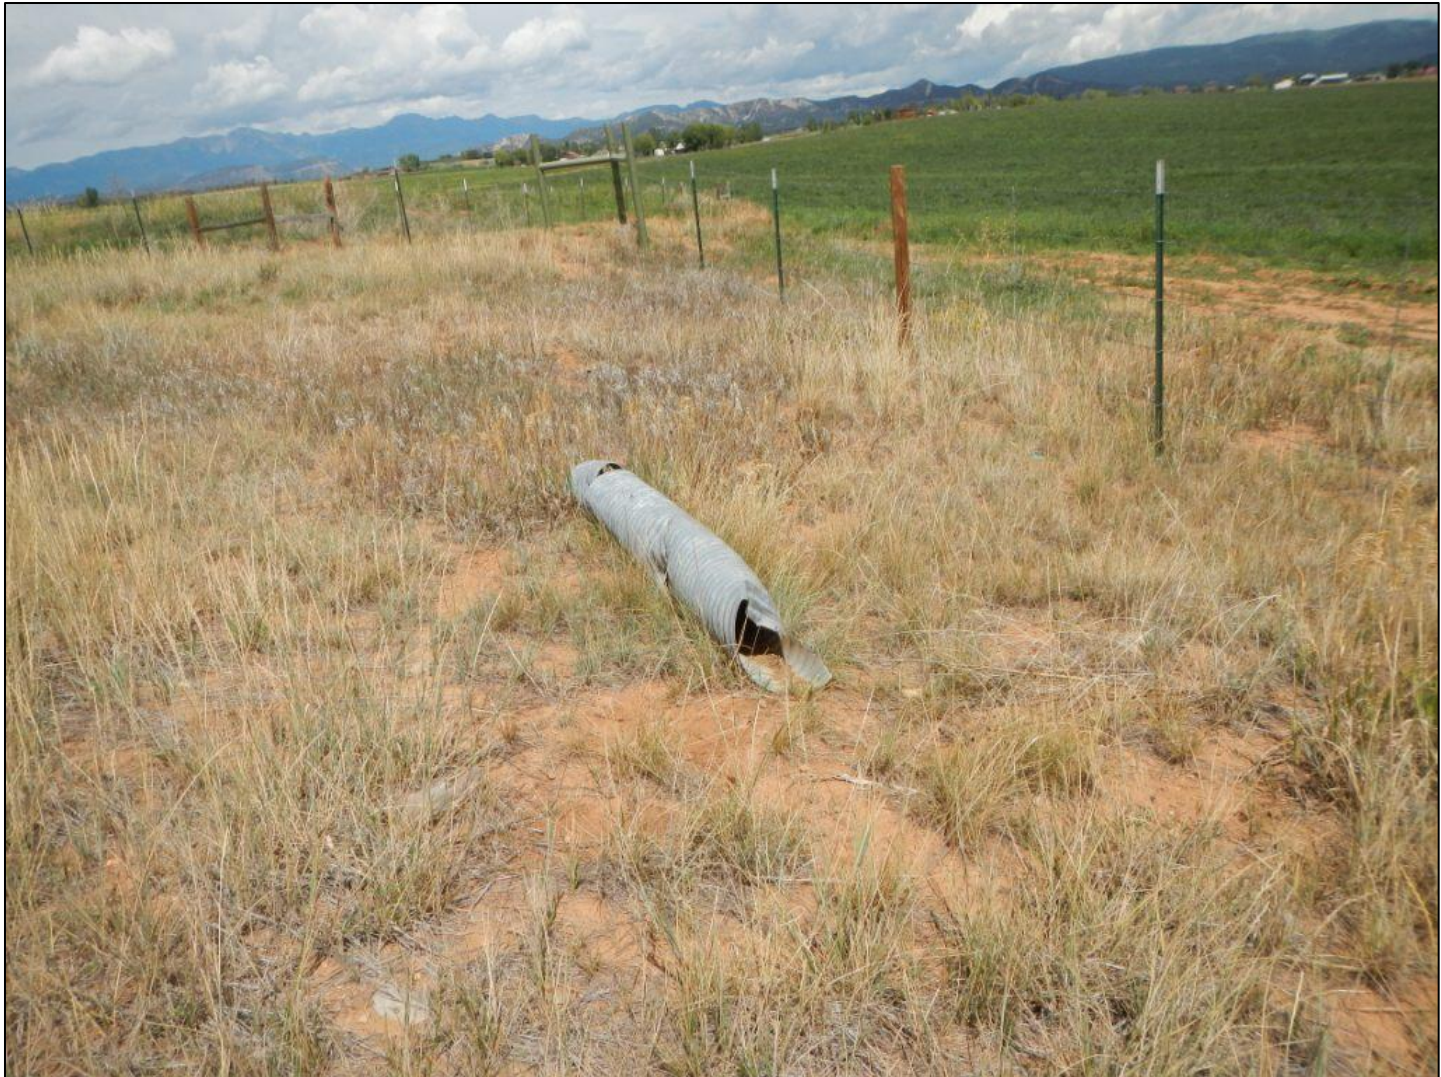
Photo 1. View of unused culvert in northeastern corner of project area.

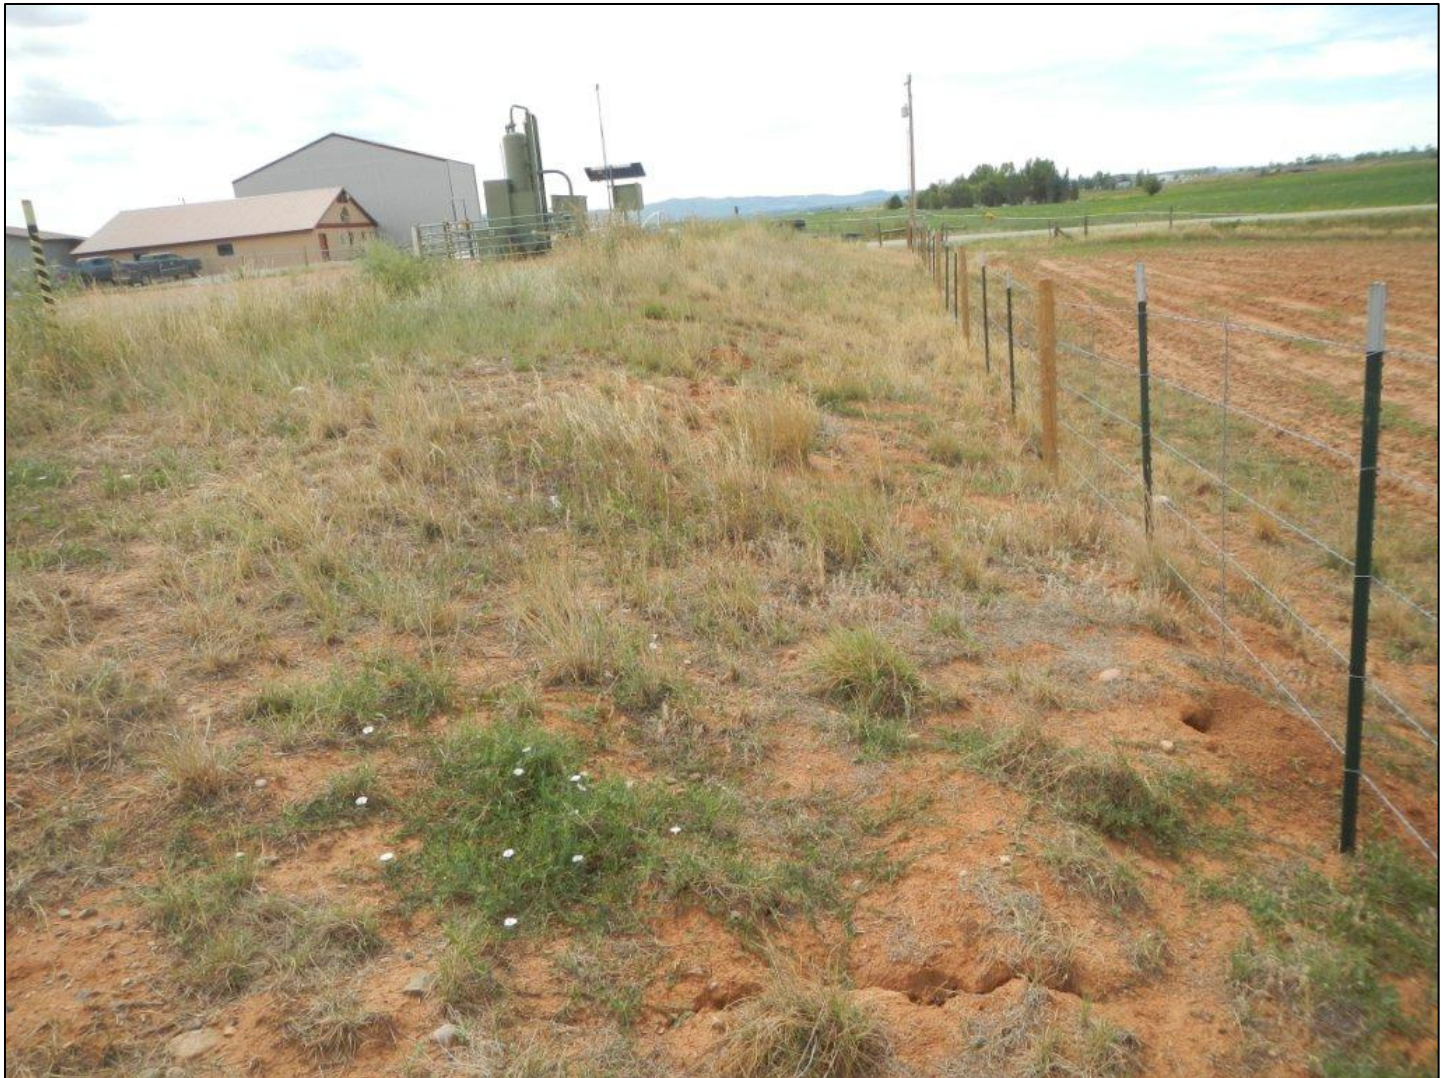
Photo 2. View of western portion of interim reclamation area facing southward.

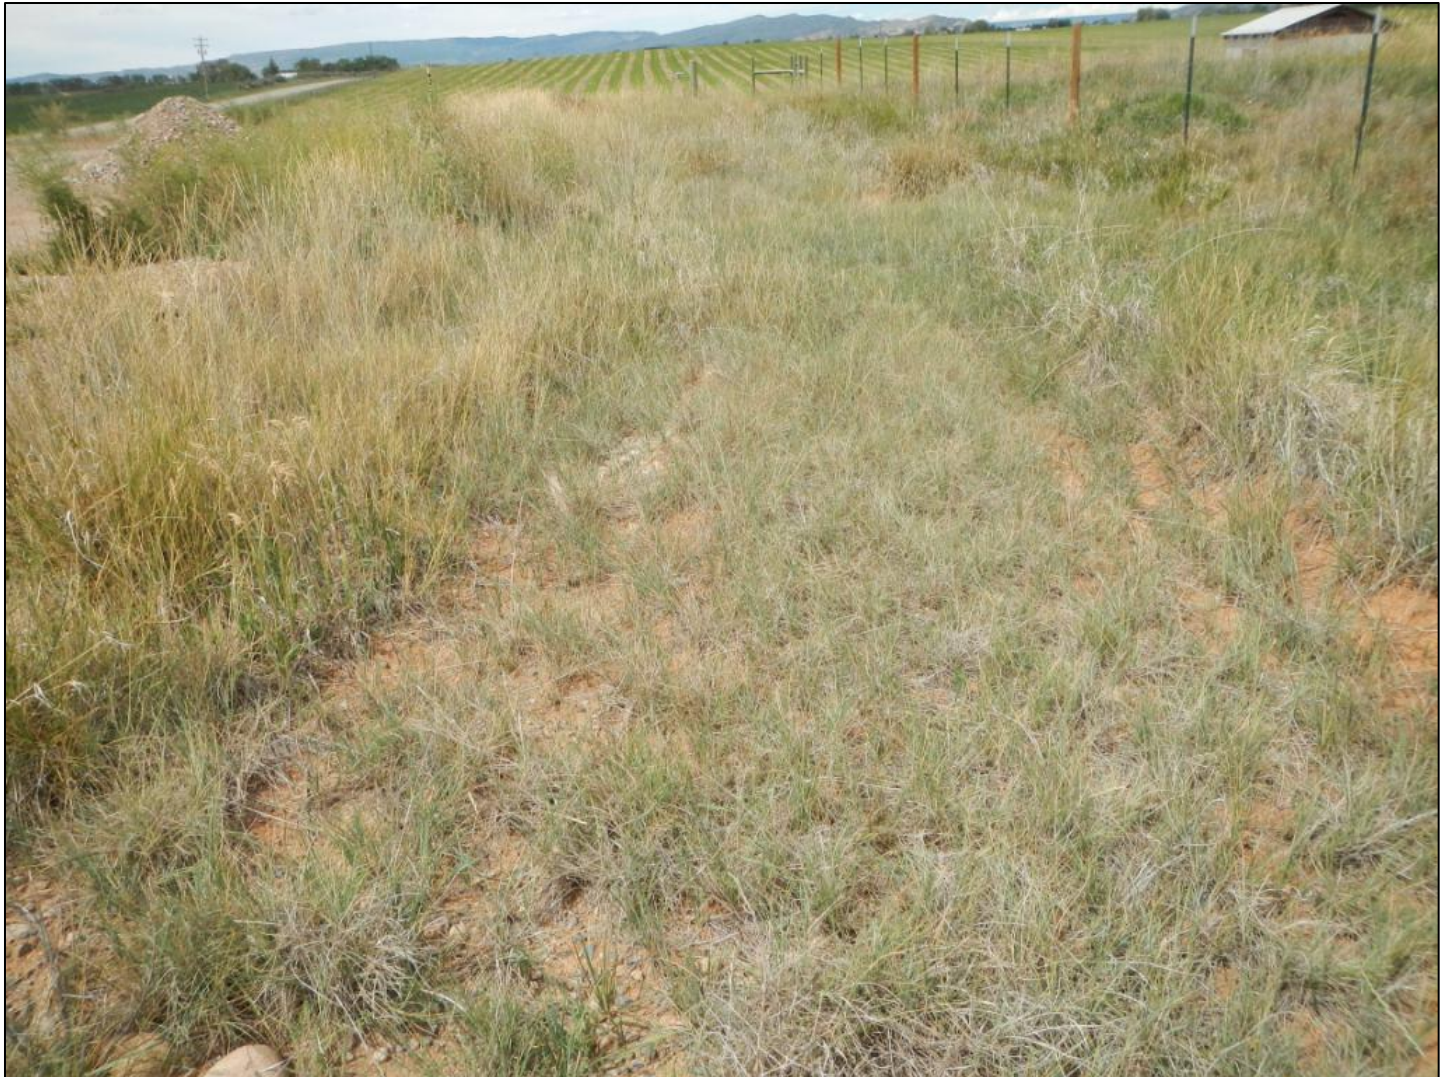
Photo 3. View of northern portion of interim reclamation area facing westward.

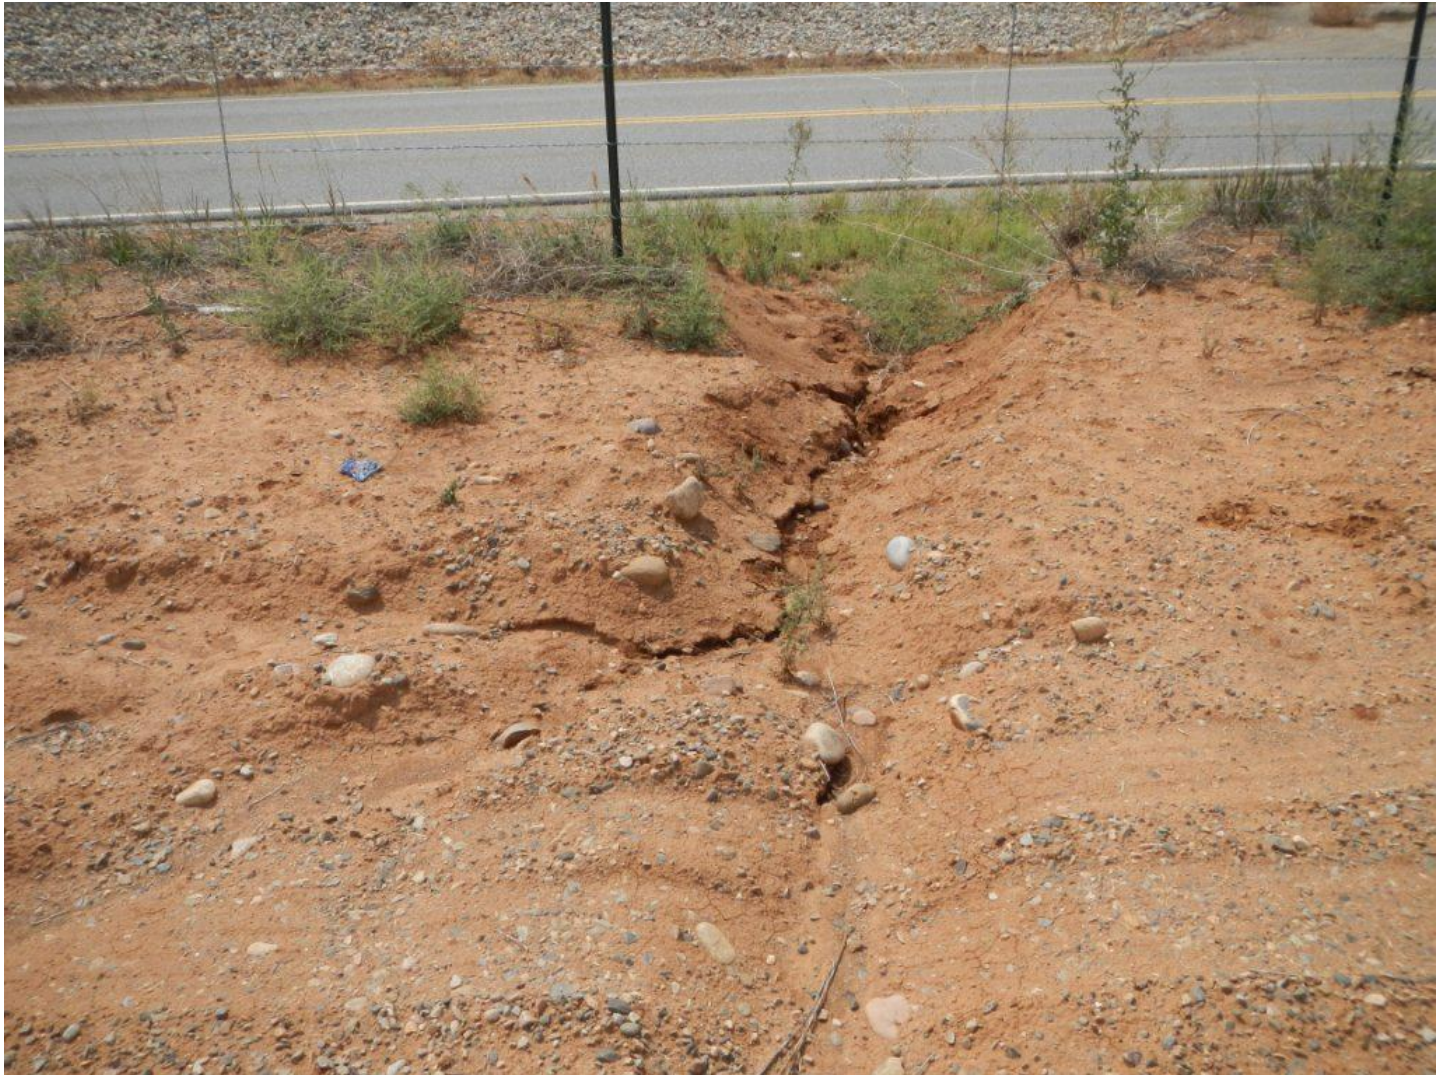
Photo 4. View of rill erosion along southern edge of well pad.
