South Shale Ridge 1-8H

Inspection# 675200516

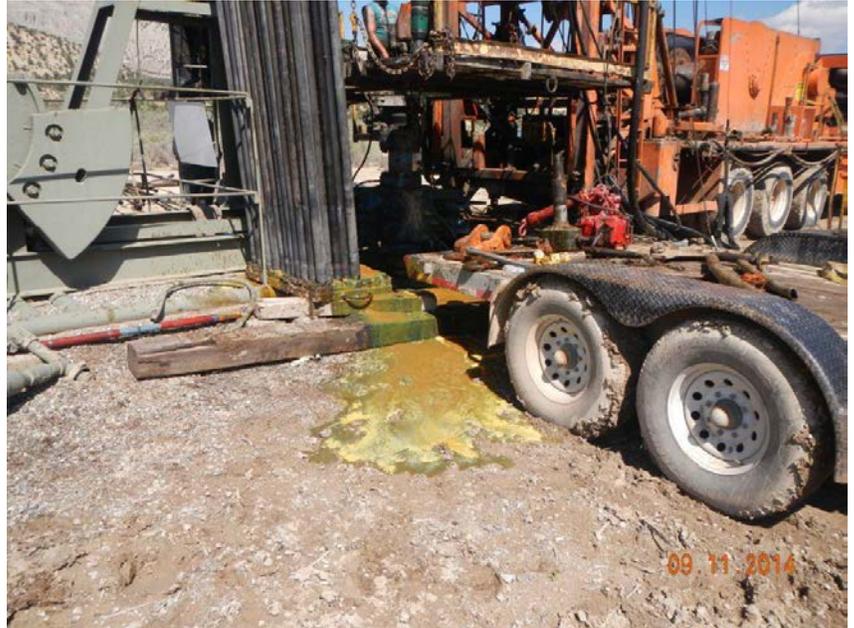
Parraffin spill

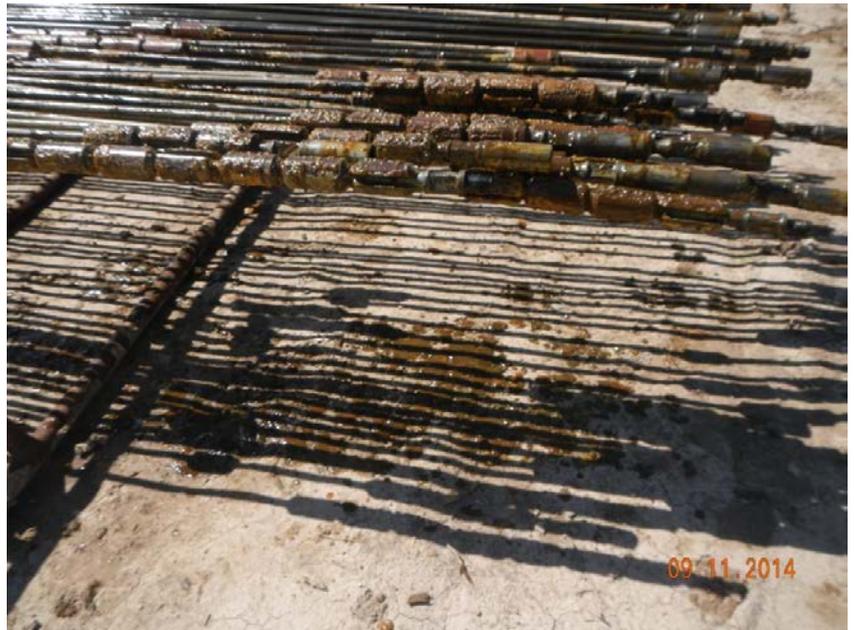
Parraffin dripping off rods pulled from well.

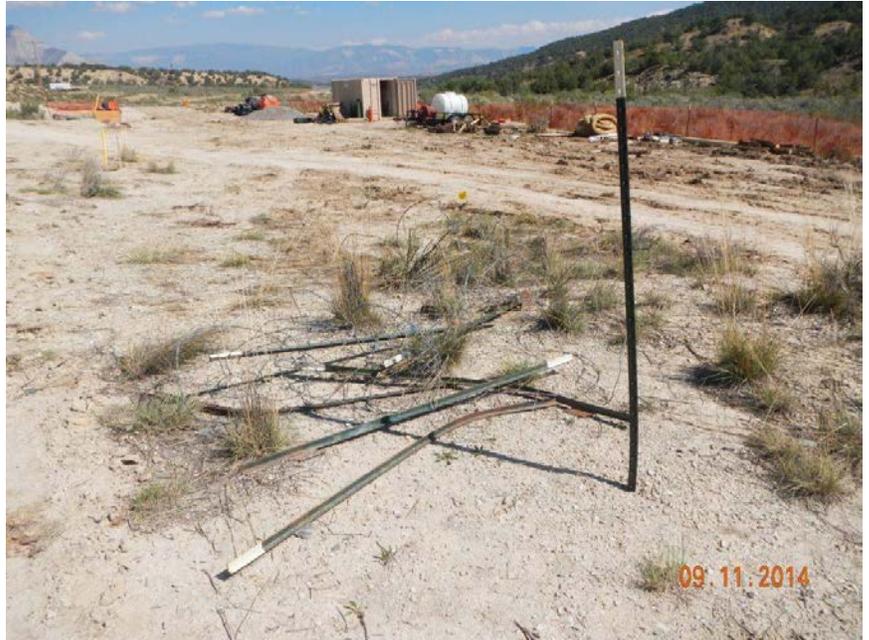
Fencing material to be removed

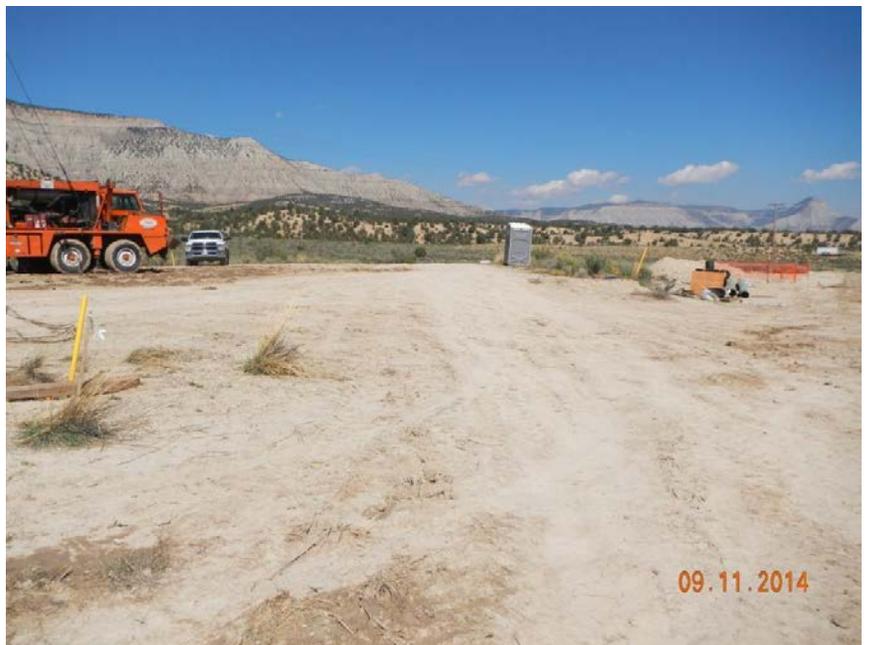
No stormwater BMPs in place.
Access to pipeline.

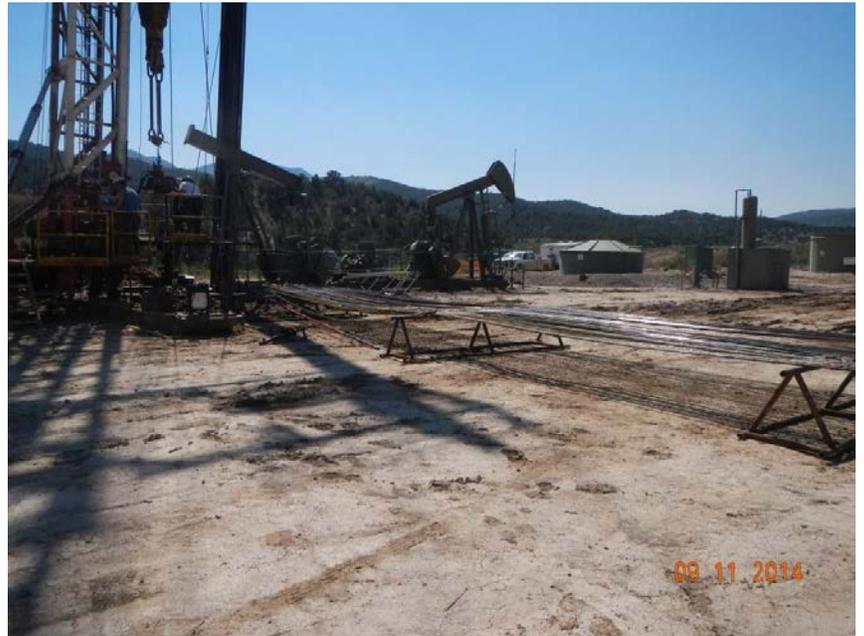
Rods from Pump Jack.

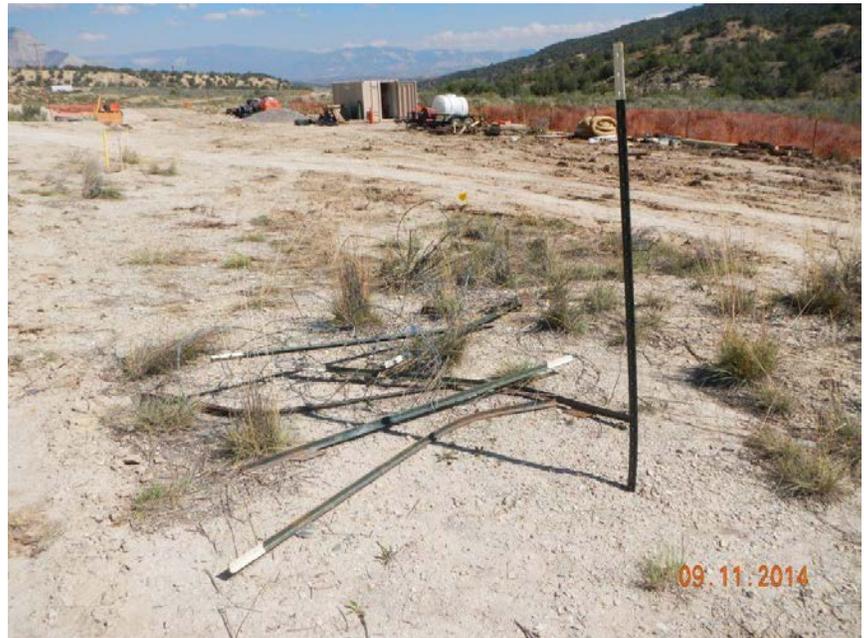
Fencing material to be removed
