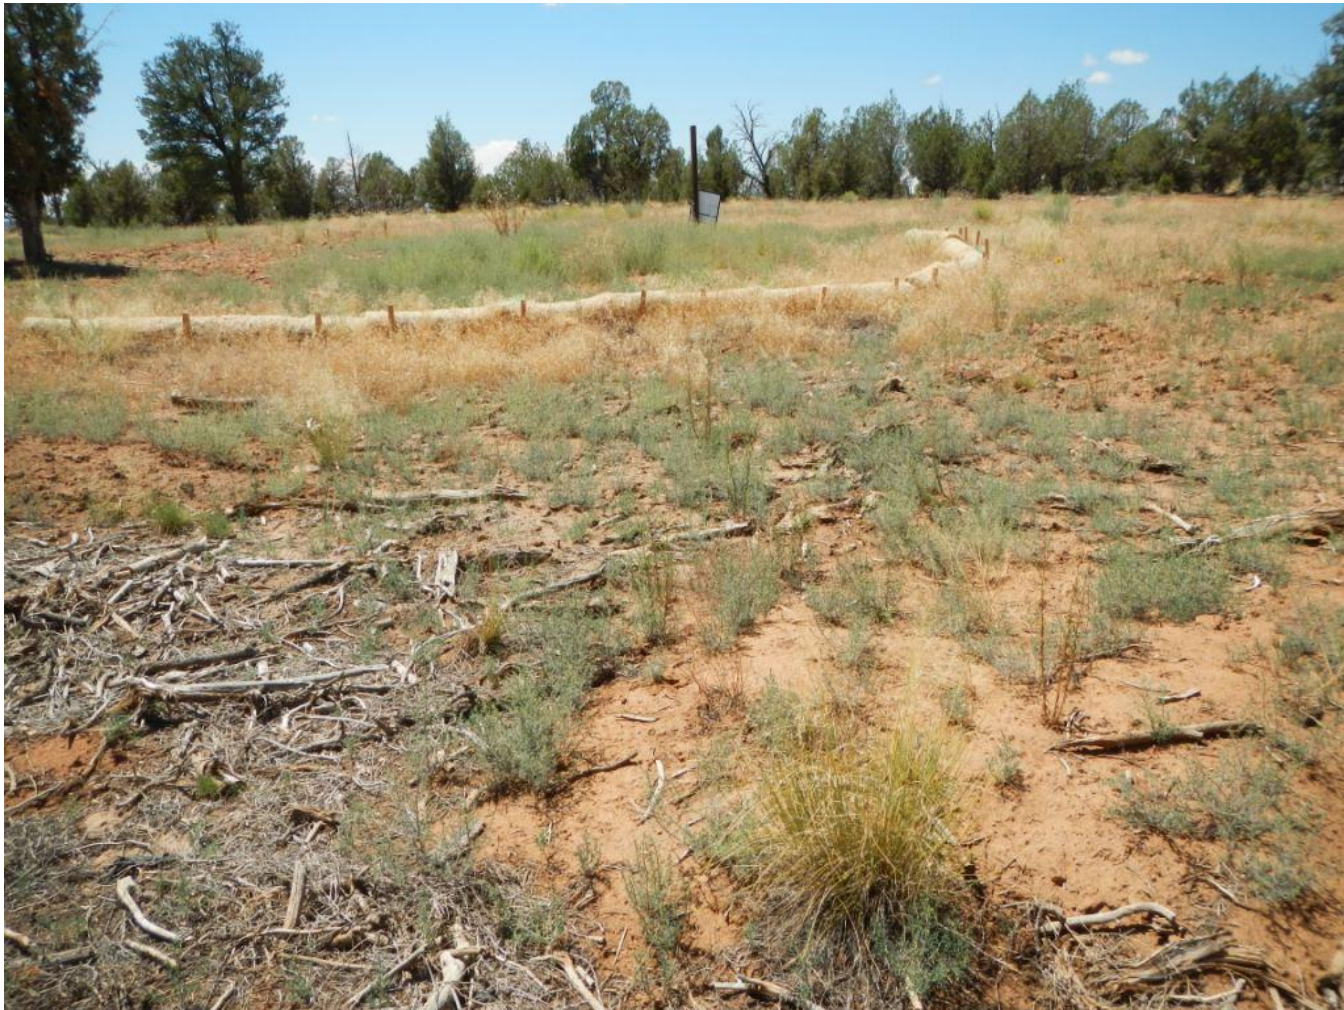
Photo 1. View from northeastern corner of well pad toward center. Straw wattle appears to be functioning properly.

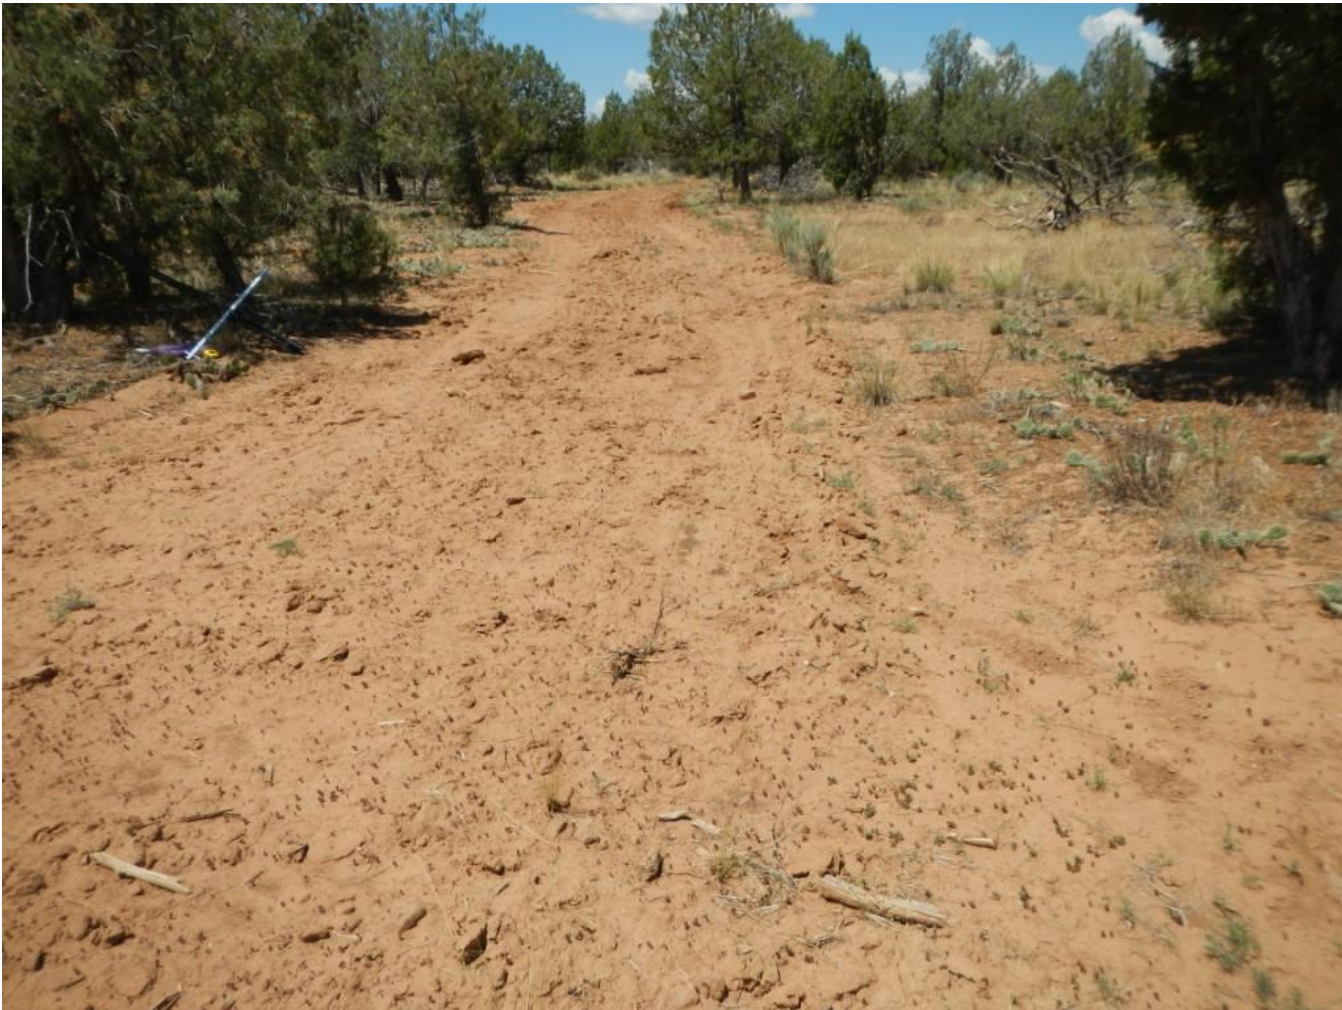
Photo 2. View of access road alignment from well pad facing westward.

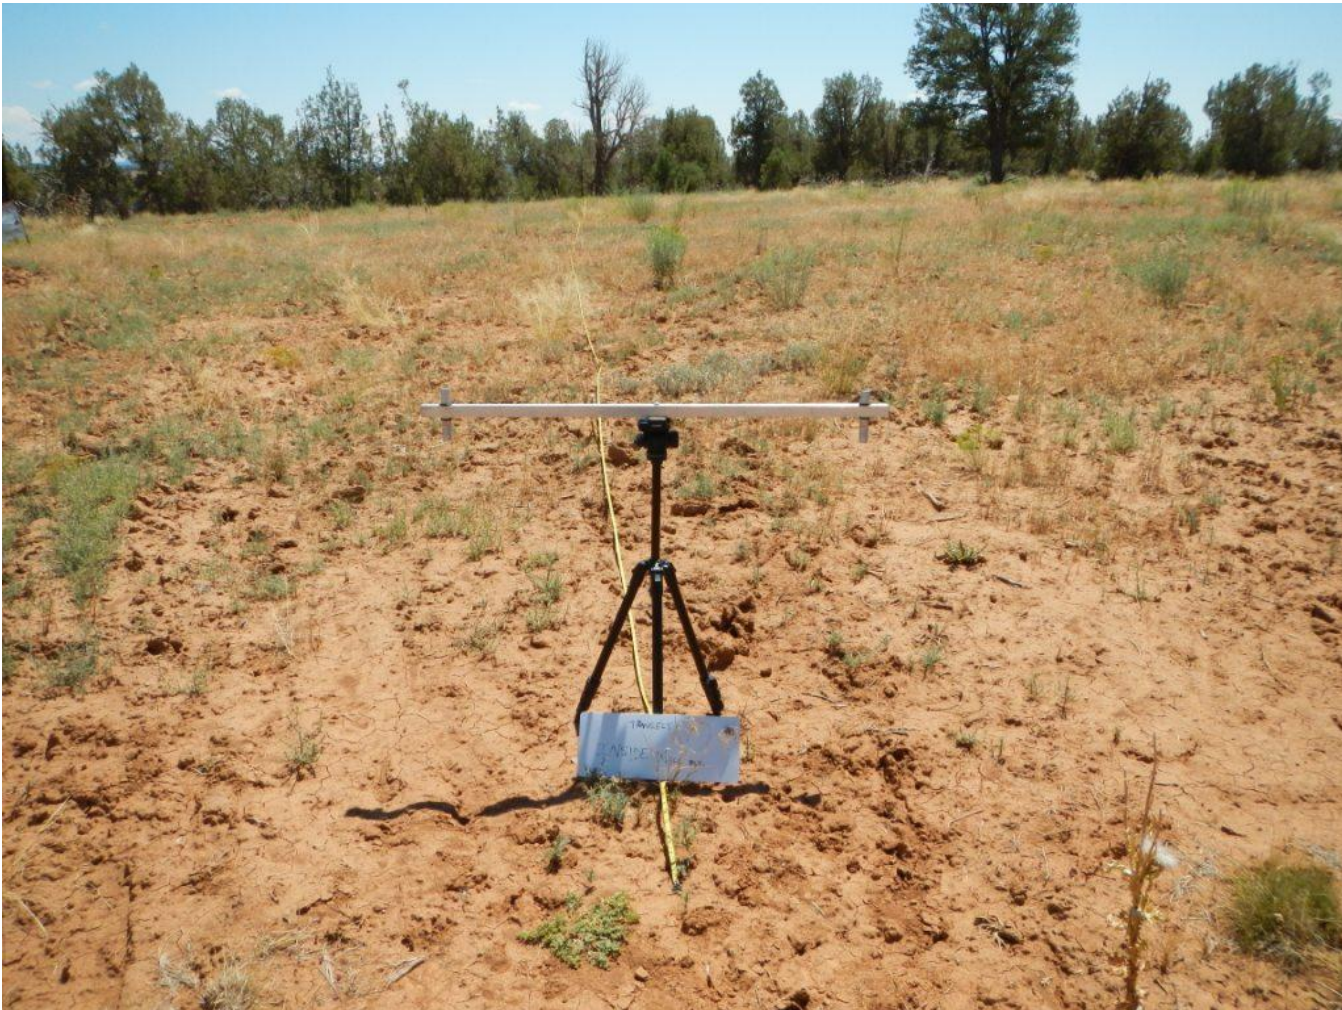
Photo 3. View of vegetation transect within well pad facing eastward.

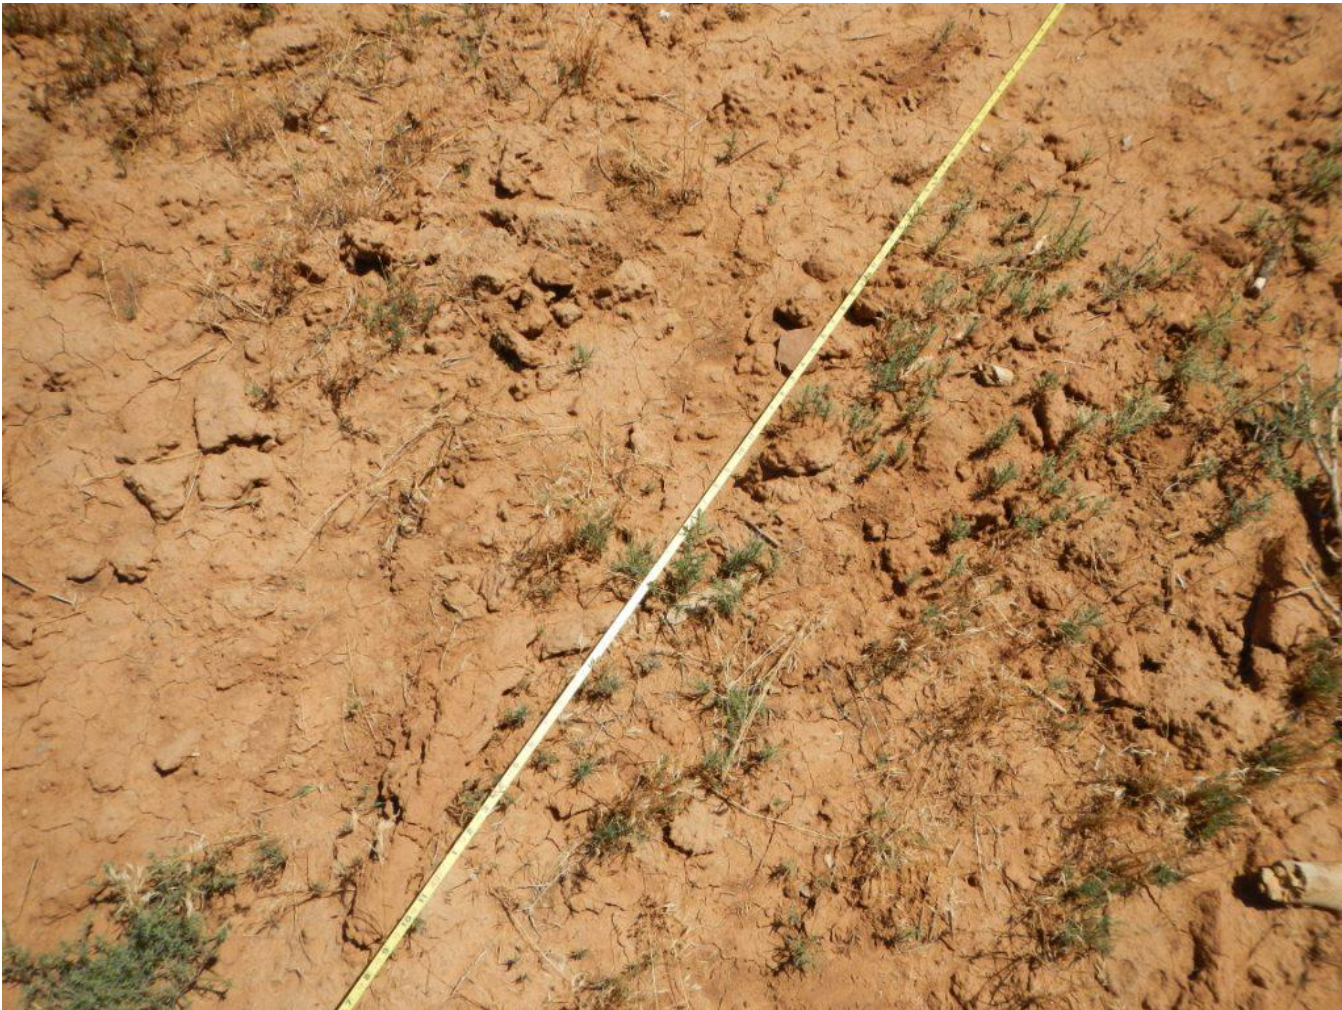
Photo 4. Birdseye view of vegetation at midpoint of transect within the well pad area.
