SOUTHWESTERN ENERGY PRODUCTION COMPANY – 10396

API # 107-06263 Inspection Photographs (19 total) 09/08/2014

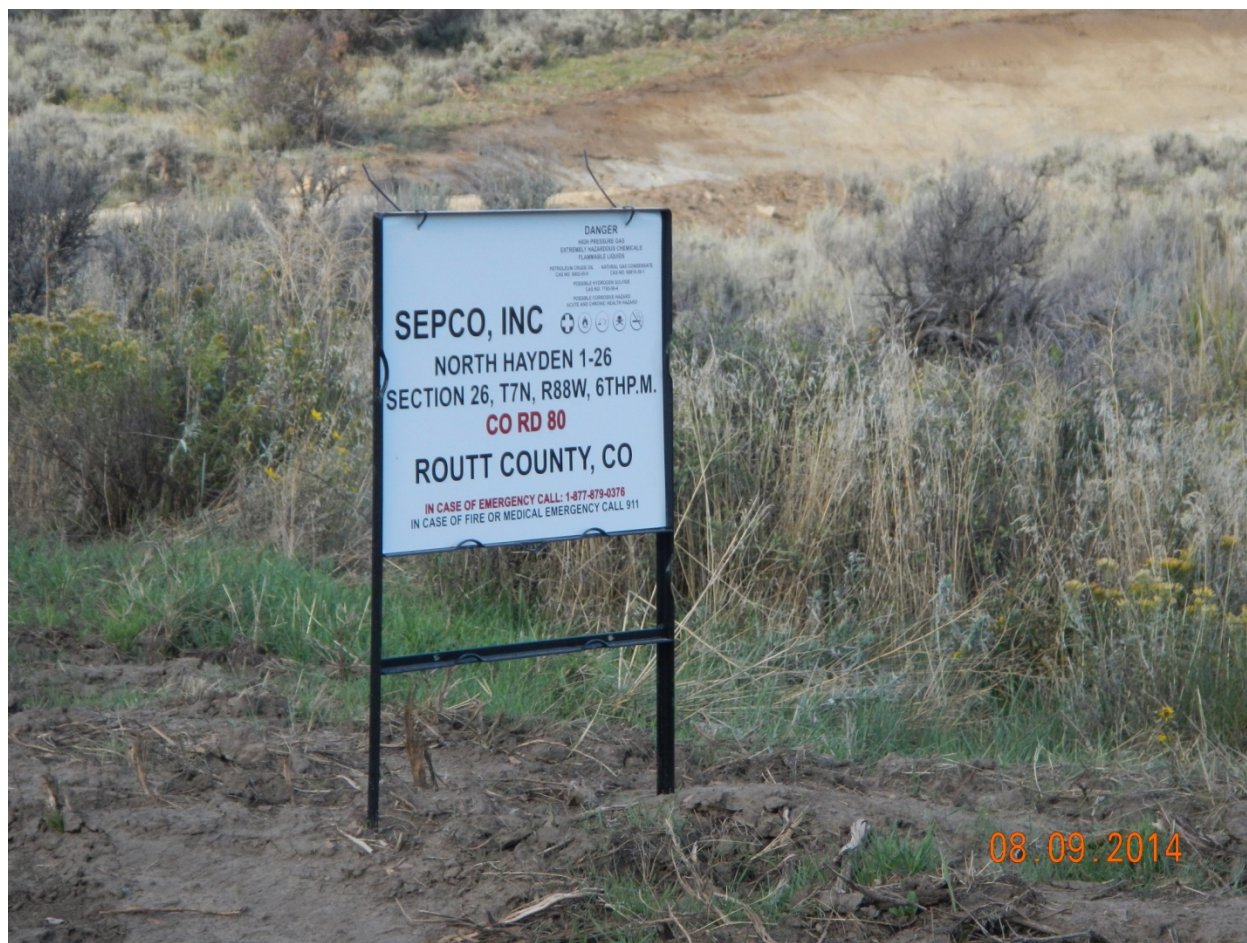
2. Location sign and information at entrance acceptable.

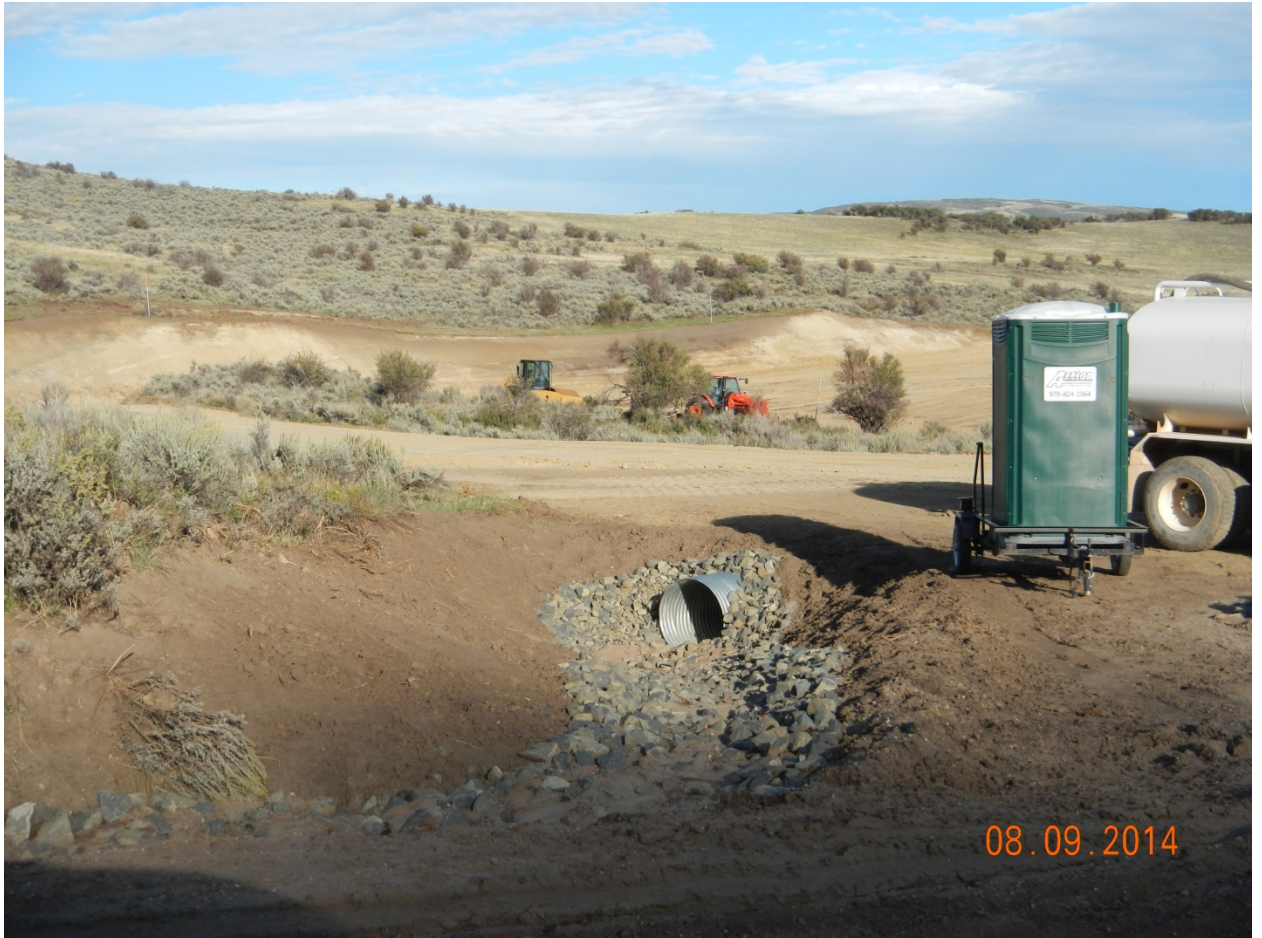
4. Entrance stormwater bmps performing (1).

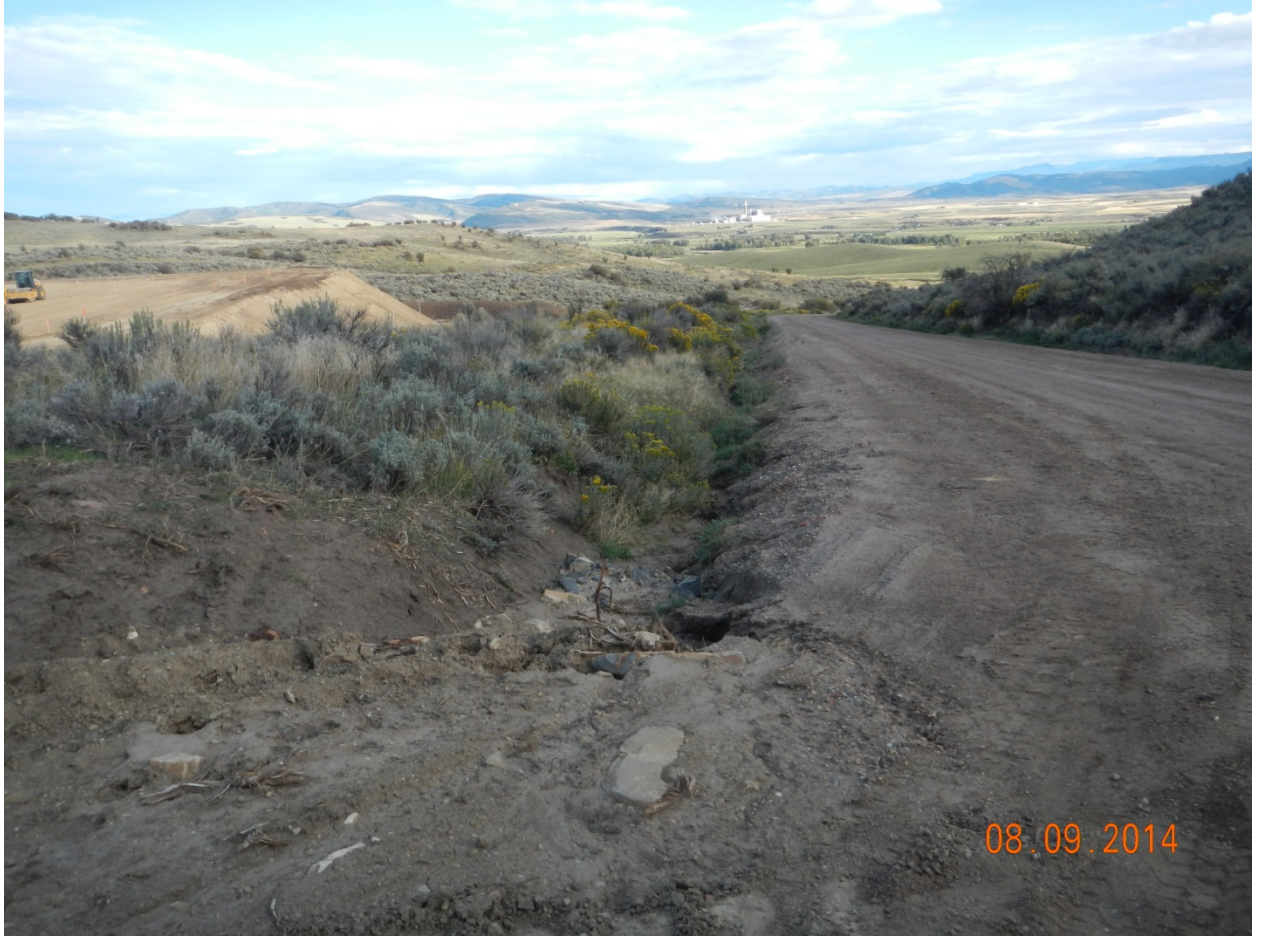
5. Entrance stormwater bmps performing (2).

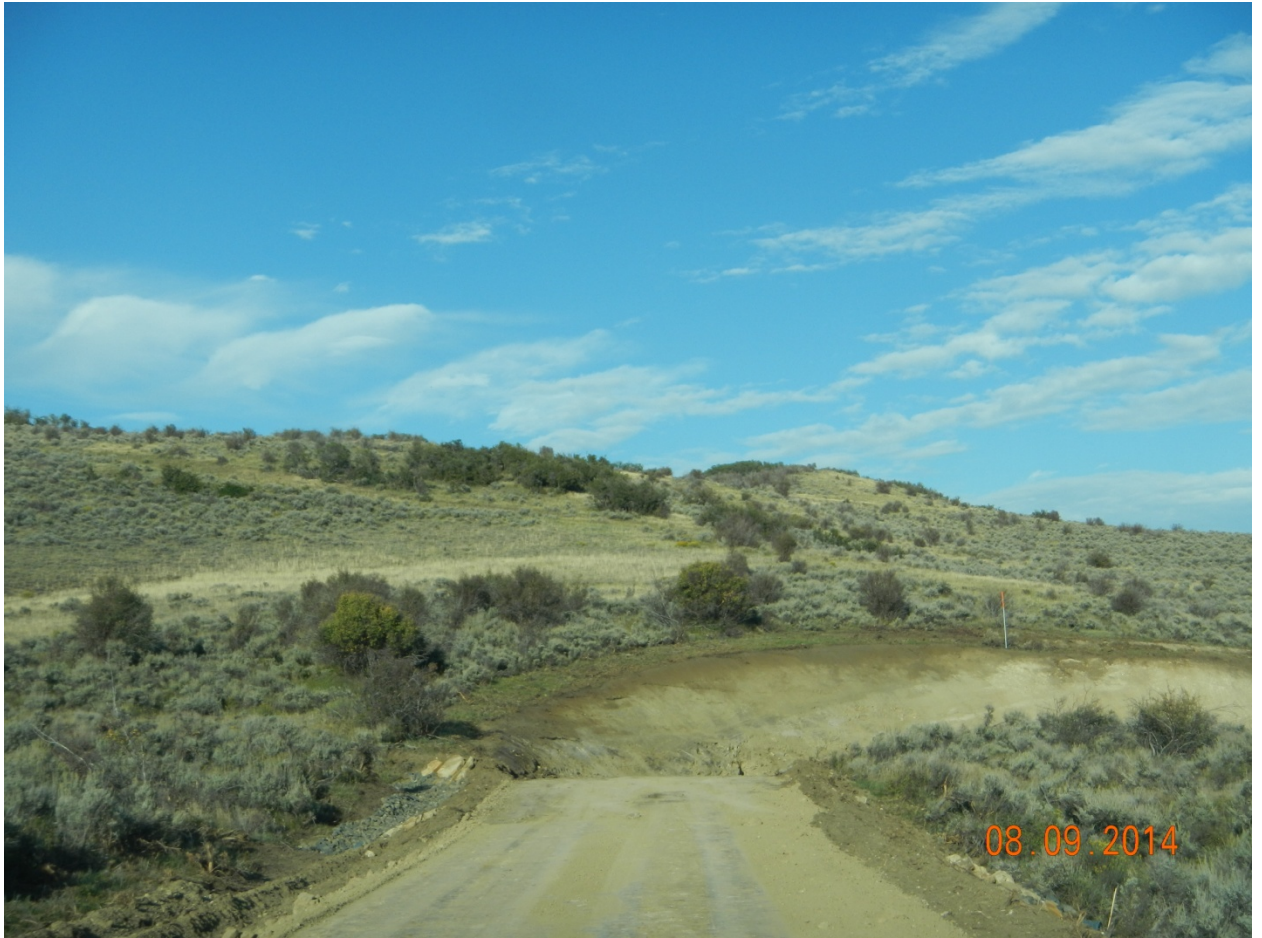
6. Entrance cut stable.

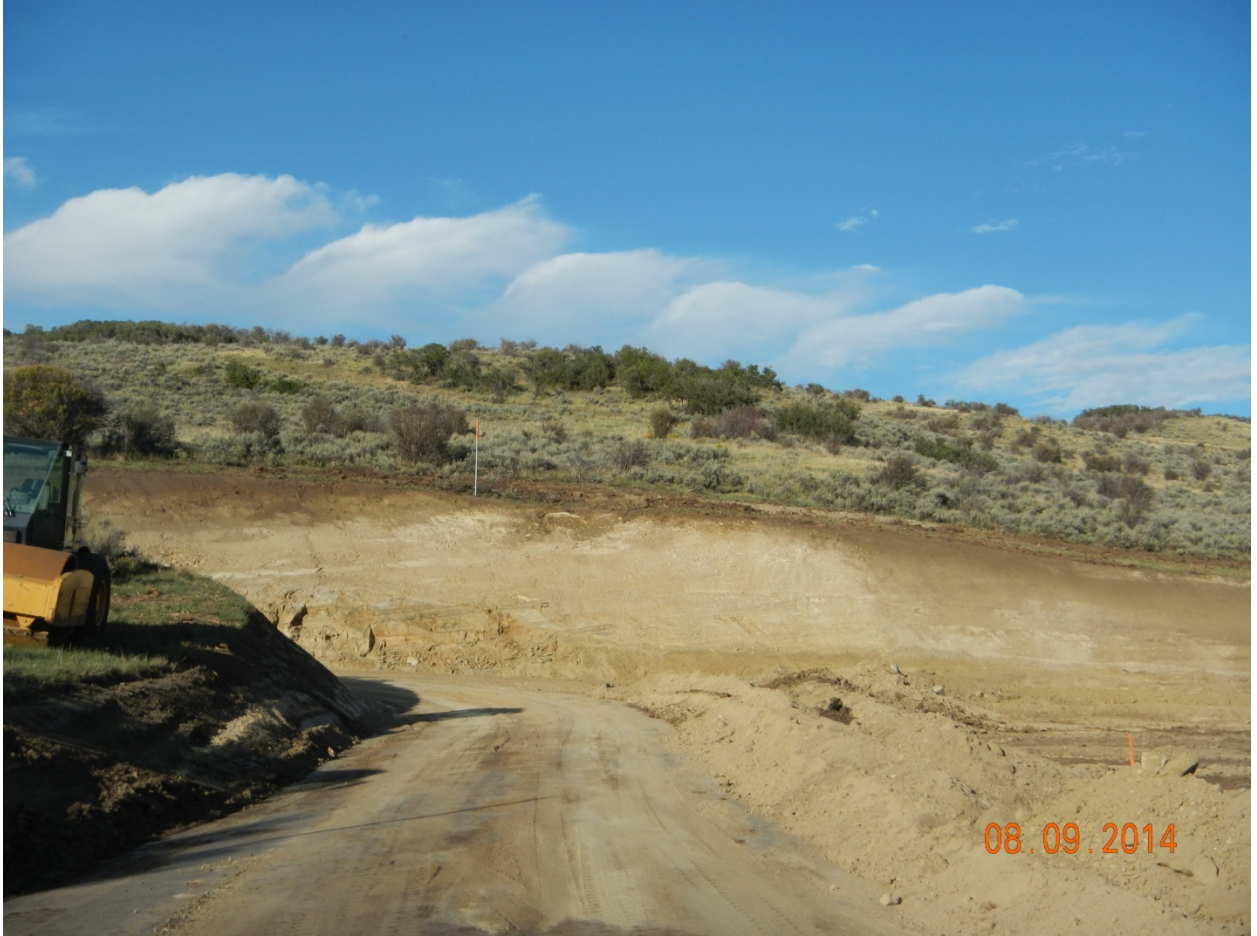
7. Northern face cut stable.

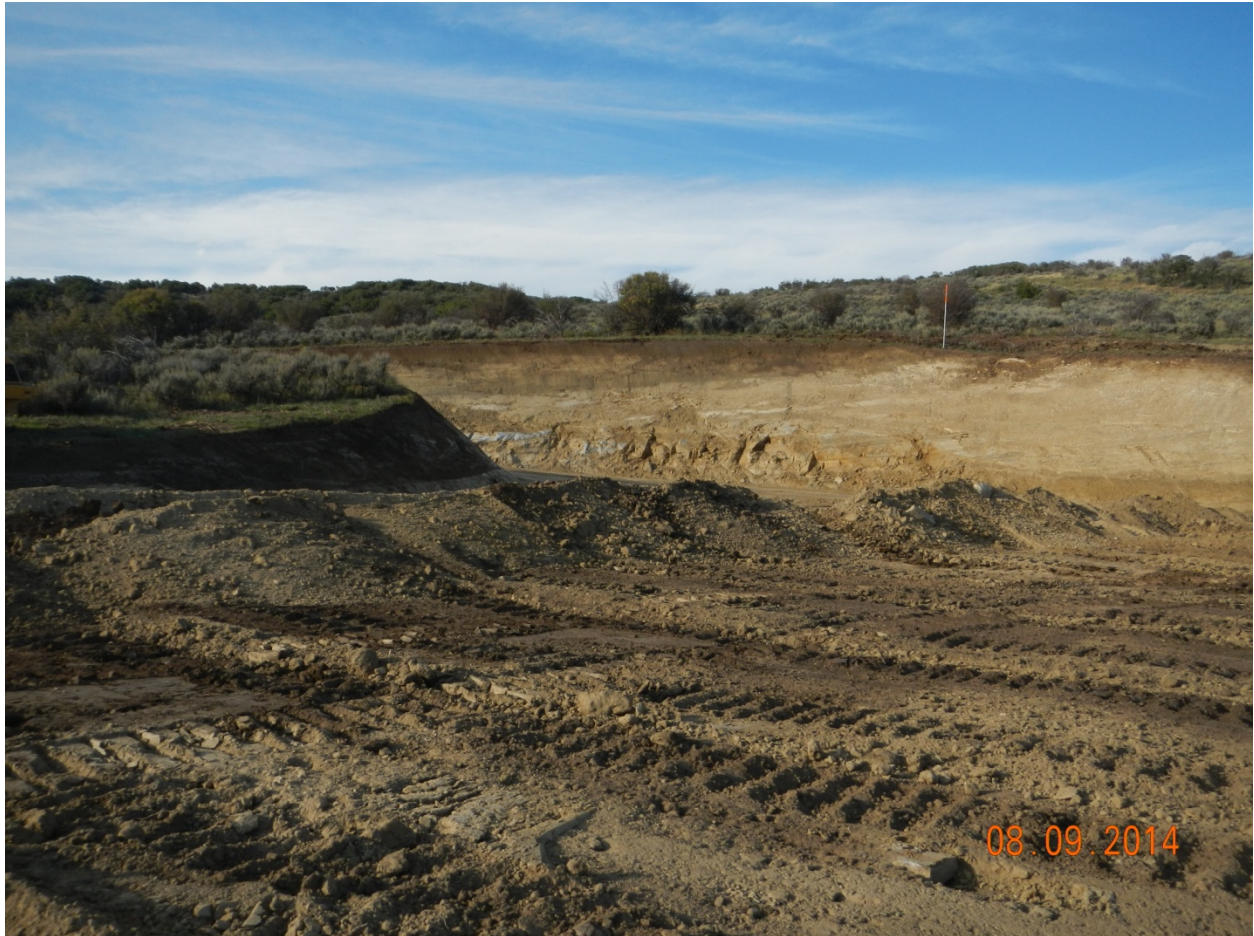
8. Cut on opposite side of access road (South) stable.

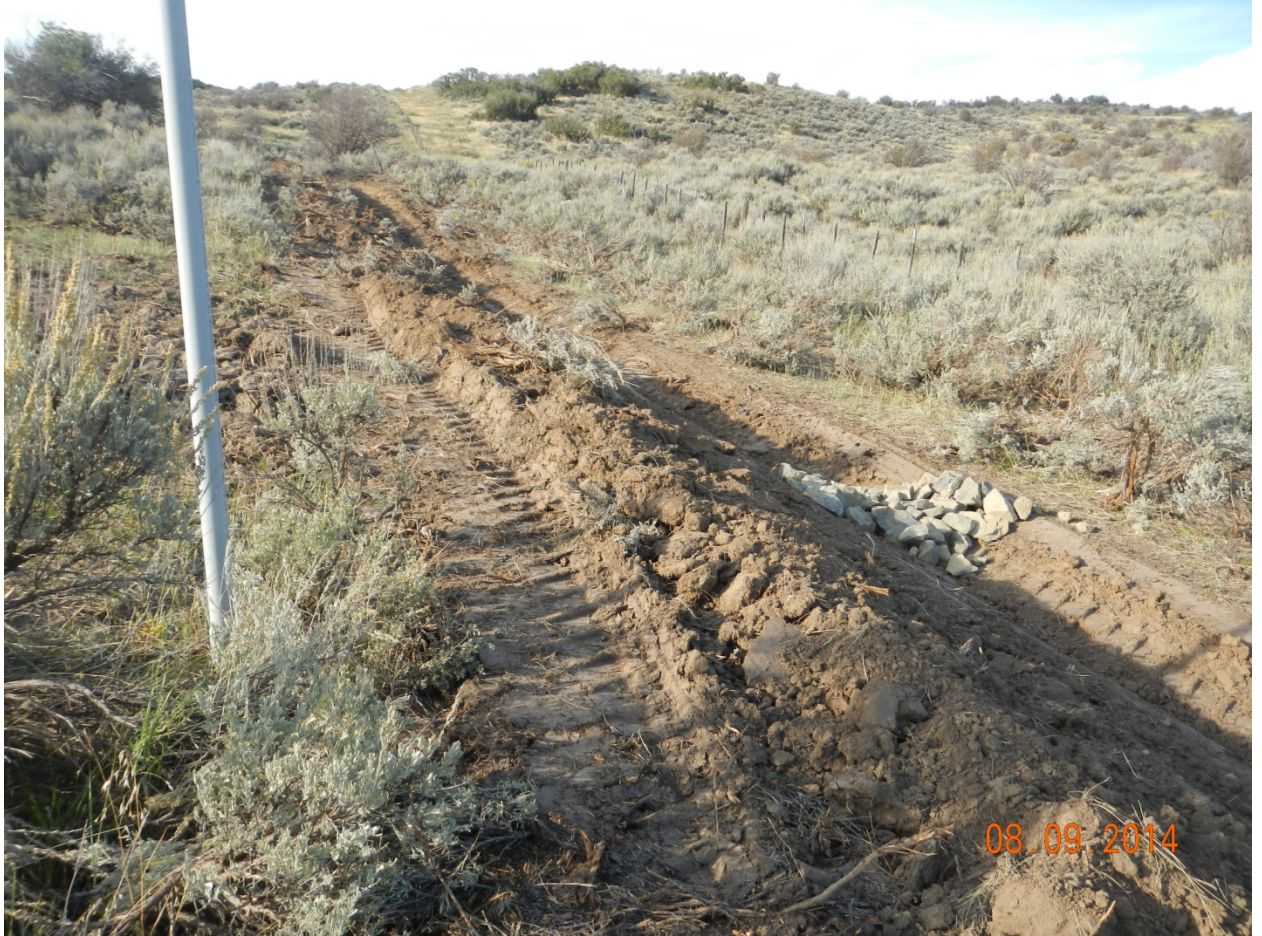
10. Diversion above North cut tracked with stormwater check-dams.

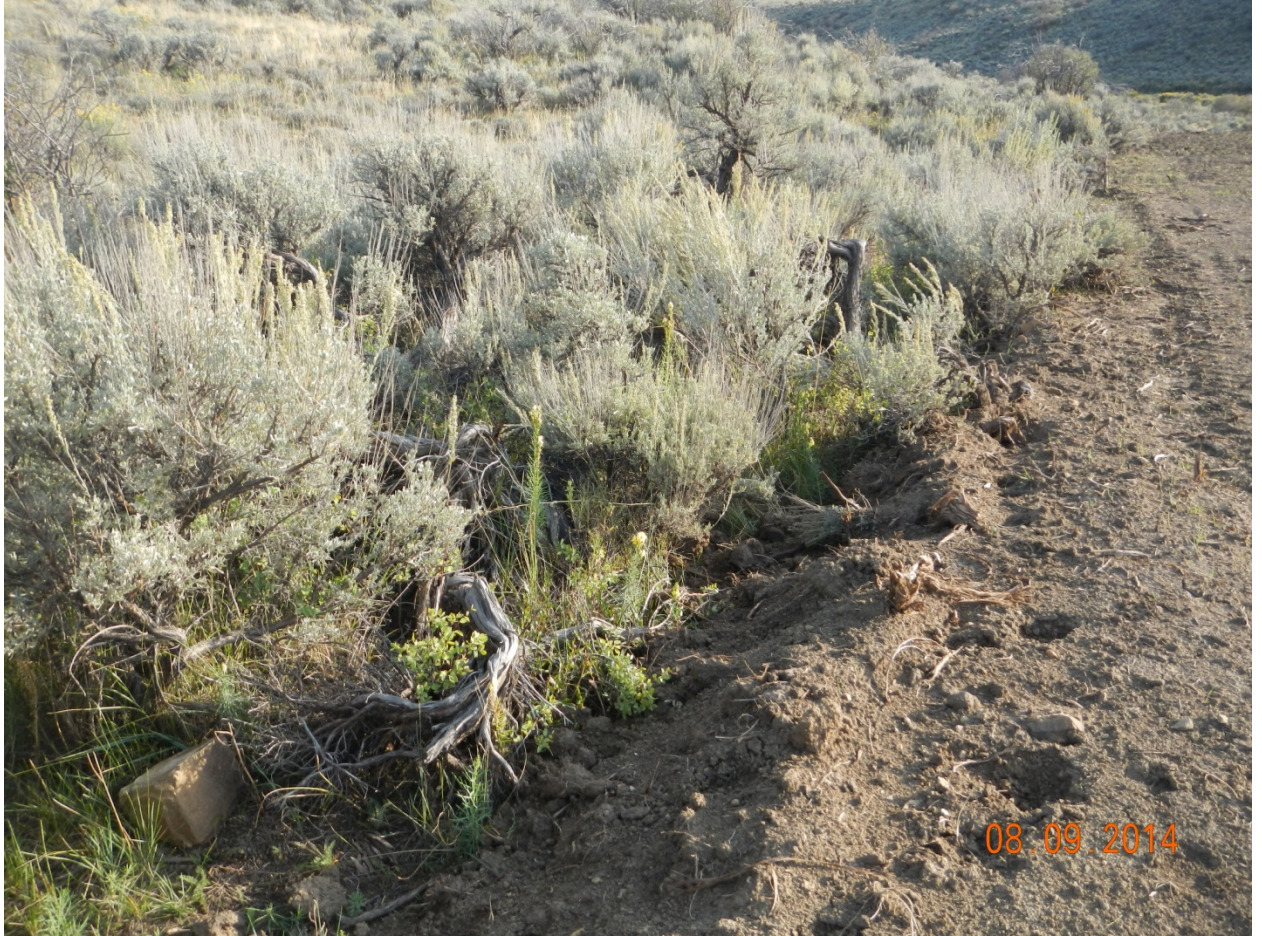
12. Yellow Toadflax (Class B, Colorado noxious weed) observed along 100' of West pad perimeter, approximately 50 plants in sagebrush within the vicinity.

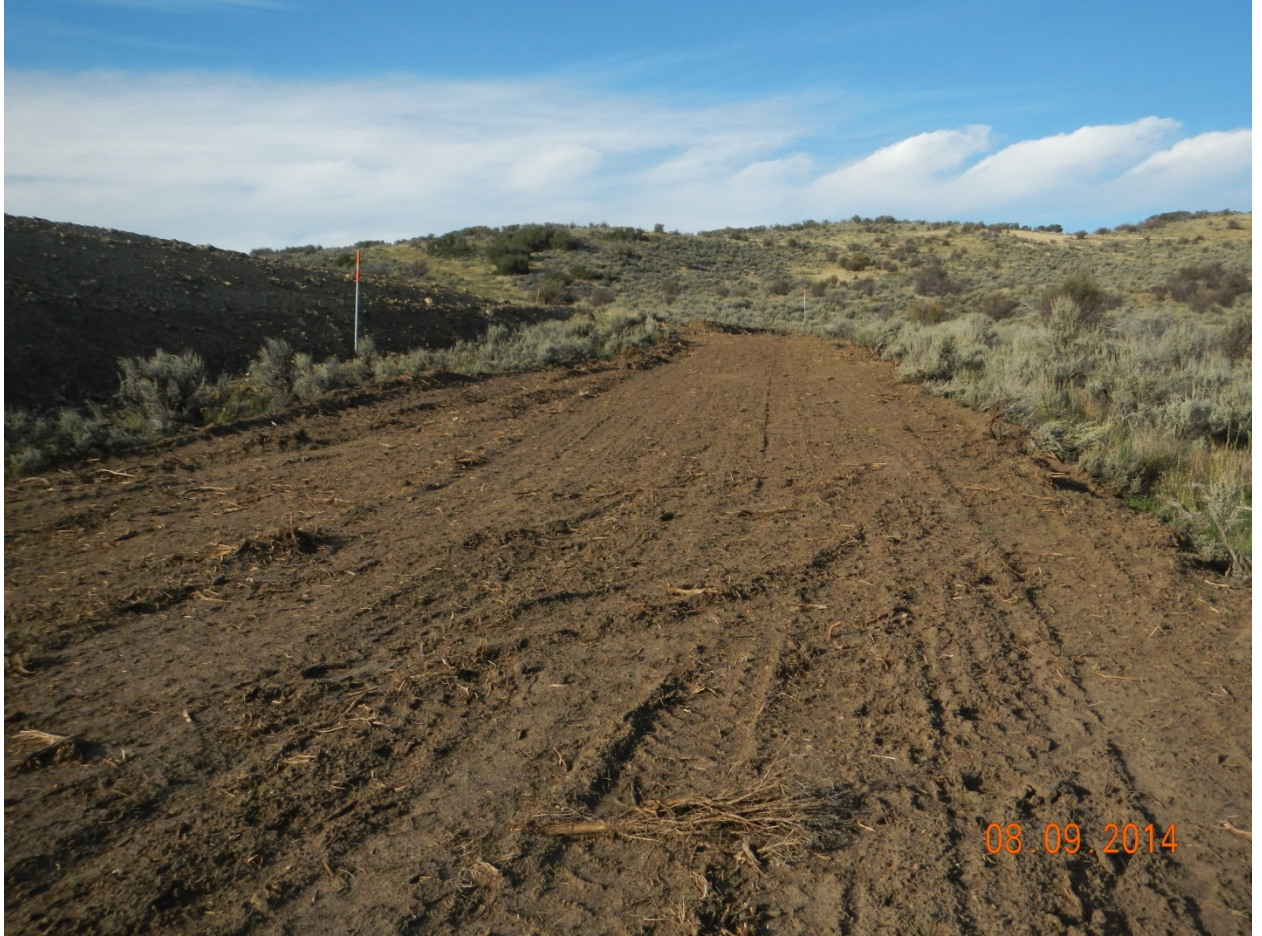
13. Topsoil stockpile tracking (1). Stockpile wraps around SW to SE of pad.

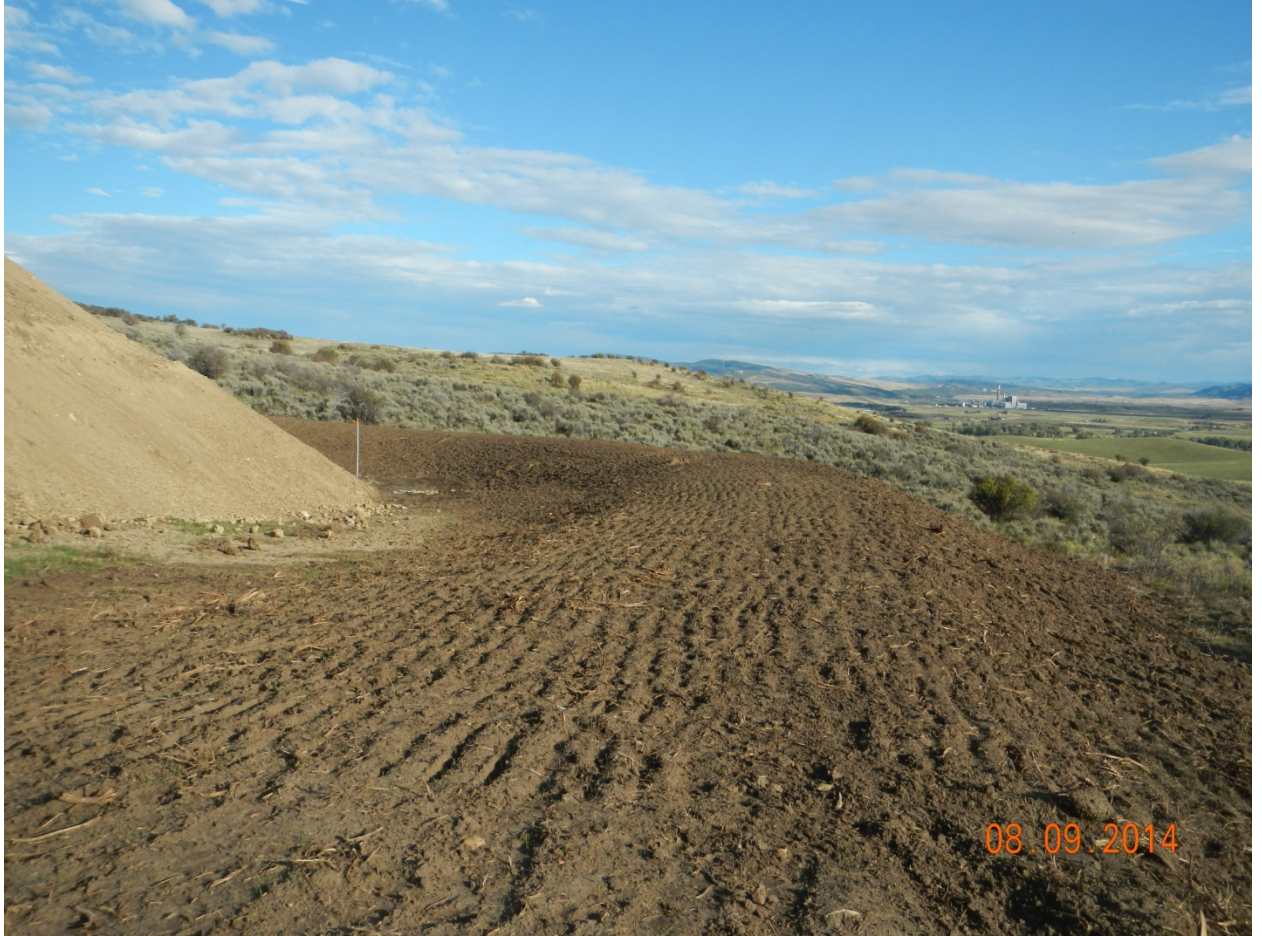
14. Topsoil stockpile tracking (2). Stockpile wraps around SW to SE of pad.

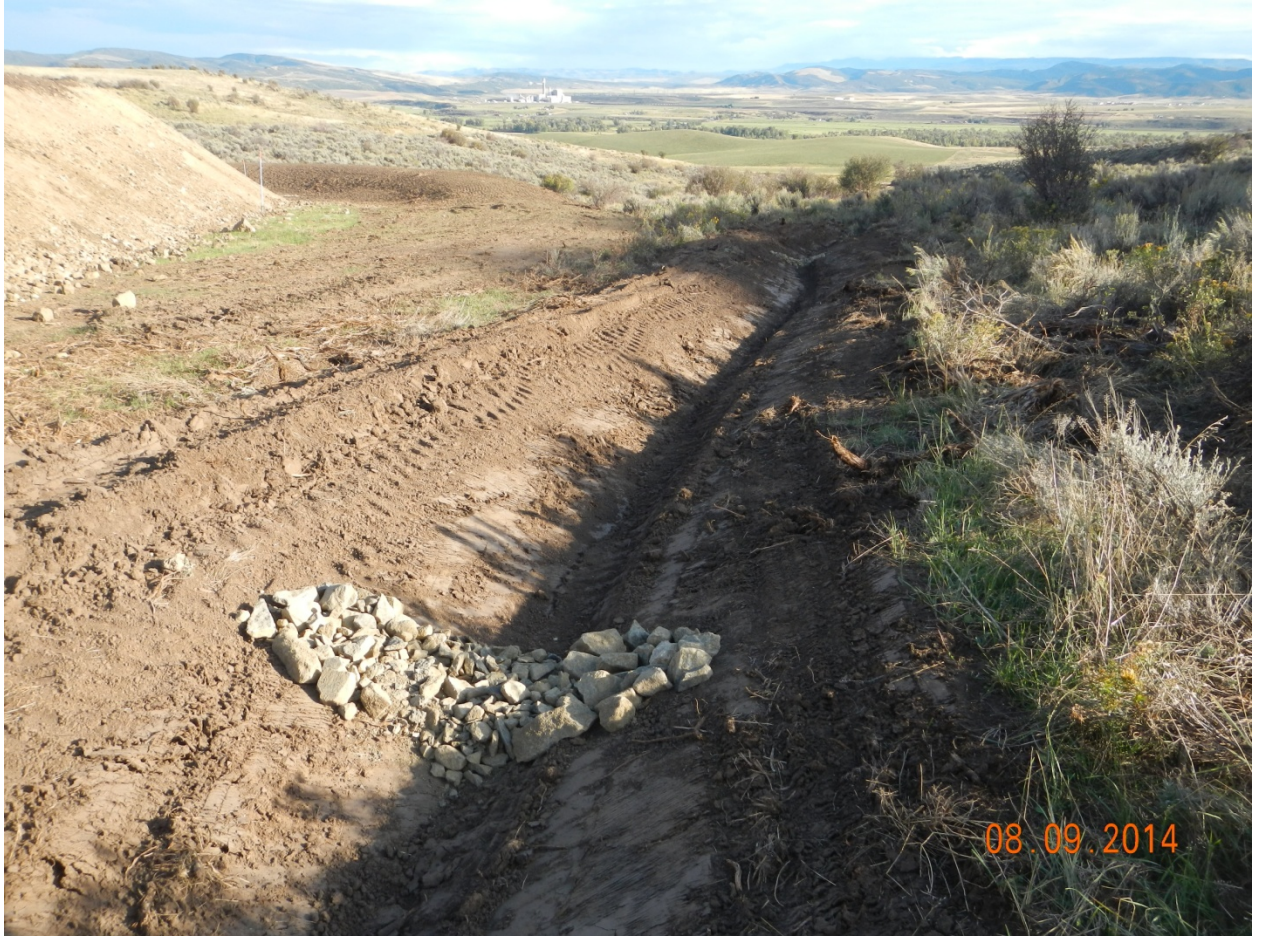
15. Check dams on Eastern diversion appear minimal for angle of diverted stormwater flow. May breach without increased velocity reduction.

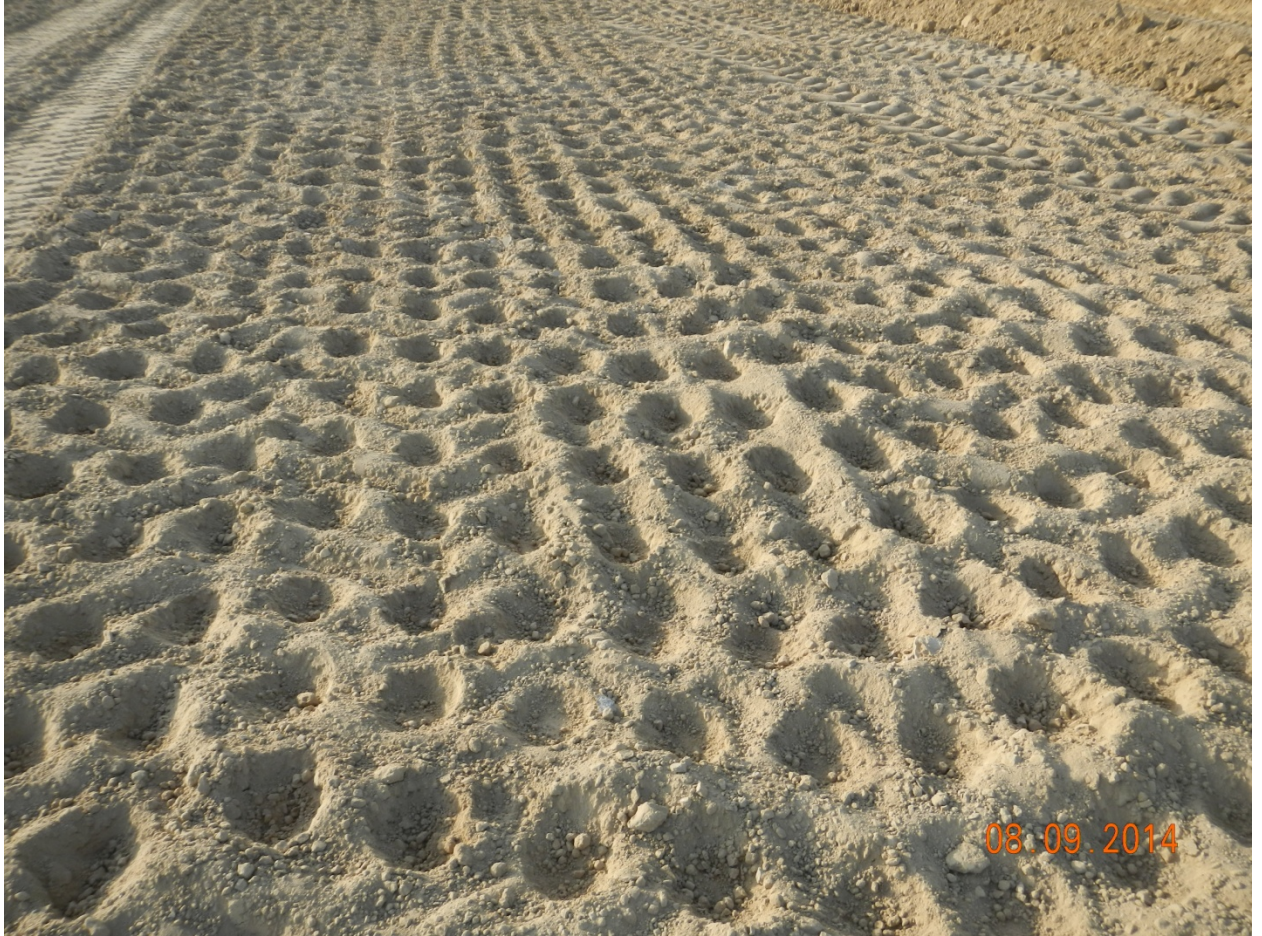
16. Sheep-foot surface roughening on fill areas of location.

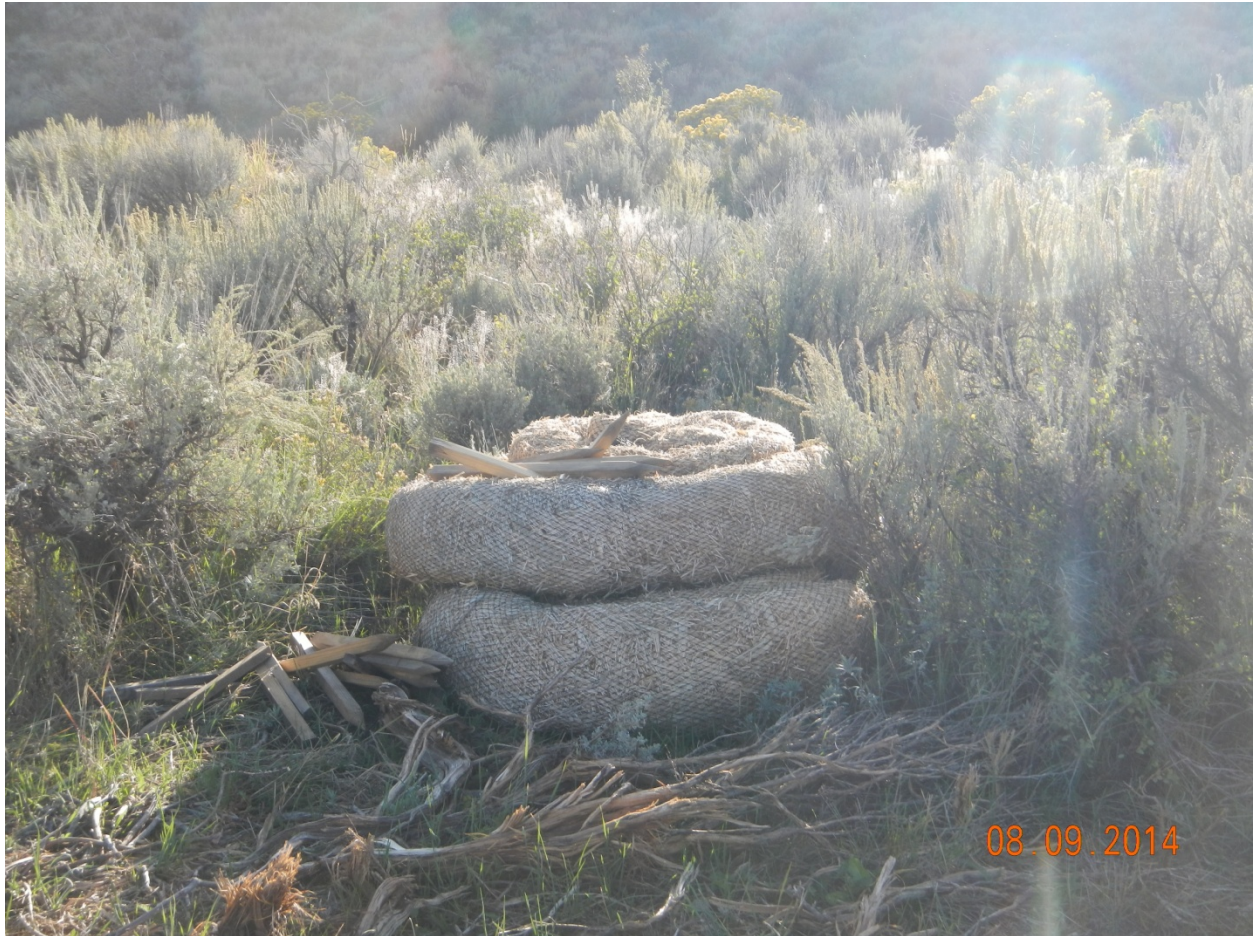
17. Waddles on West perimeter yet to be installed.

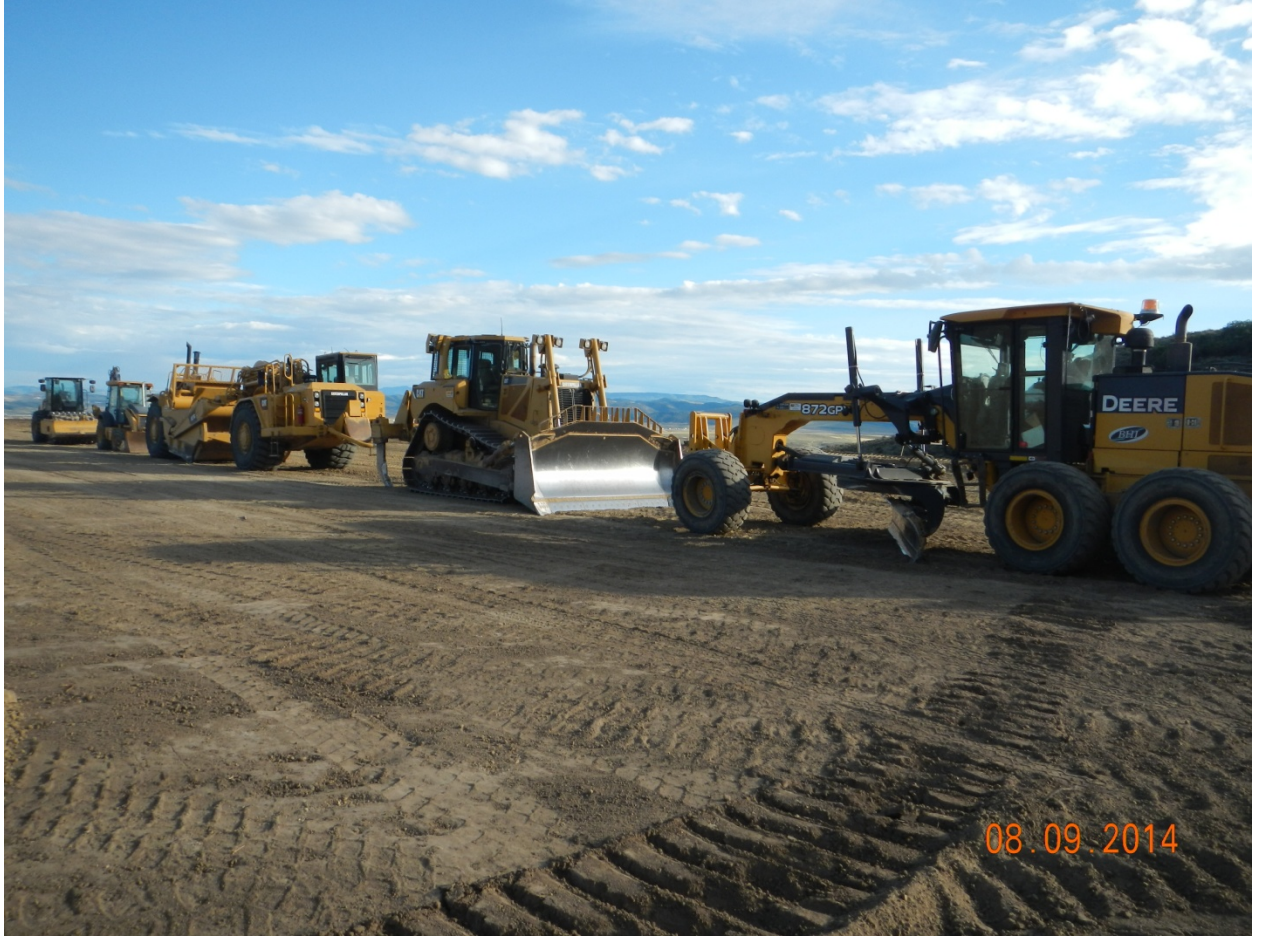
18. Equipment parking acceptable (1).
