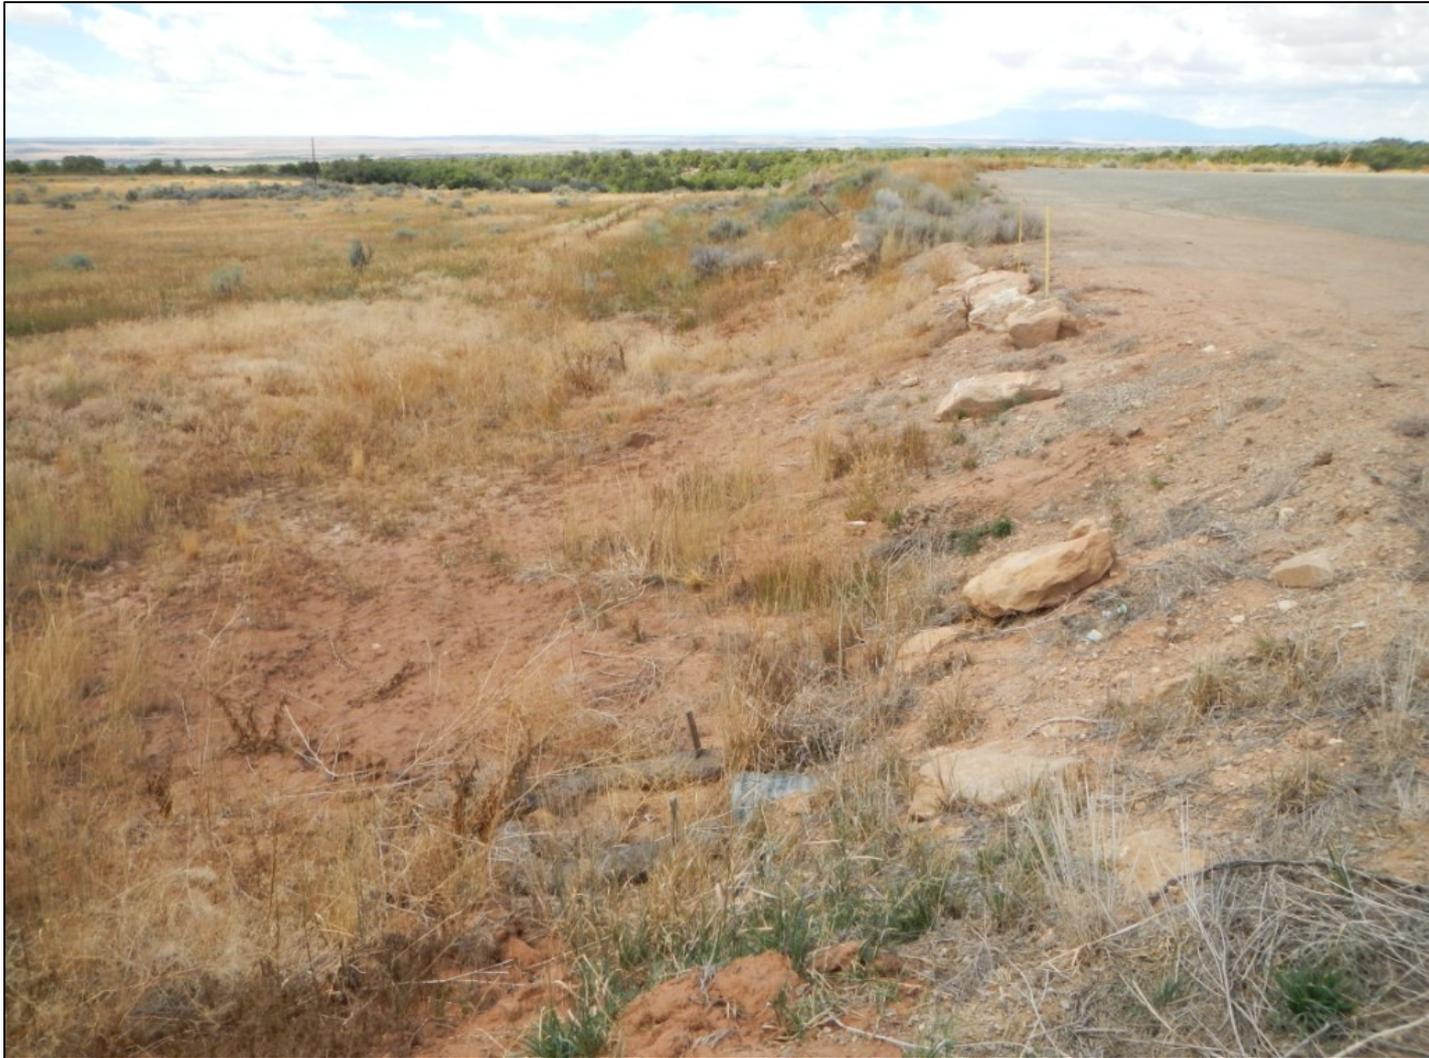
Photo 1. View of southern edge of well pad facing westward.

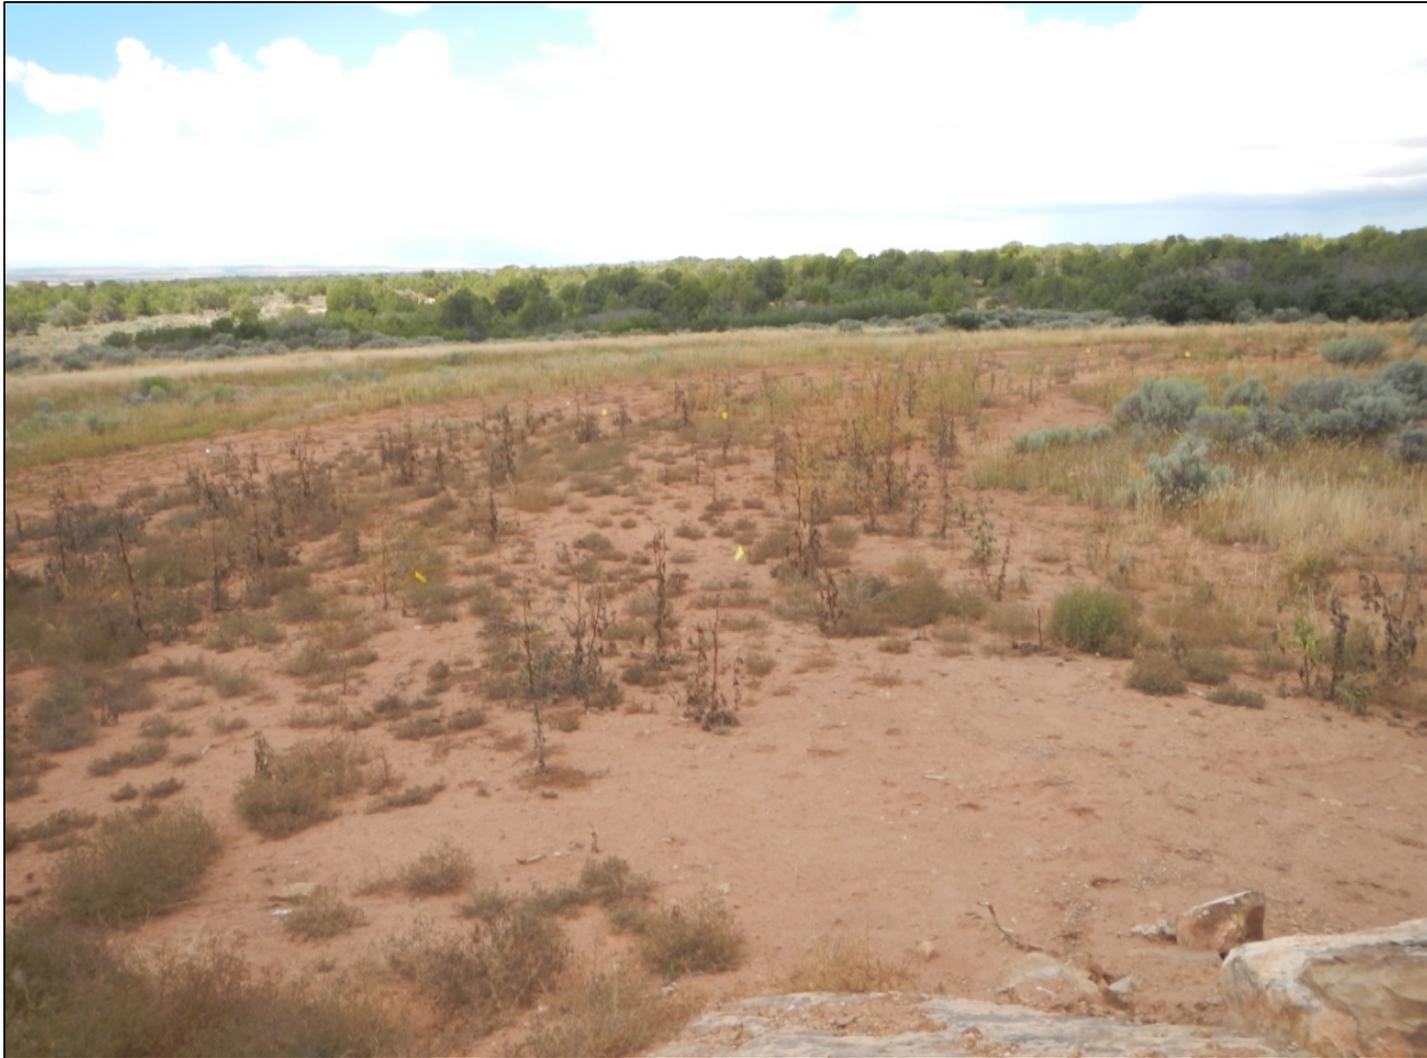
Photo 2. View of area that appears to be pipeline disturbance within interim reclamation area that is weedy and not revegetated.

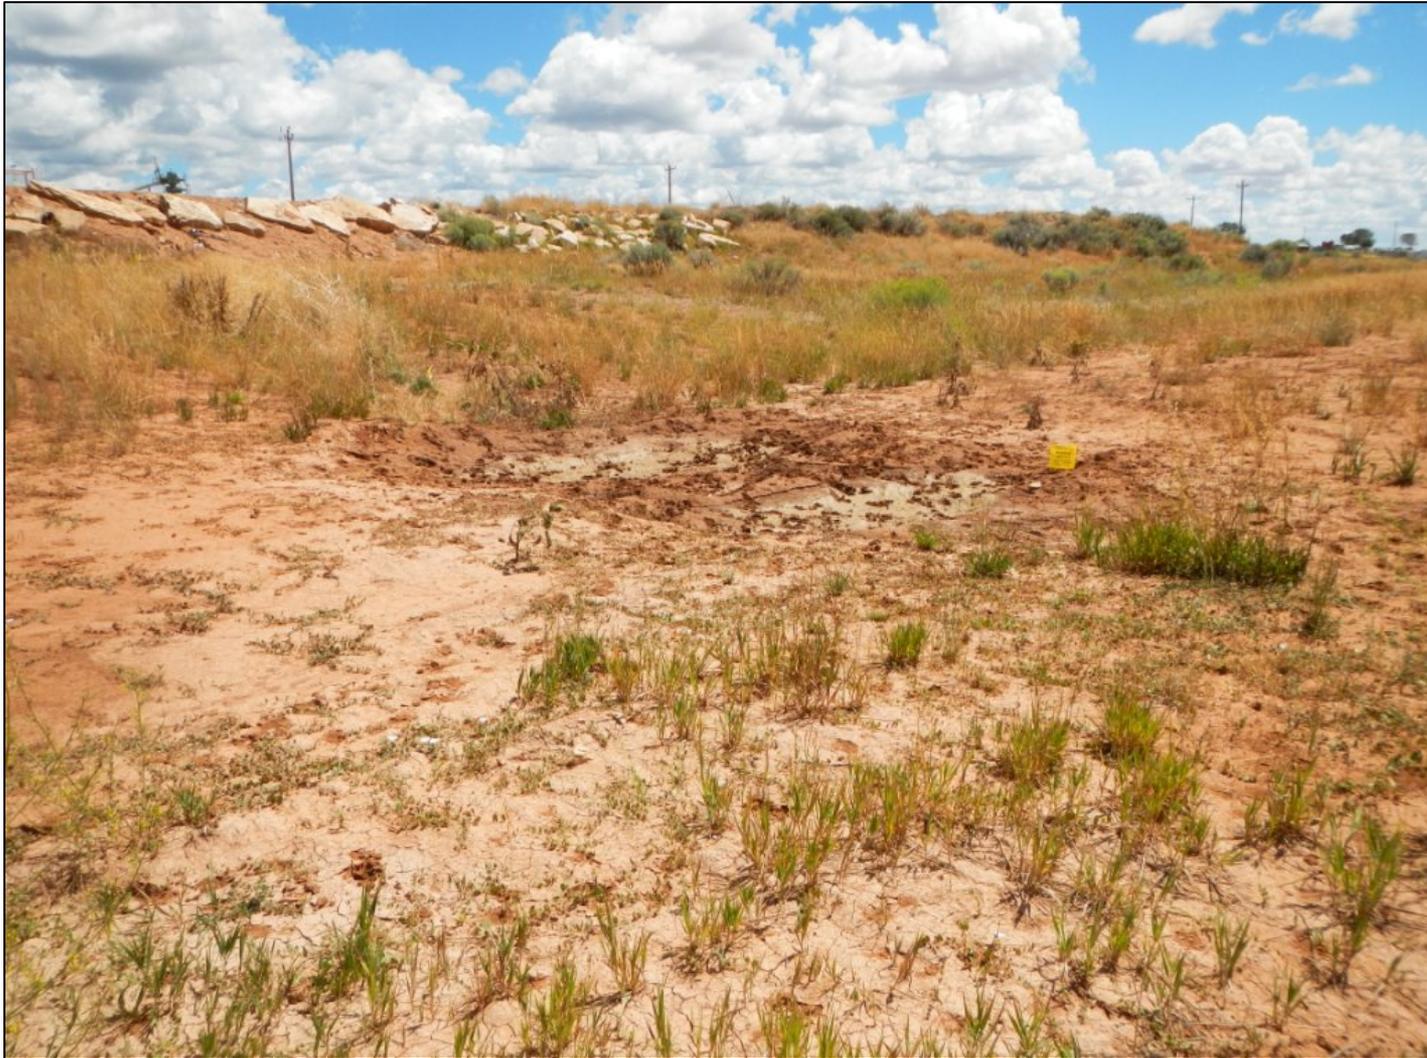
Photo 3. View of silt trap in western portion of interim reclamation area that is filling with sediment.

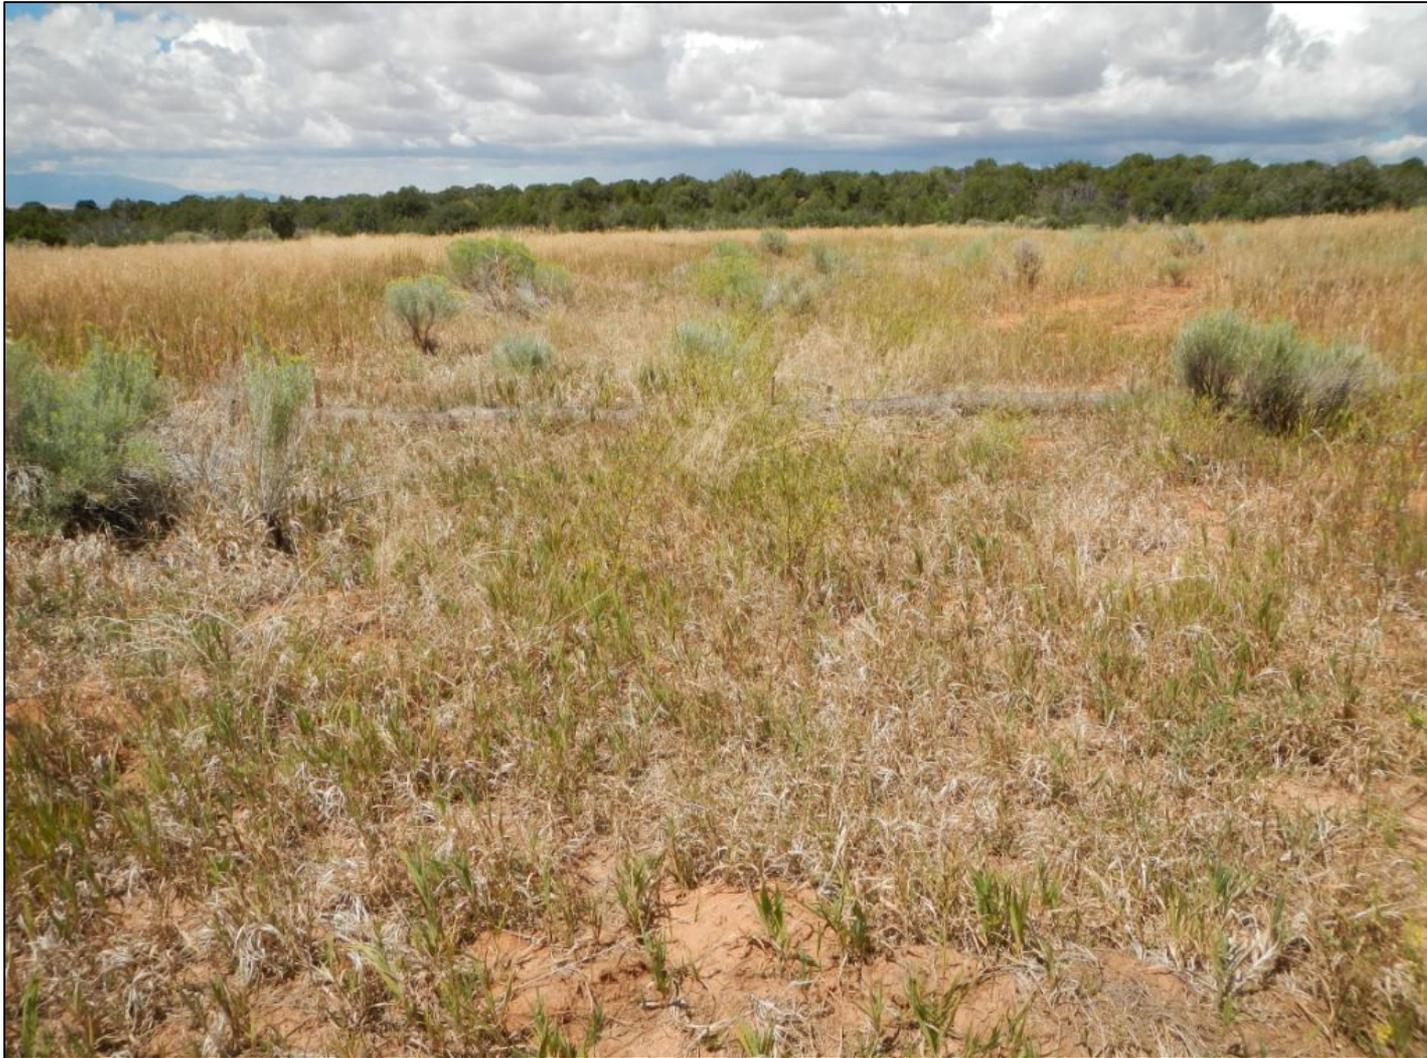
Photo 4. View of straw wattle and vegetation that appear to be effectively filtering and de-energizing stormwater flows exiting the western edge of the project area.

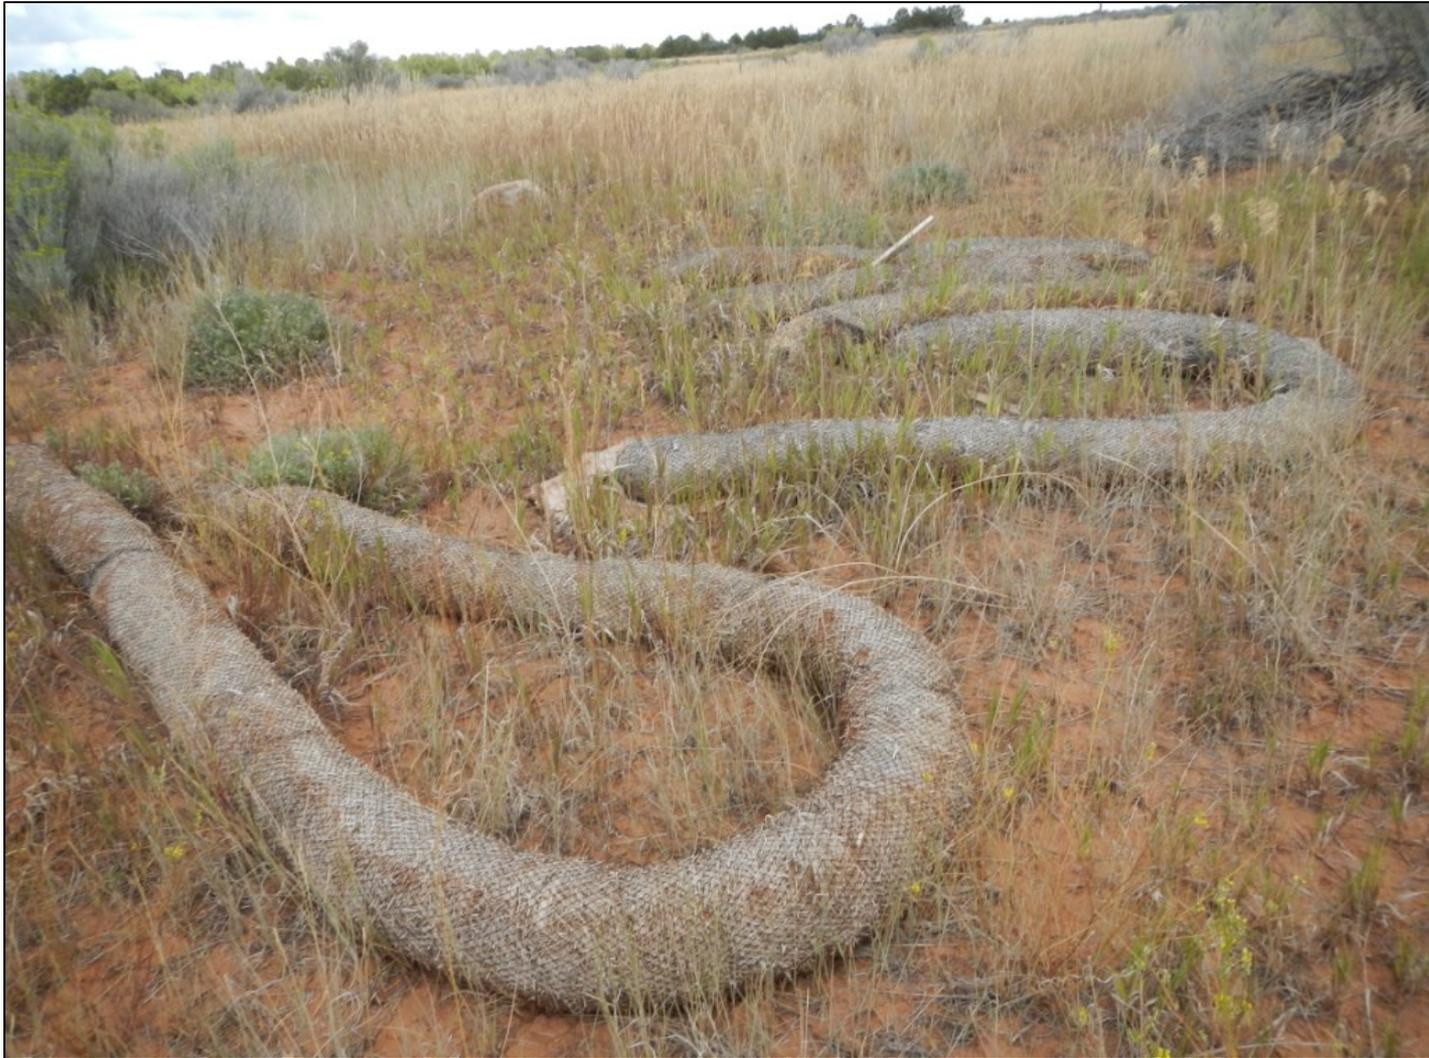
Photo 5. View of unused straw wattles that need to be properly installed or removed from project area.
