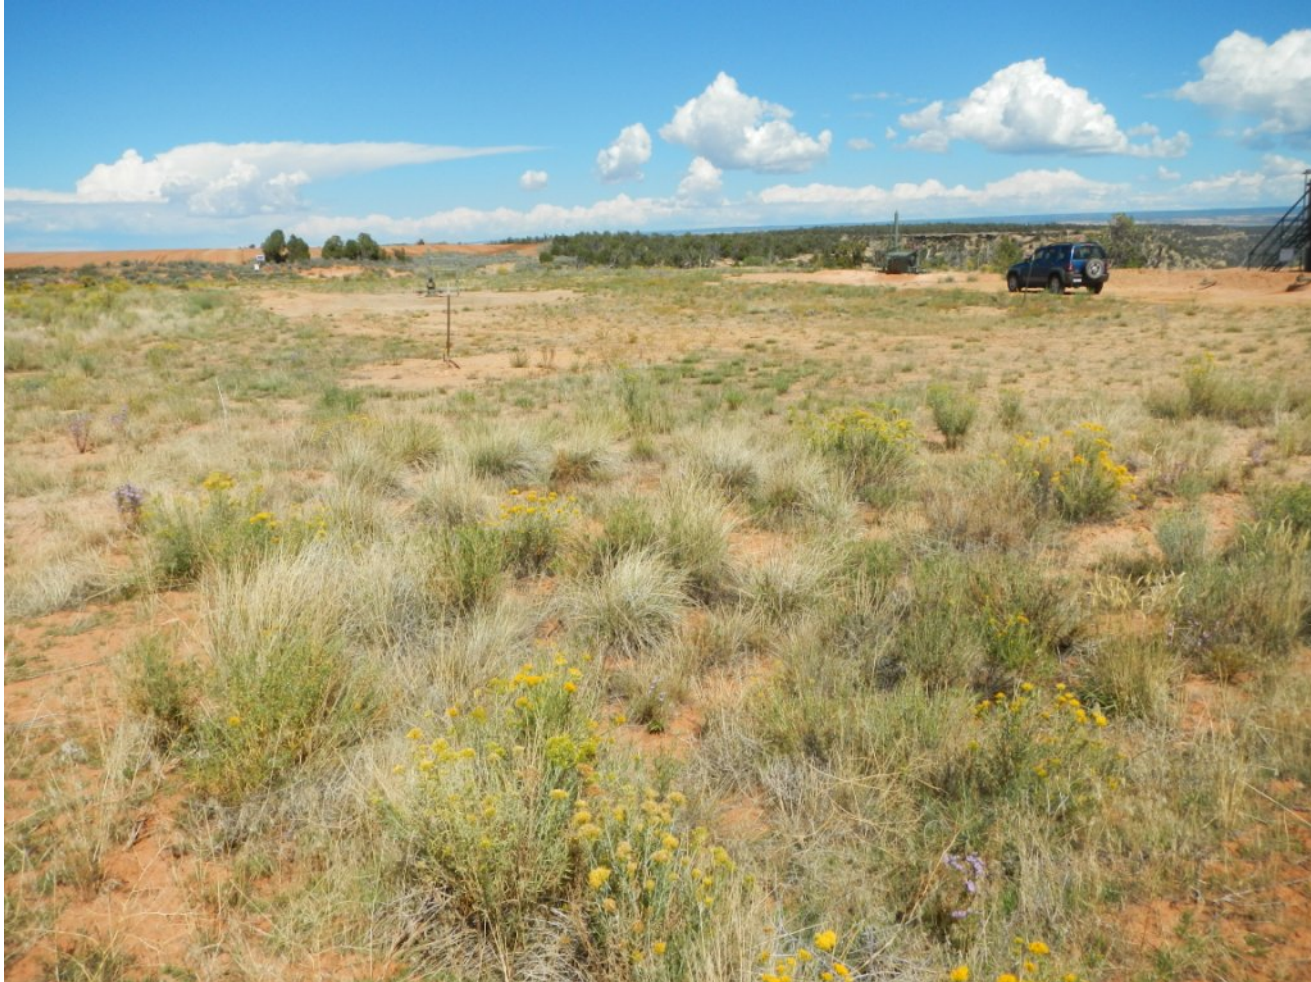
Photo 1. View of western portion of interim reclamation area from the southern edge facing northward.

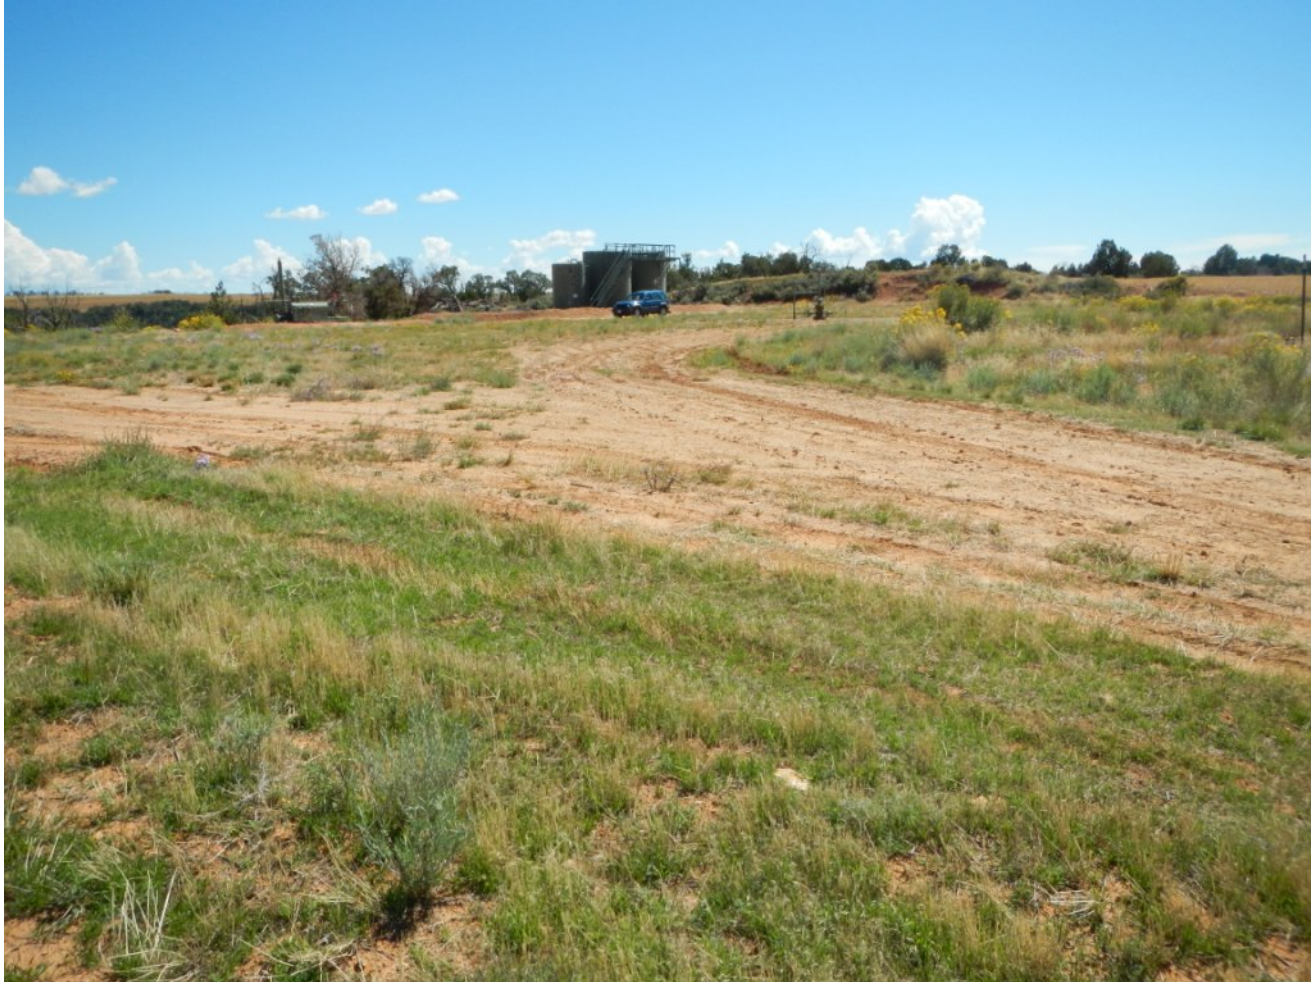
Photo 2. View from northwestern corner of well pad facing center.

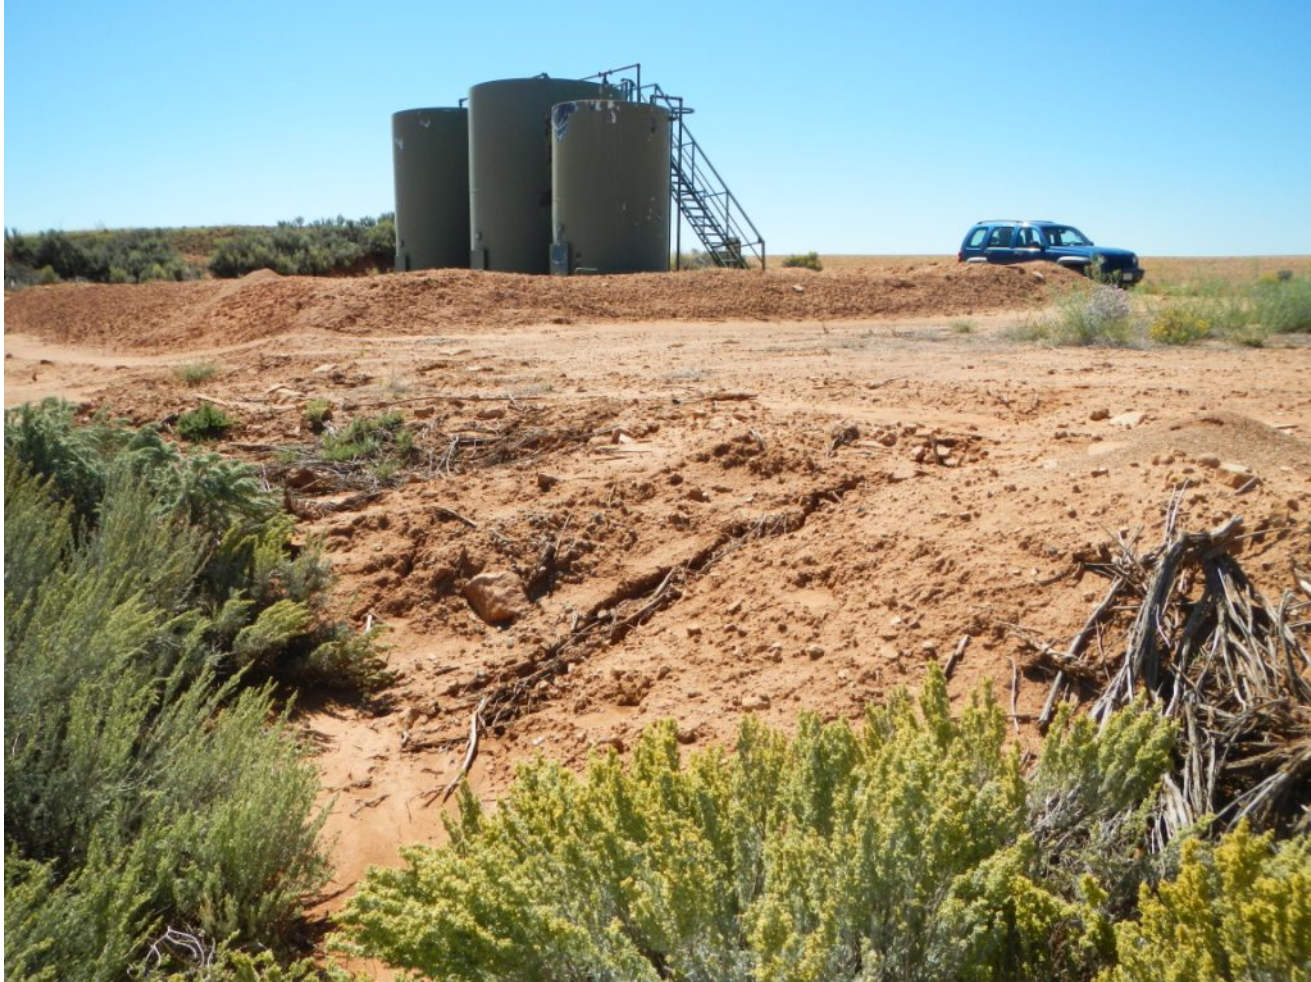
Photo 3. View of rill erosion on eastern edge of well pad.

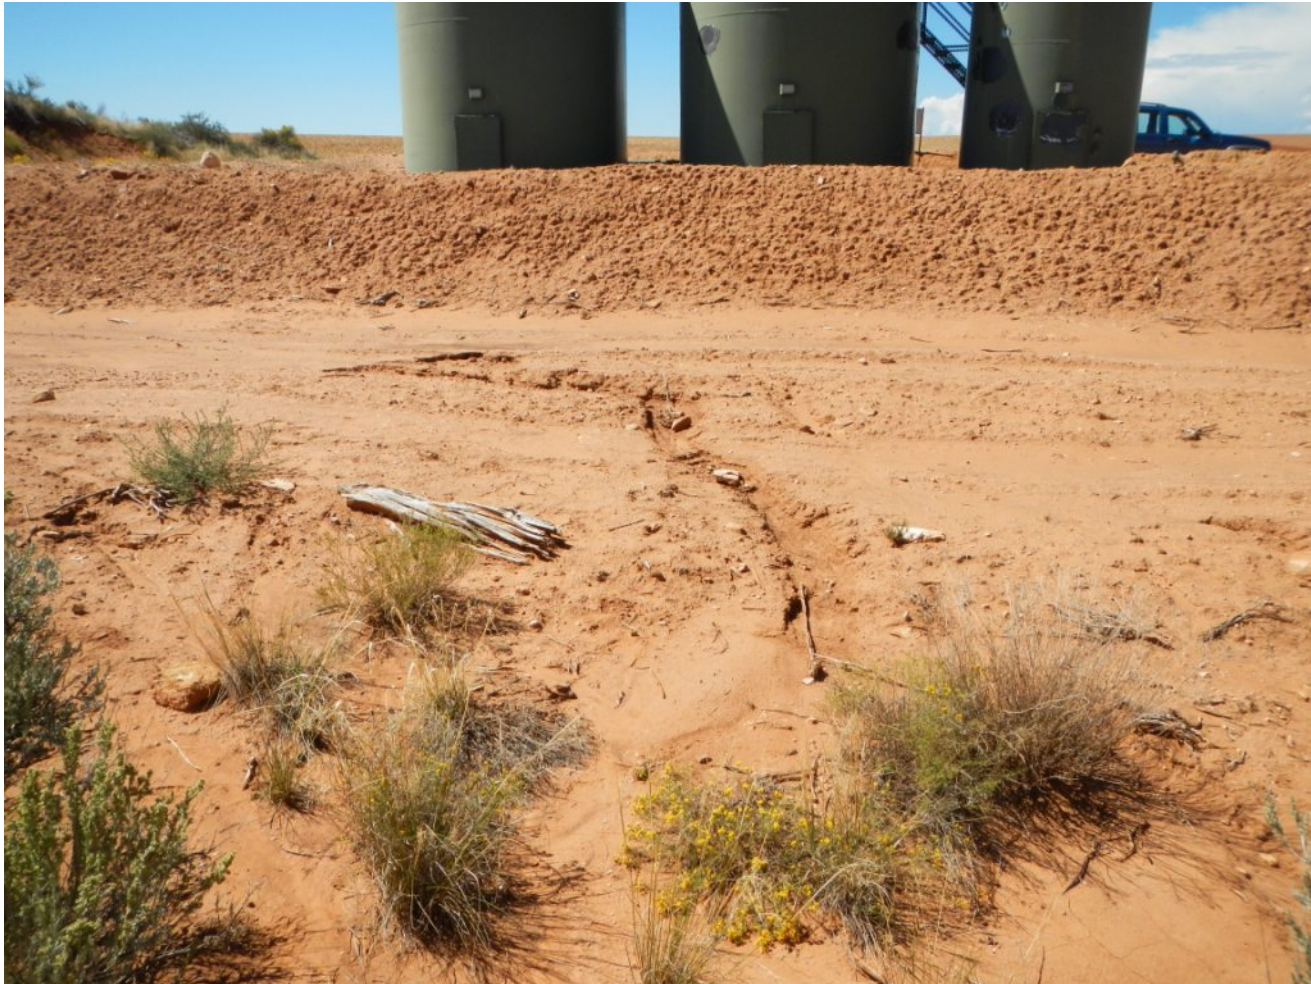
Photo 4. View of more rill erosion on eastern edge of well pad.
