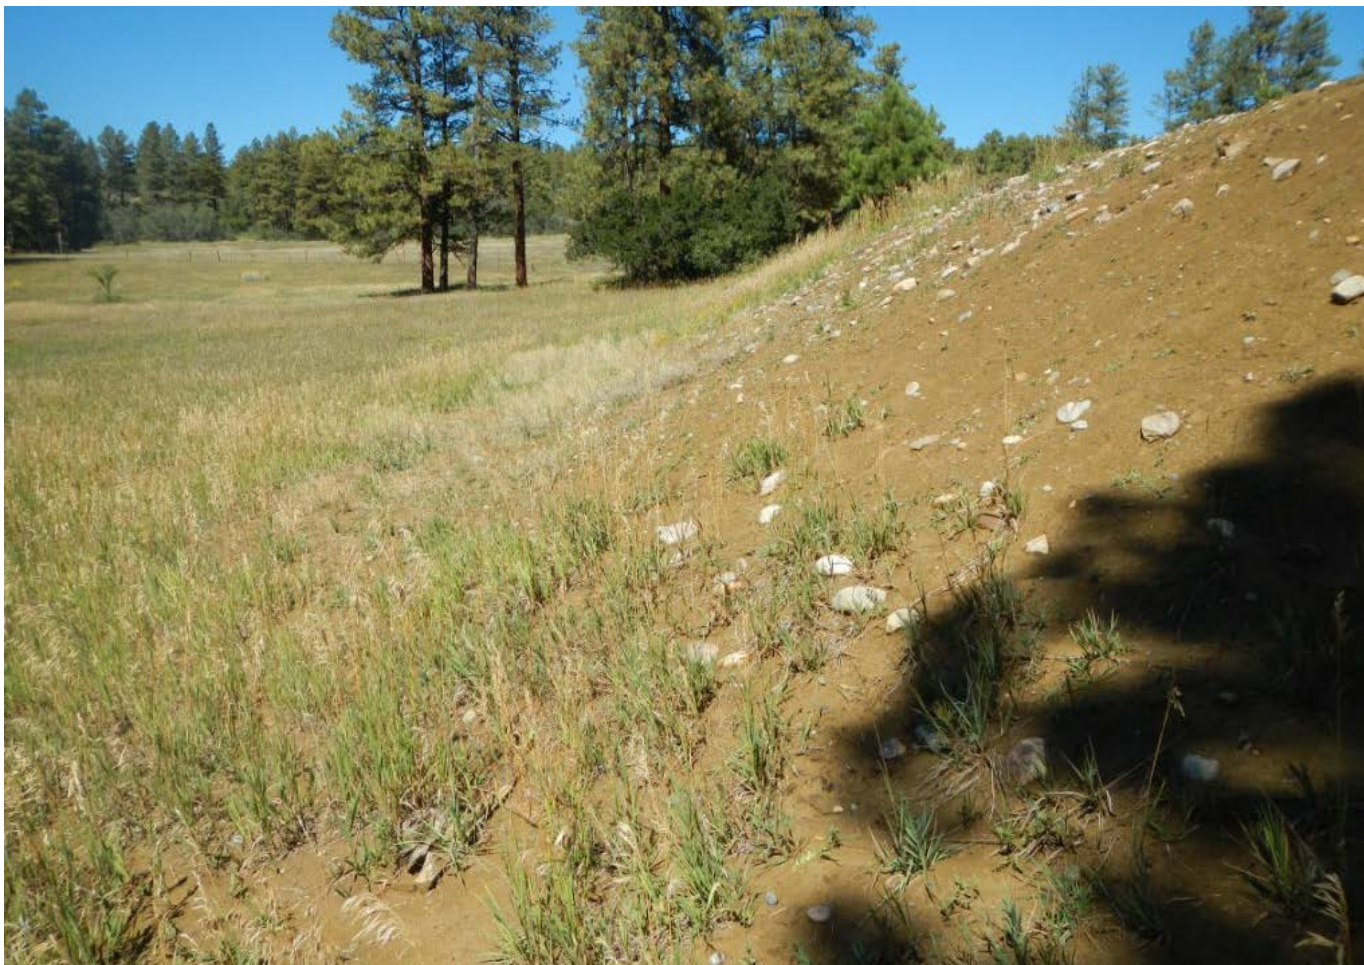
Photo 1. View of western edge of project area and adjacent habitat from southwestern corner facing northward.

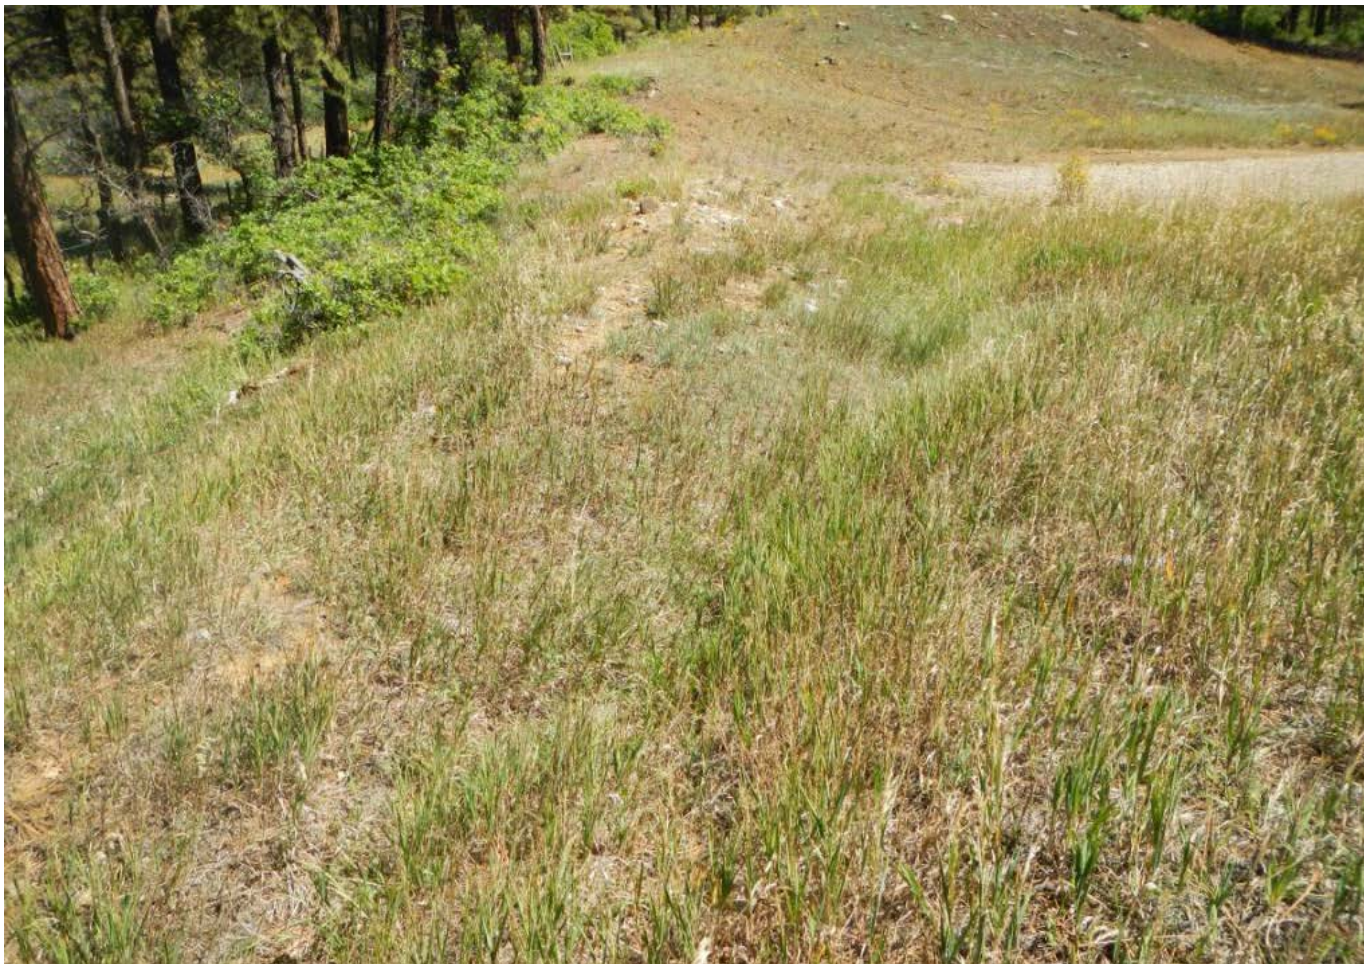
Photo 2. View of northern edge of project area from southwestern corner facing eastward.

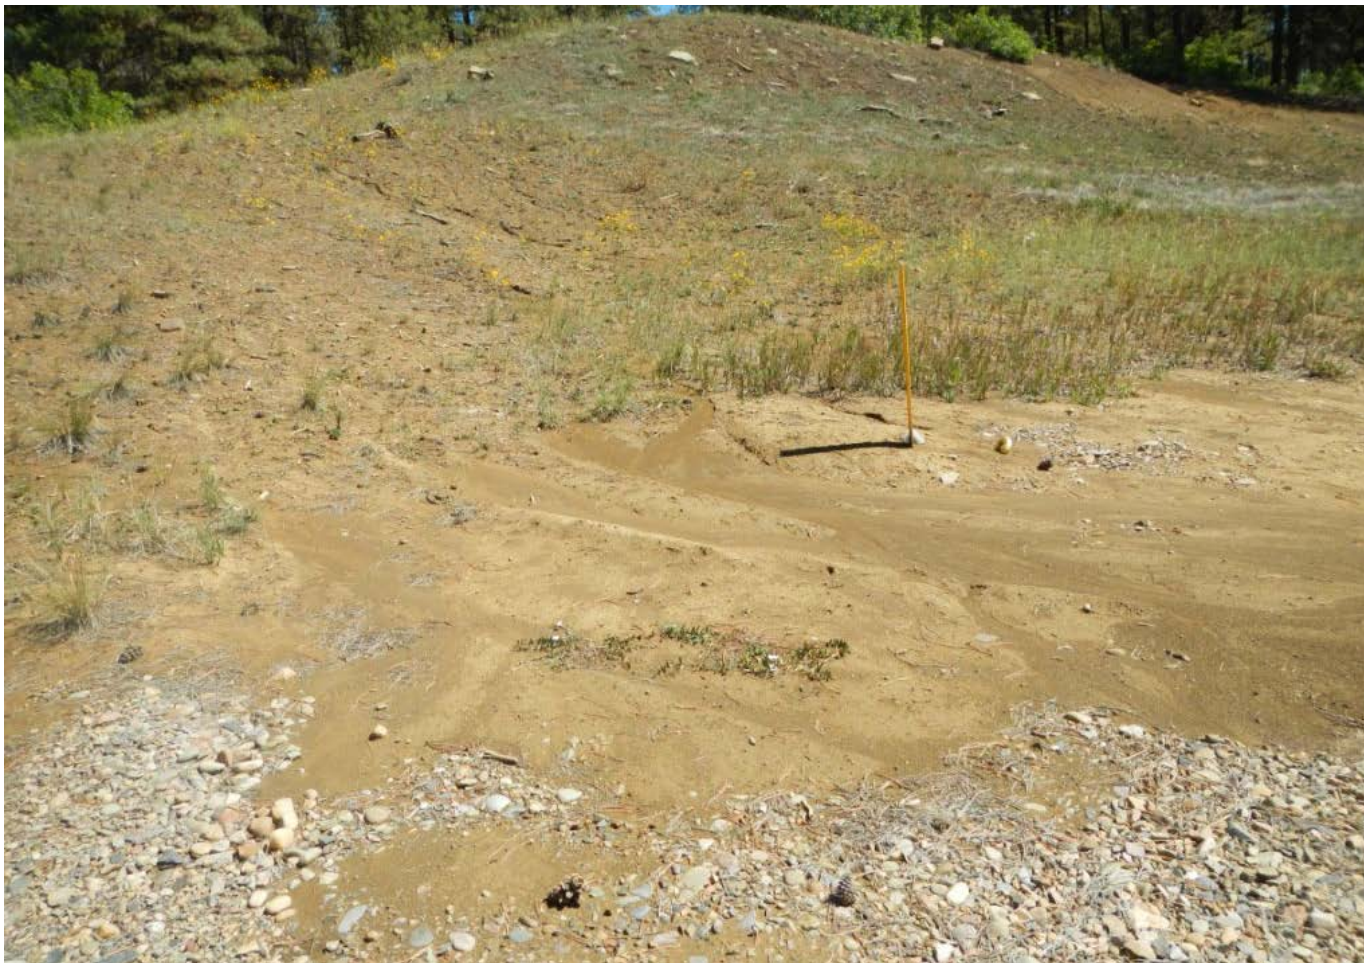
Photo 3. View of cut slope on the eastern edge of the project area. Rill erosion is occurring on the slope and sediment is running onto the well pad.

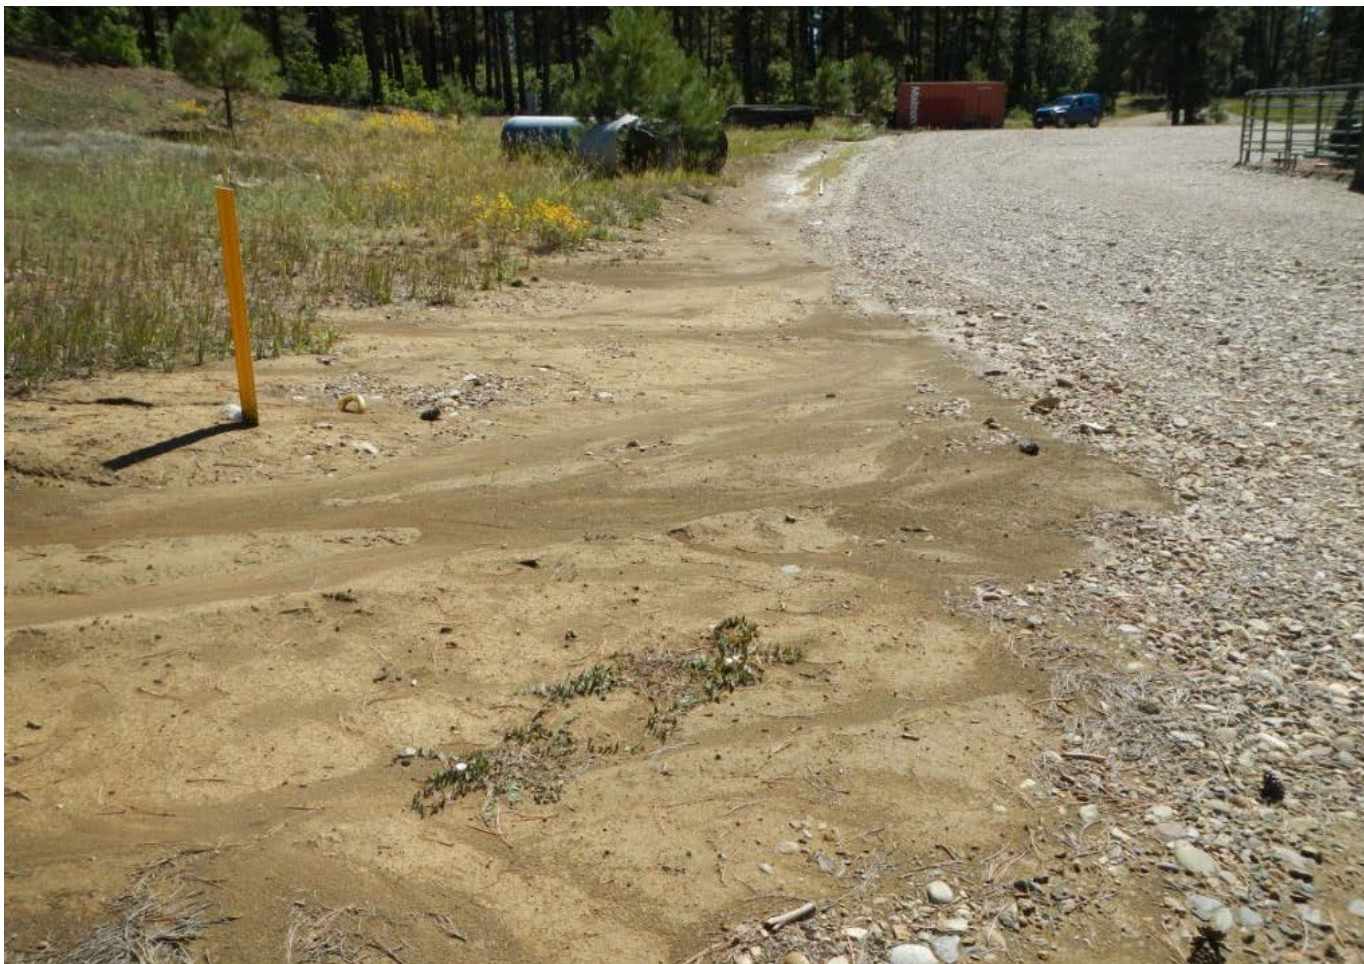
Photo 4. View of sediment deposition on the well pad at the base of the cut slope shown in Photo 3. Sediment appears to be contained but erosion needs to be monitored.

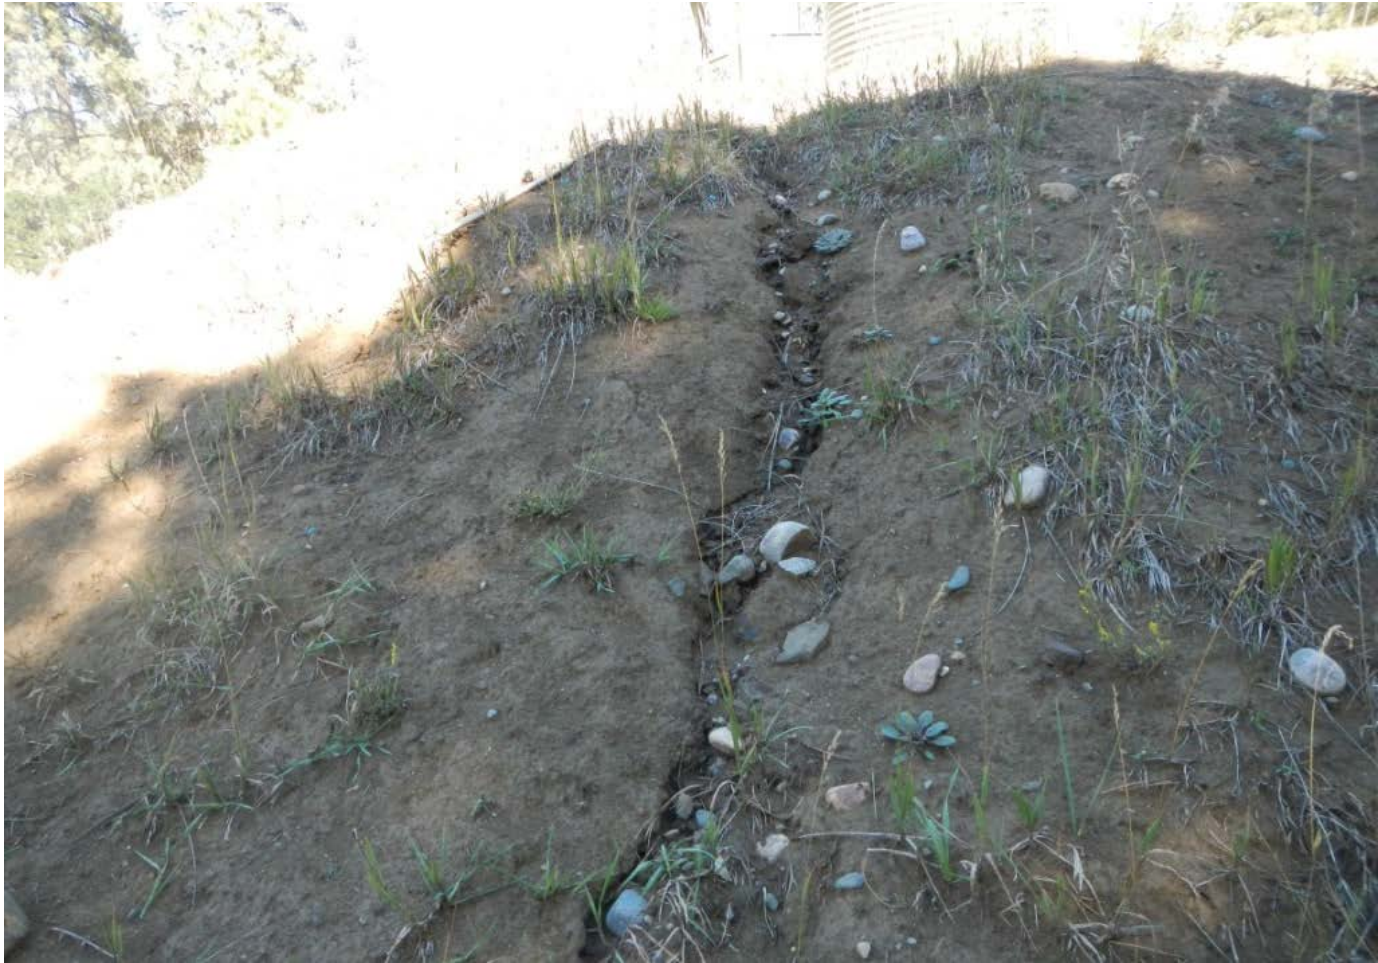
Photo 5. View of rill erosion on the southwestern corner of the project area.
