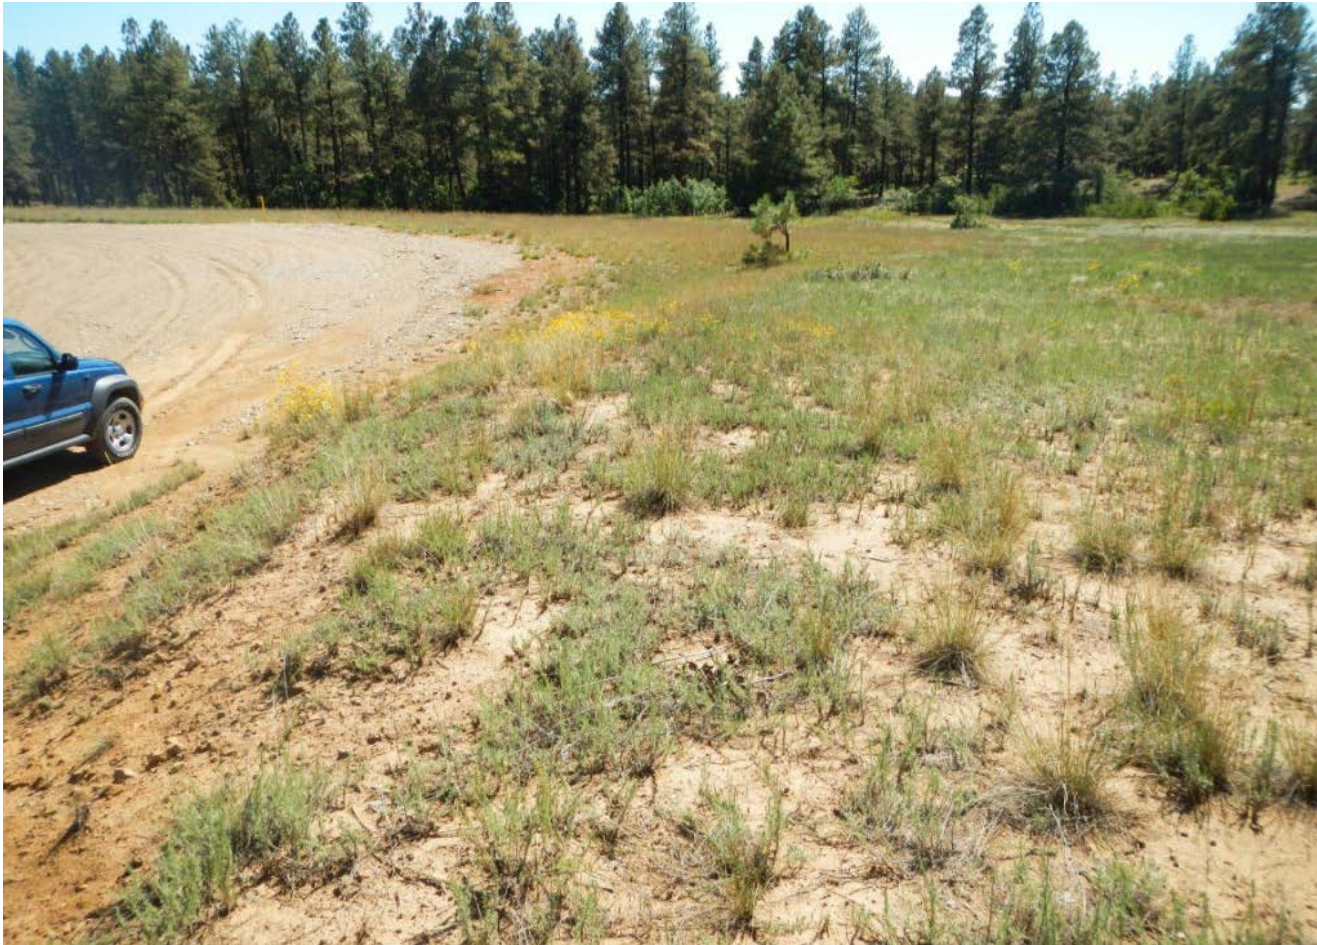
Photo 1. View of the western edge of the project area from the northwestern corner facing southward. Good vegetative cover throughout the majority of the interim reclamation area.

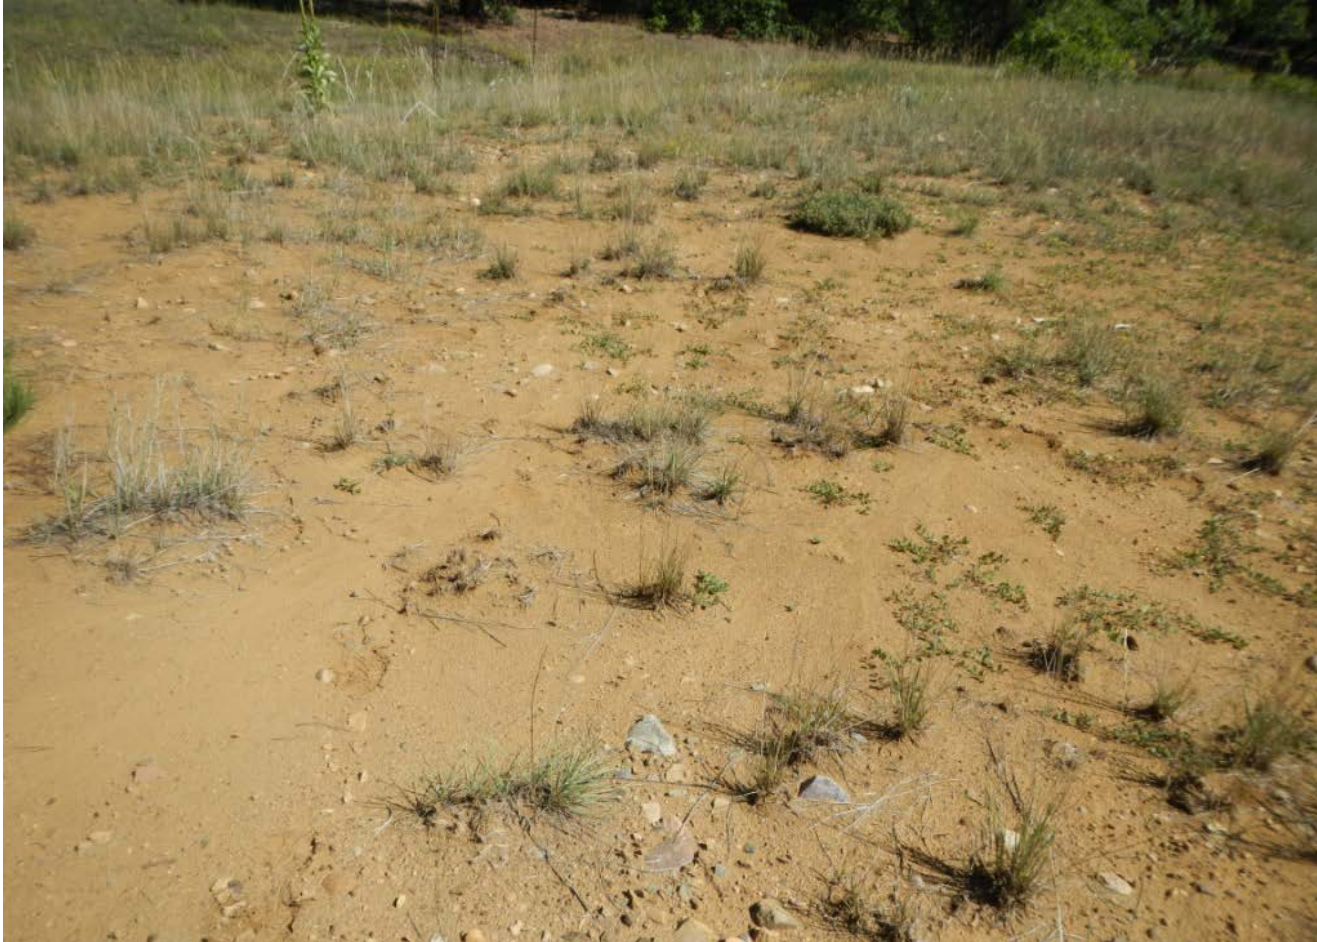
Photo 2. View of an area within the eastern portion of the interim reclamation area with poor revegetation that needs to be monitored and possibly re-seeded.

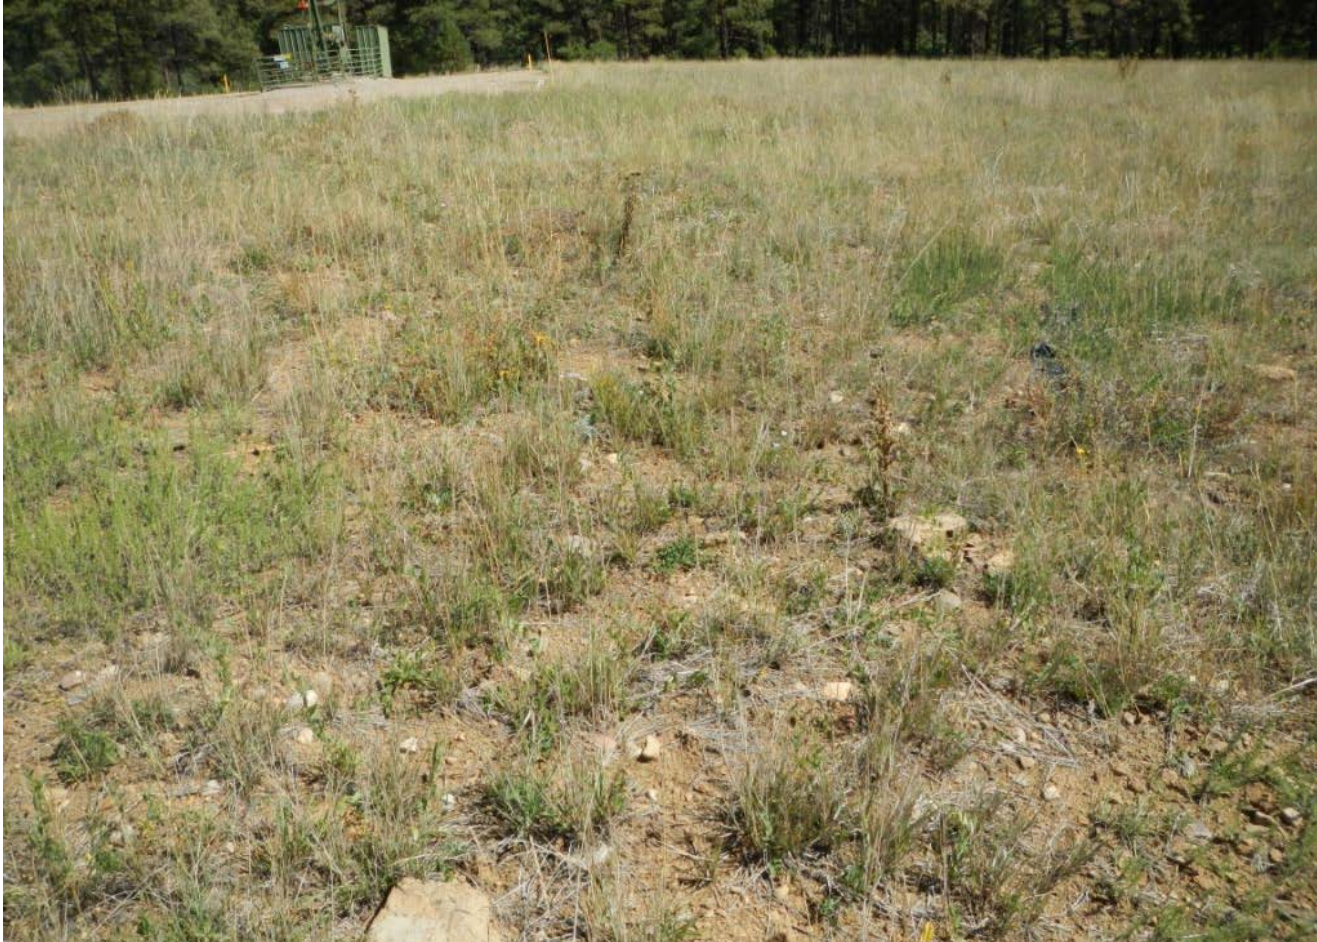
Photo 3. View of southern portion of interim reclamation area with good revegetation.

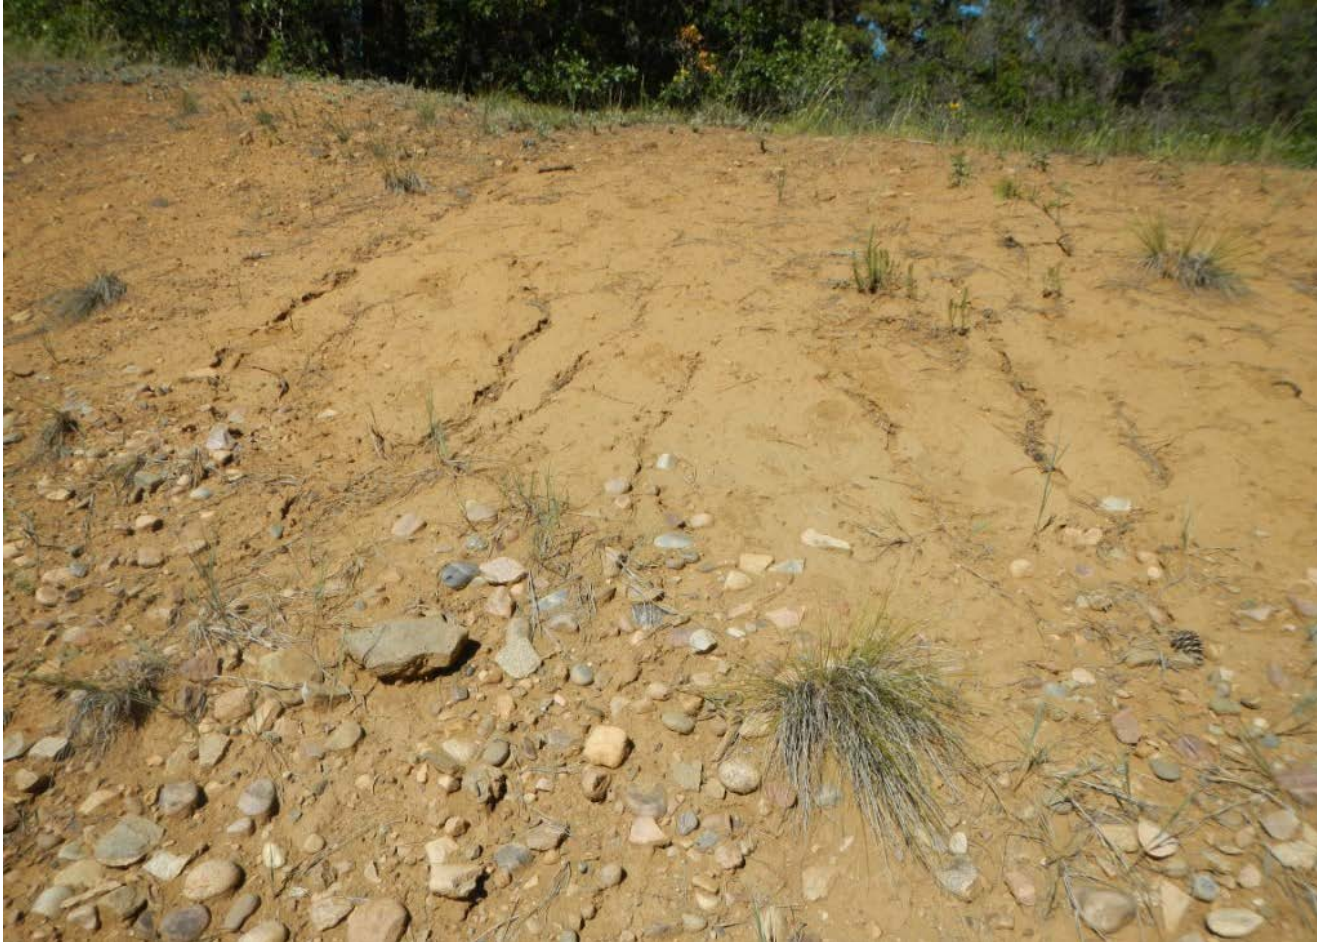
Photo 4. View of rill erosion on the cut slope within the northern portion of the interim reclamation area.

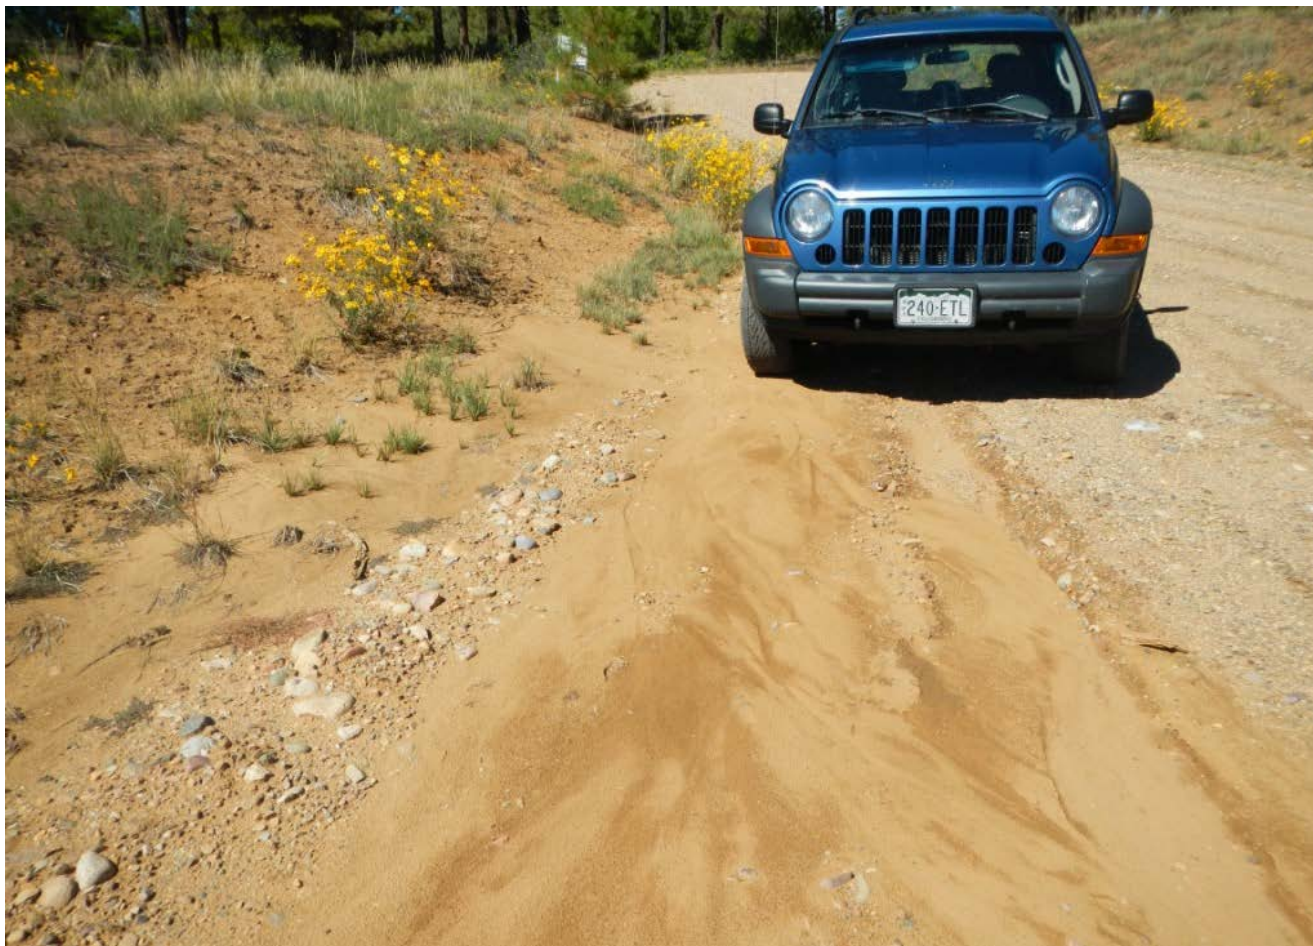
Photo 5. View of sediment run-on from the western edge of the access road near the entrance to the well pad.
