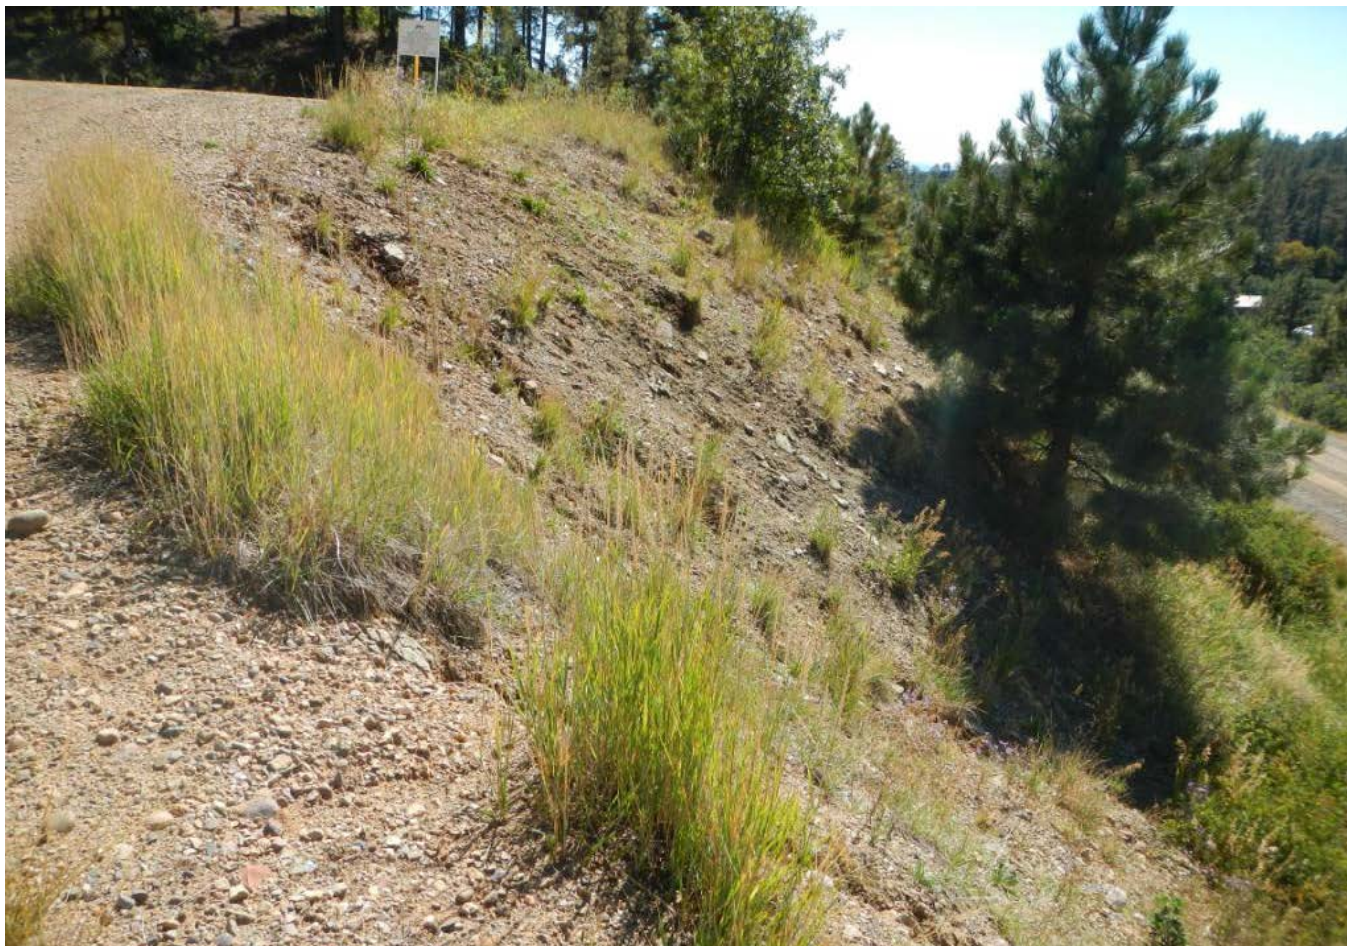
Photo 1. View of fill slope with some rill erosion occurring on the western edge of the well pad from the access road facing southward.

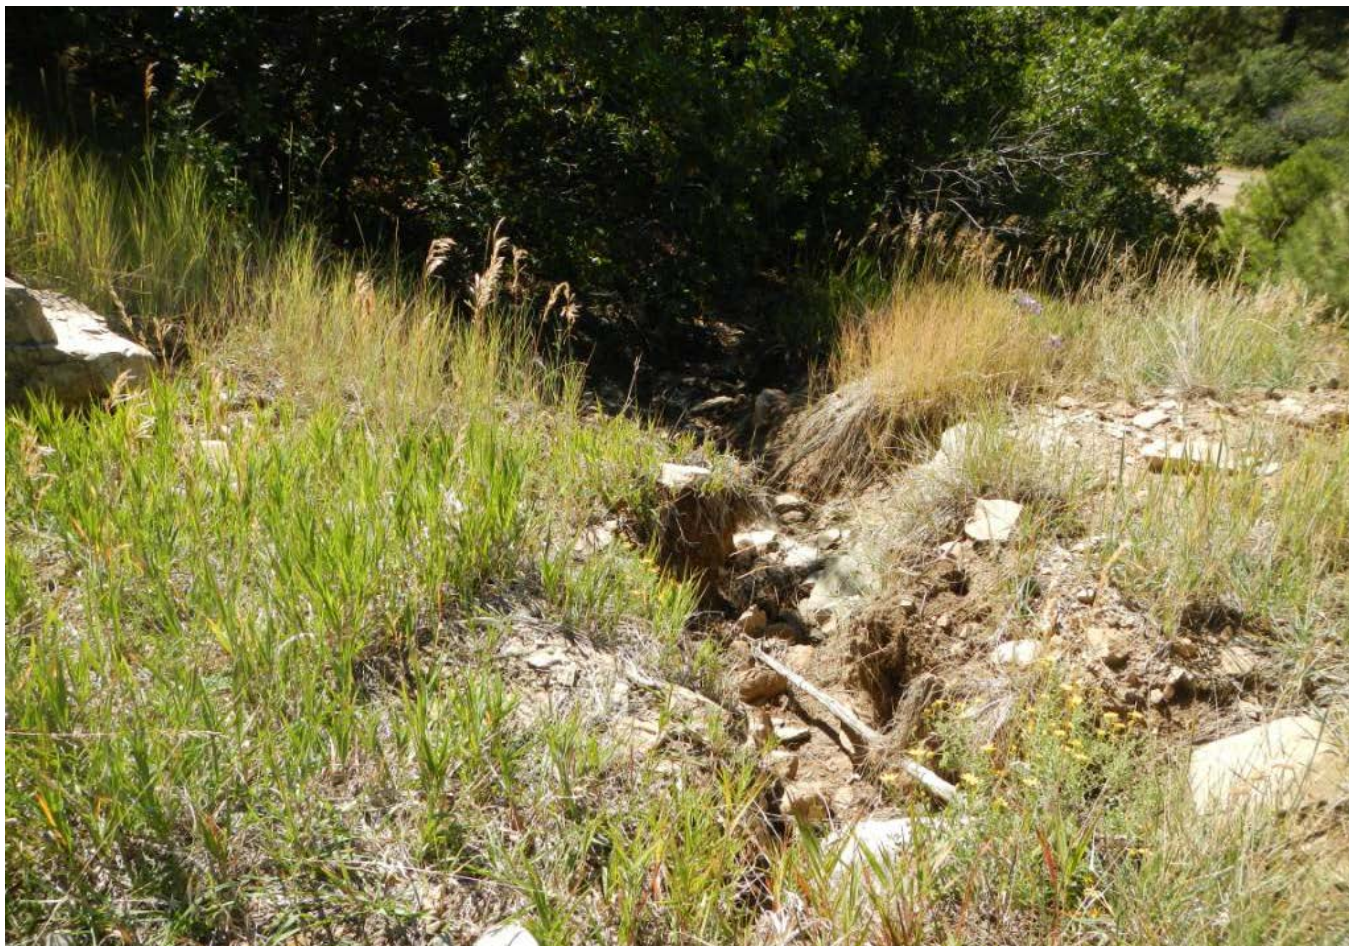
Photo 2. Gully that is approximately 2 to 3 feet wide and 1 to 1.5 feet deep eroding the fill slope in southwestern corner of the well pad.

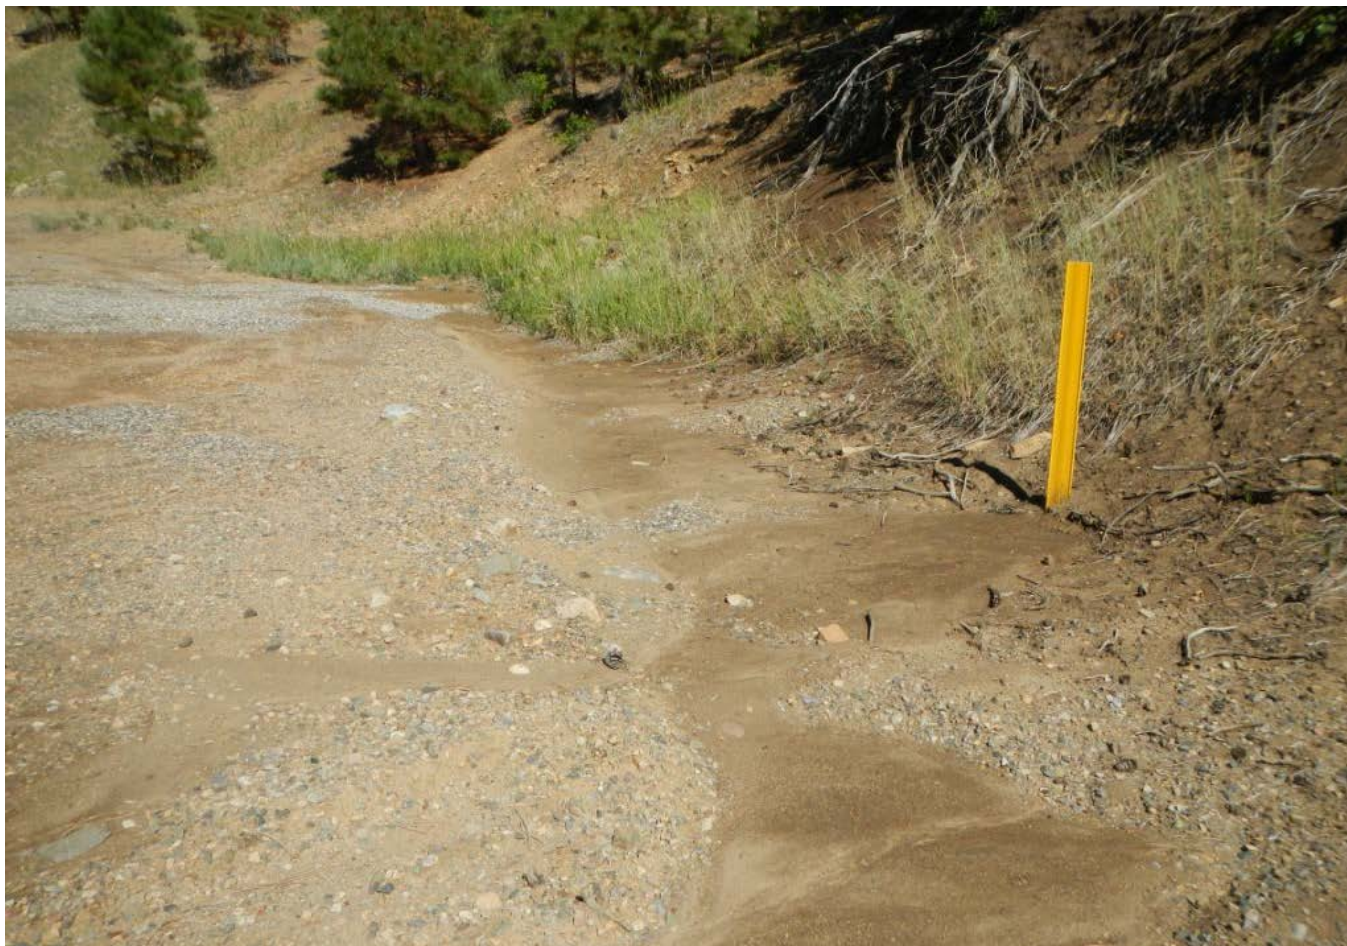
Photo 4. View of sediment deposition on the well pad from the cut slopes along the eastern edge of the well pad.

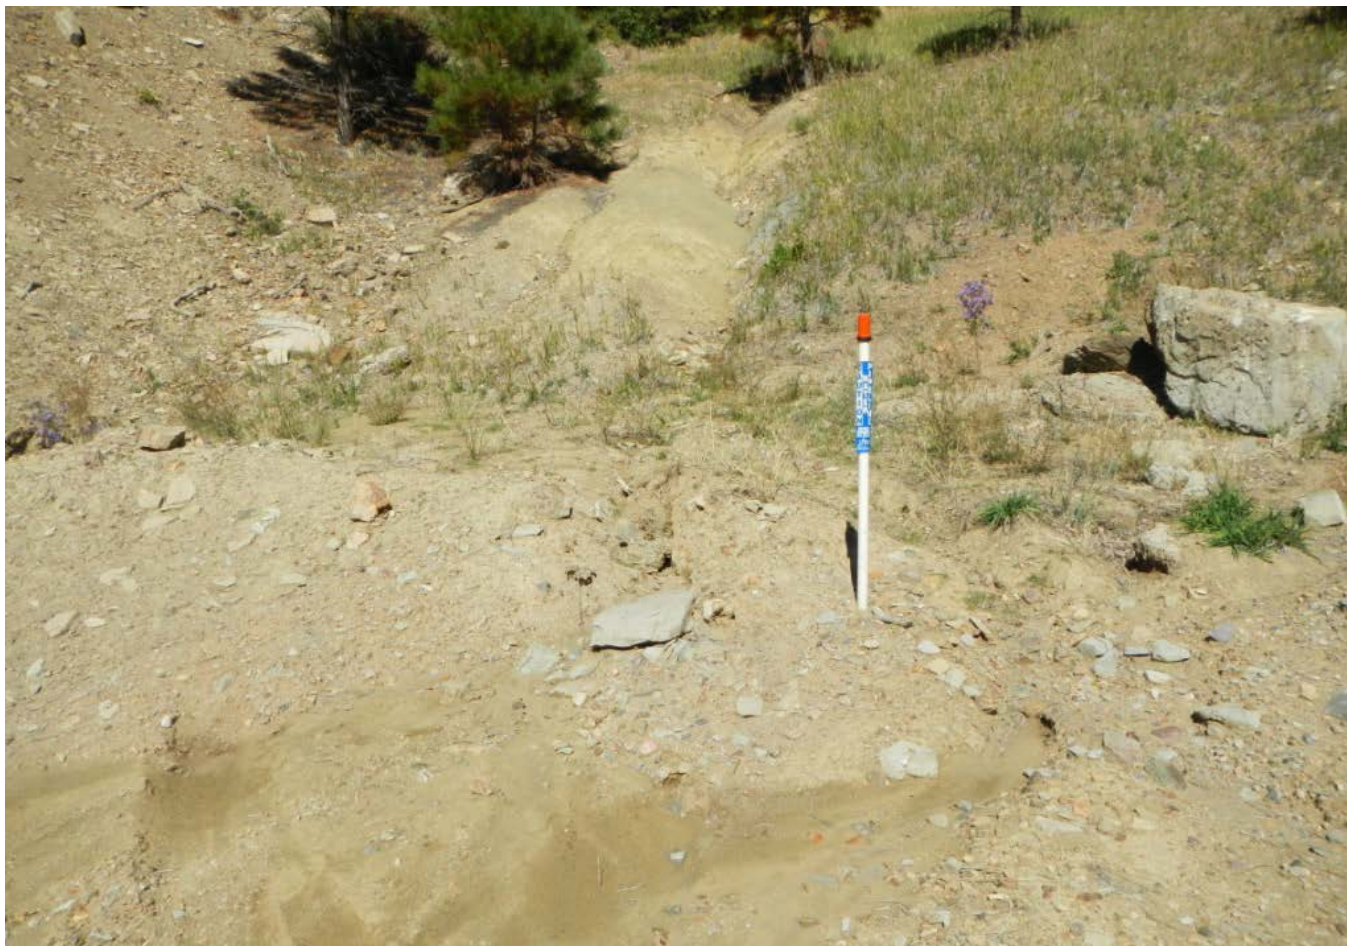
Photo 5. View of gully in northeastern corner of well pad that has eroded through a diversion berm and is eroding sediment onto the well pad.

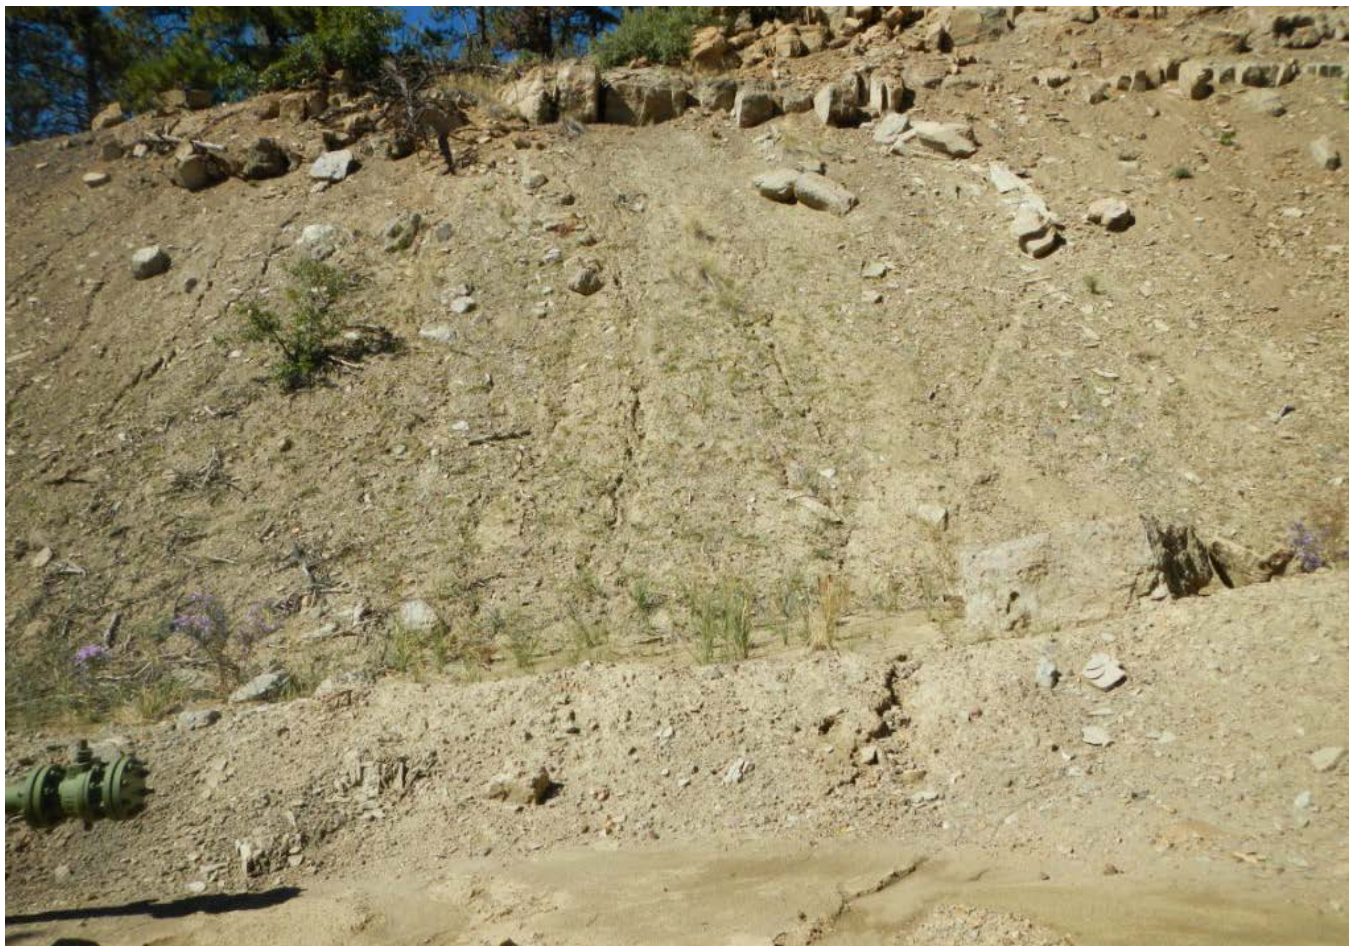
Photo 6. View of rill erosion in the cut slope on the northern edge of the well pad.

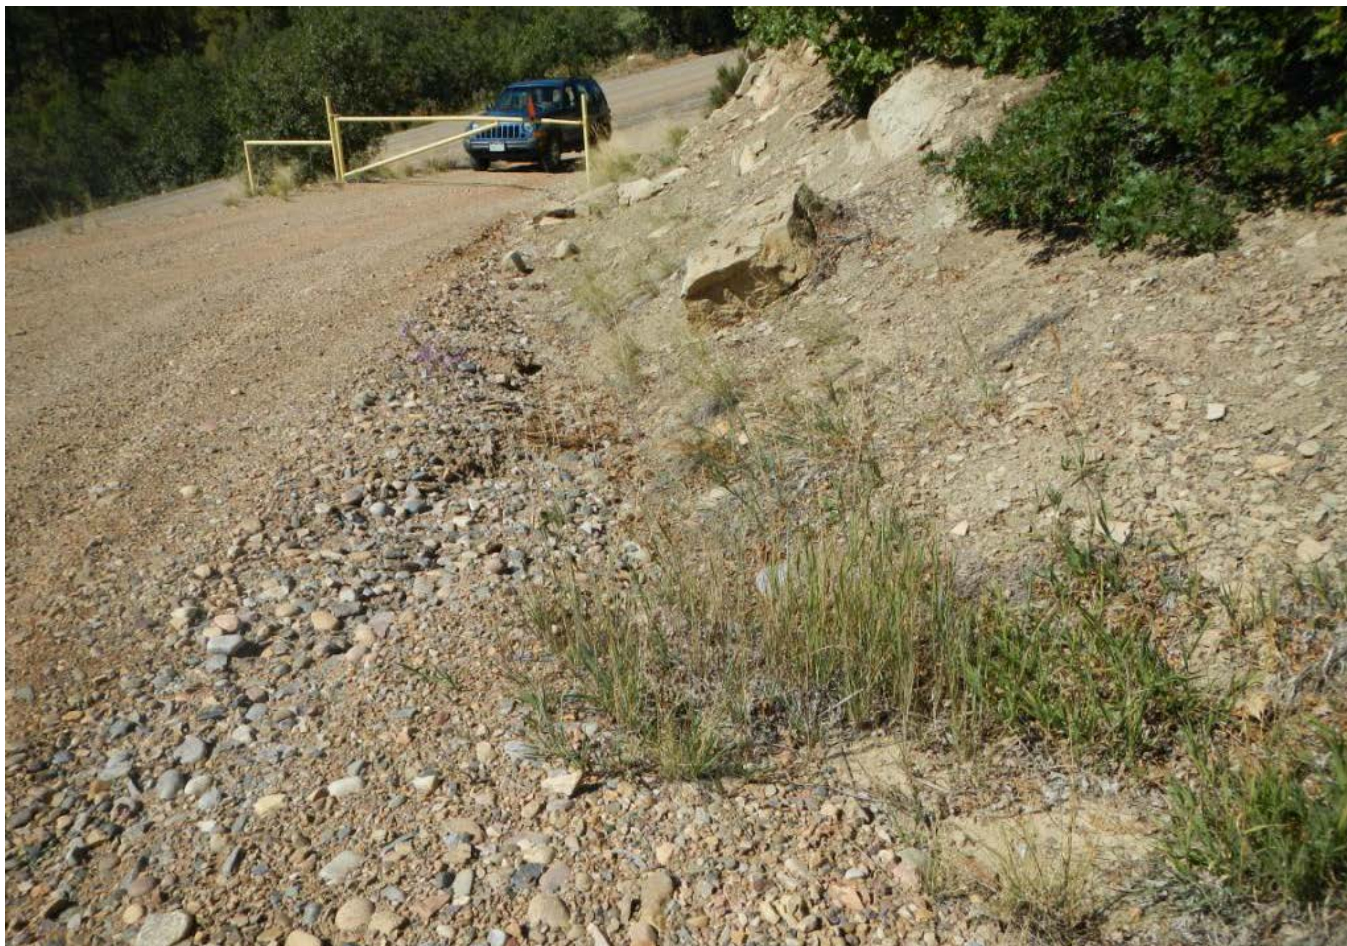
Photo 7. View of erosion along the access road from the well pad facing downhill and westward.

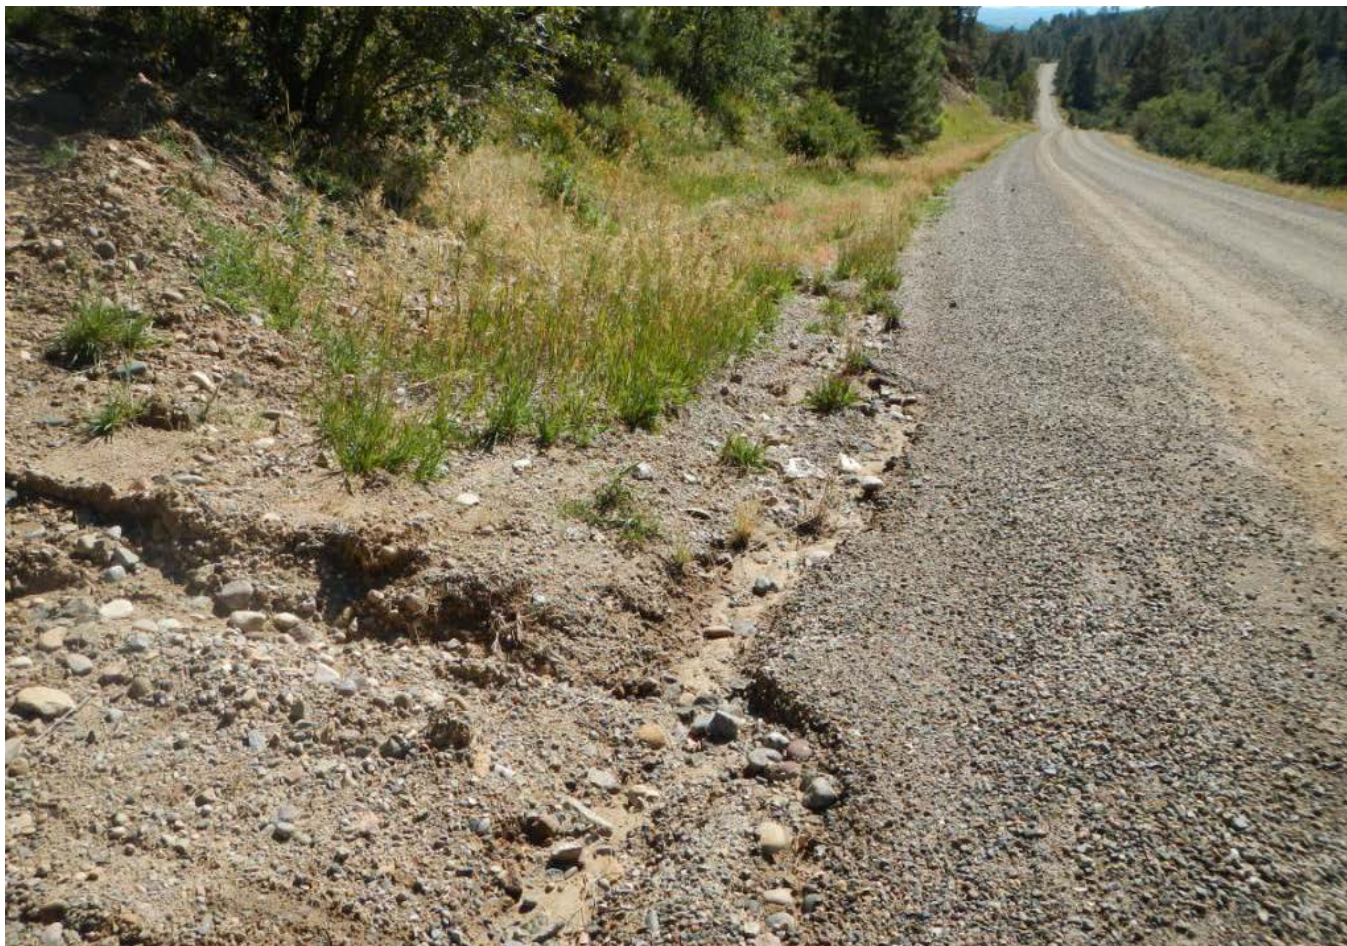
Photo 8. View of erosion along Road 502 and downstream from the entrance to the access road that appears to be caused from stormwater exiting the well pad.
