## Remediation Project 3438 (Energy O&G) - Bayswater Eleanor 1-29 location (05-123-12703)

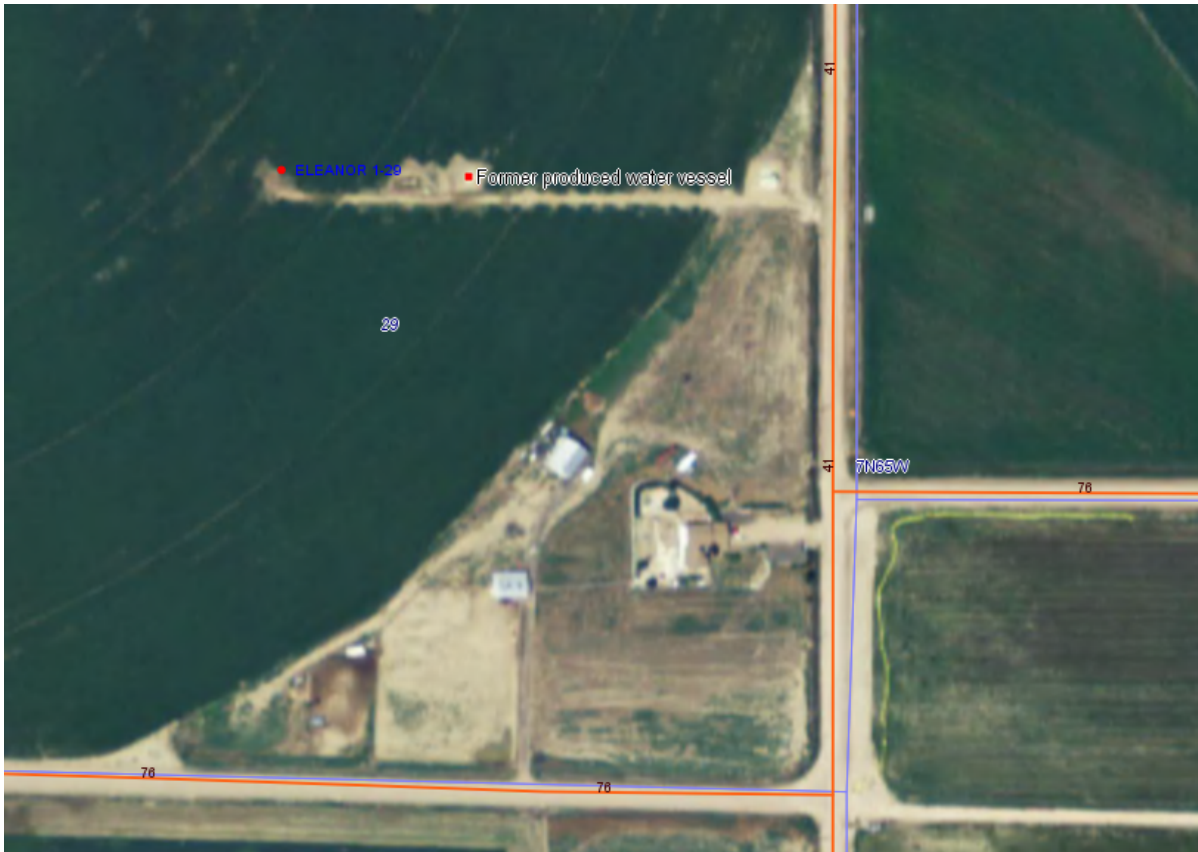
2011 Aerial Image

COGCC records do not include any documentation that the conditionally approved workplan was executed. In addition, it appears that the subject buried produced water vessel was located approximately 325-350 feet west of the current production facilities toward the wellhead. The produced water vessel has since been removed and relocated to the current production facility location. However, no assessment of the subsurface at the former produced water vessel location has been provided to COGCC. See the 2011 aerial image below, followed by the 2013 aerial image:

Therefore, COGCC requests Bayswater Exploration and Production to conduct an investigation to resolve Remediation Project Number 3438 and to perform a subsurface assessment at the former produced water vessel location. Please submit a Form 27 Site Investigation and Remediation Workplan within 60 days with a proposal to perform the requested work. The assessment should focus on the area at the former produced water vault location as seen in historical aerial imagery.
