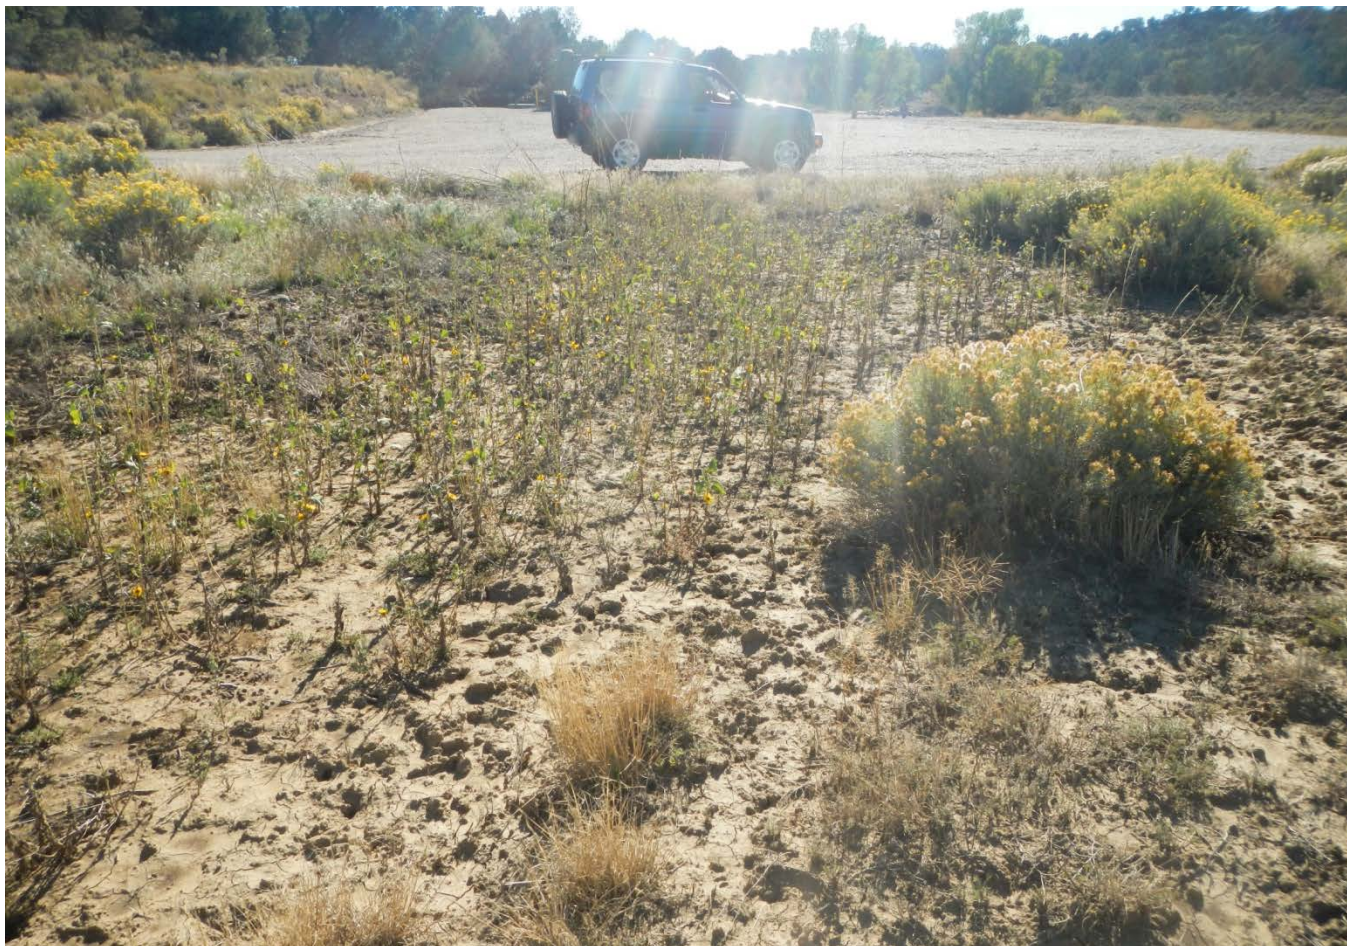
Photo 1. View of silt trap largely full of sediment within the northern portion of the interim reclamation area.

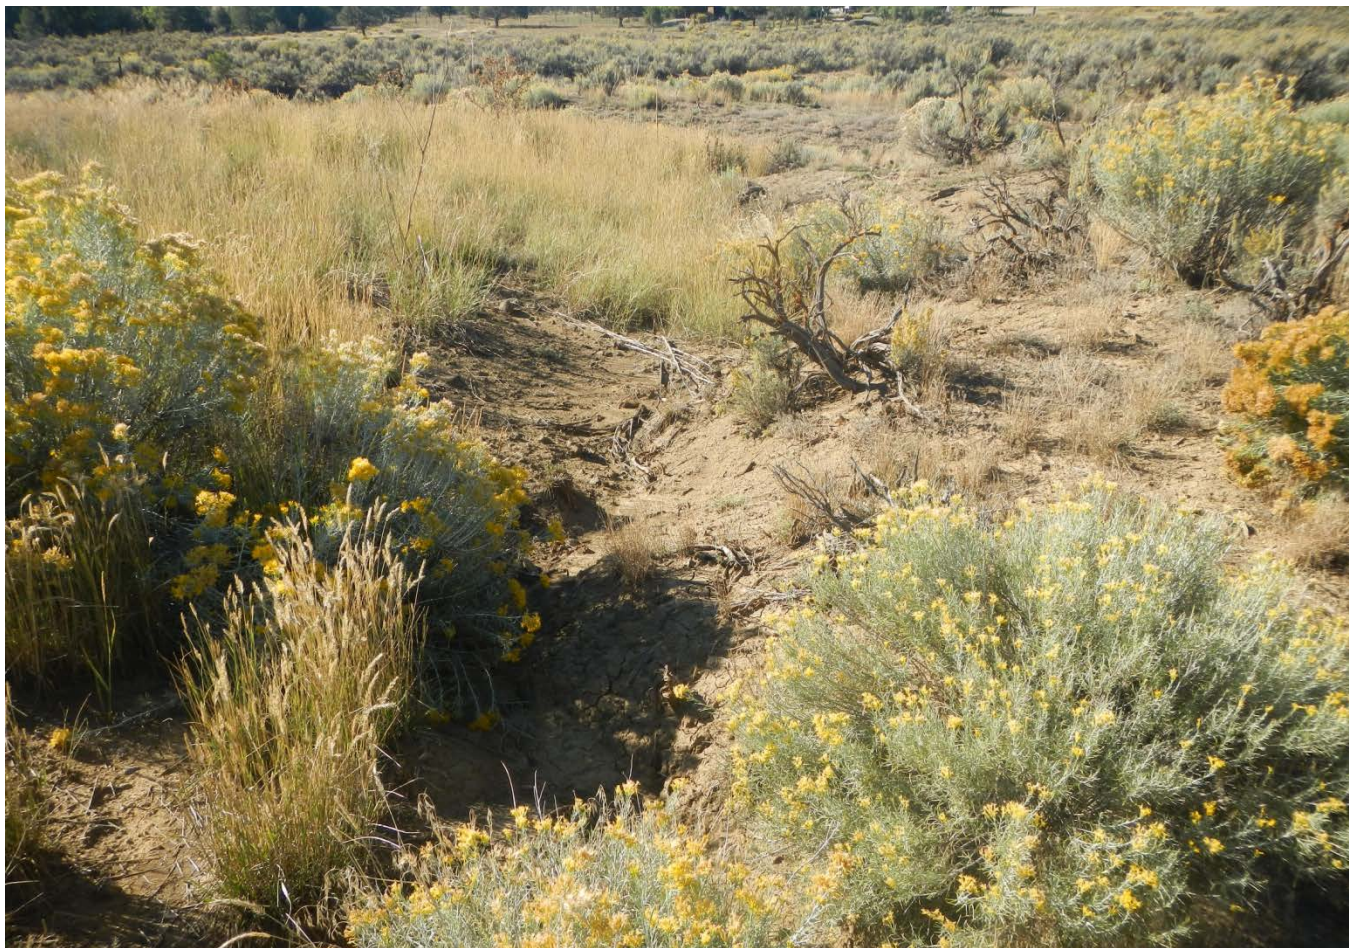
Photo 2. View of erosional channel downstream from silt trap within the northern portion of the interim reclamation area.

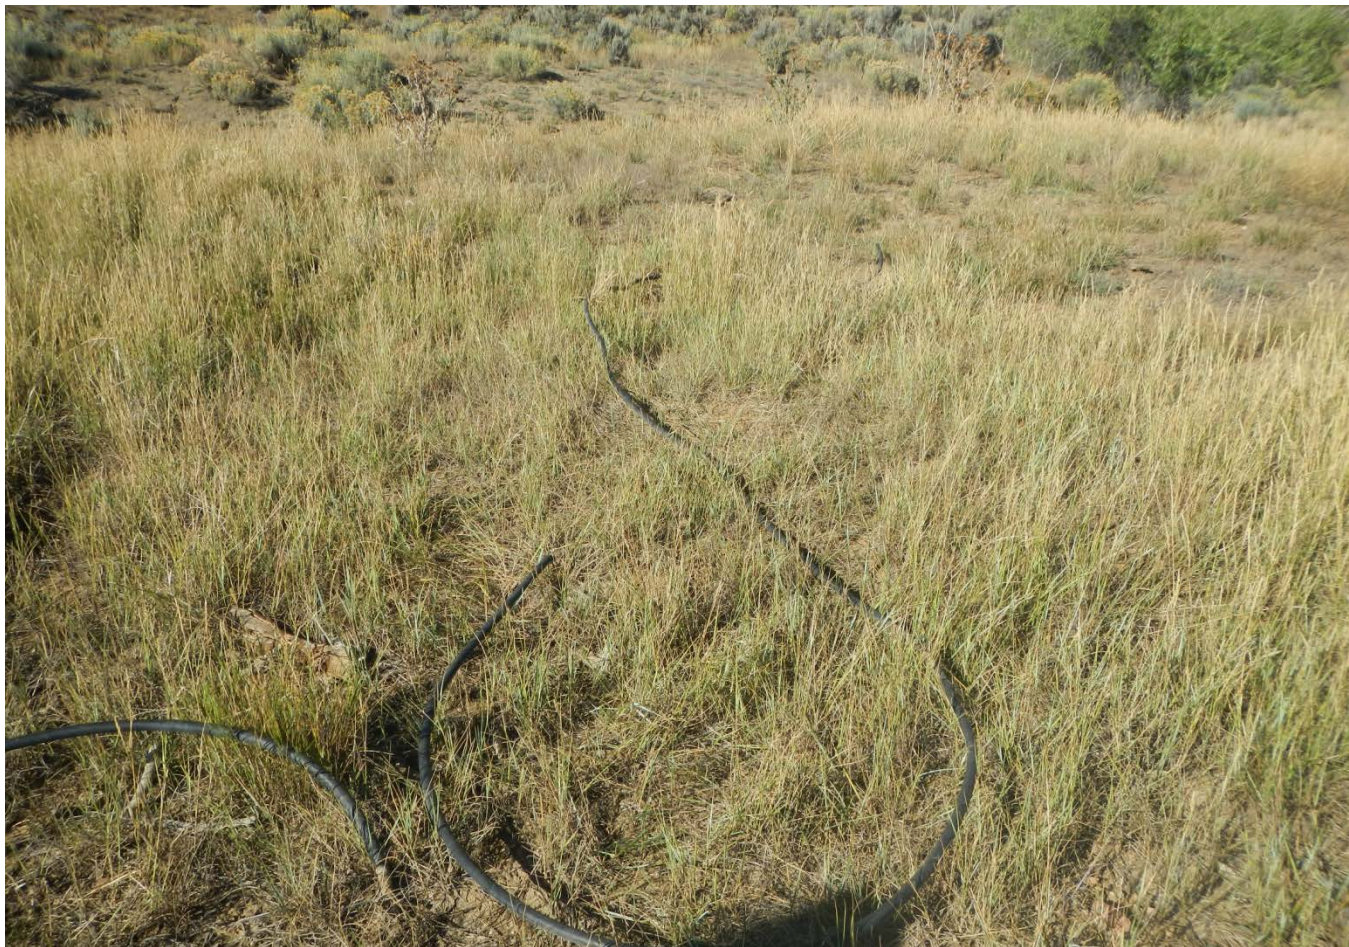
Photo 3. View of unused drip line within western portion of the interim reclamation area.
