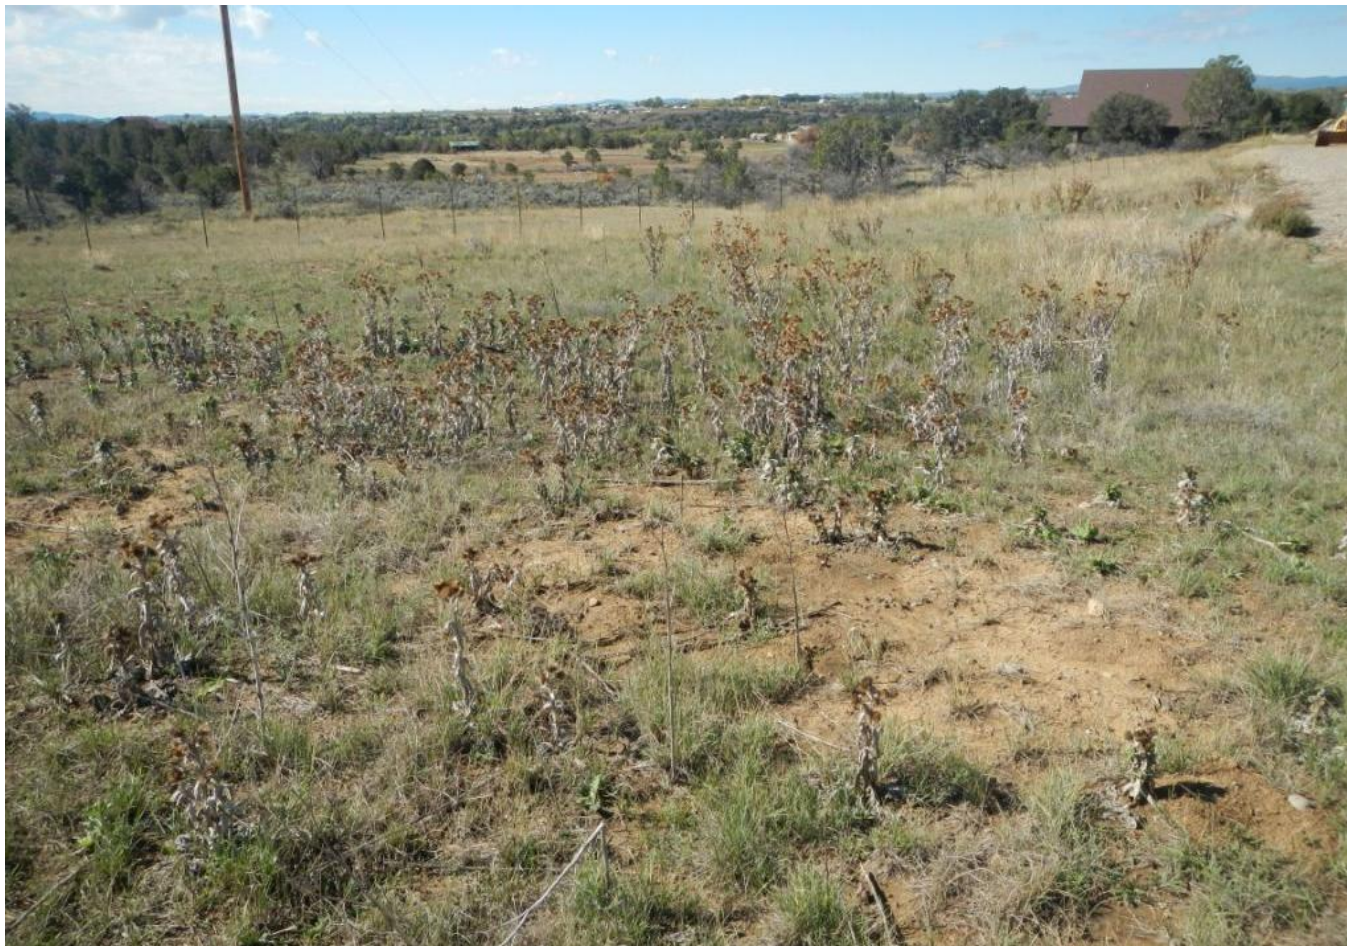
Photo 1. Infestation of Scotch thistle within the eastern and northern portion of the interim reclamation area.

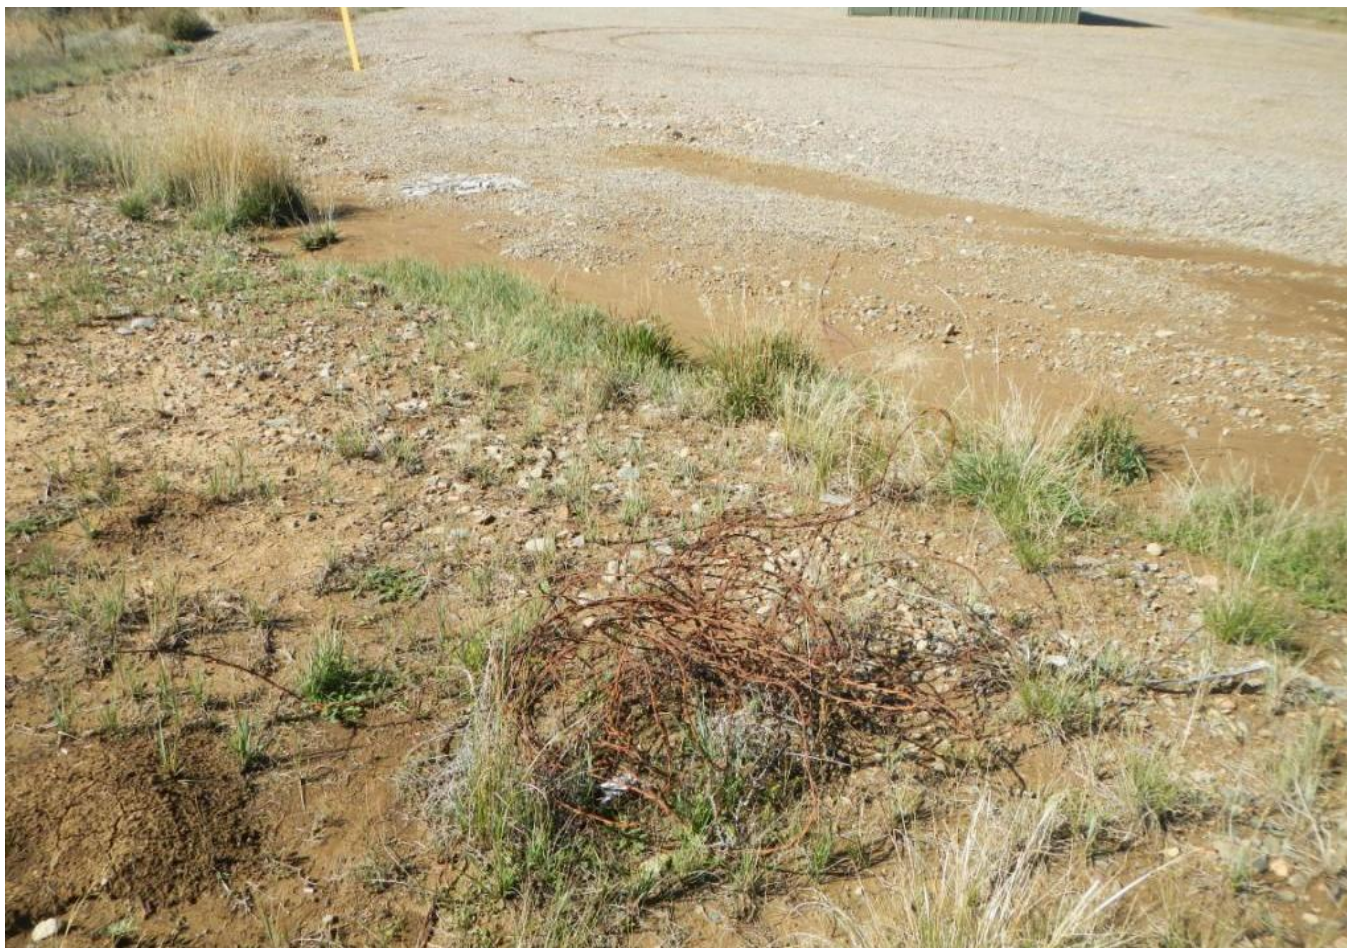
Photo 2. Barbed wire near the northeastern edge of the interim reclamation area and the working area of the well pad.

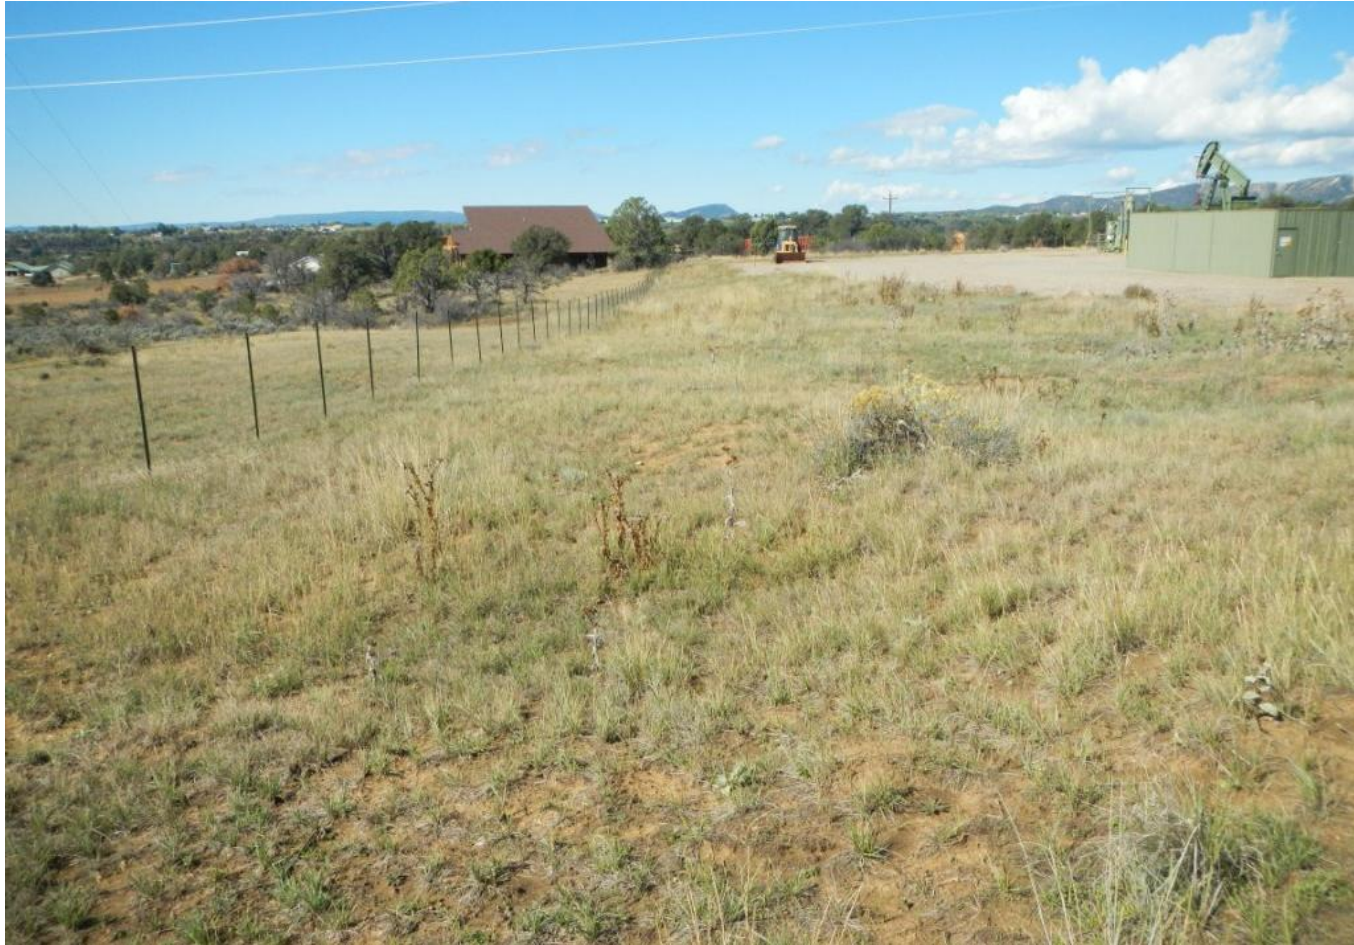
Photo 3. View of eastern portion of the interim reclamation area with good grass cover and slope stabilization.

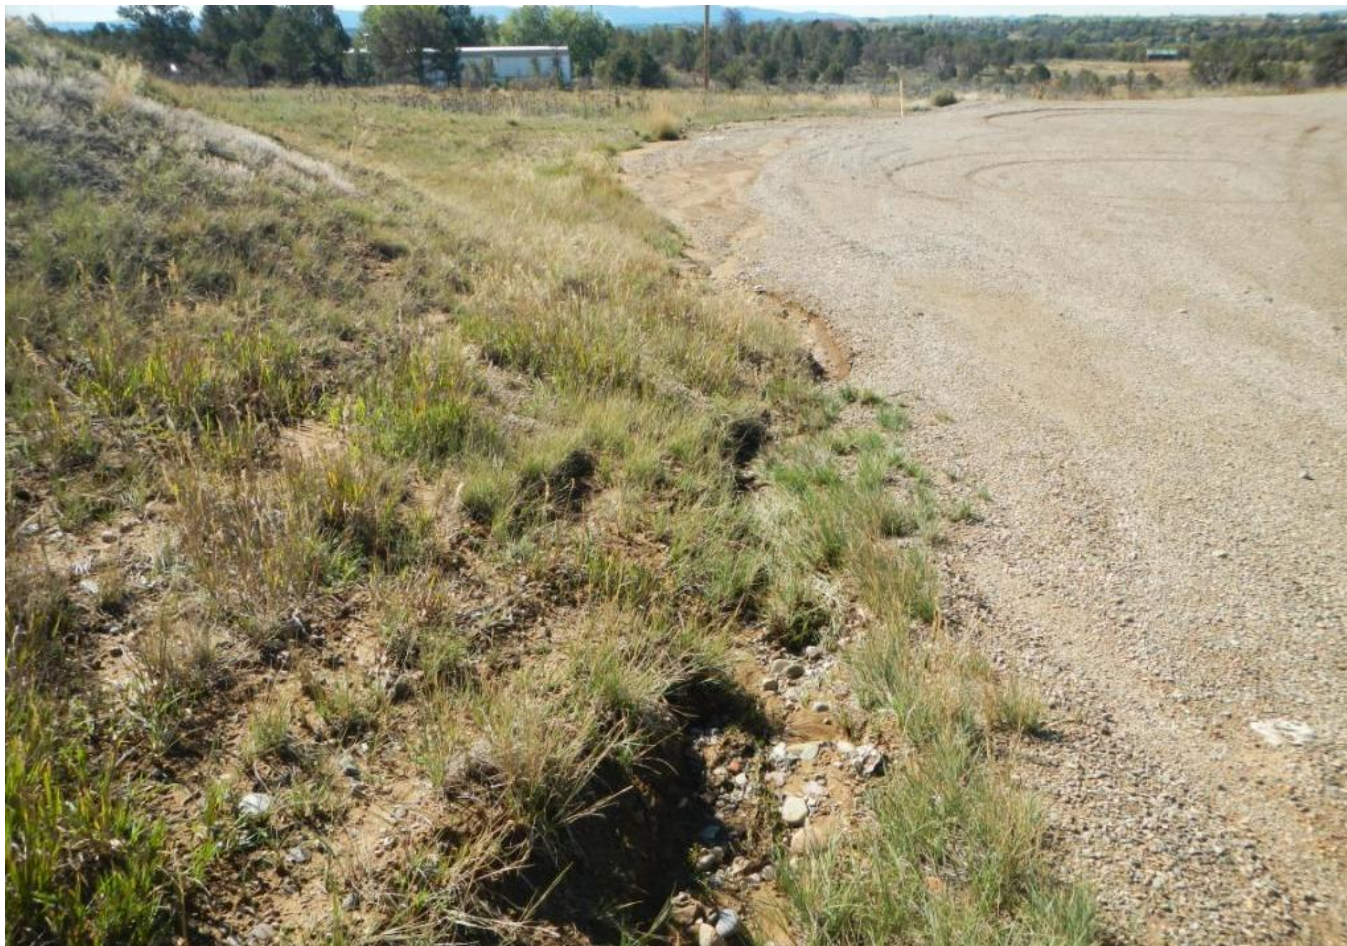
Photo 4. View of erosional channel eroding the eastern edge of the access road and depositing sediment on the well pad.

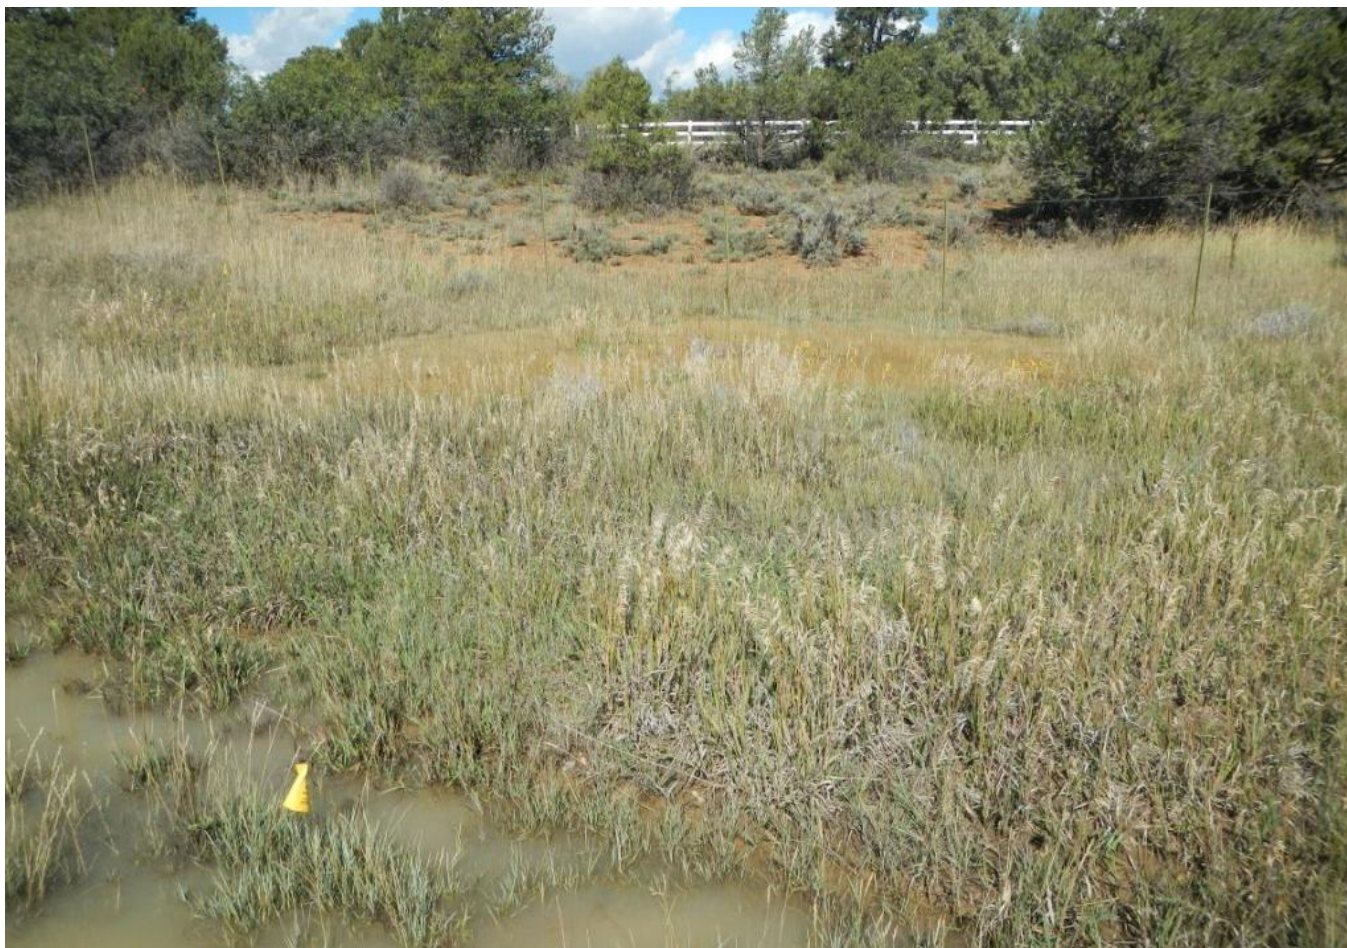
Photo 5. View of silt trap in western portion of interim reclamation area containing significant stormwater flows.

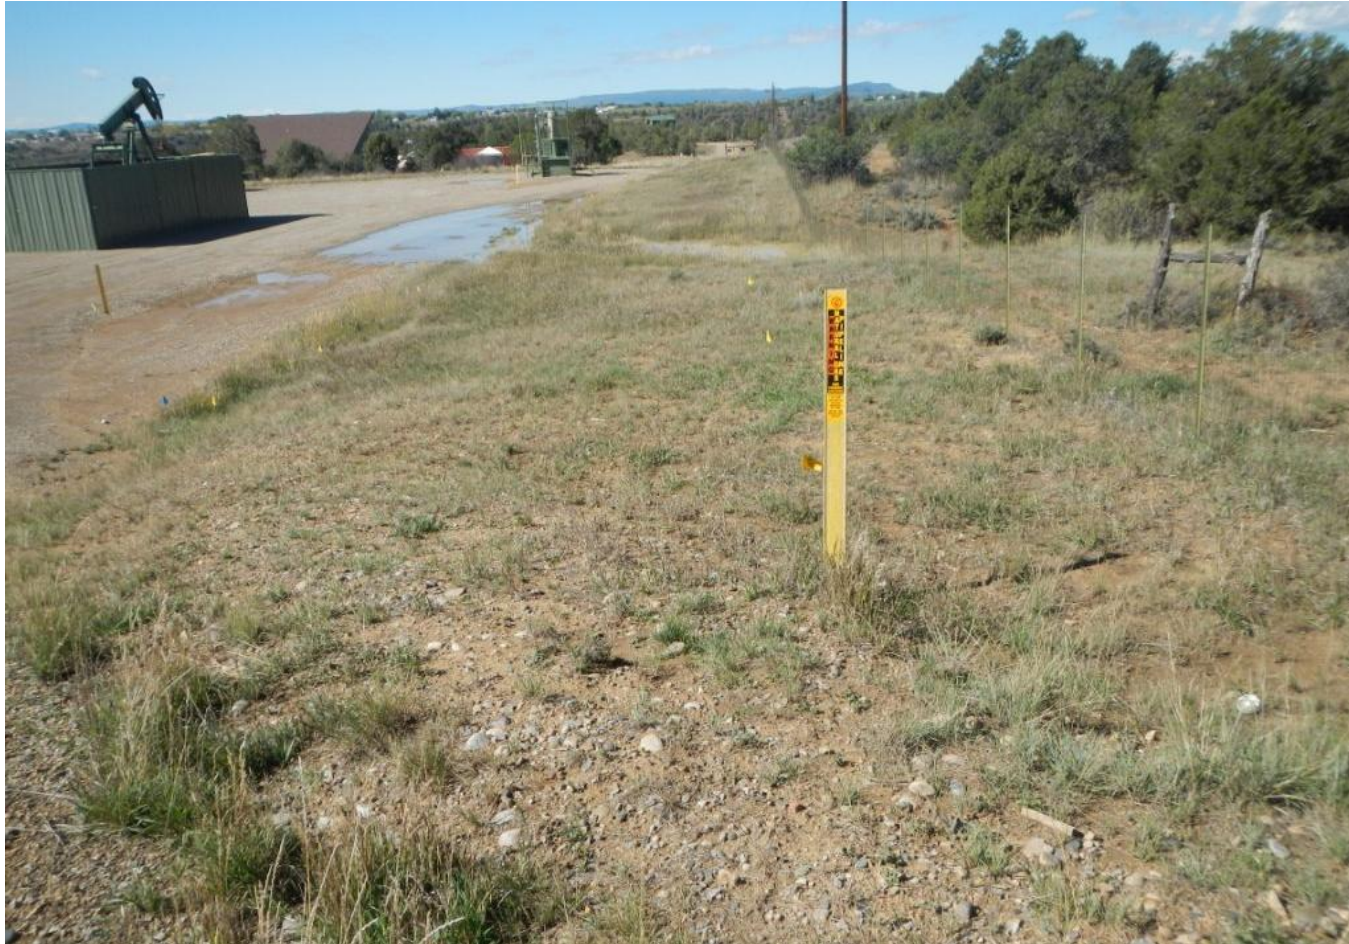
Photo 6. View of western portion of interim reclamation area with silt trap full of water and ponding on the well pad that does not appear to be on the driving surface and does not appear to be overflowing off of the well pad.
