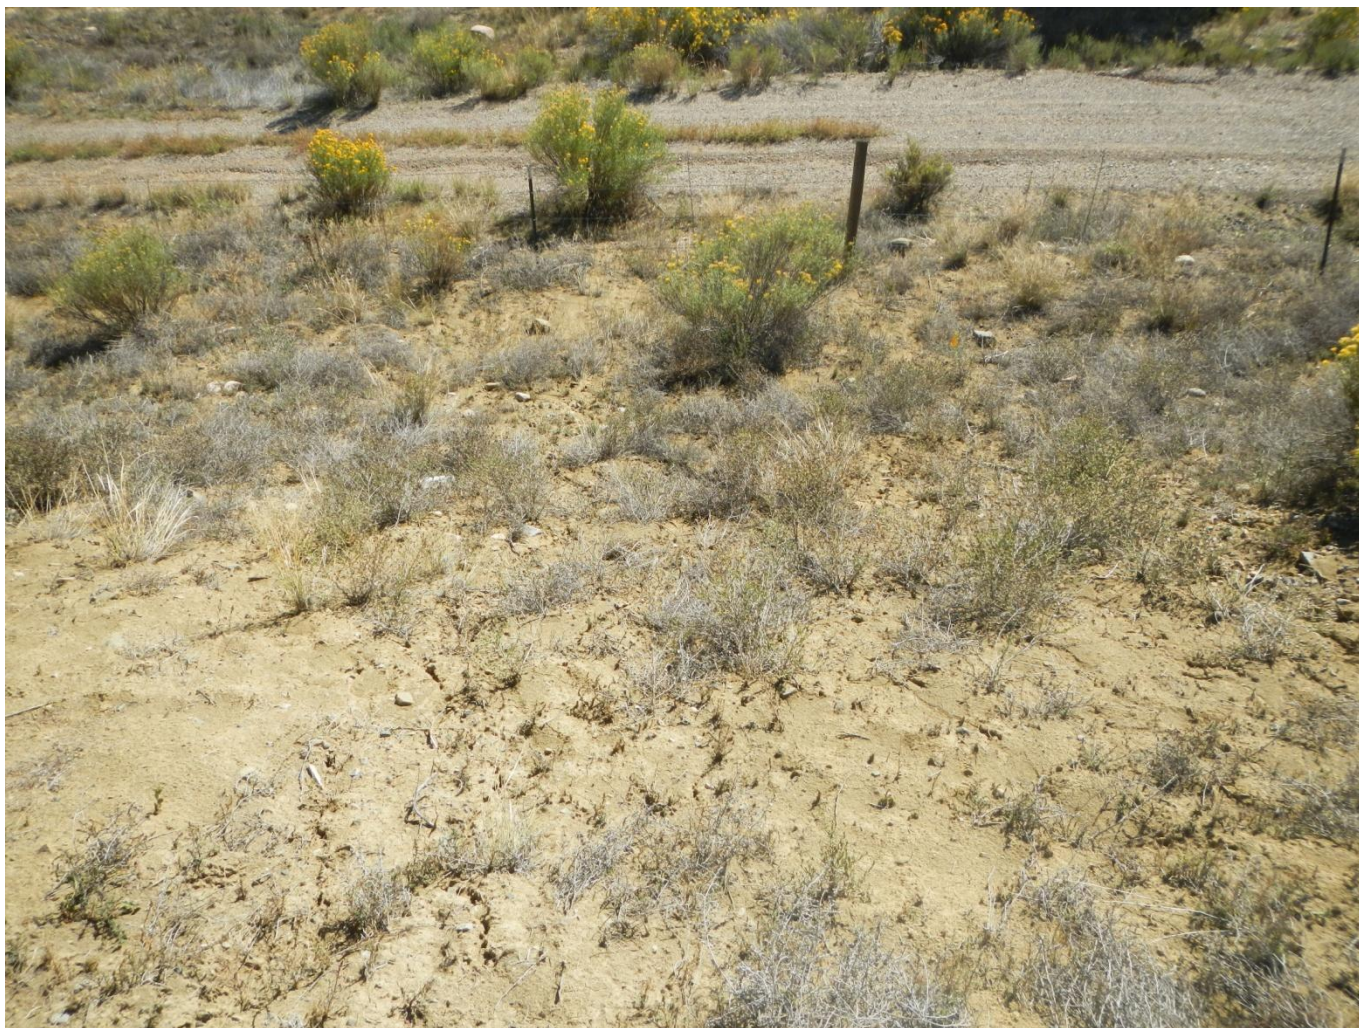
Photo 1. View of revegetation within the eastern portion of the interim reclamation area. The brushy green and brown plants in the midground are County and State-listed Russian knapweed plants.

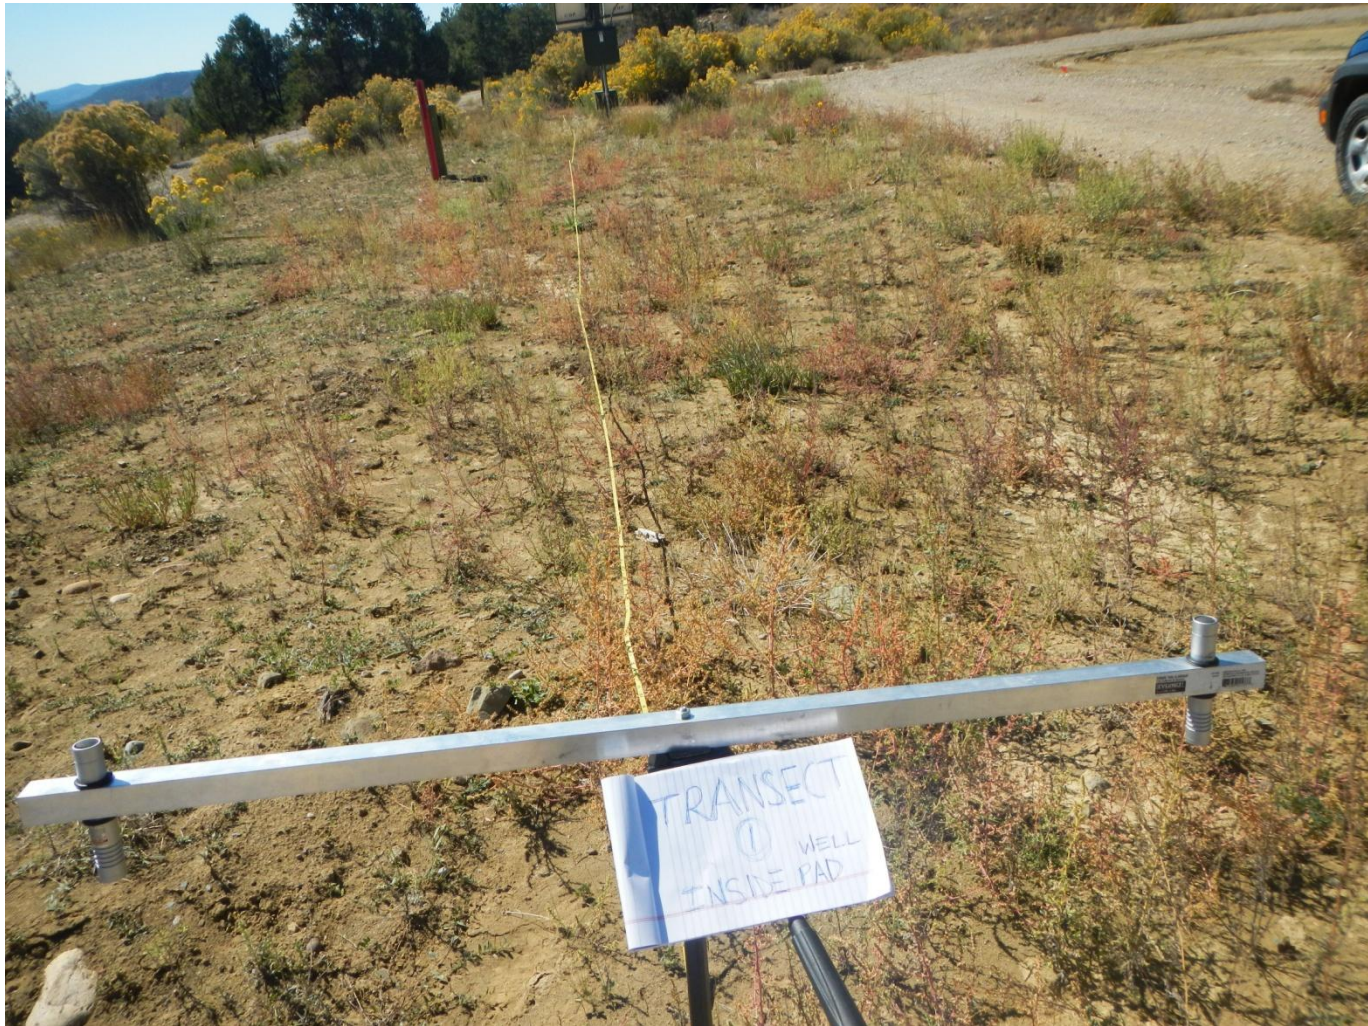
Photo 2. View of the beginning of the vegetation transect within the project area facing southward.

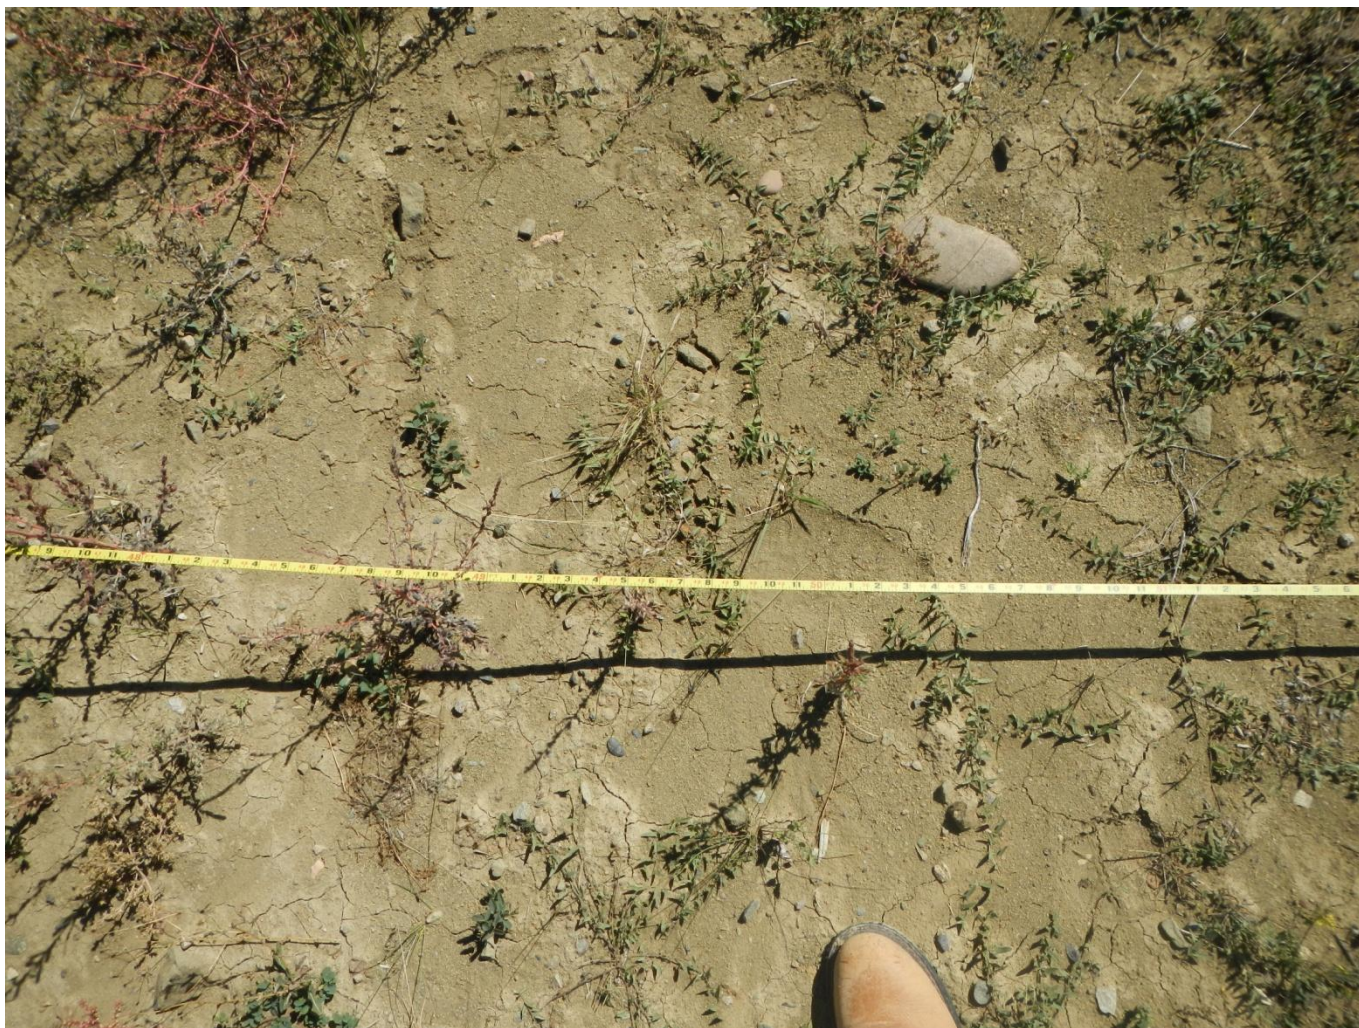
Photo 3. Birdseye view of vegetation at the midpoint of the vegetation transect within the project area. Vegetation here is mostly kochia and field bindweed.

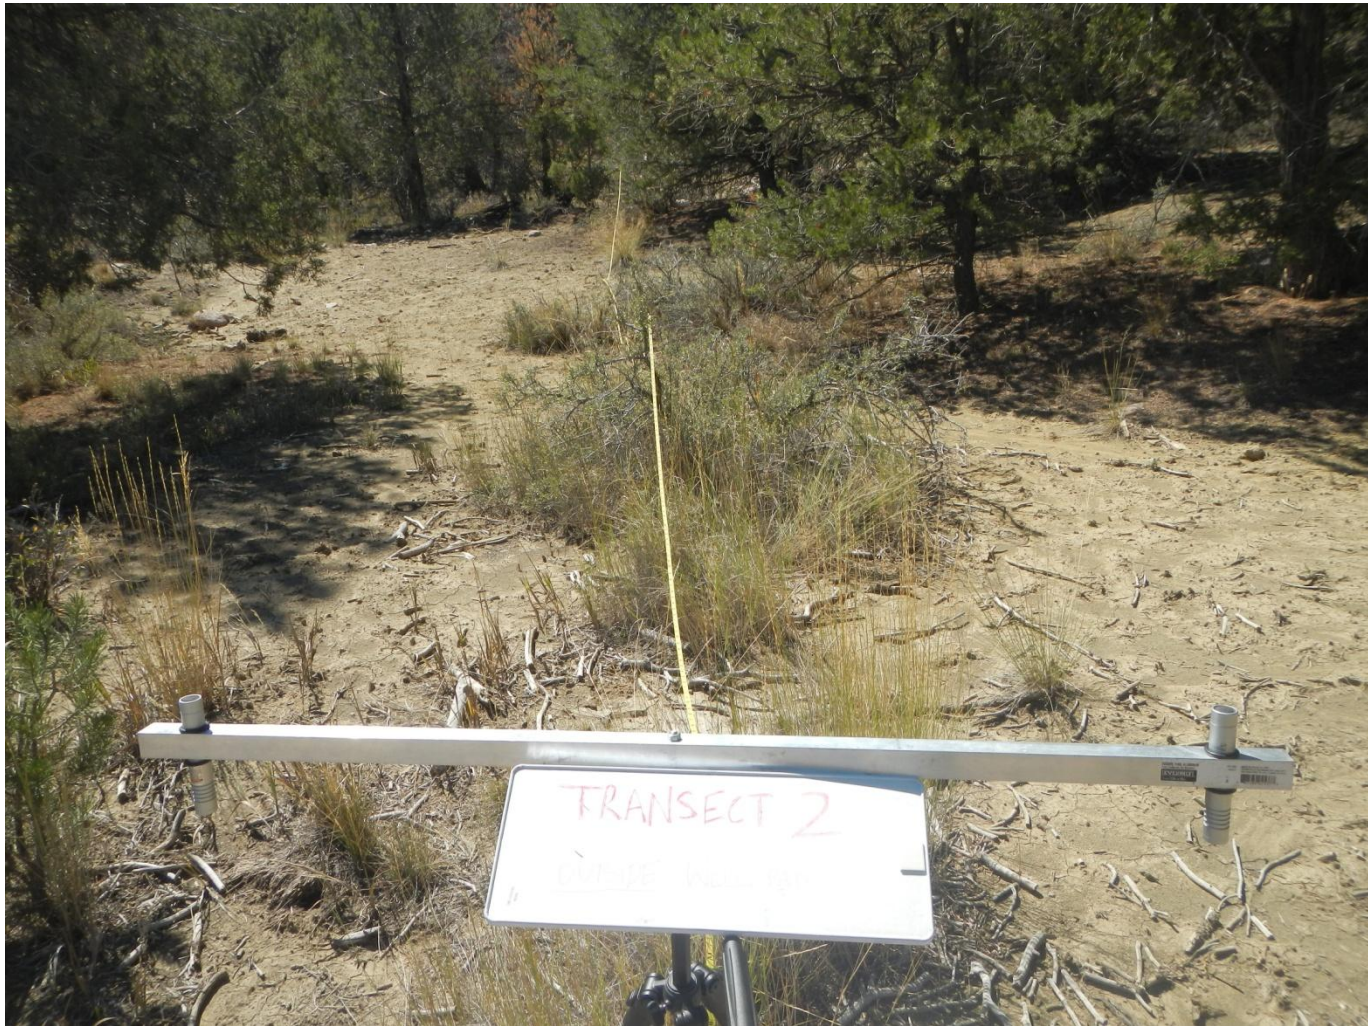
Photo 4. View of the beginning of the vegetation transect within the reference area (west of the well pad).

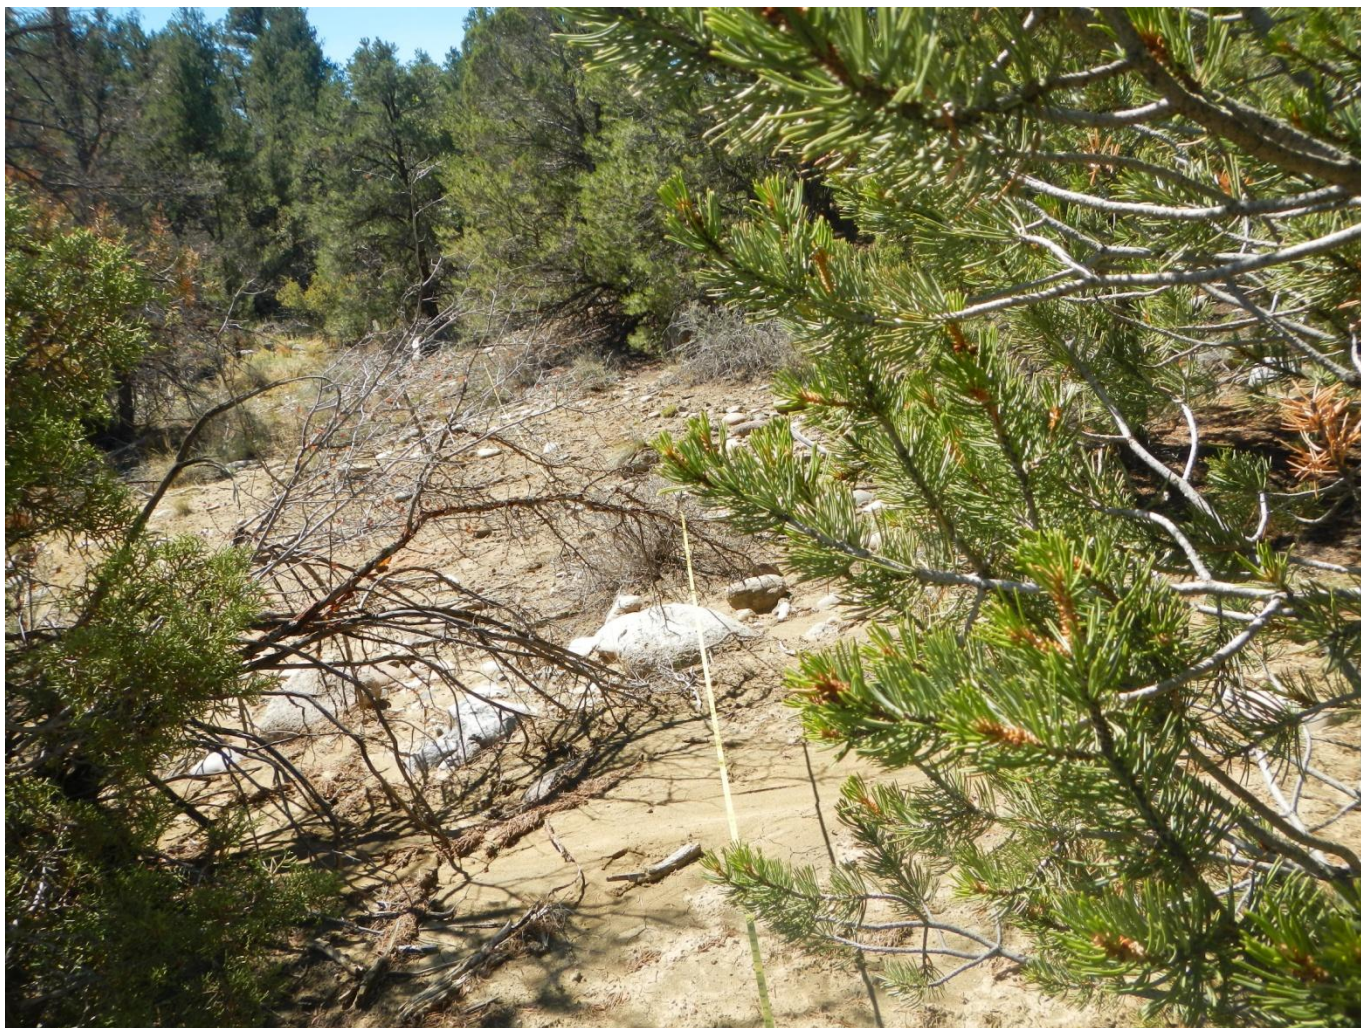
Photo 5. View from the mid-point of the reference area transect facing south toward the end of the transect.

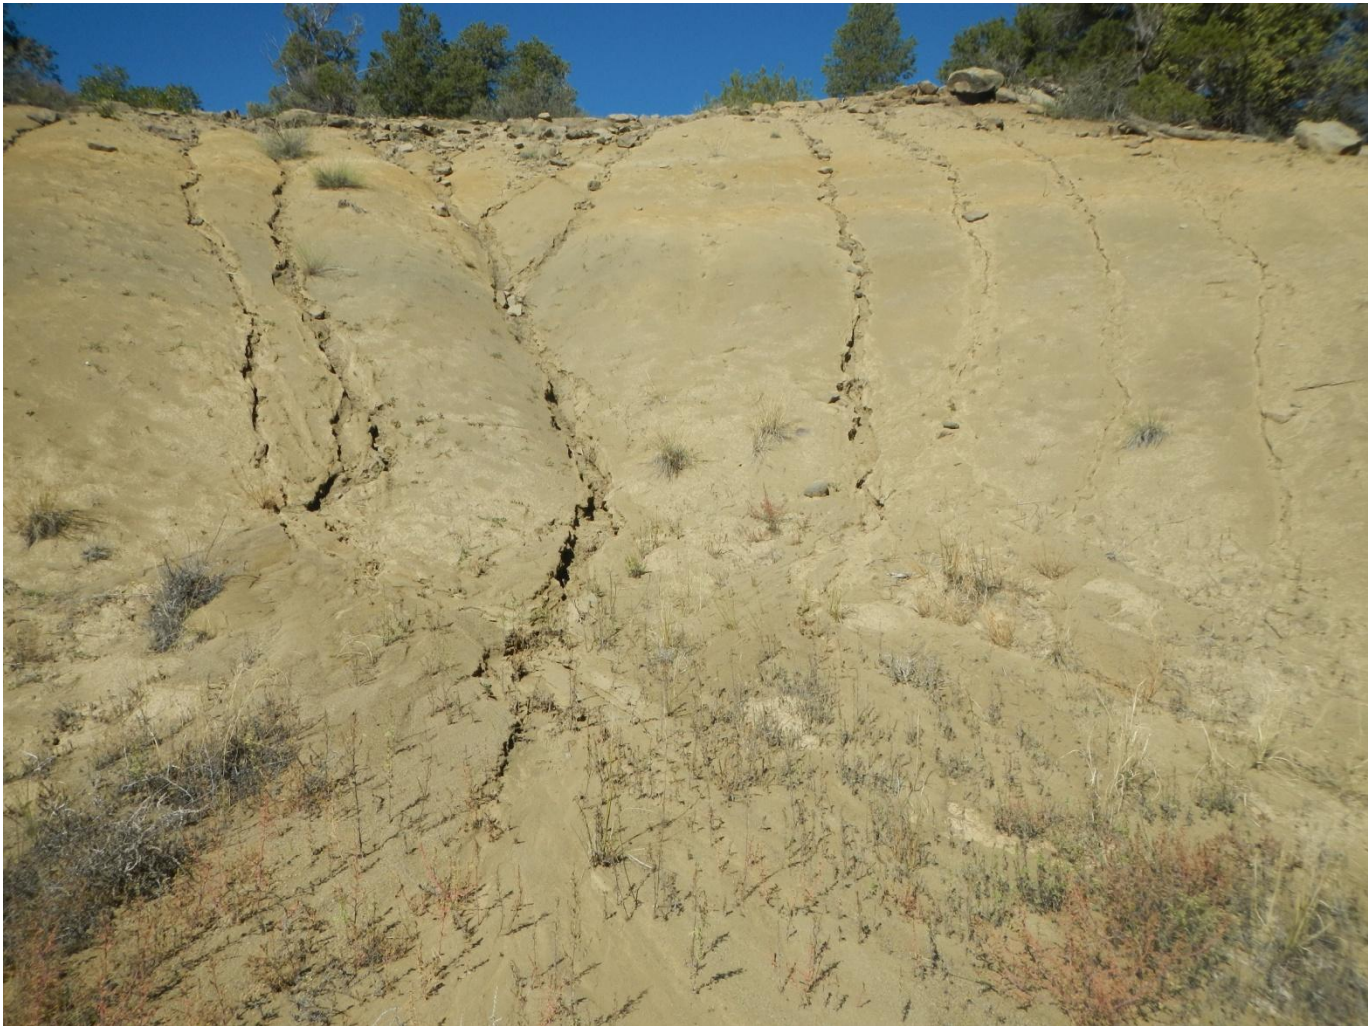
Photo 6. View of the slope above the eastern side of the well pad where rill erosion and sediment deposition is occurring.

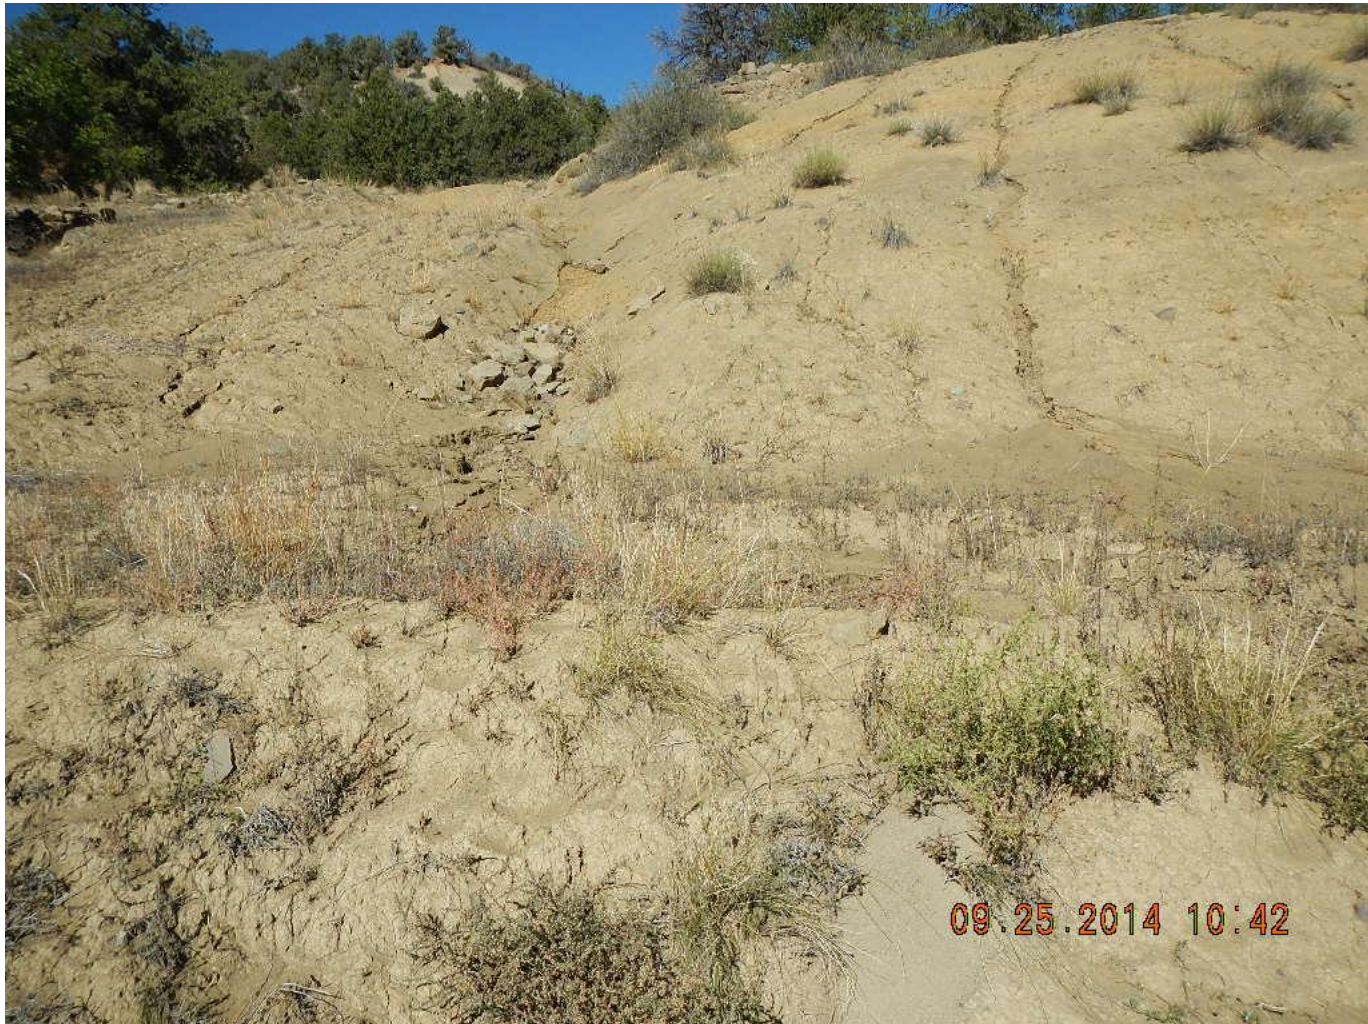
Photo 7. View of gully erosion occurring on the western edge of the well pad area.

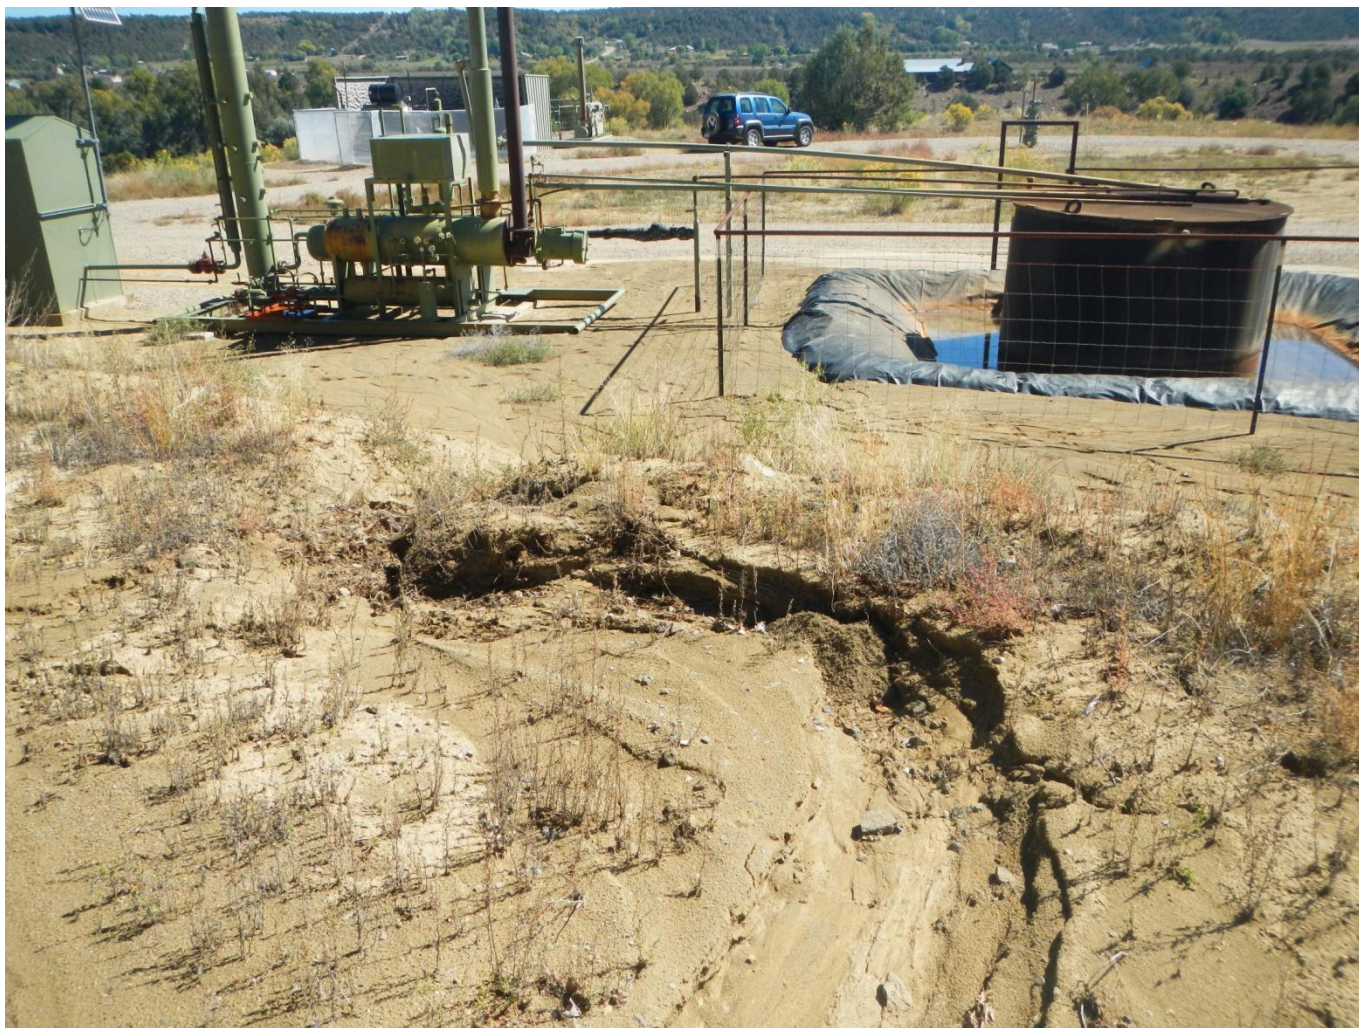
Photo 8. View of failed water diversion berm and sediment deposited on the well pad at the toe of the slope along the western edge of the well pad.

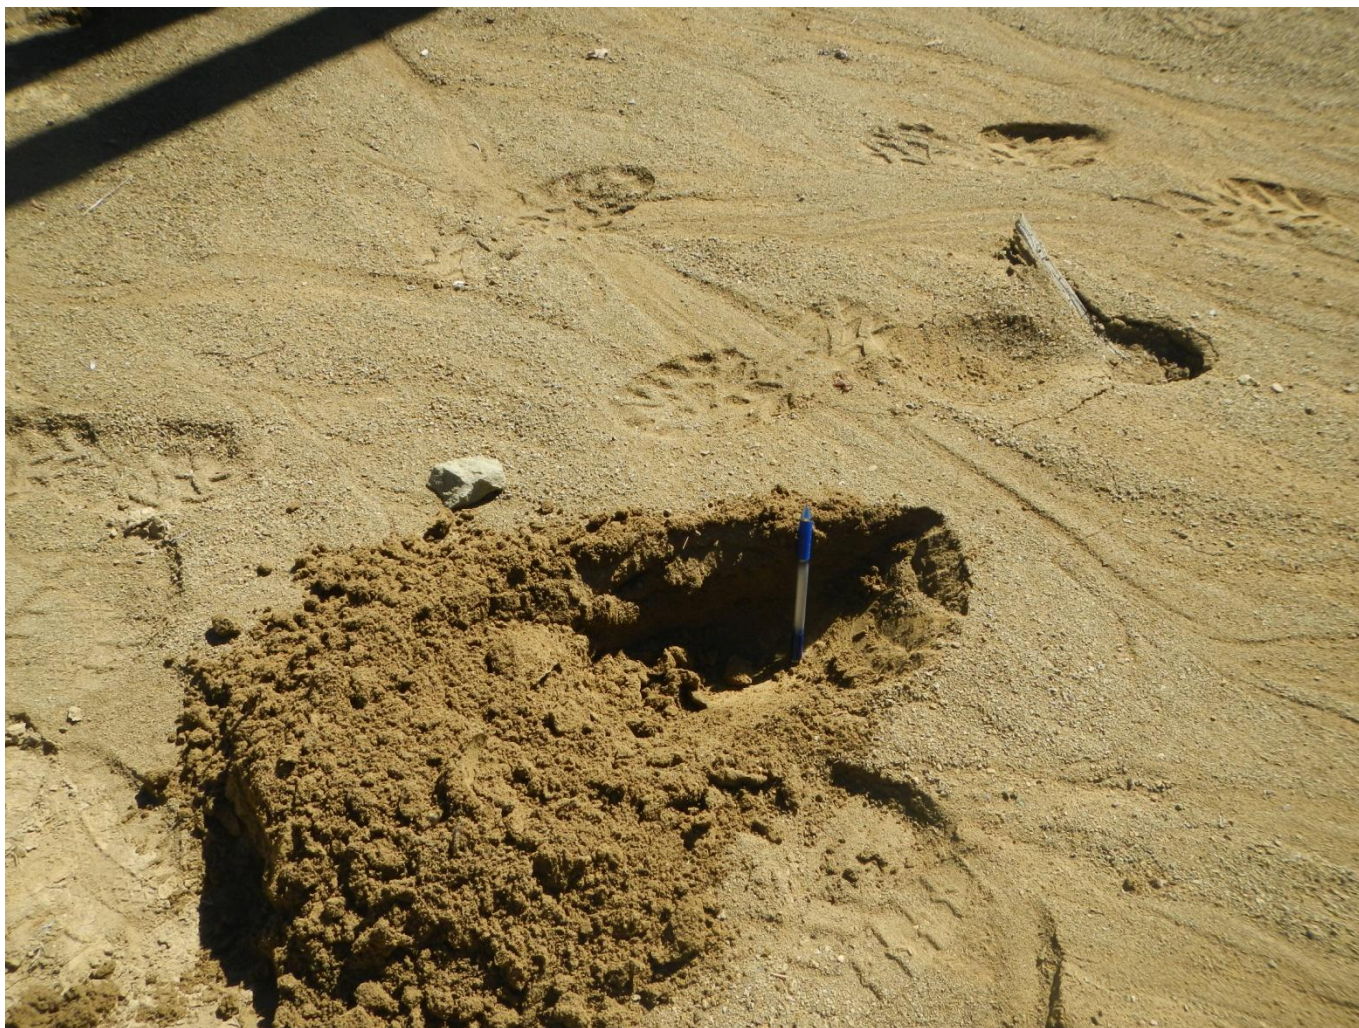
Photo 9. Sediment deposited on the well pad is approximately 6 inches deep.

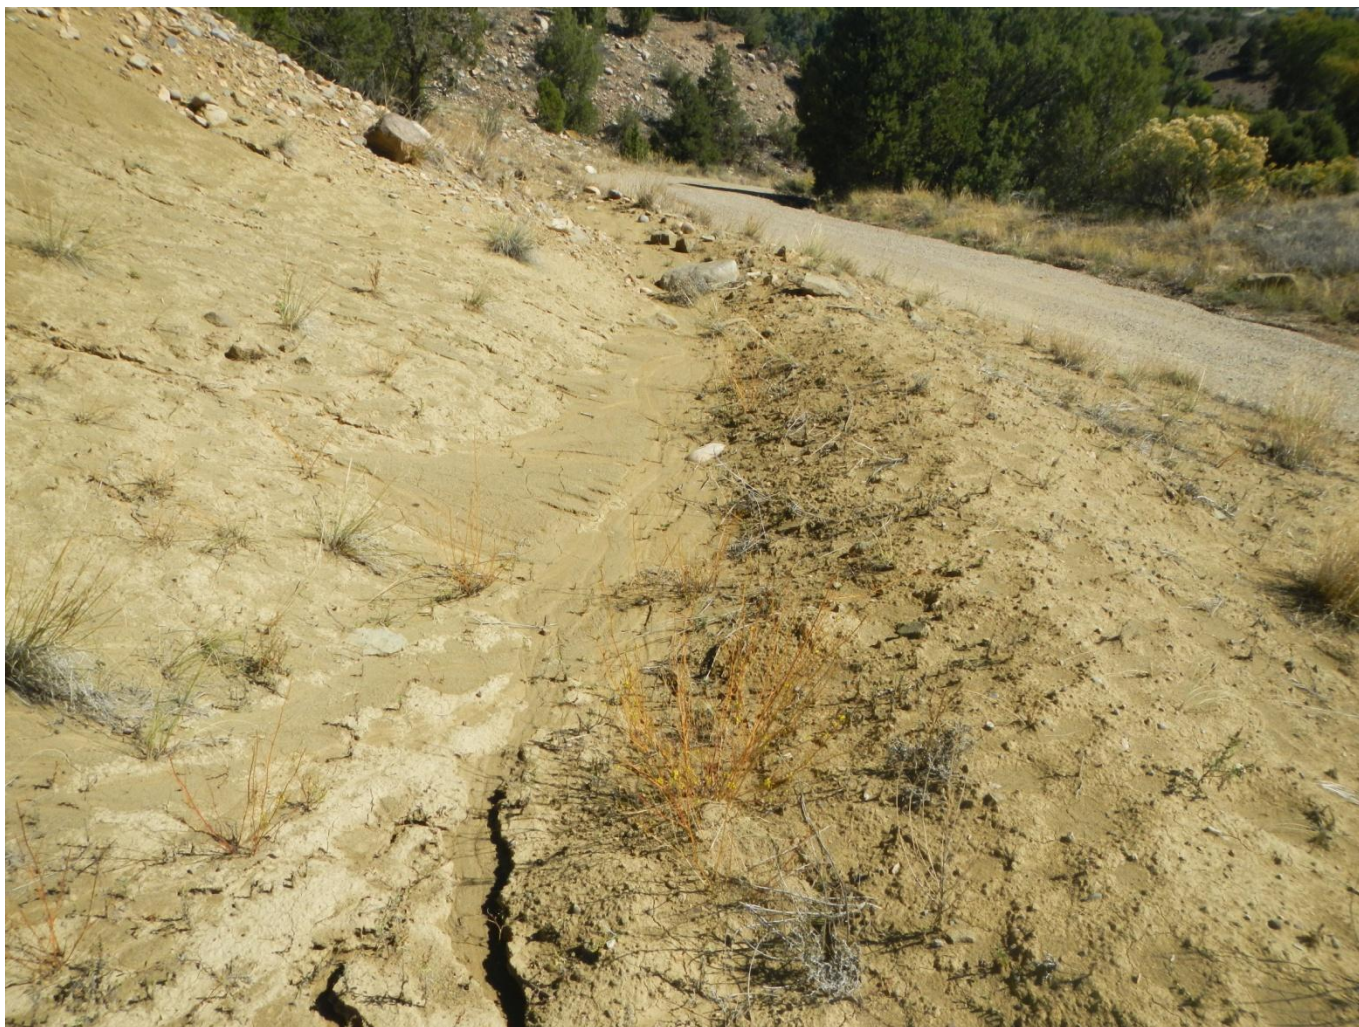
Photo 10. View of water diversion berm on western edge of well pad full of sediment and directing stormwater flows toward the access road.

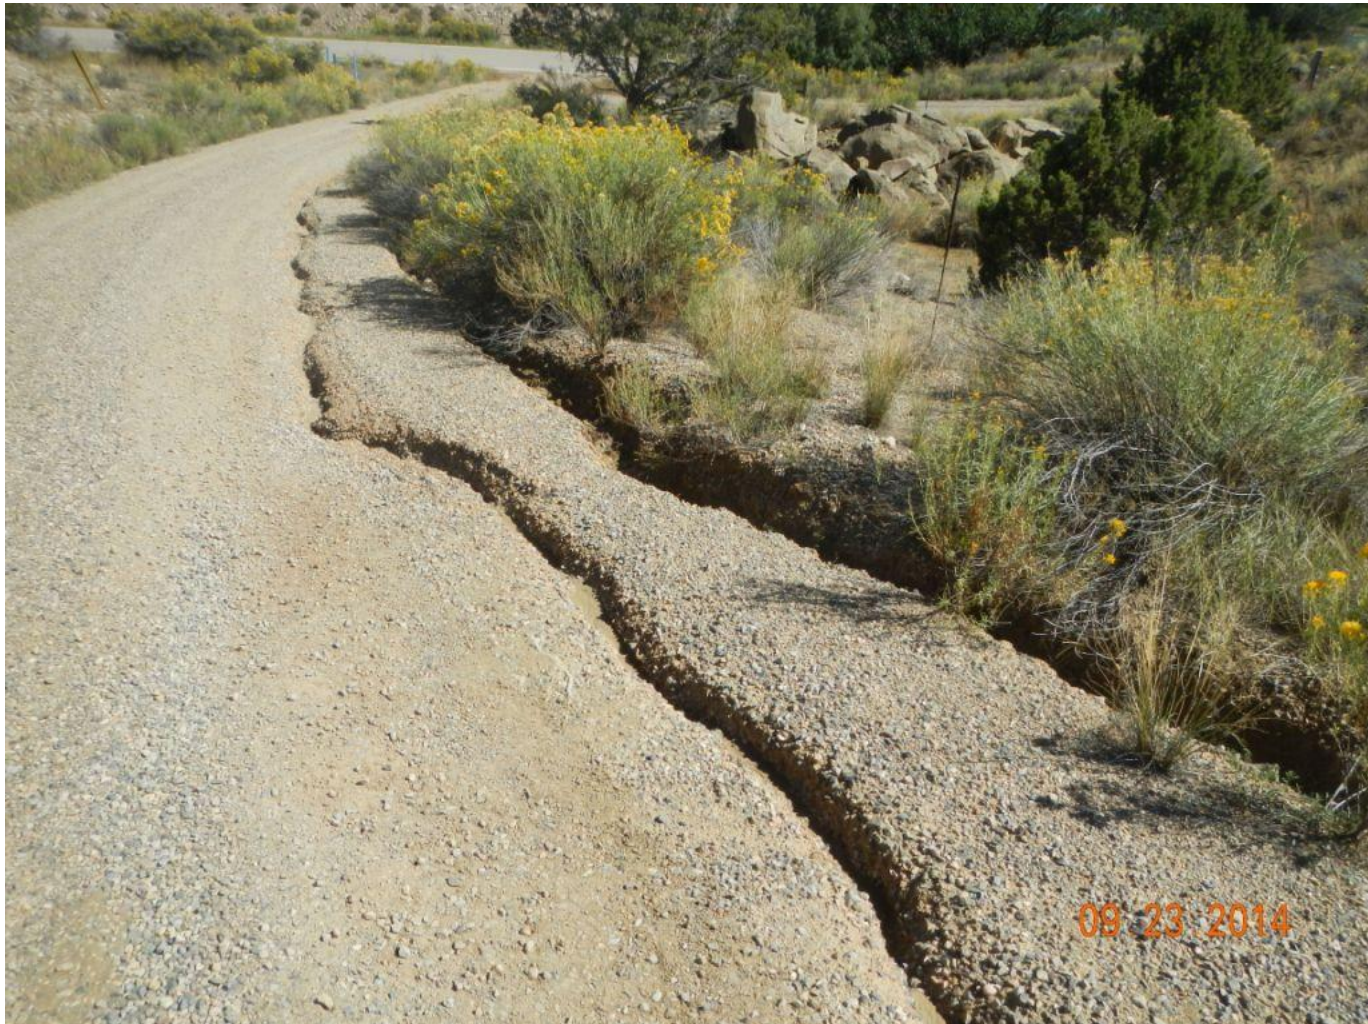
Photo 11. View of erosion on the southern edge of the access road.

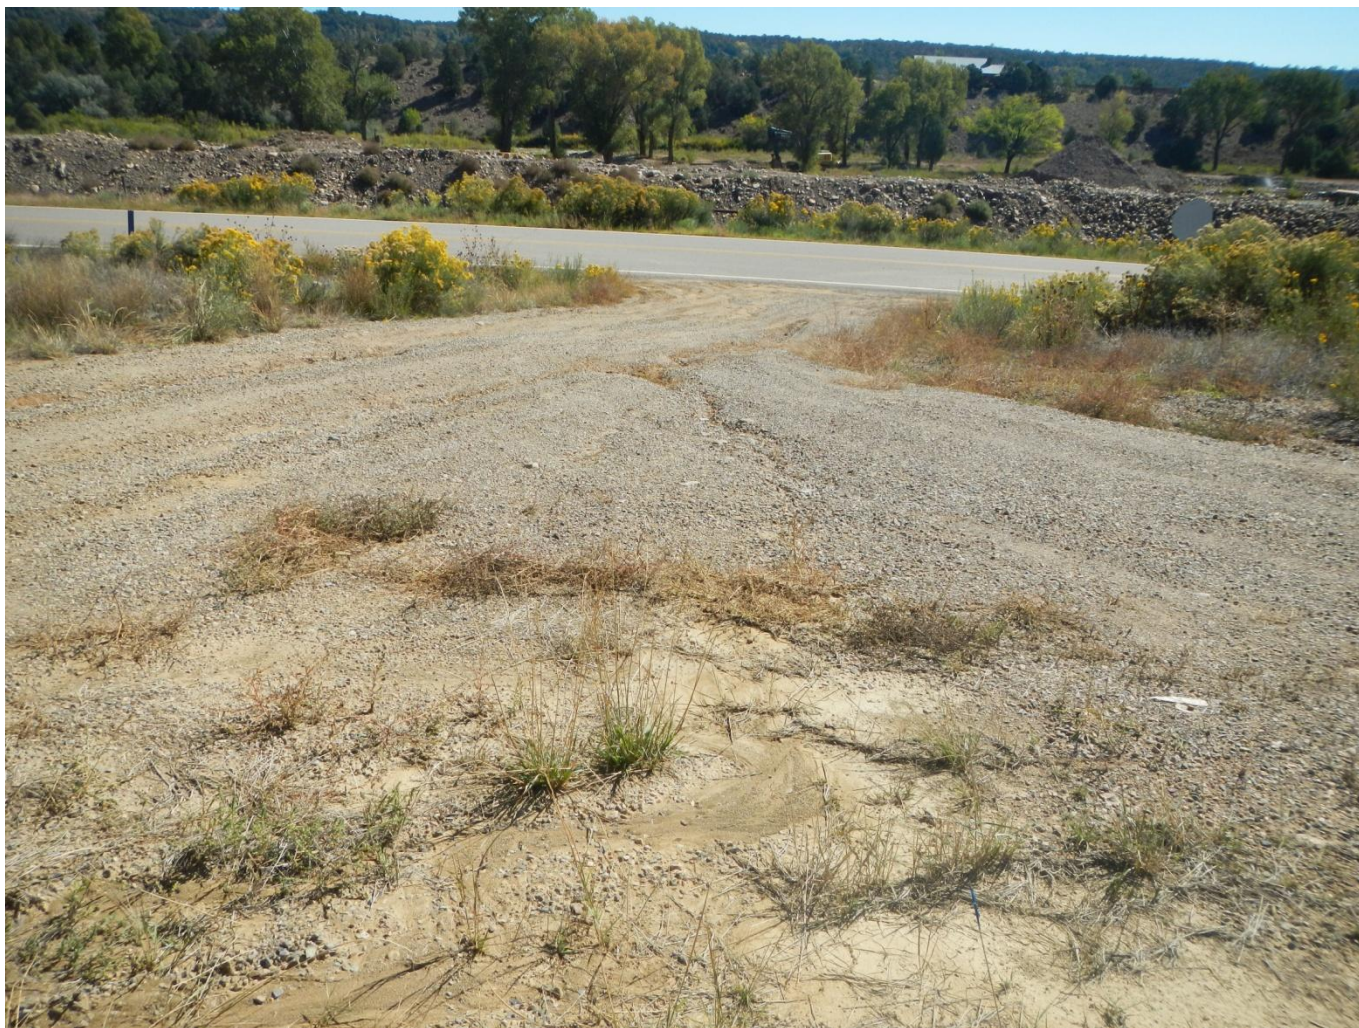
Photo 12. View of location where sediment and stormwater flows off of the northeastern corner of the well pad and flows over the access road.

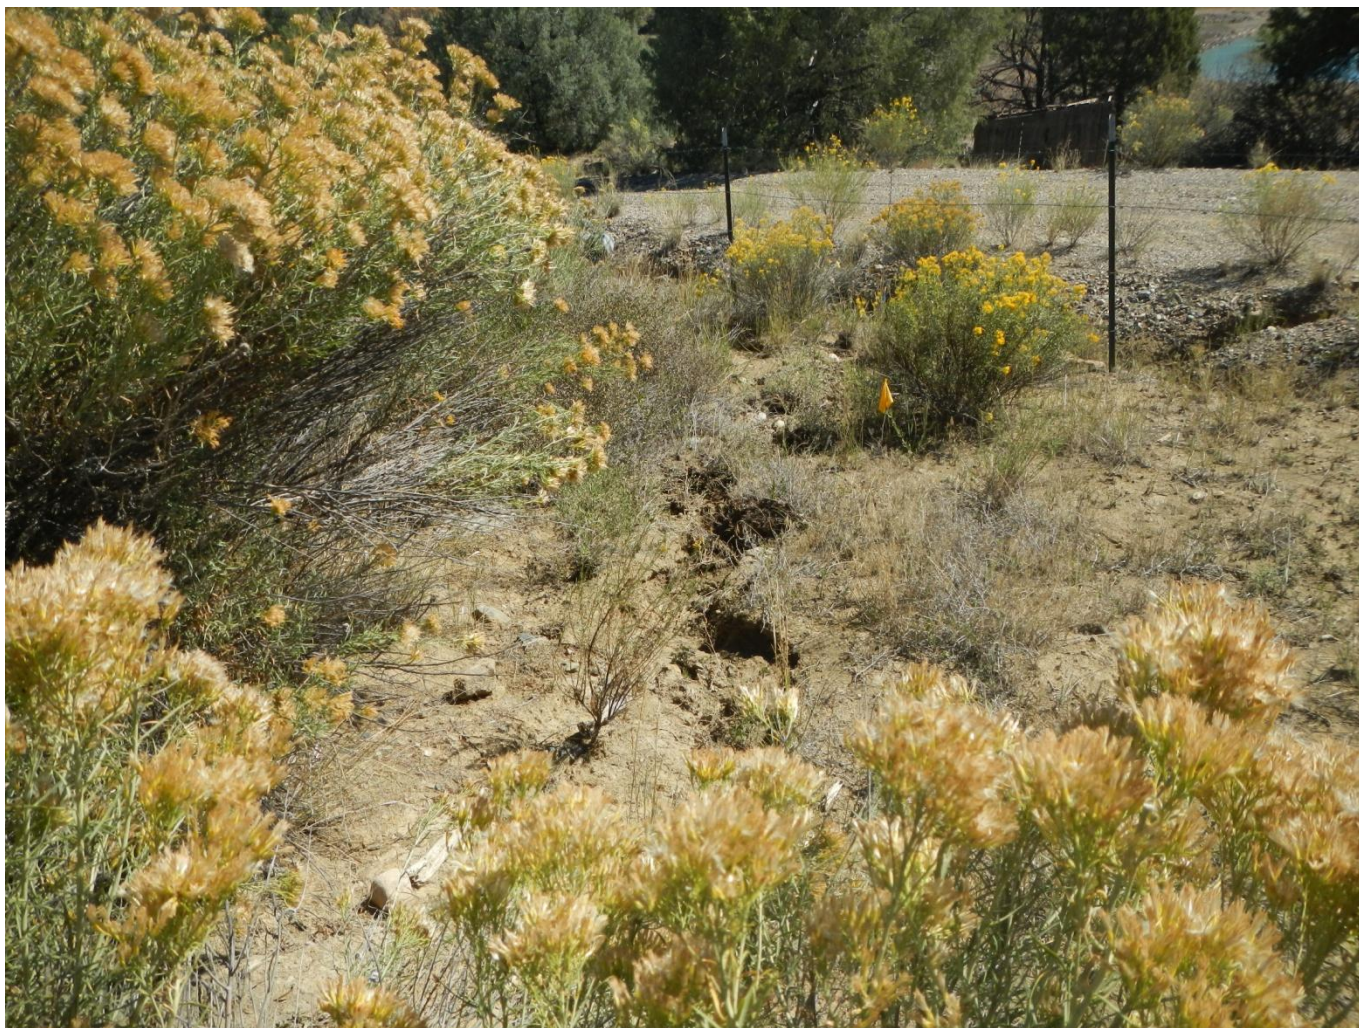
Photo 13. View of gully erosion within the southeastern corner of the interim reclamation area where stormwater flows offsite via a culvert.
