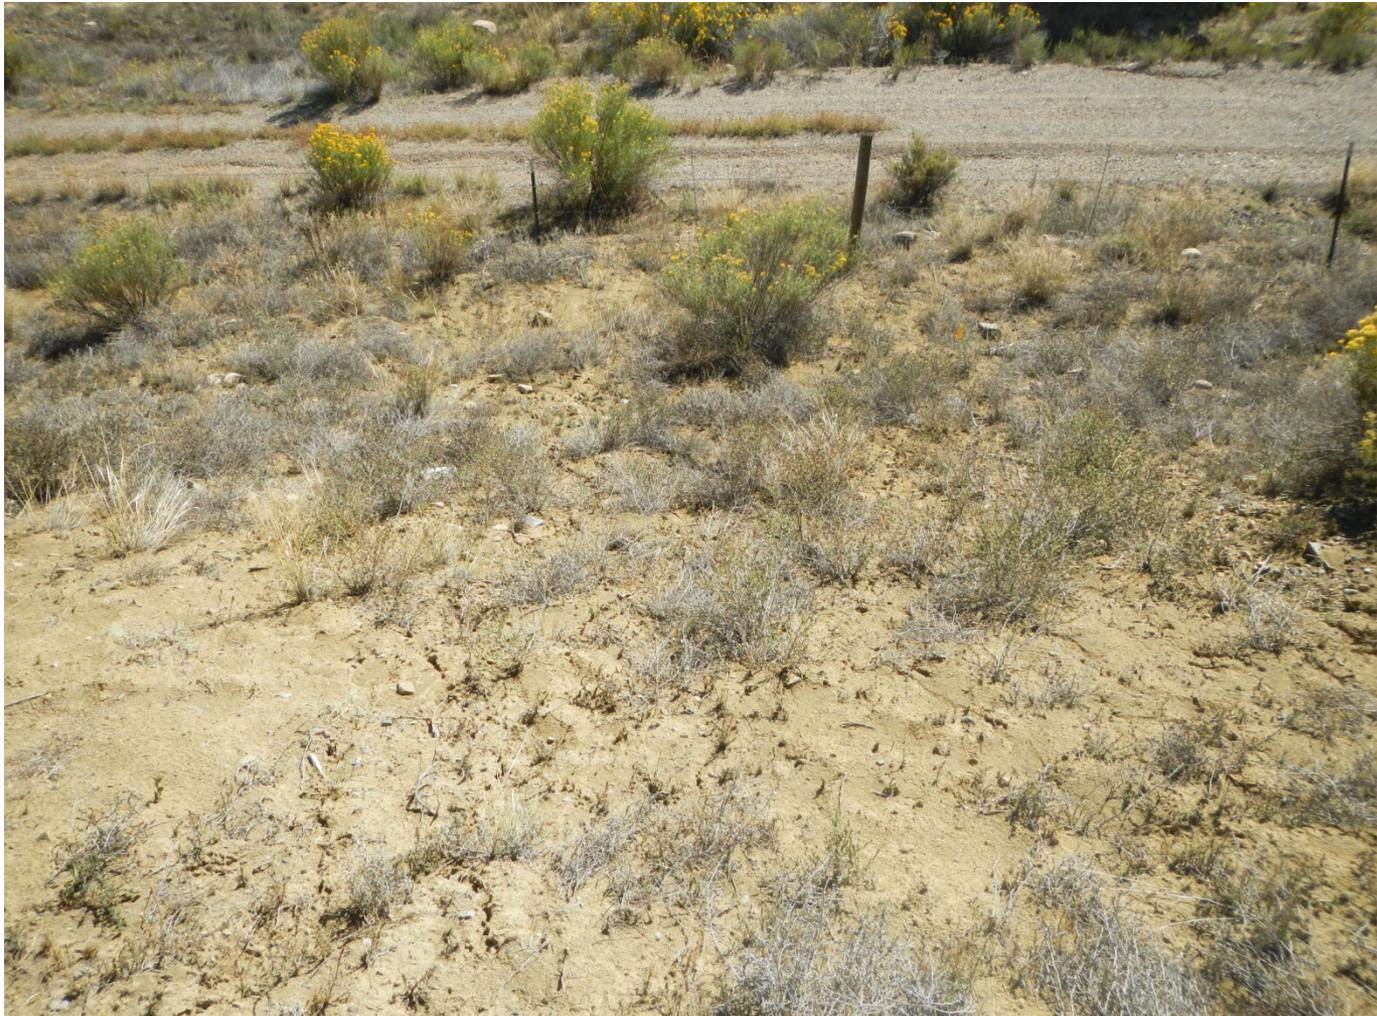
Photo 1. View of revegetation within the eastern portion of the interim reclamation area. The brushy green and brown plants in the mid-ground are County and State-listed Russian knapweed plants.

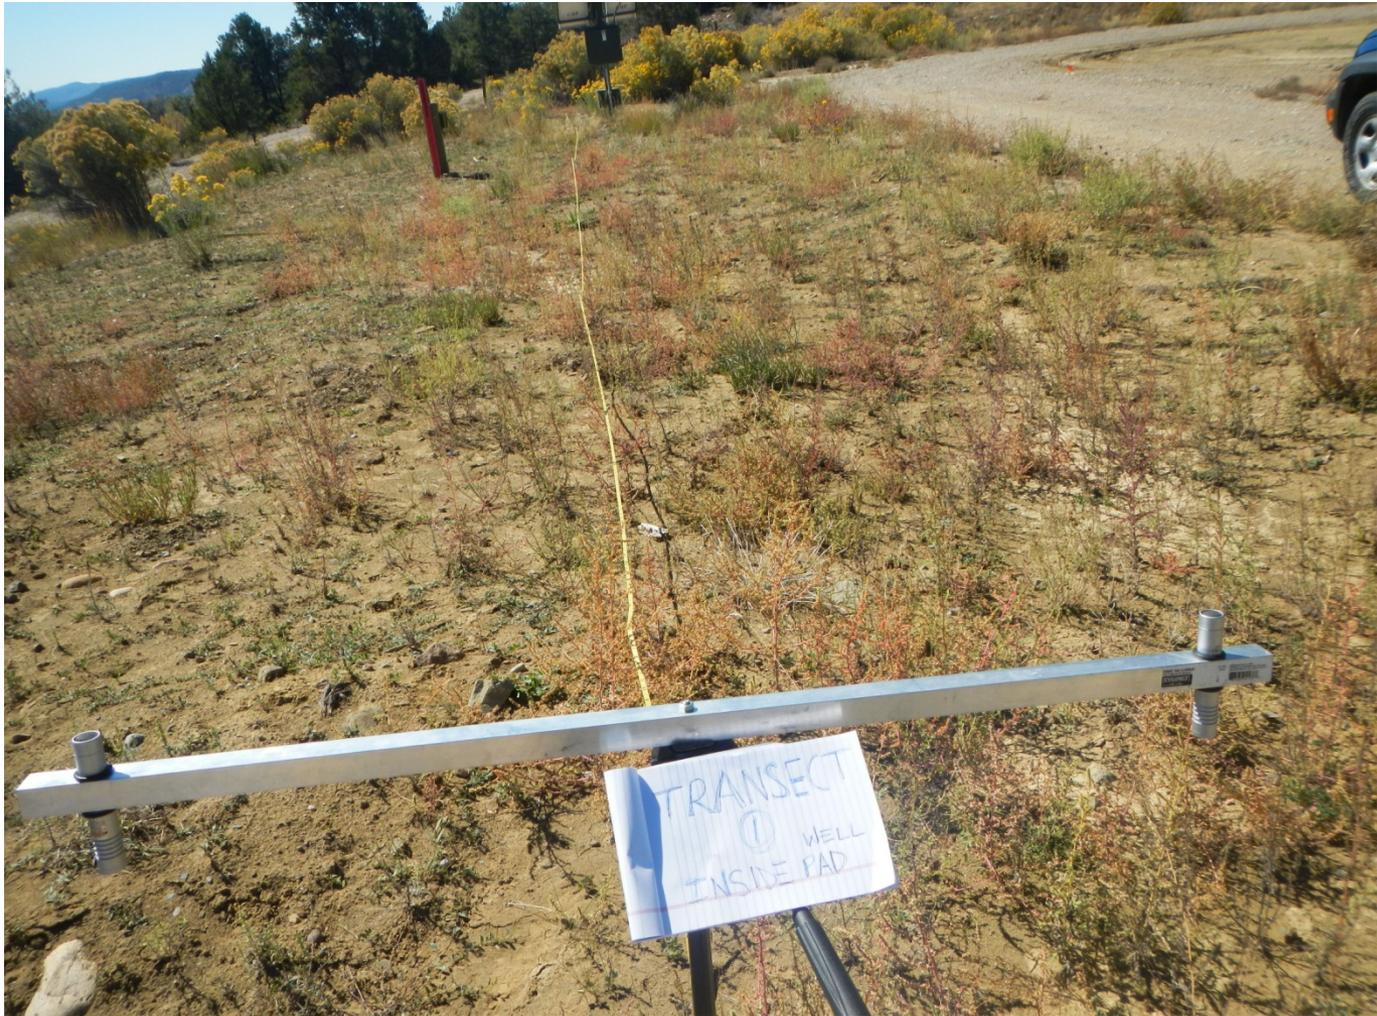
Photo 2. View of the beginning of the vegetation transect within the project area facing southward.

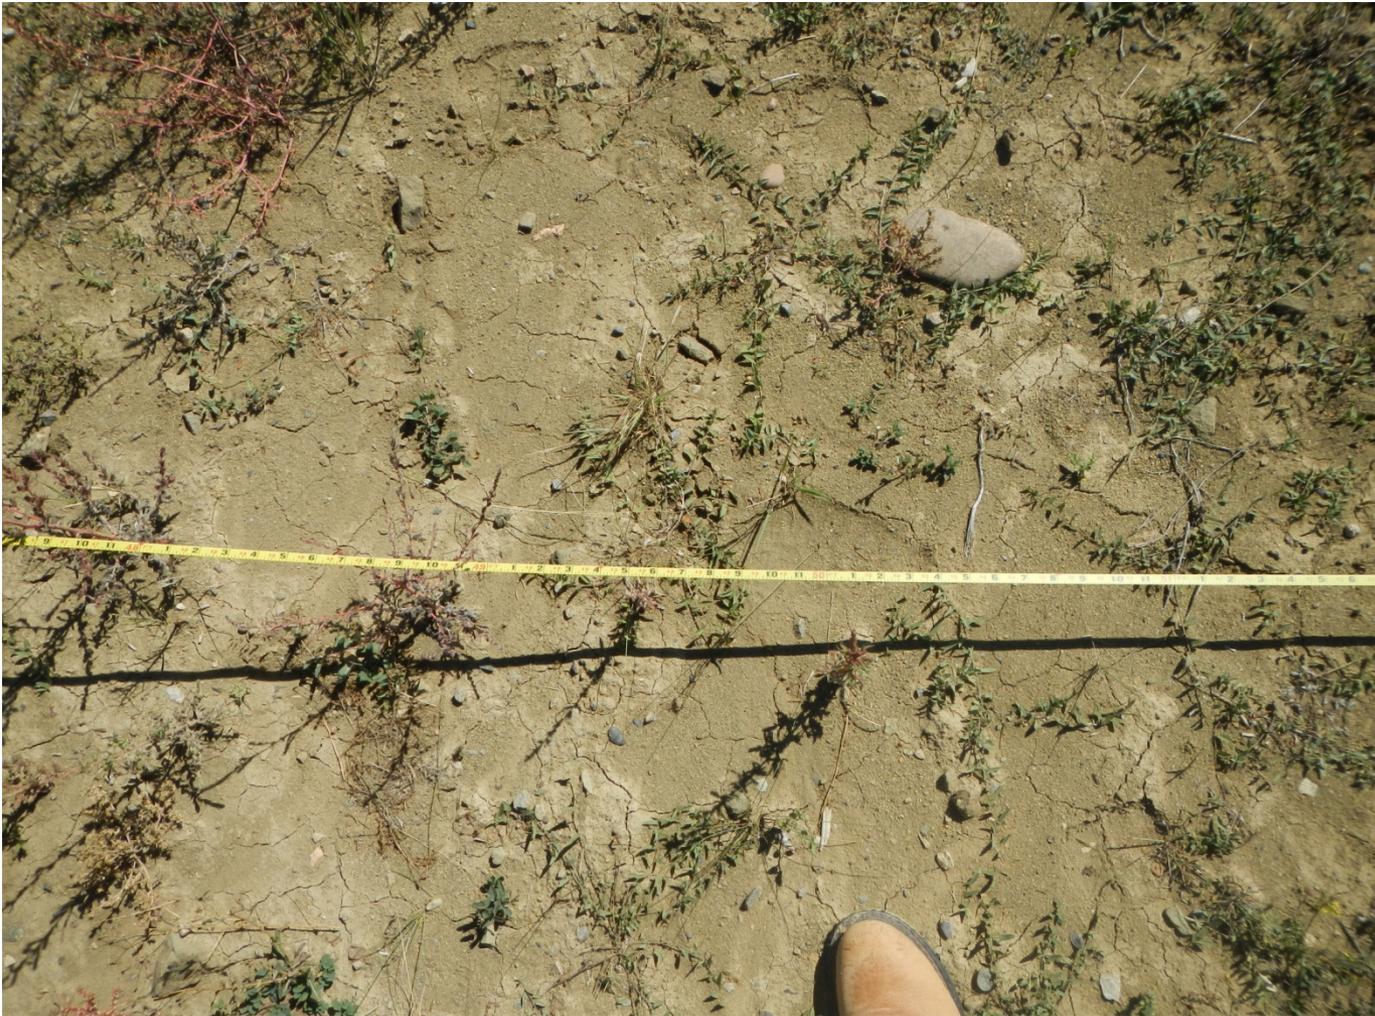
Photo 3. Birdseye view of vegetation at the midpoint of the vegetation transect within the project area. Vegetation here is mostly kochia and field bindweed.

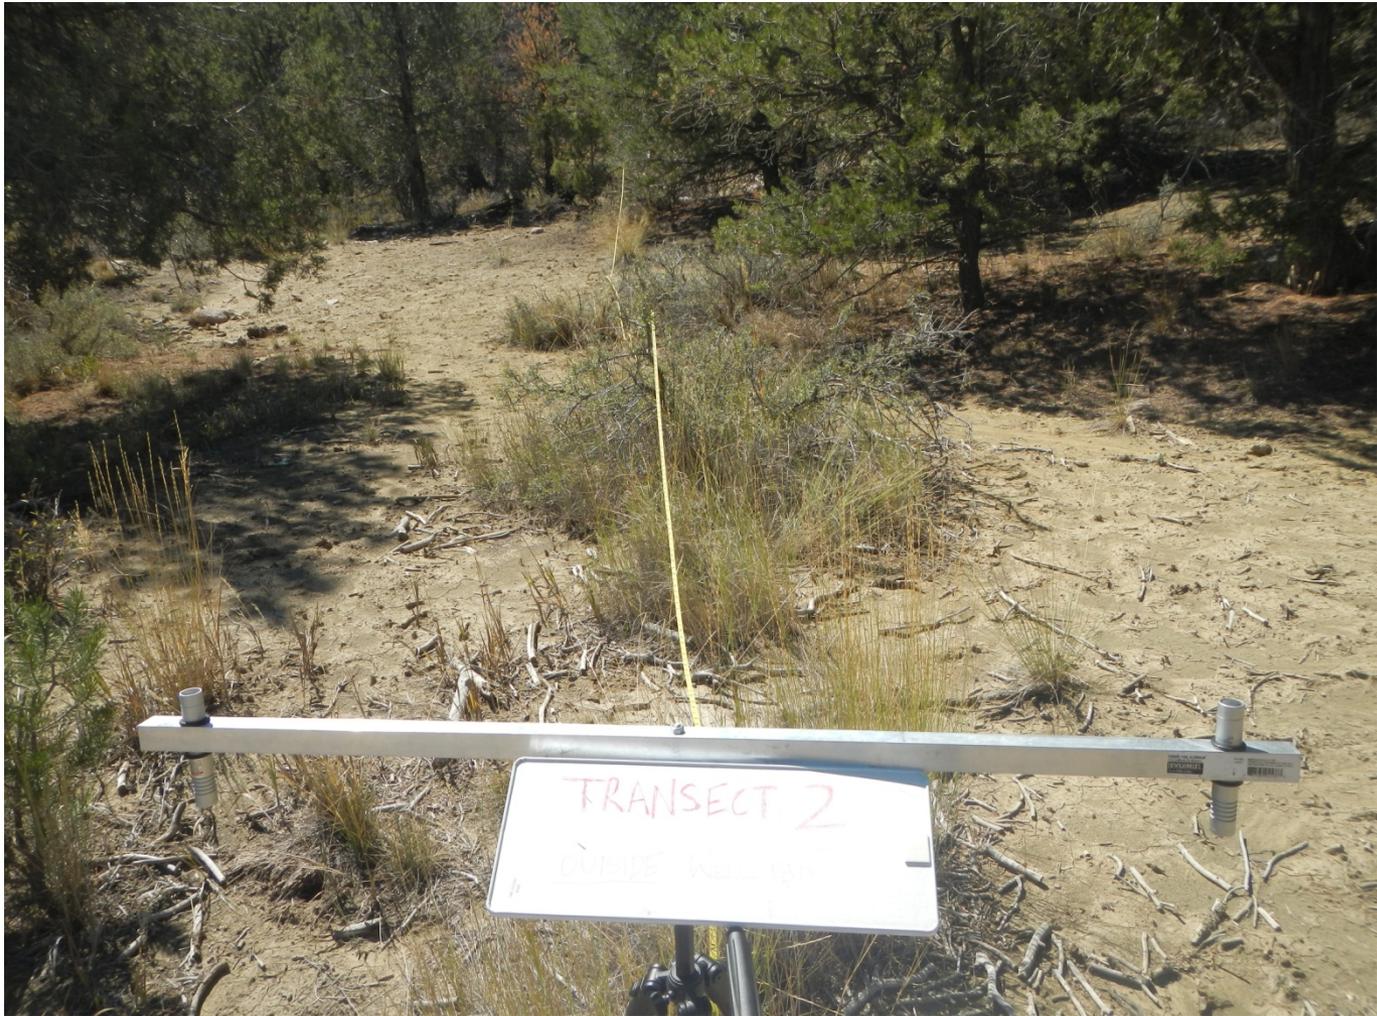
Photo 4. View of the beginning of the vegetation transect within the reference area (west of the well pad).

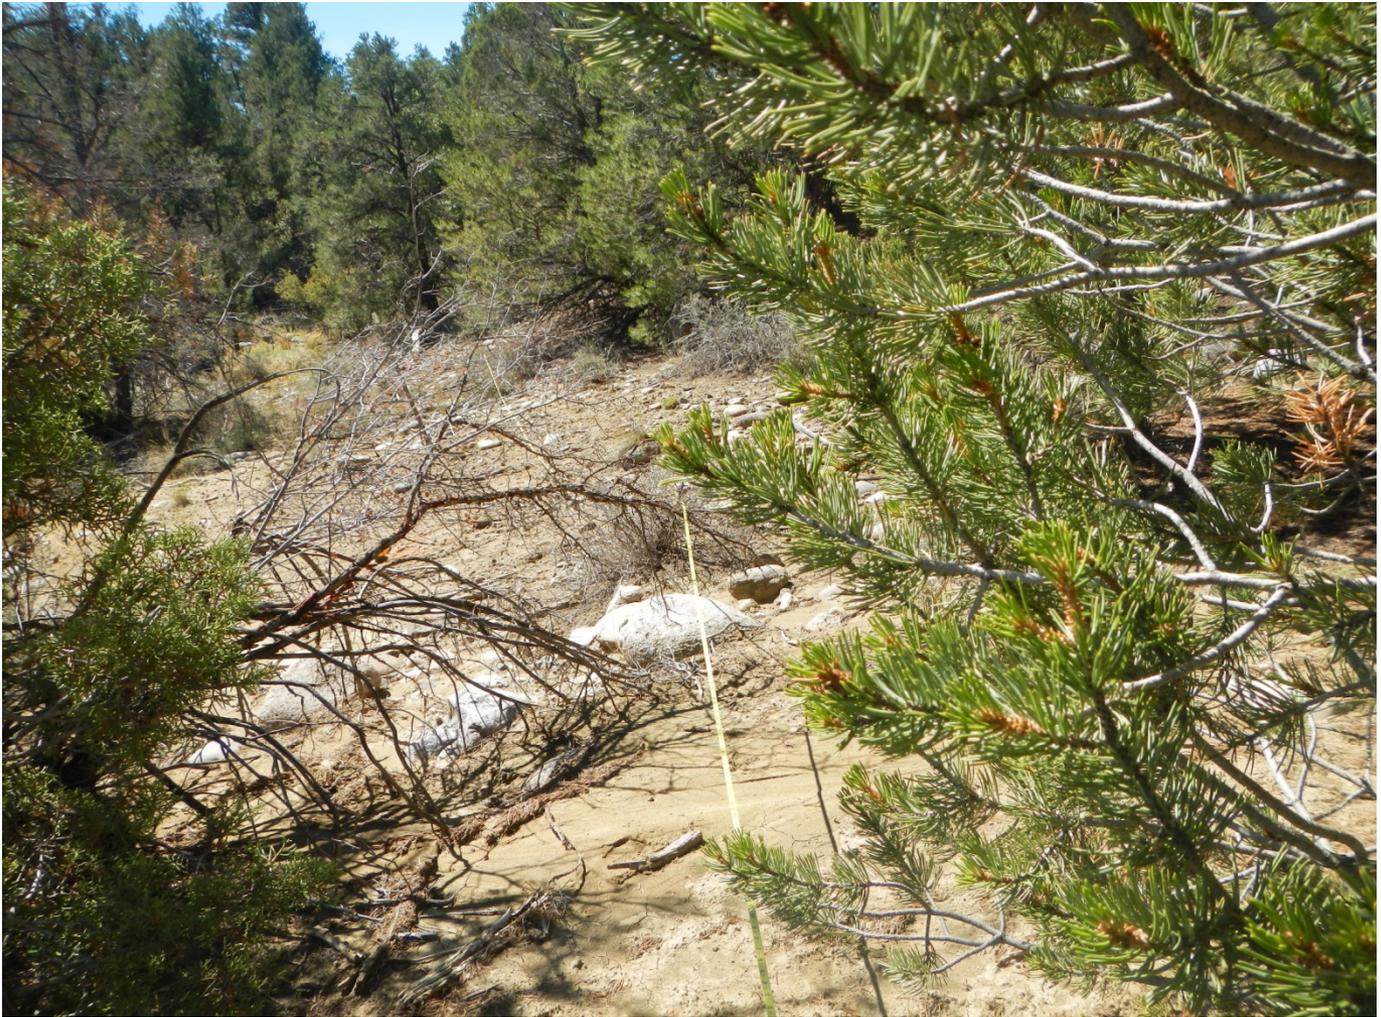
Photo 5. View from the mid-point of the reference area transect facing south toward the end of the transect.

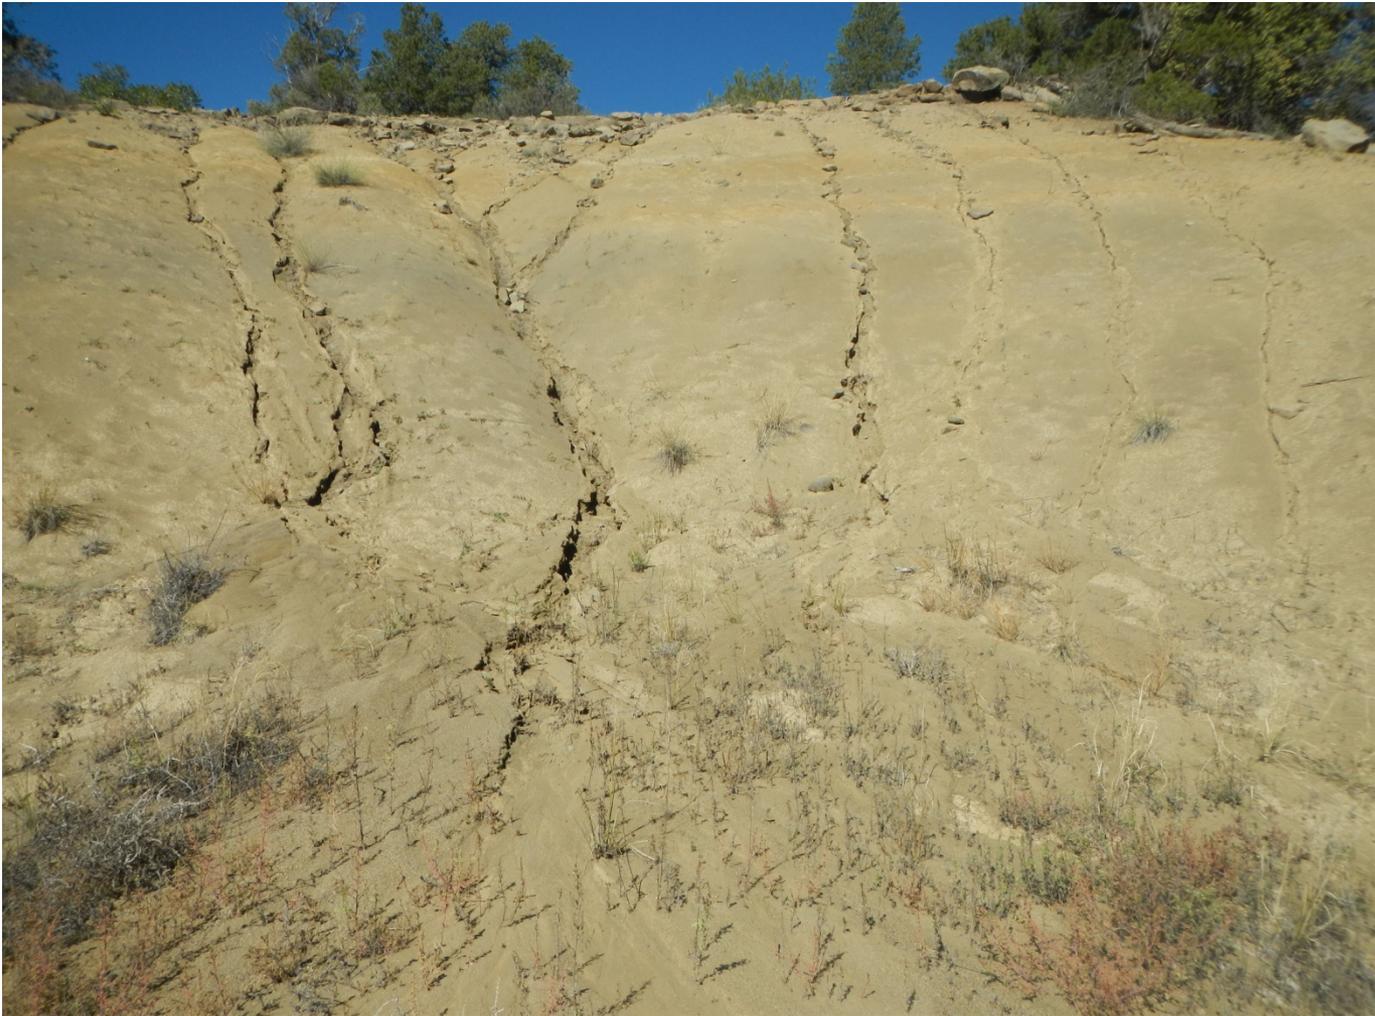
Photo 6. View of the slope above the eastern side of the well pad where rill erosion and sediment deposition is occurring.

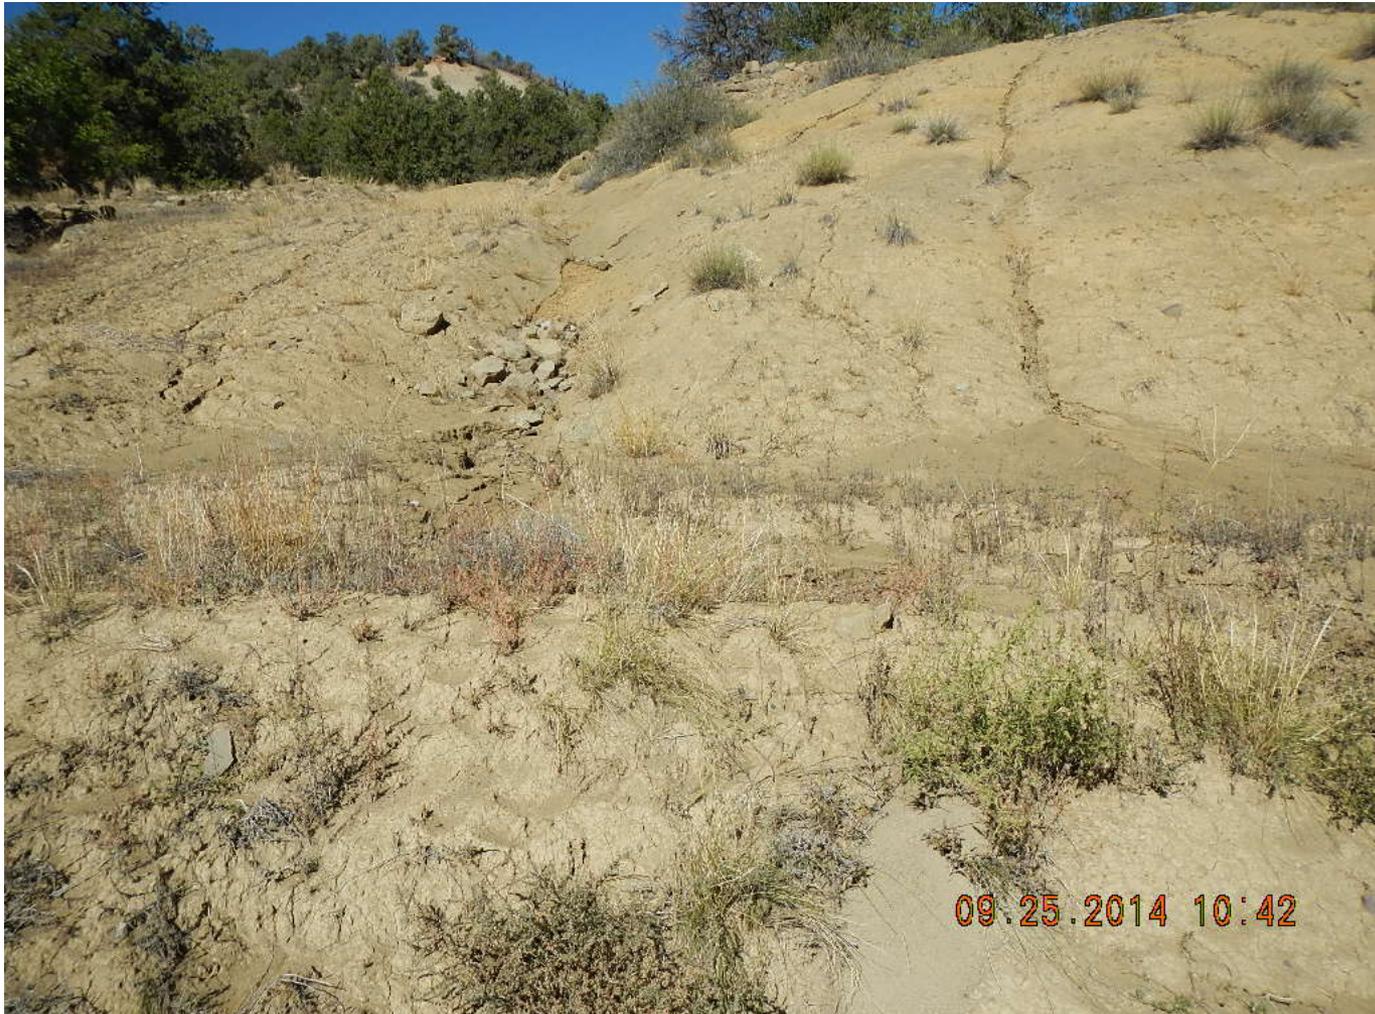
Photo 7. View of gully erosion (approximately 2 to 3 feet wide and 6 to 15 inches deep) occurring on the western edge of the well pad area.

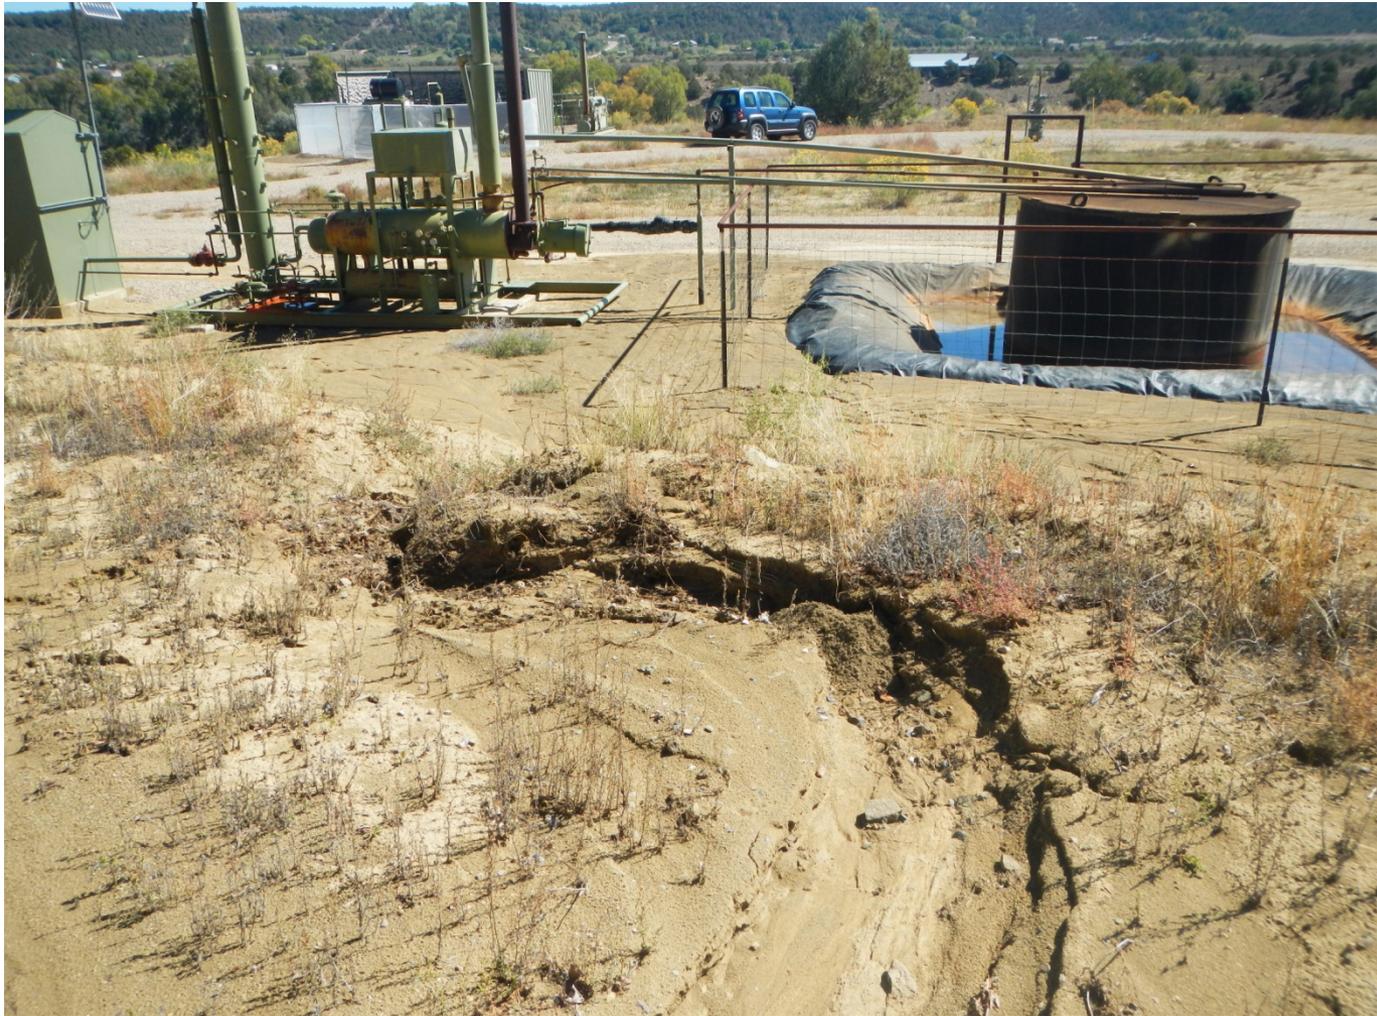
Photo 8. View of failed water diversion berm and sediment deposited on the well pad downstream of the erosional gully shown in Photo 7.

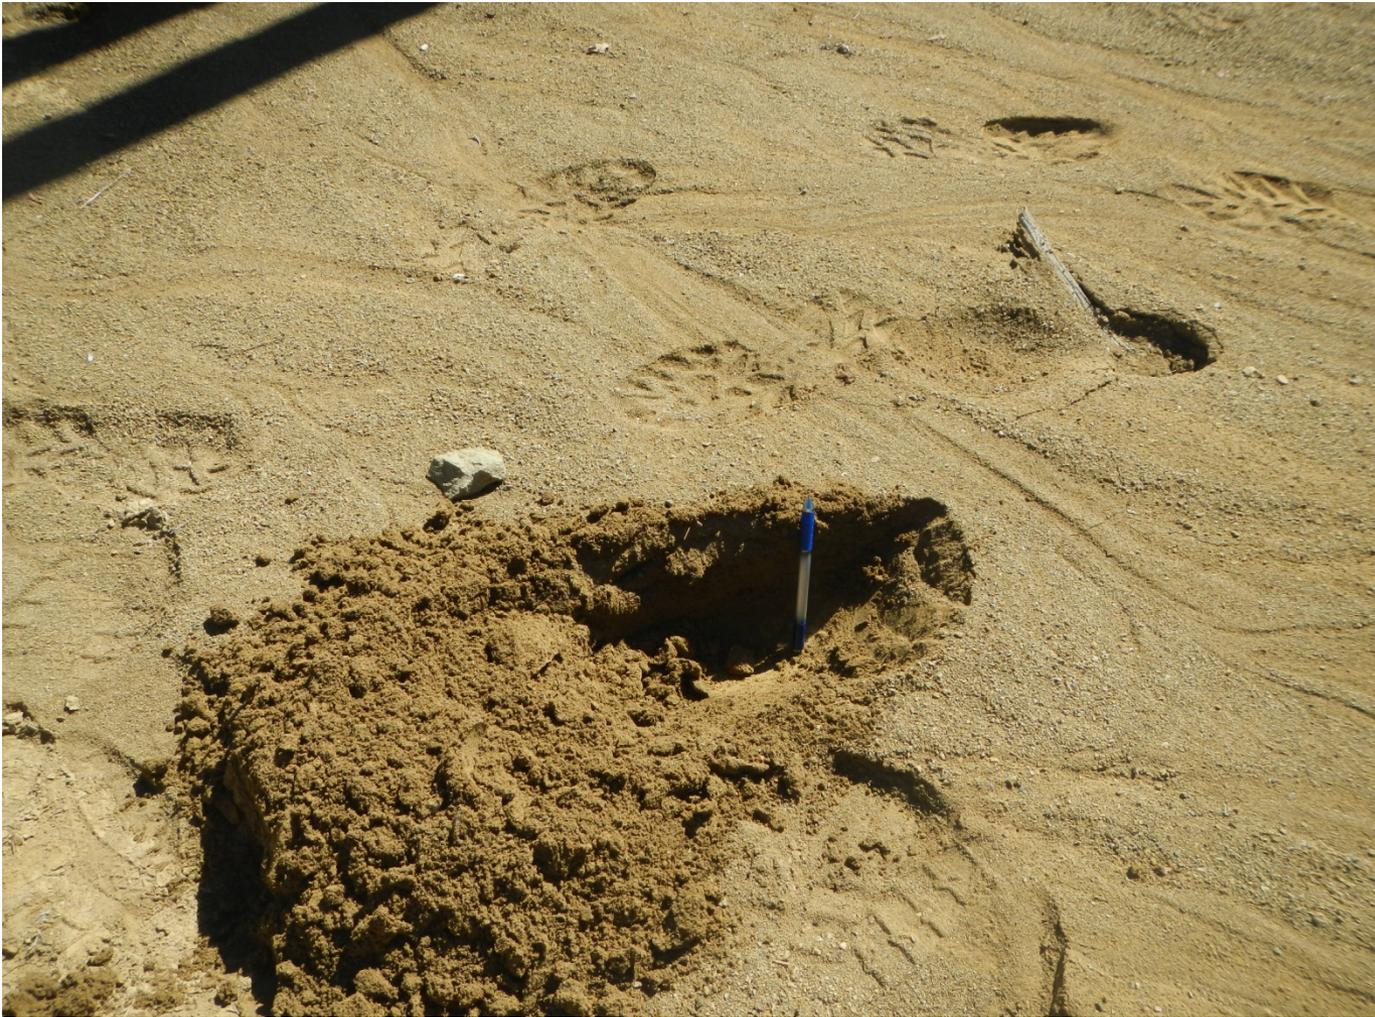
Photo 9. Sediment deposited on the well pad is approximately 6 inches deep in this location.

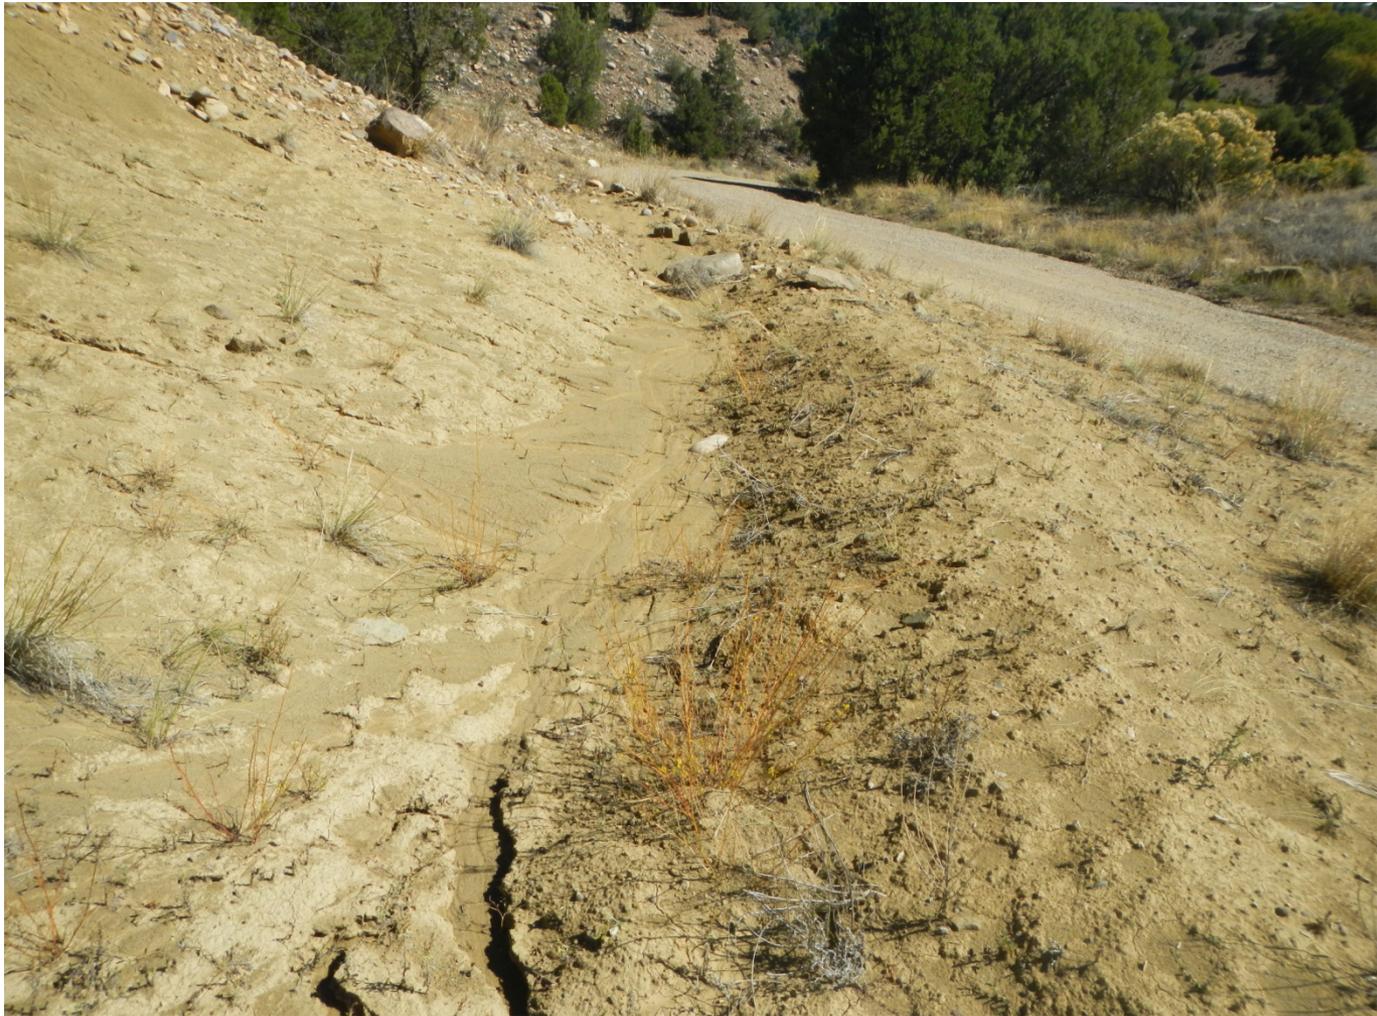
Photo 10. View of water diversion berm on western edge of well pad full of sediment and directing stormwater flows toward the access road.

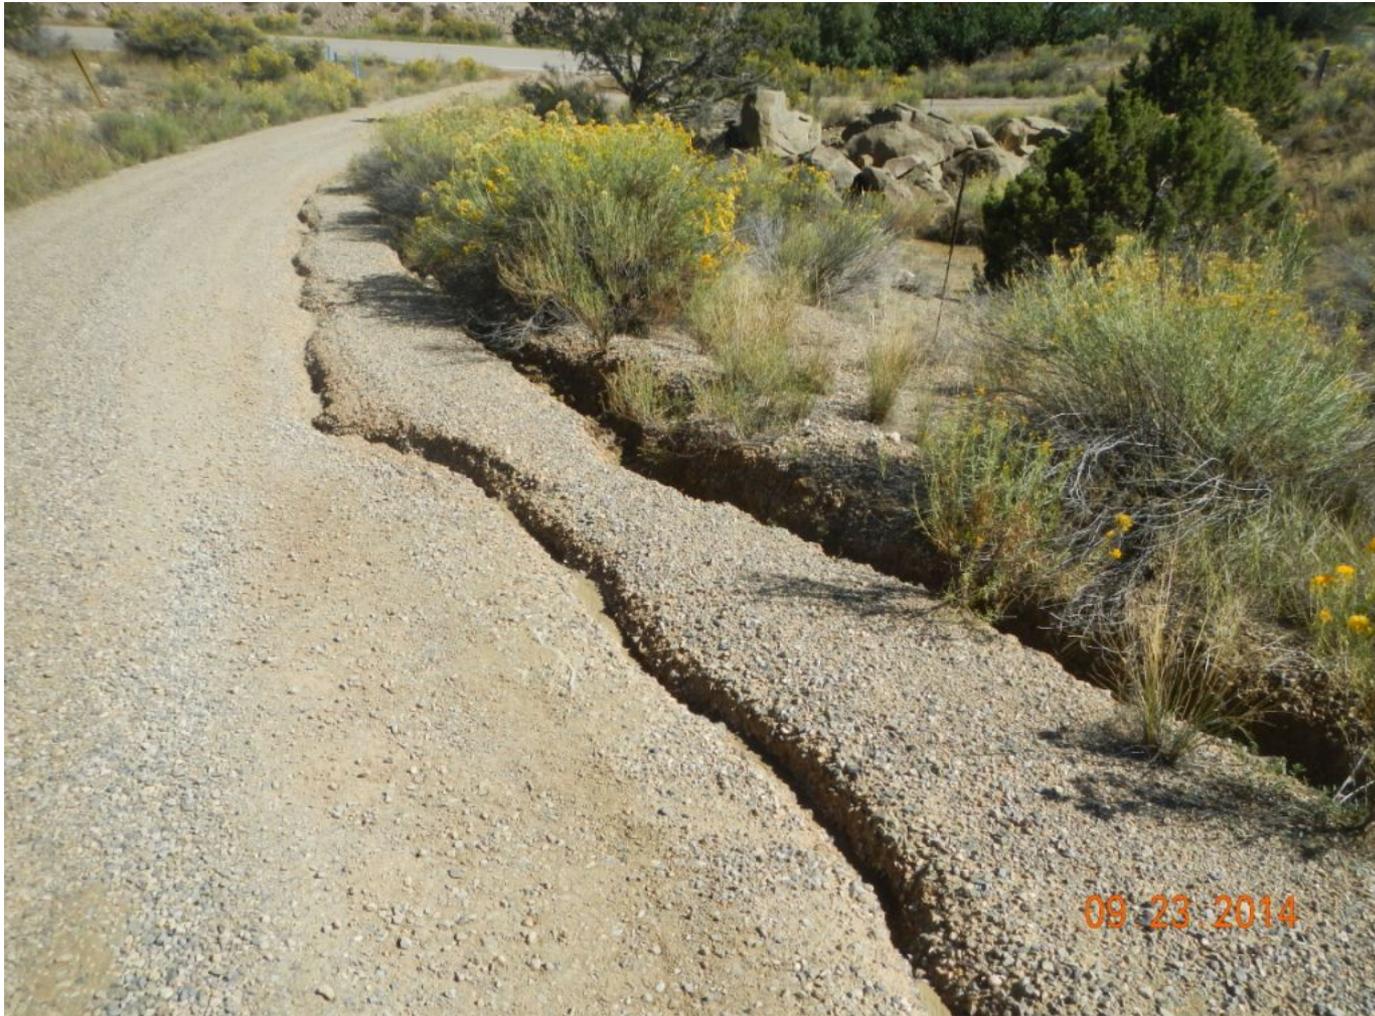
Photo 11. View of erosion on the southern edge of the access road.

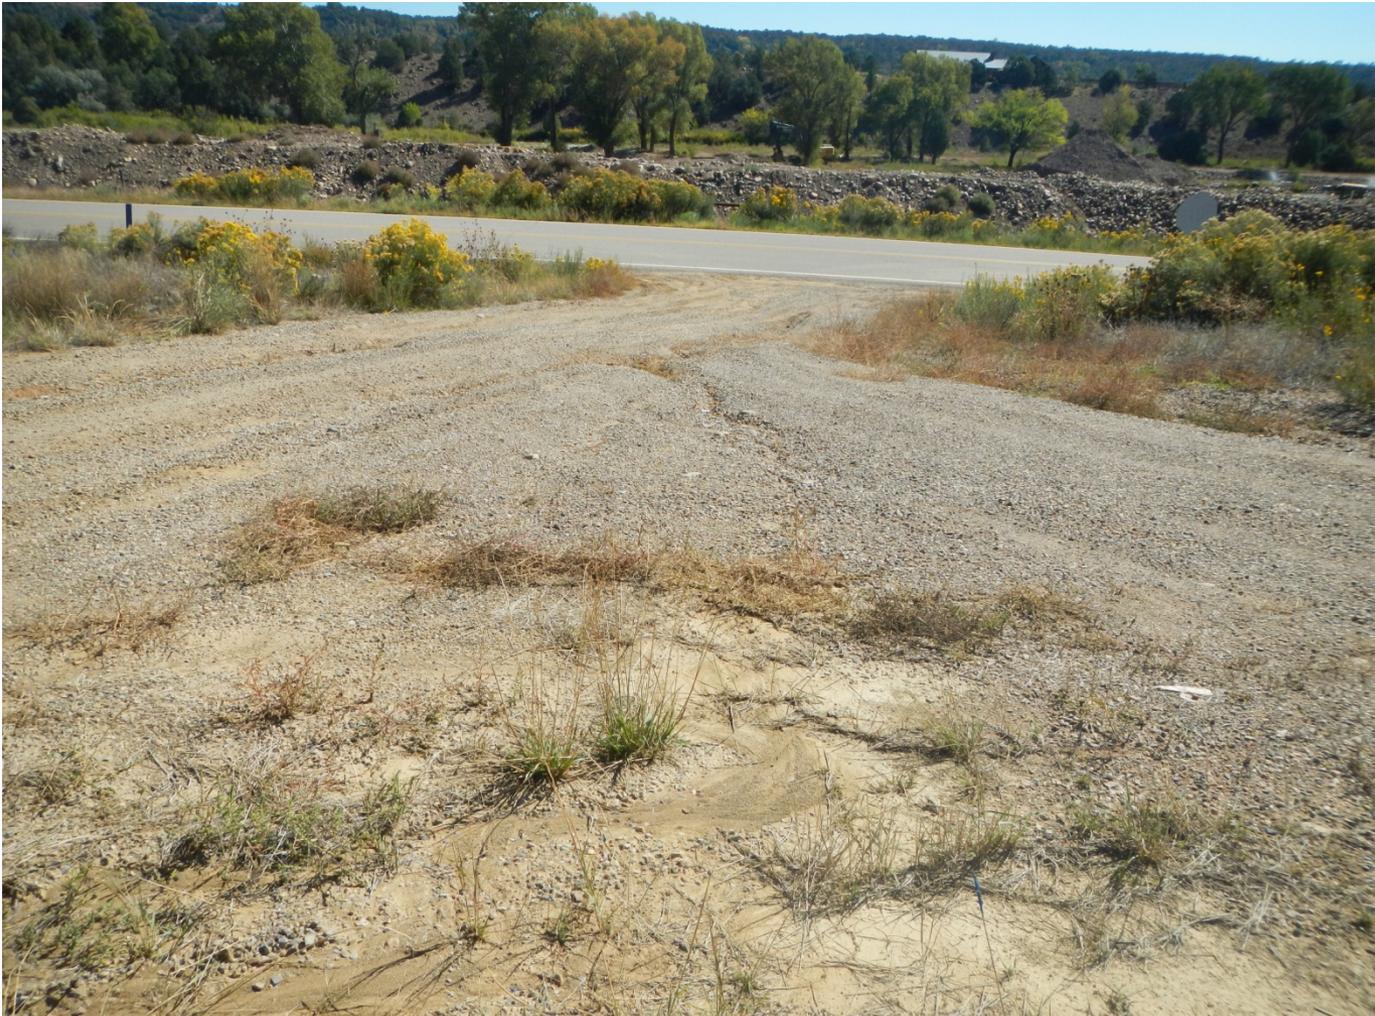
Photo 12. View of location where sediment and stormwater flows off of the northeastern corner of the well pad and flows over the access road.

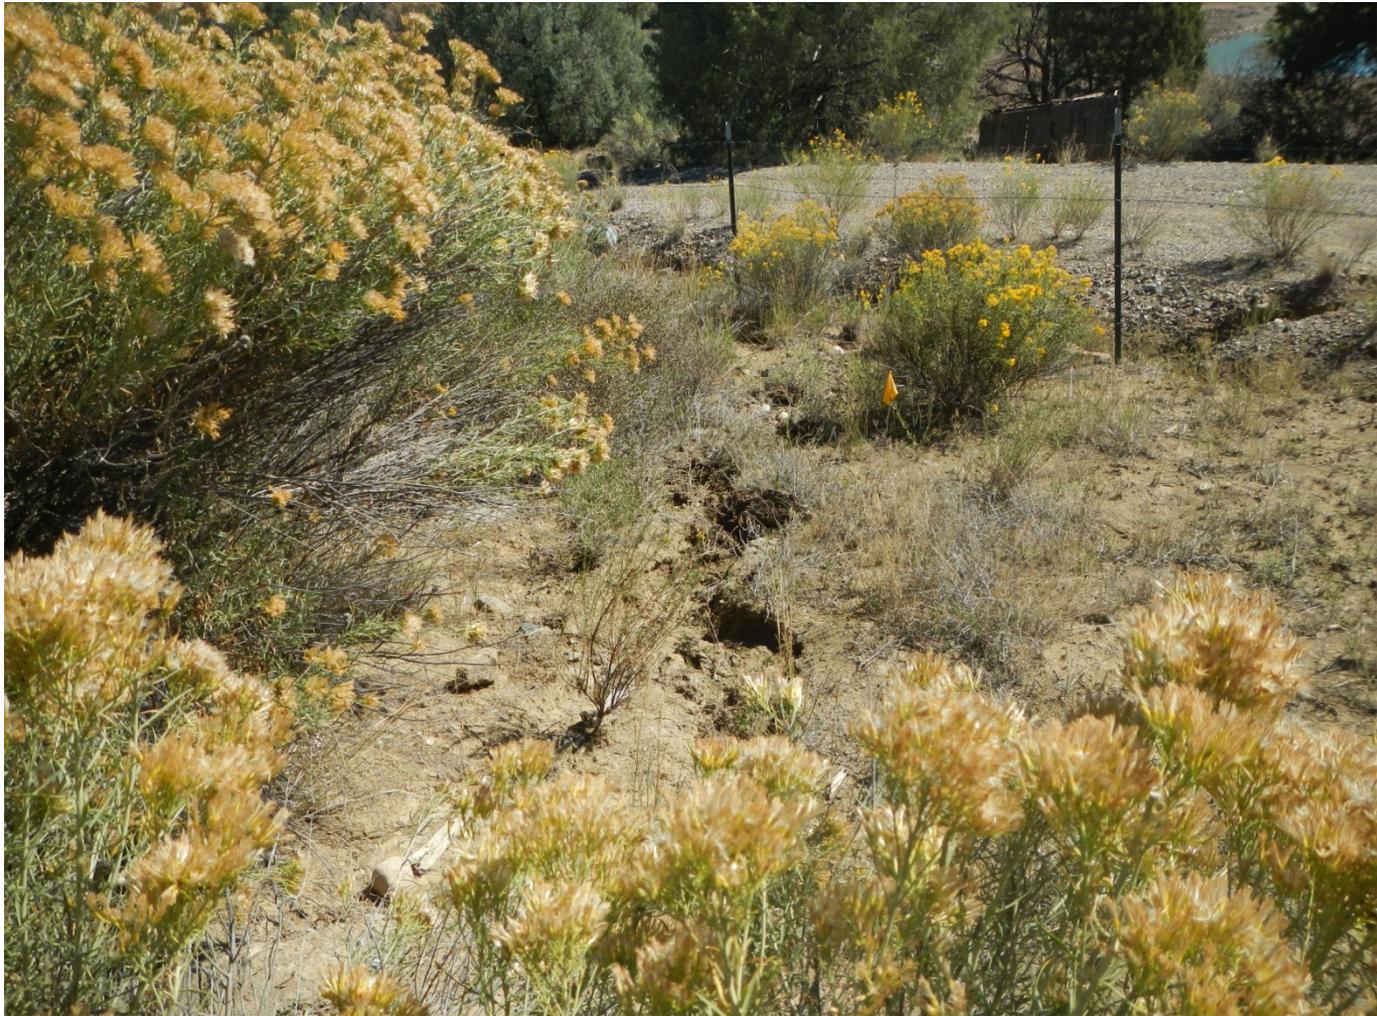
Photo 13. View of gully erosion (approximately 8 to 18 inches across and 6 to 15 inches deep) within the southeastern corner of the interim reclamation area where stormwater flows offsite via a culvert.
