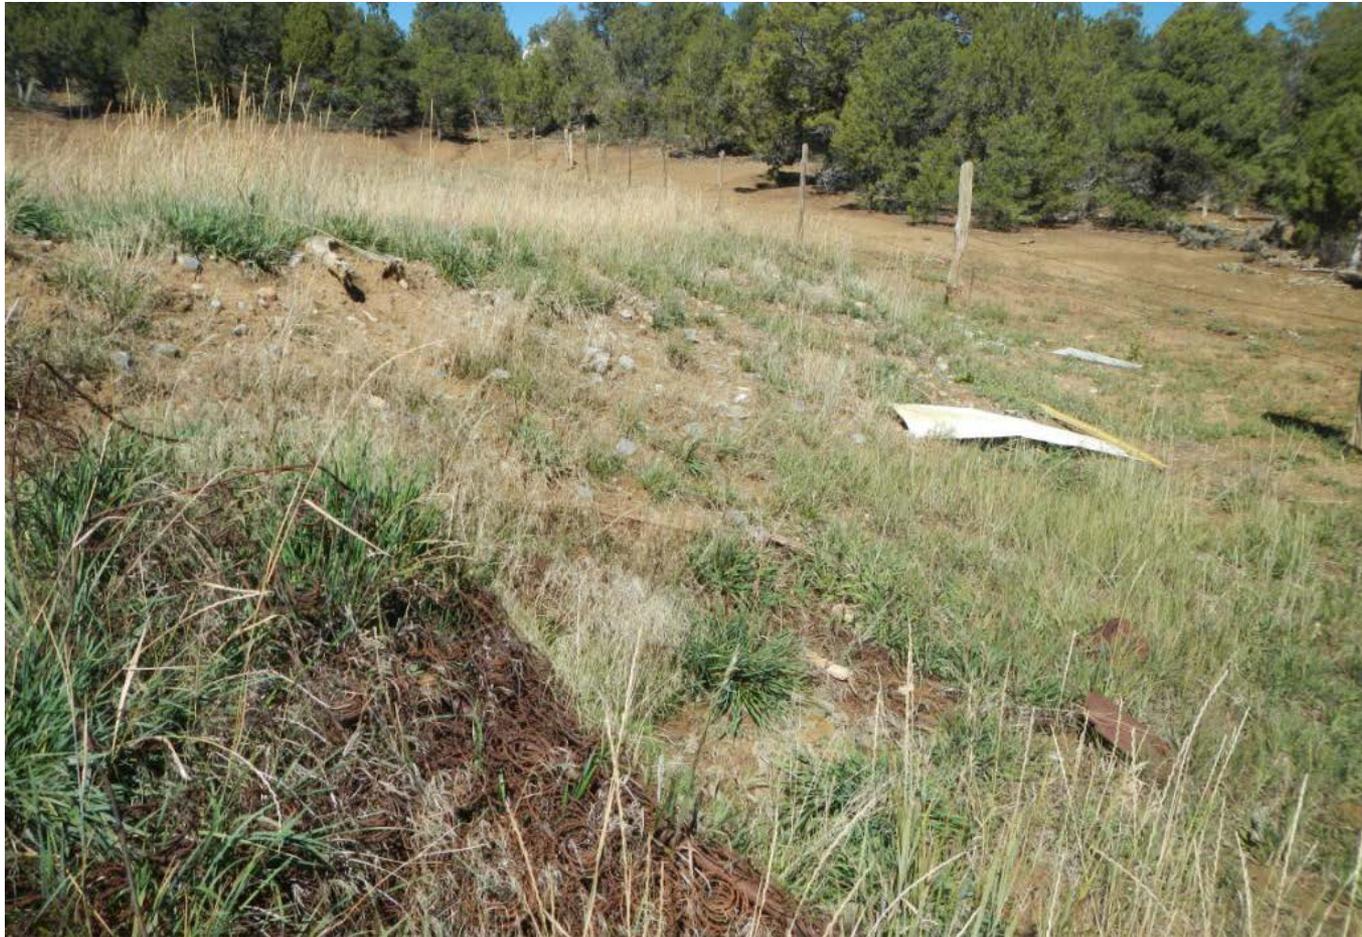
Photo 1. View of trash within the northeastern corner of interim reclamation area.

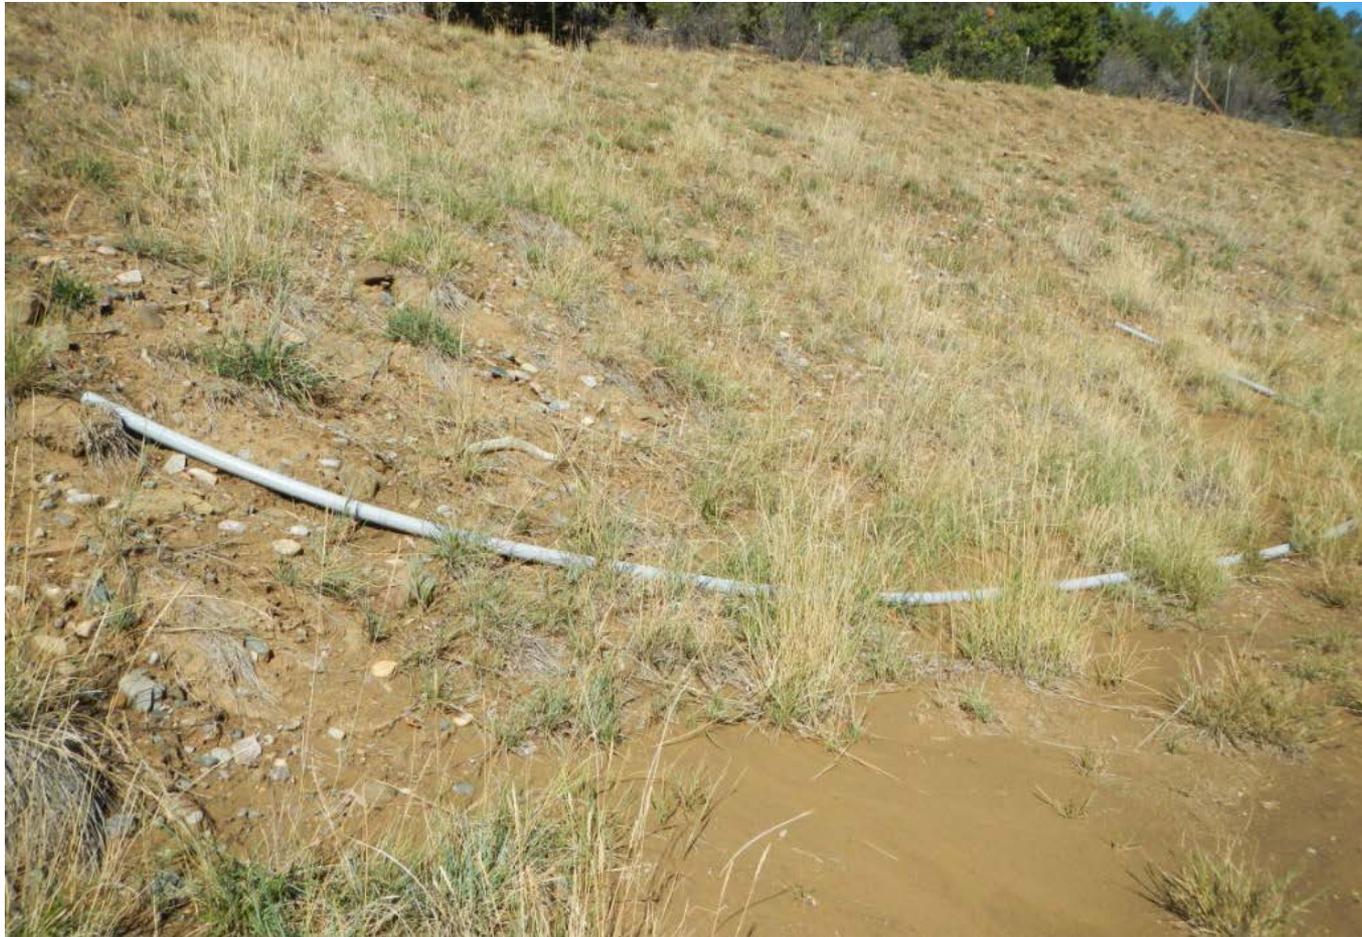
Photo 2. View of unused pipe within the western portion of the interim reclamation area.

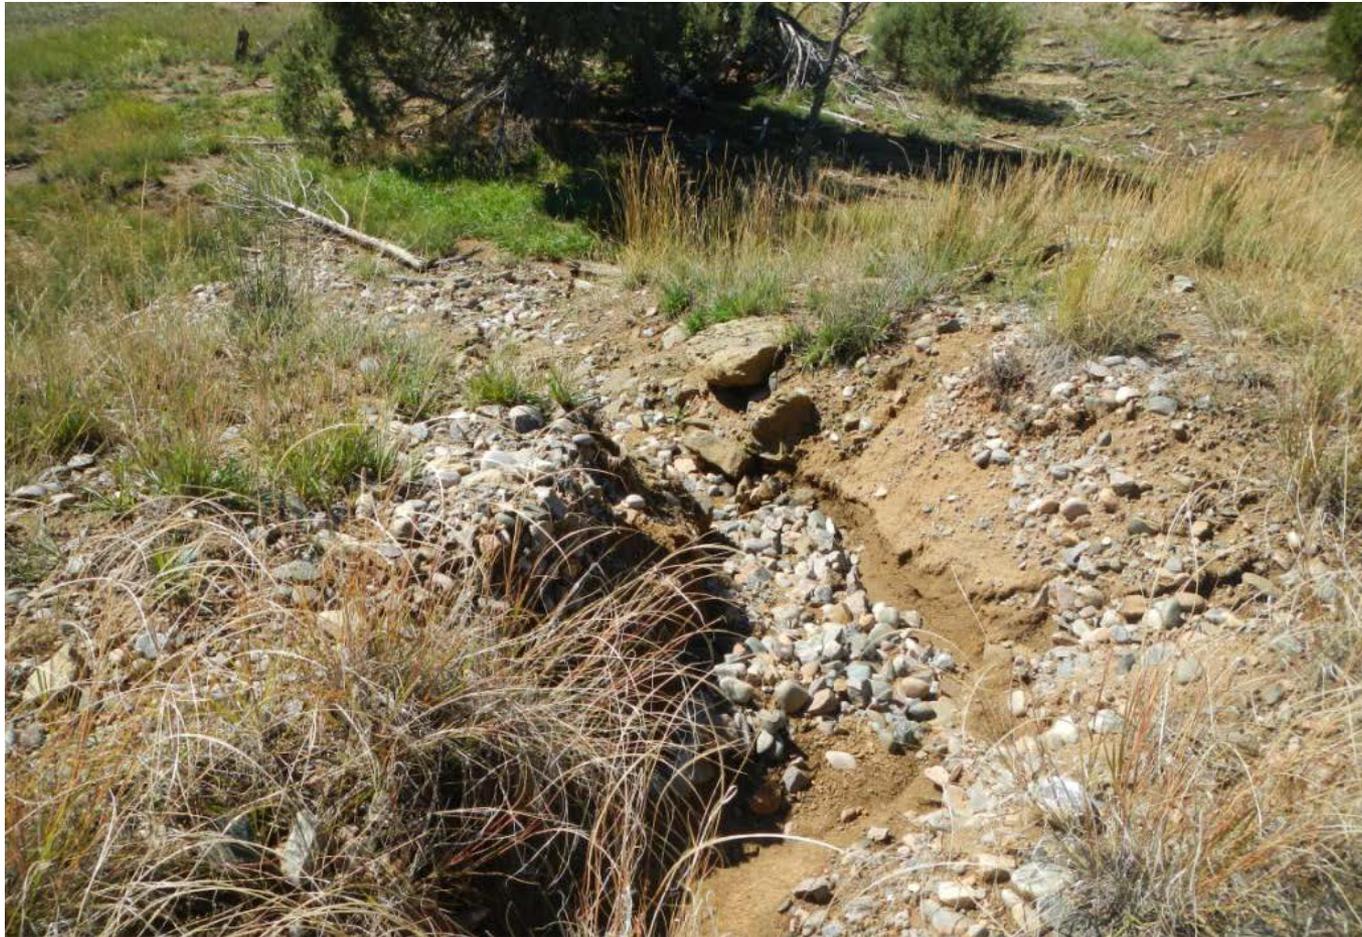
Photo 3. View of gully that is approximately 3 to 4 feet wide by 3 to 4 feet deep within eastern portion of the interim reclamation area.

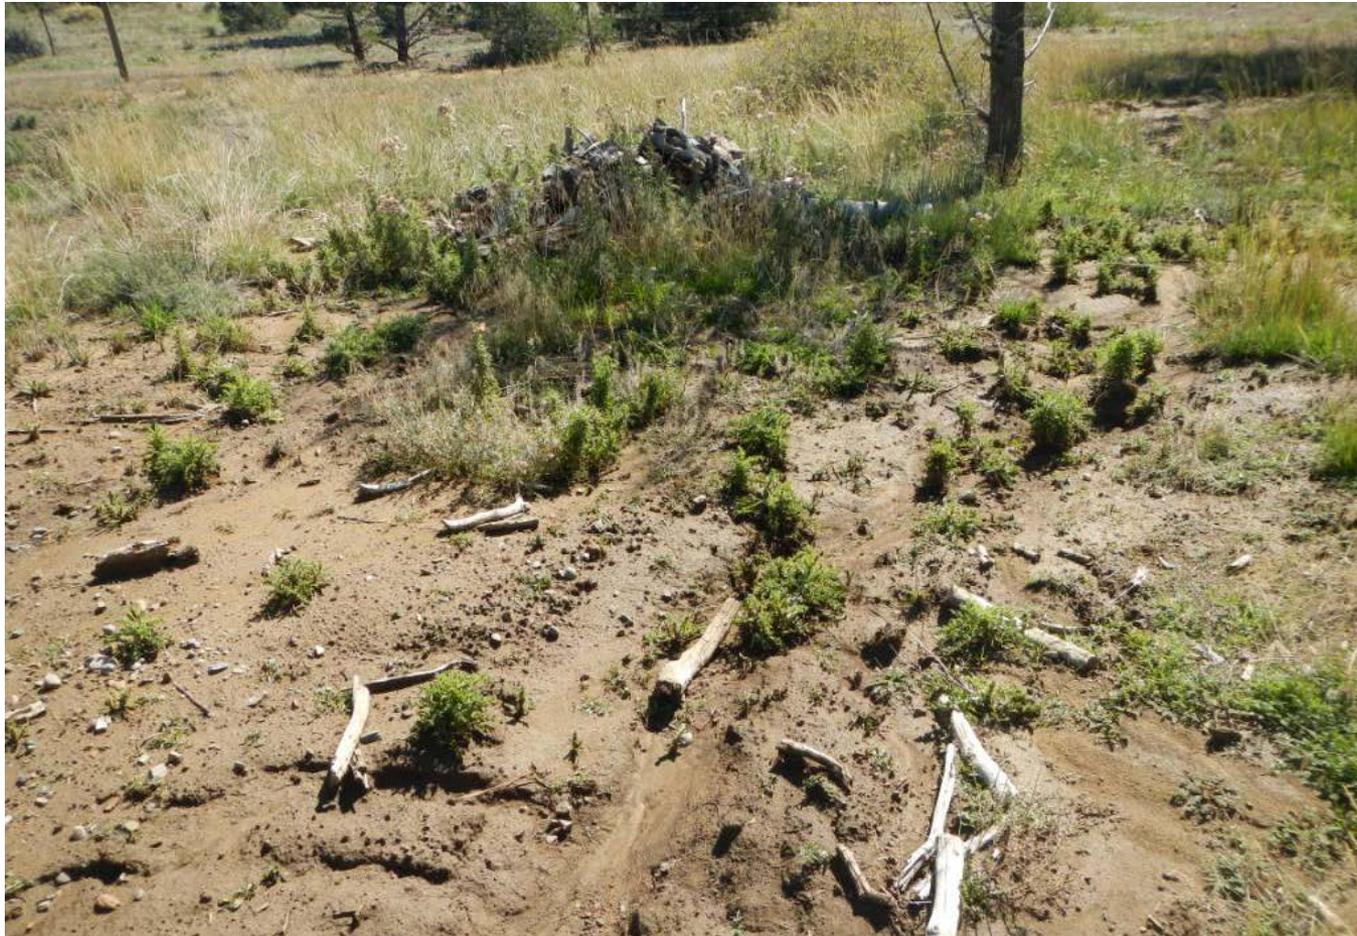
Photo 4. View of Canada thistle population downstream of erosional gully in Photo 3; growing in what appears to be sediment deposited from gully.

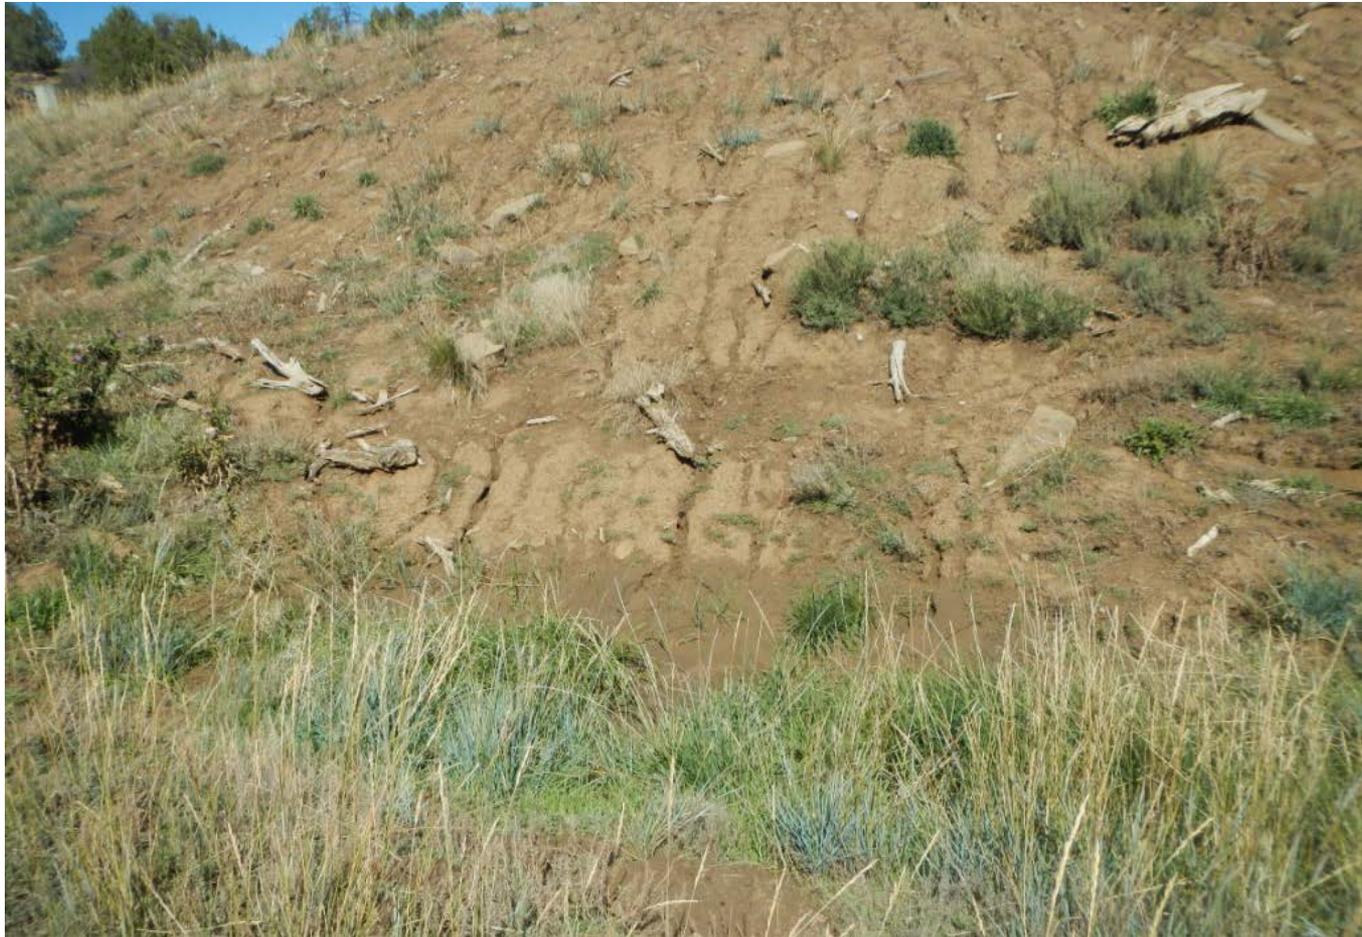
Photo 5. View of rill erosion on the fill slopes within the interim reclamation area.

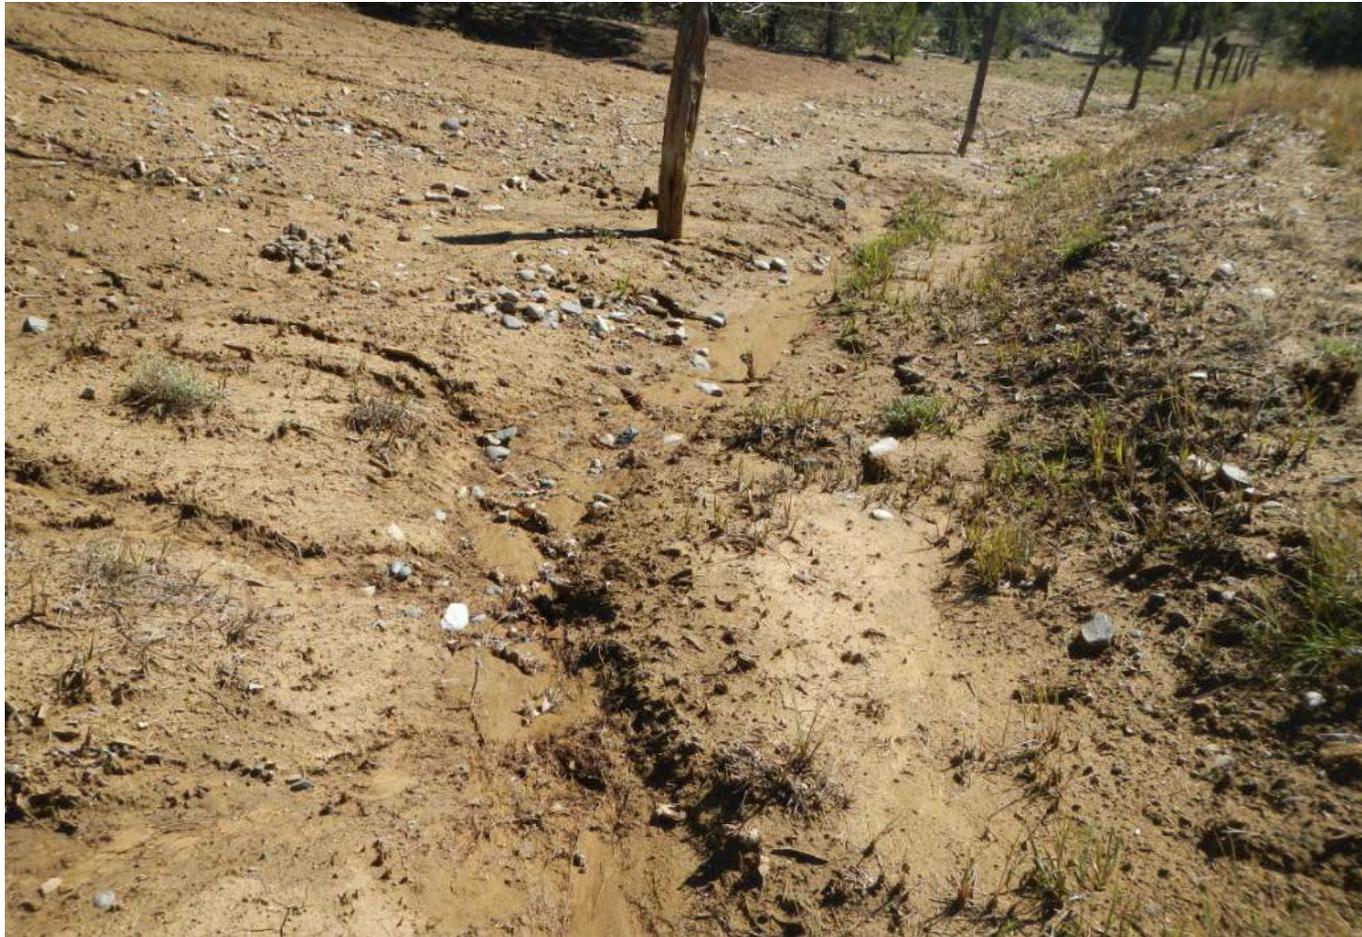
Photo 6. View of water diversion channel directing stormwater flows off of the northern edge of the well pad.

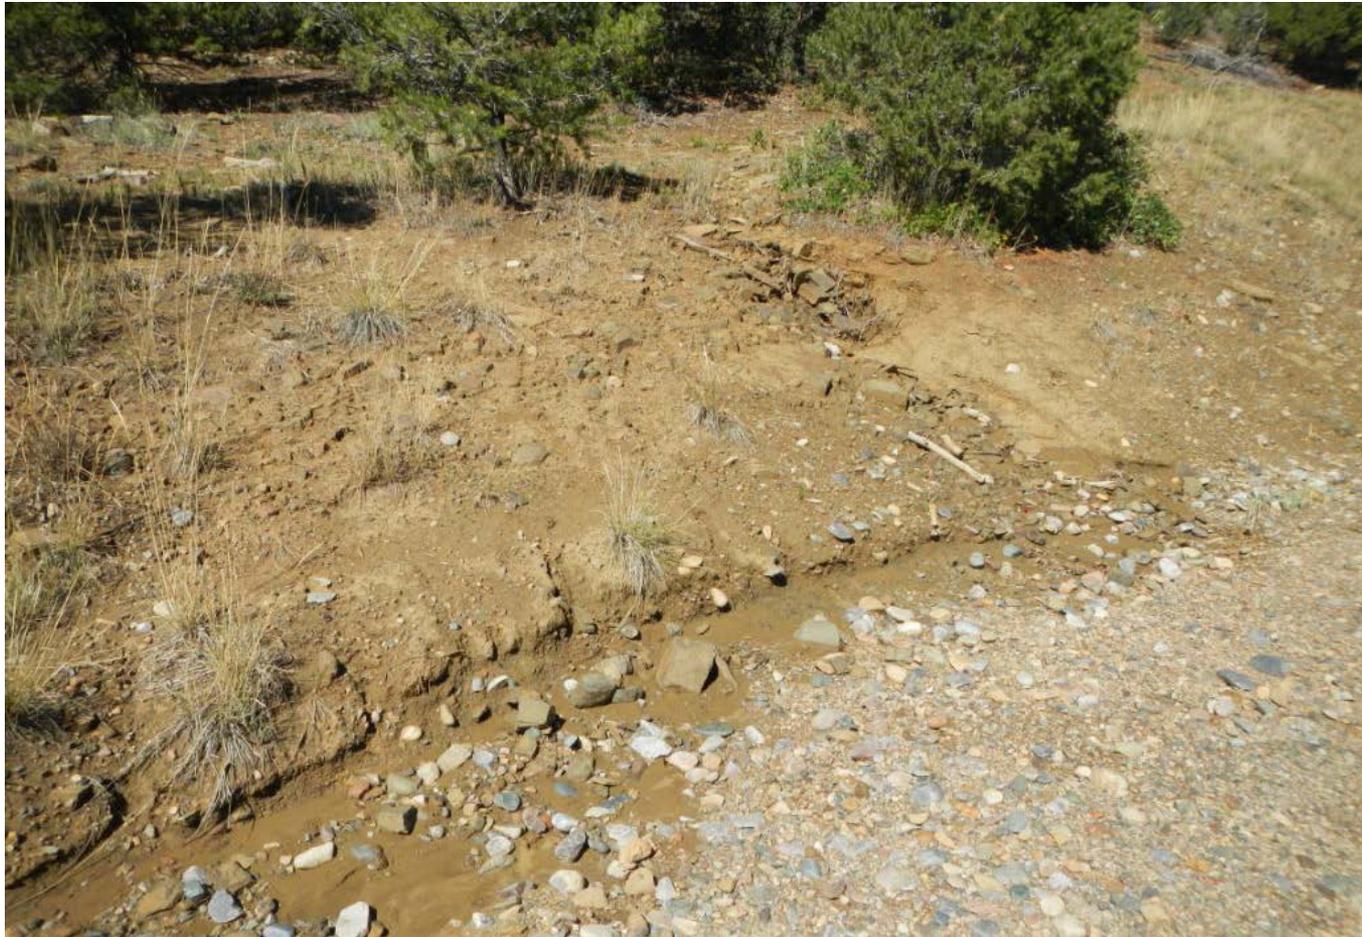
Photo 7. View of head-cut where water from stormwater diversion channel is eroding slope and meets up with access road.

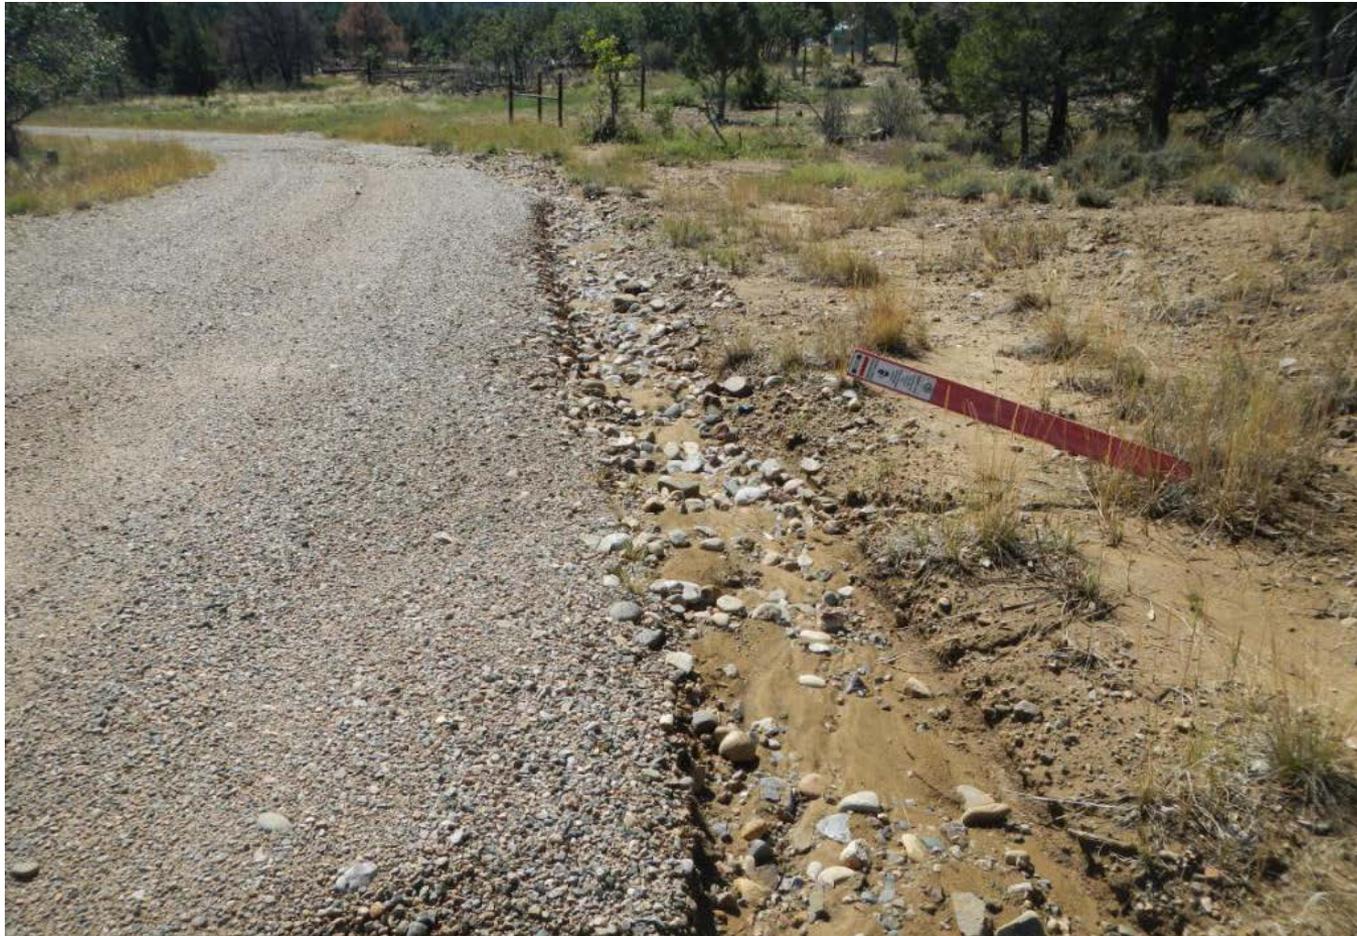
Photo 8. View of erosion along the access road that needs BMPs to de-energize and filter stormwater flows.
