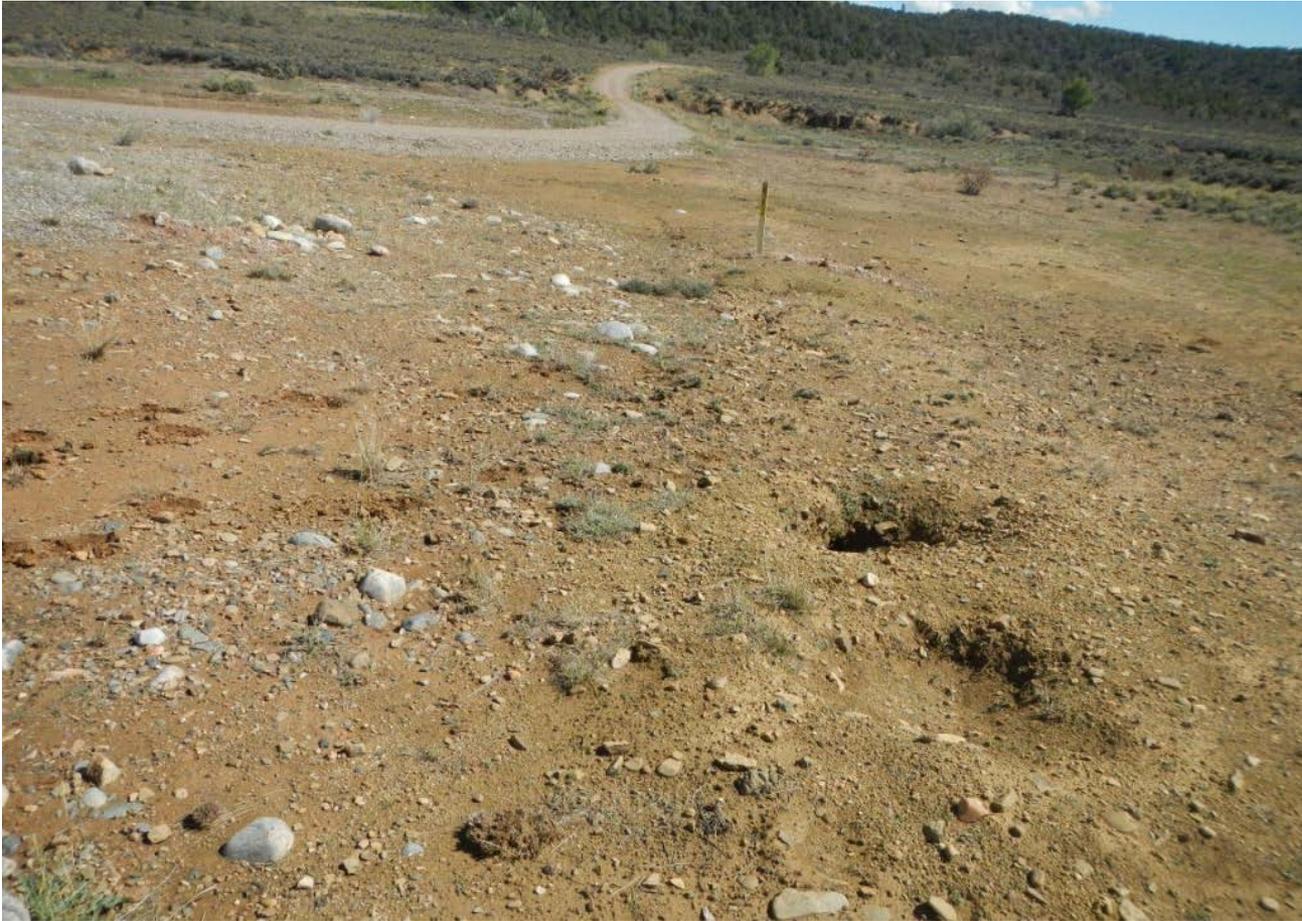
Photo 1. View of poor revegetation within the eastern portion of the interim reclamation area from eastern edge of the working area facing eastward.

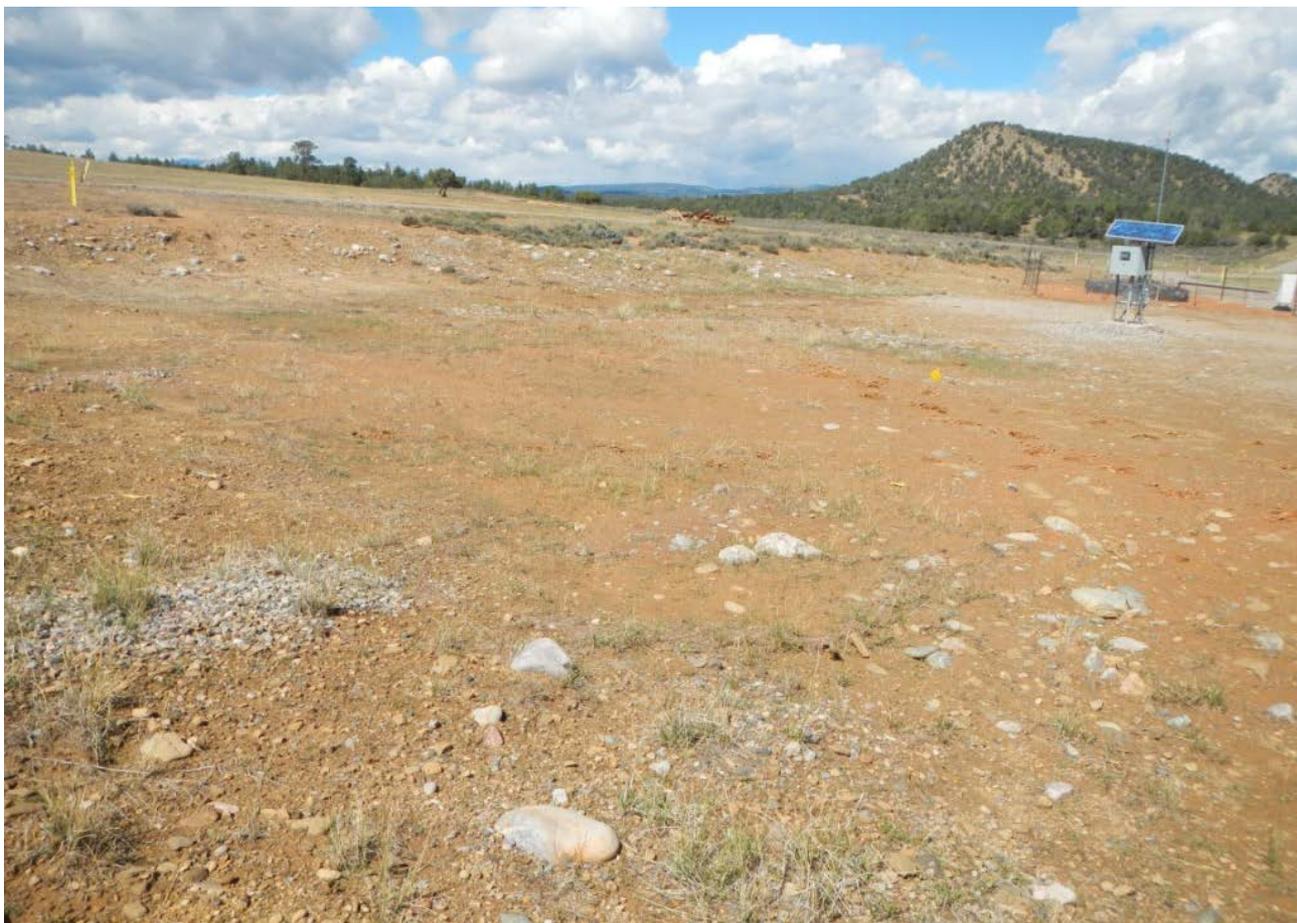
Photo 2. View of poor revegetation within the southern portion of the interim reclamation area from southeastern corner of the well pad facing westward.

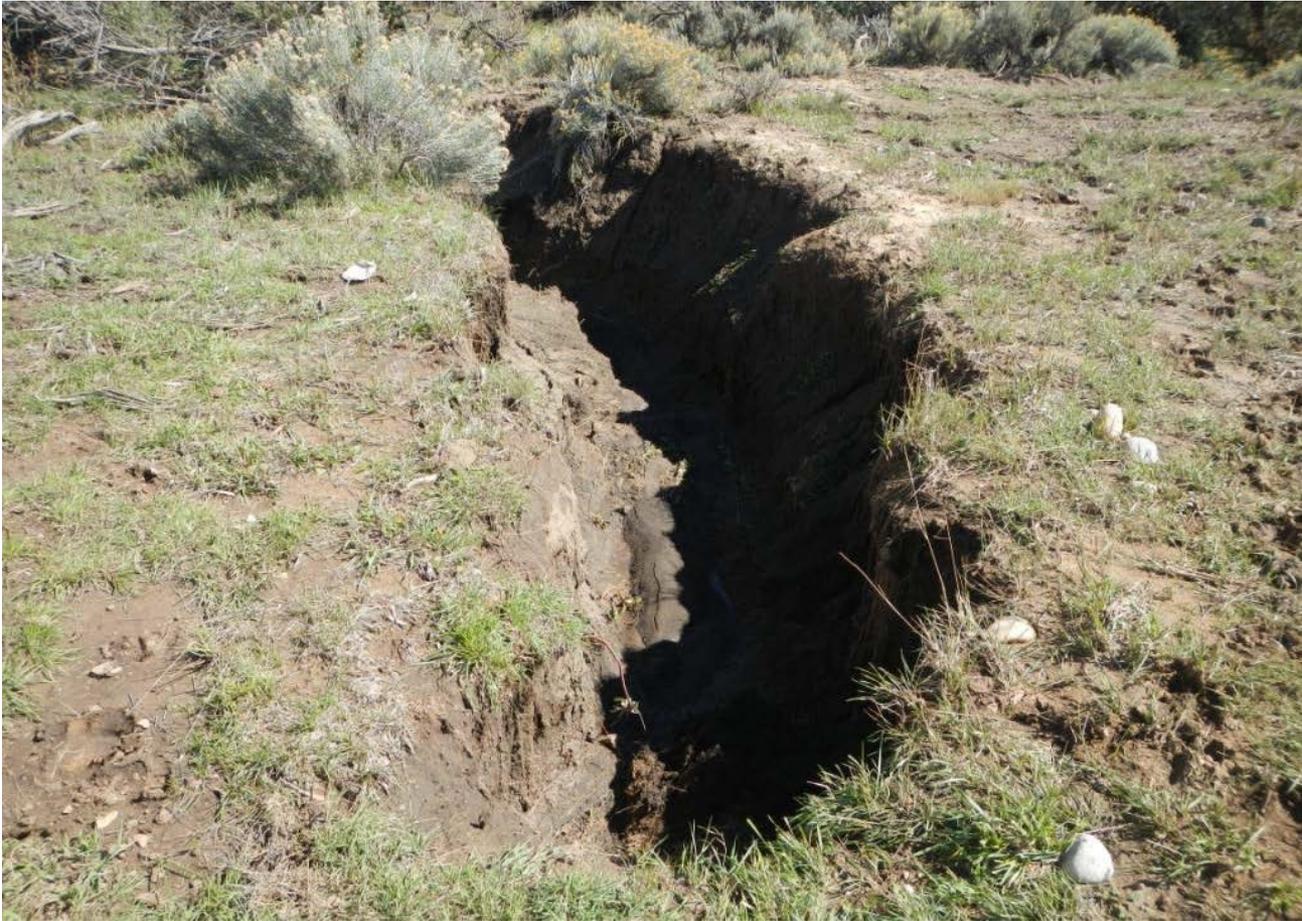
Photo 3. View of erosional head-cut approximately 2 feet wide and 2 feet deep adjacent to the northern edge of the project area.

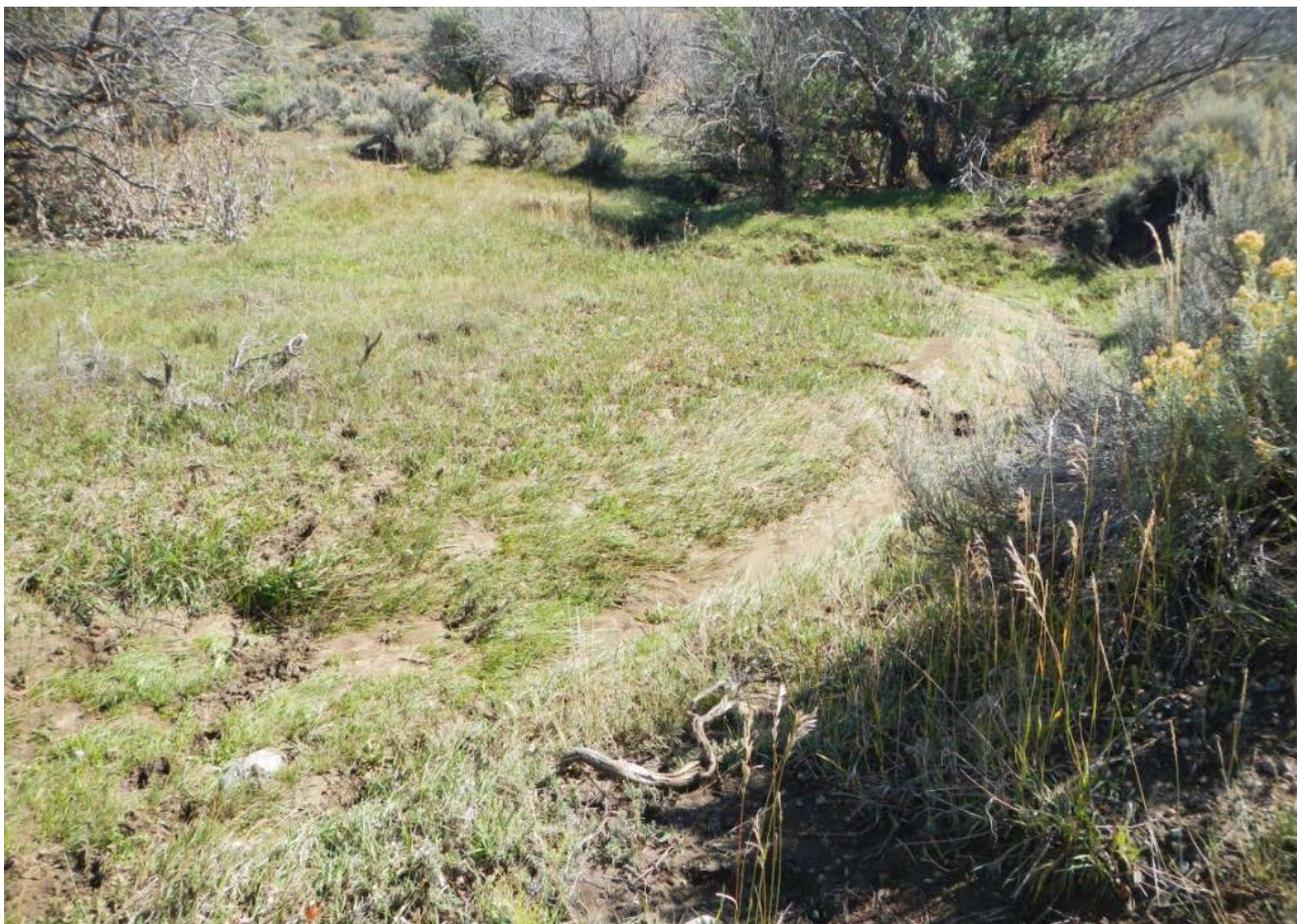
Photo 4. View of drainage adjacent to the northern edge of the project area facing east-northeastward.

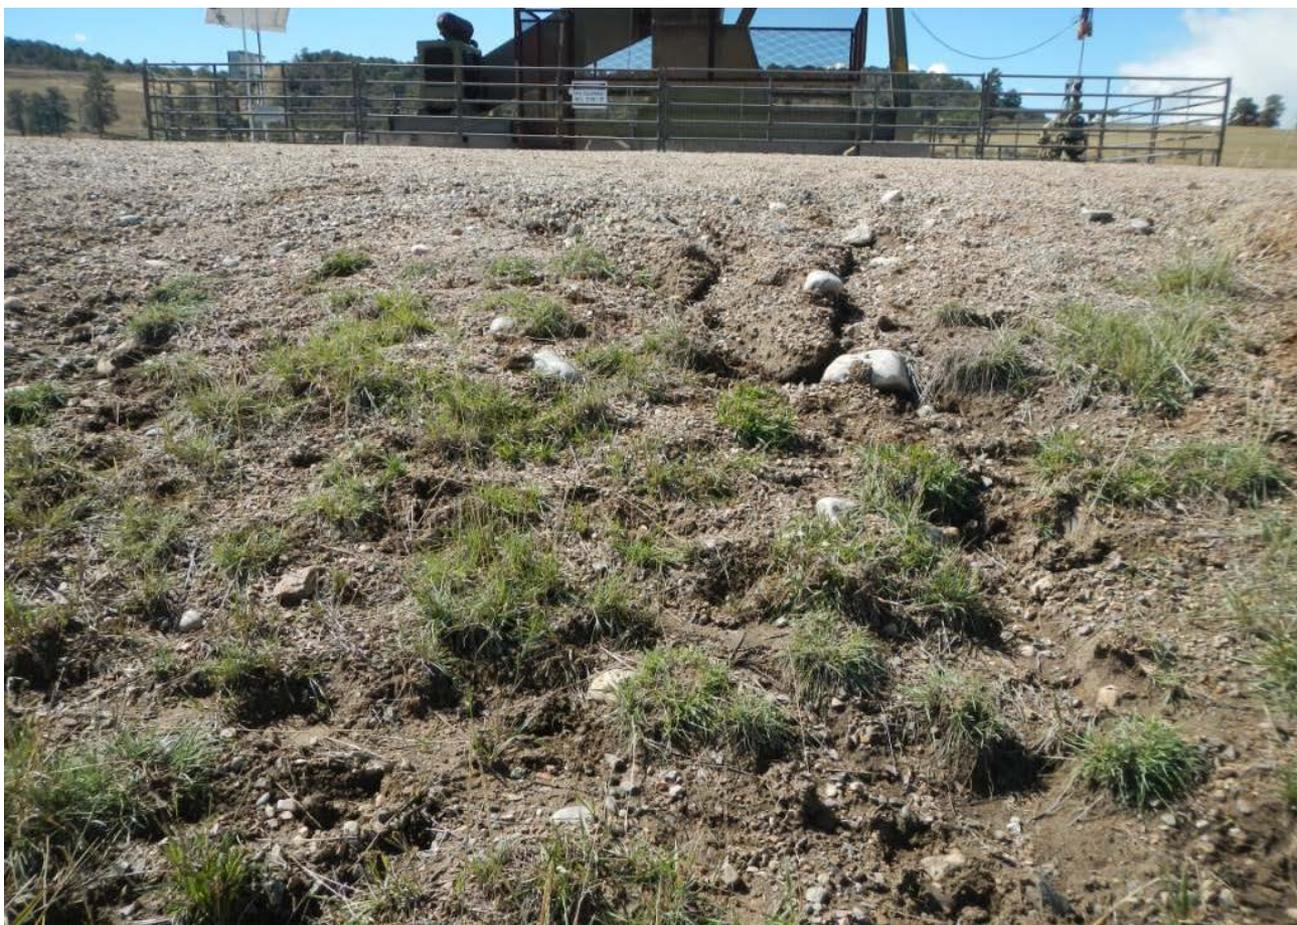
Photo 5. View of erosional rills that are eroding sediment toward the drainage adjacent to the northern edge of the well pad shown in Photo 4.

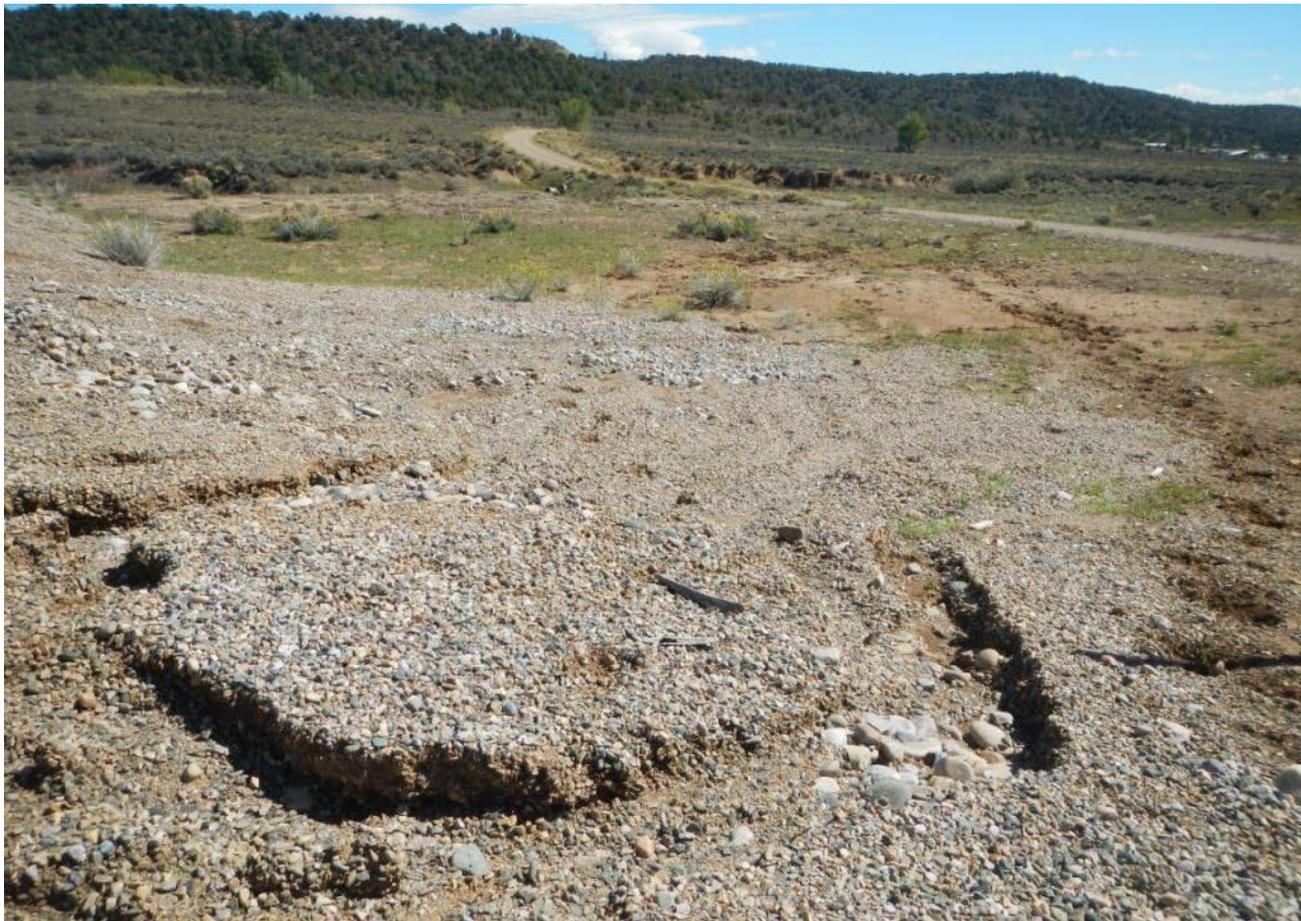
Photo 6. Location on the eastern edge of the well pad where concentrated stormwater flows exit the working area and appear to be eroding sediment from the interim reclamation area and depositing sediment below. Sediment deposition can be seen in the bare patch of ground beyond the gravel.
