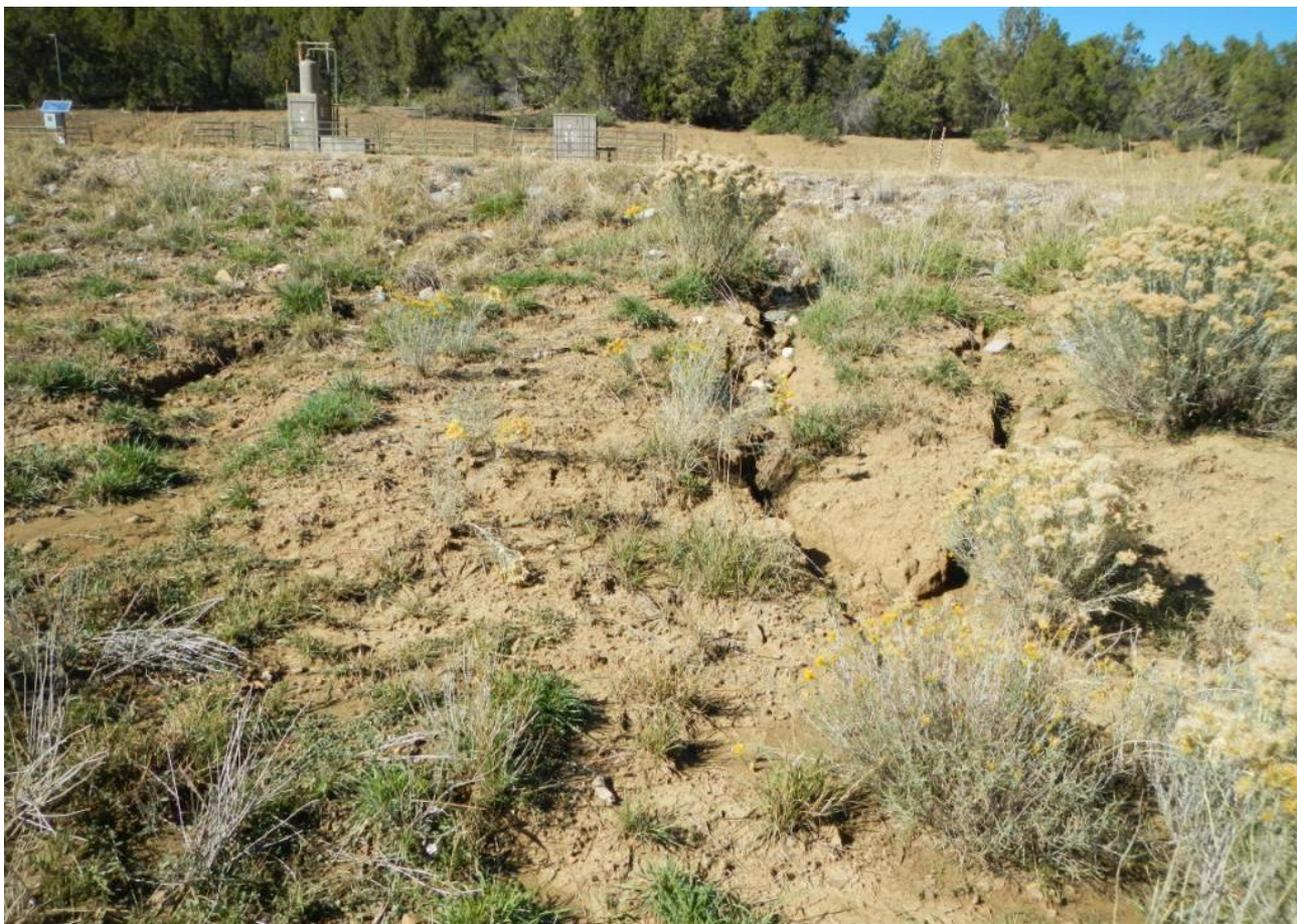
Photo 1. View of rill erosion (approximately 1 foot wide and 1 foot deep) within the southern portion of the interim reclamation area.

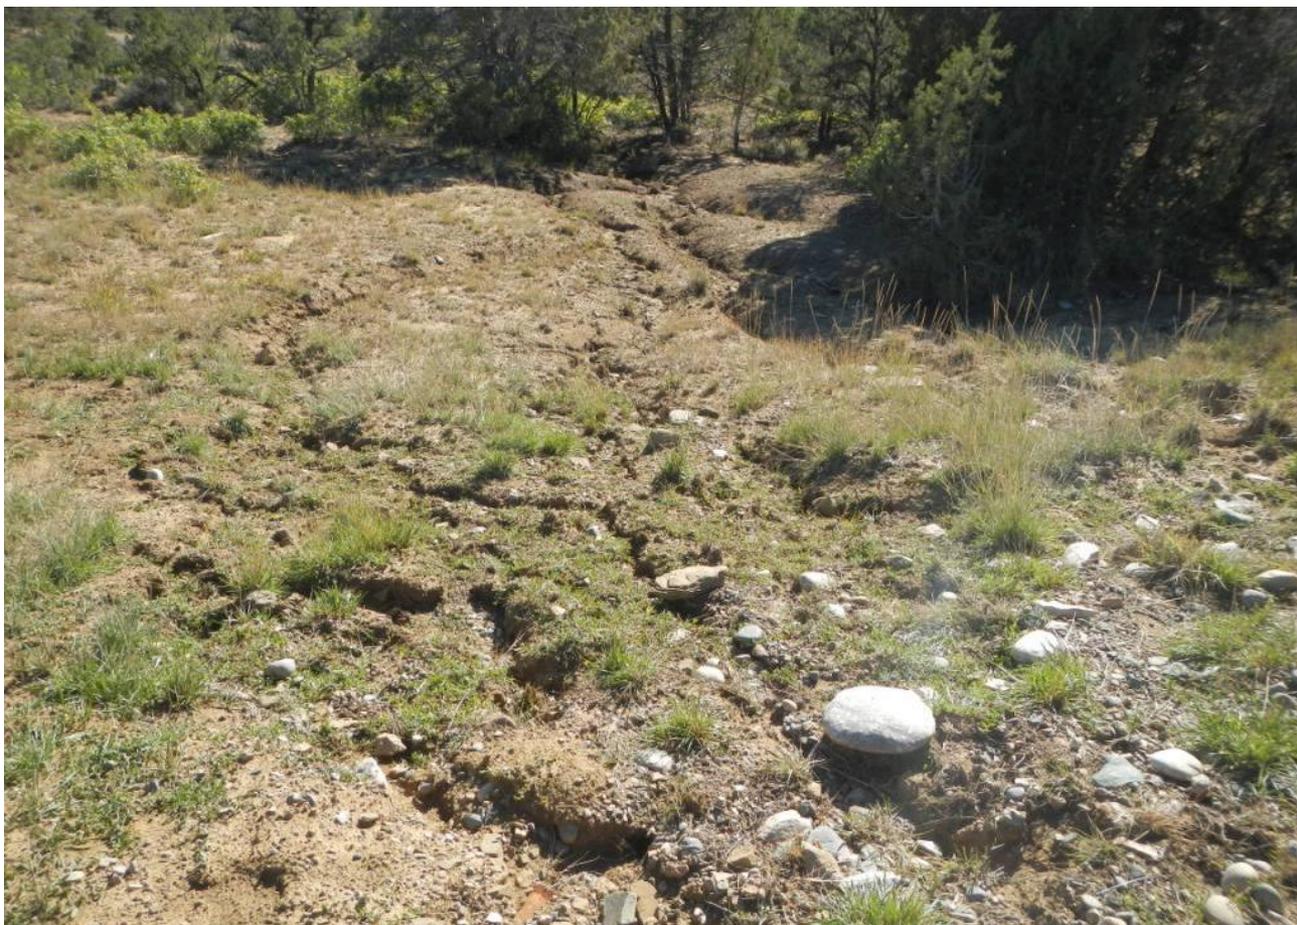
Photo 2. View of deep rills within the southern portion of the interim reclamation area eroding offsite.

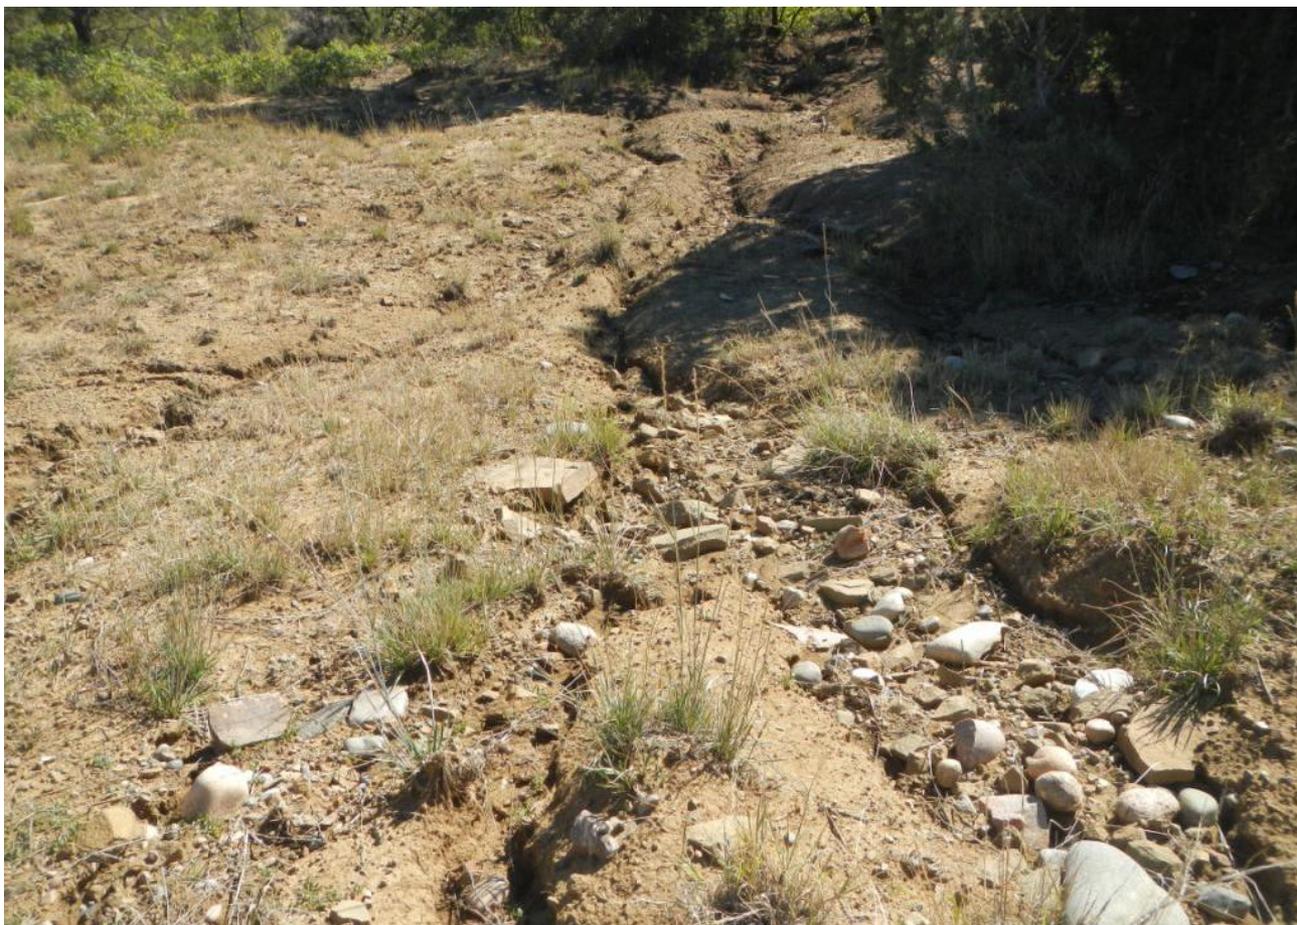
Photo 3. View of continued deep rills and gully forming in the fill slopes within the southern portion of the interim reclamation area.

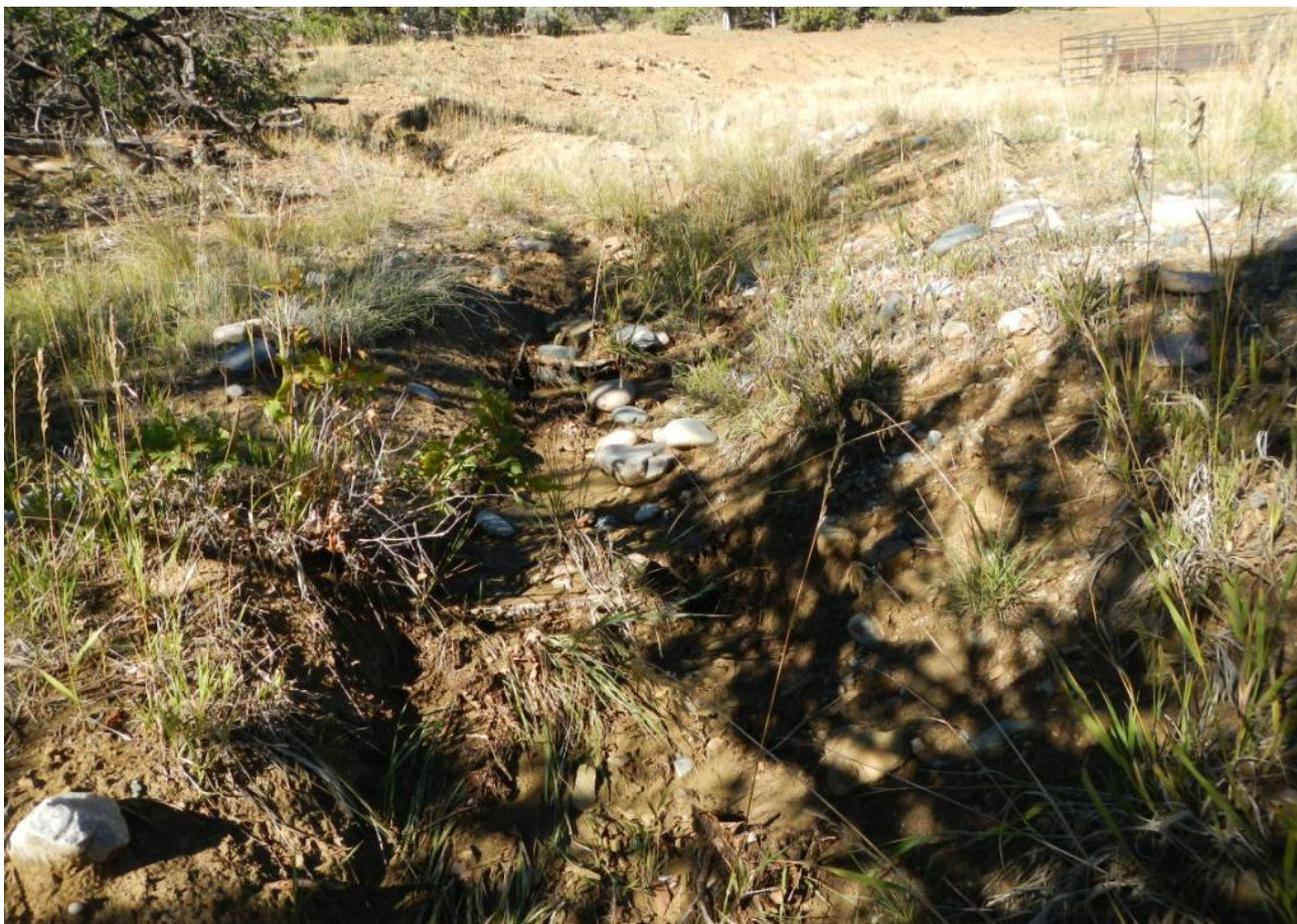
Photo 4. View of water diversion channel on the western edge of the well pad. Storm water flows appear to move rapidly through this area and carrying sediment off of the location.

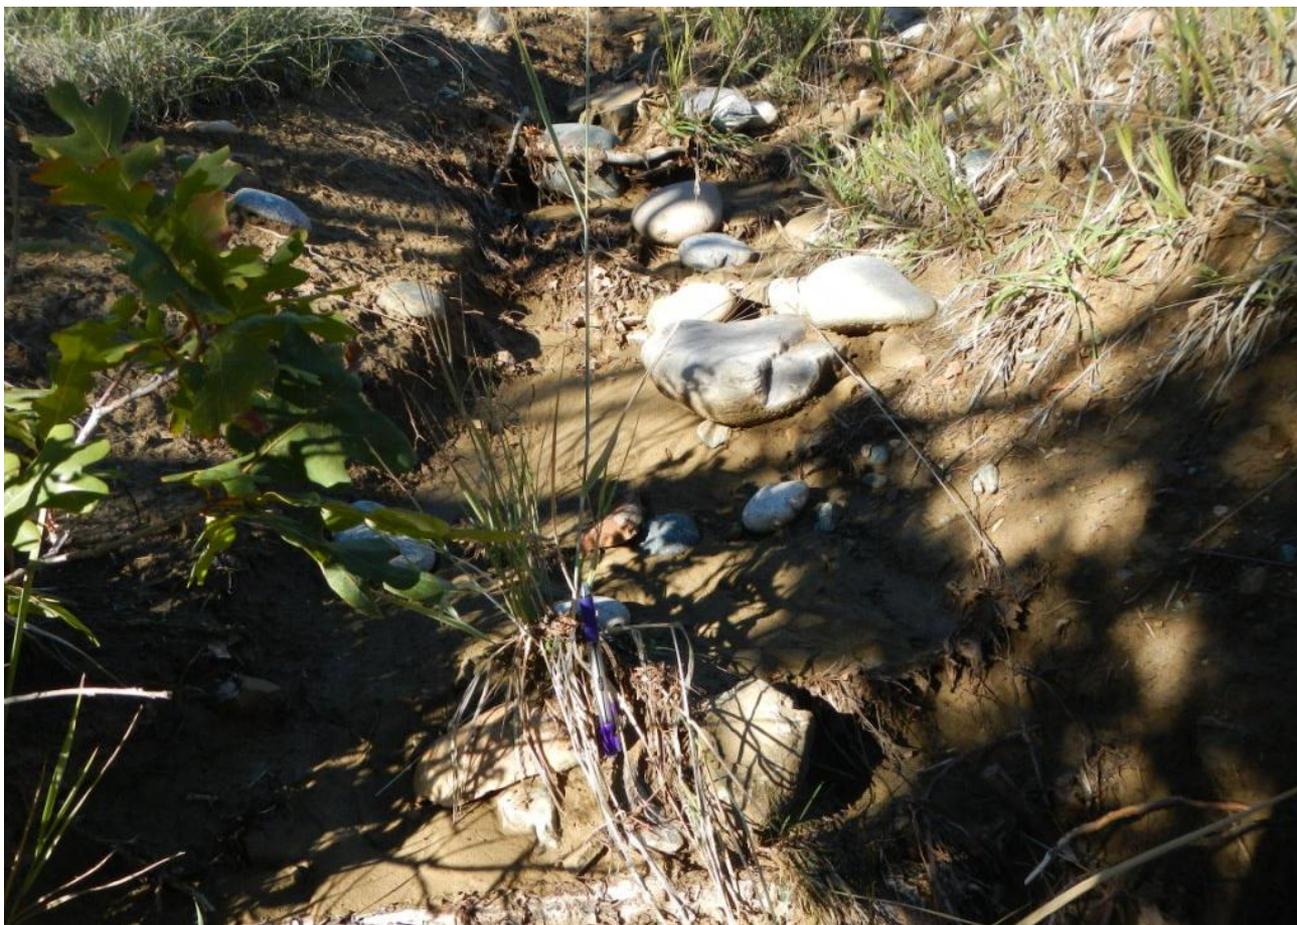
Photo 5. View of water diversion channel on the western edge of the well pad. Approximately six inches of soil has recently been removed as evidenced by the exposed roots on the living grass within the channel bottom.

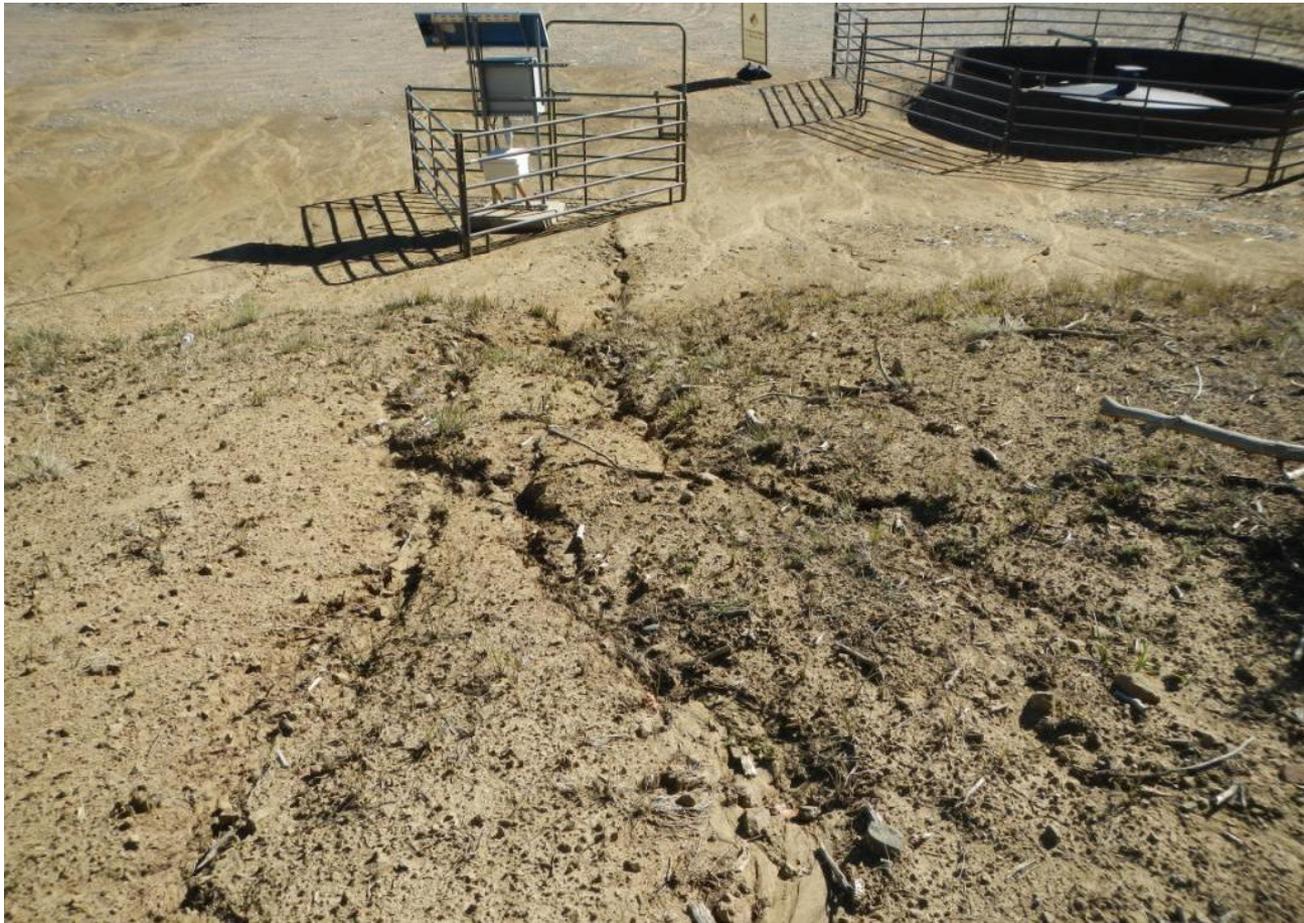
Photo 6. View of rill erosion on the cut-slope in the northern portion of the interim reclamation area and sediment run-on to the well pad from the cut-slope.

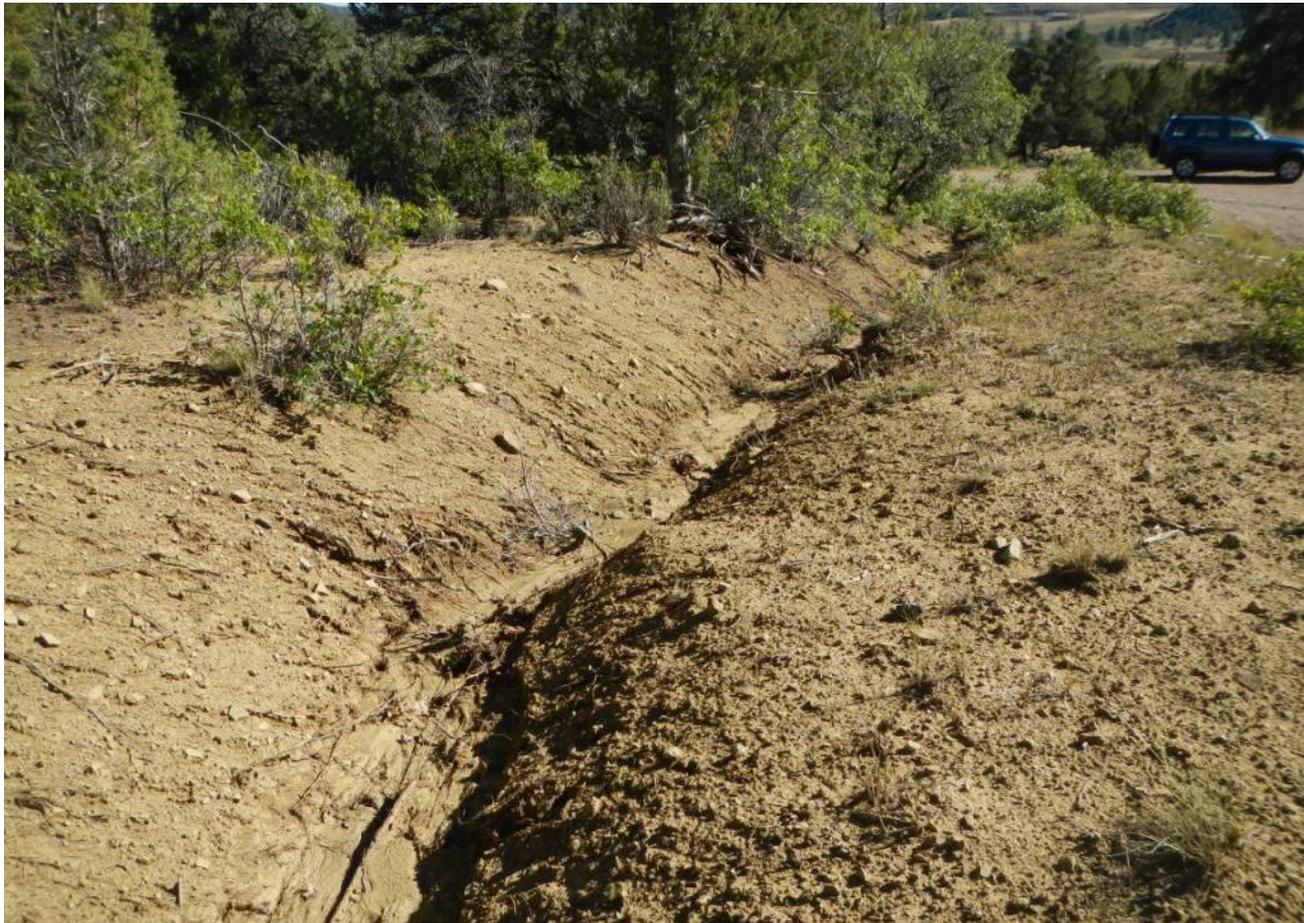
Photo 8. View of water diversion channel on the eastern edge of the project area. Storm water flows appear to move rapidly through this area; down cutting the channel, and carrying sediment off of the location.

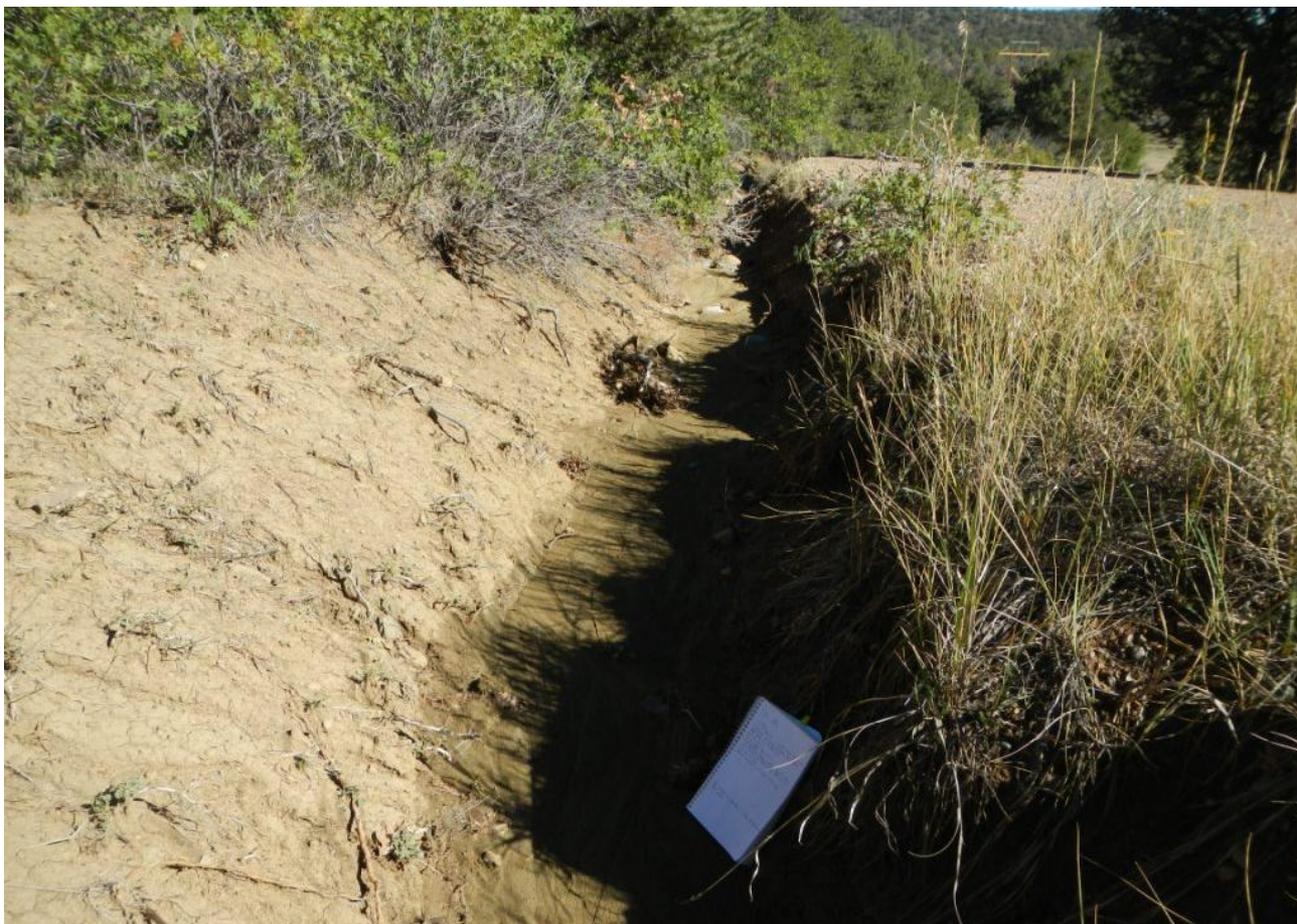
Photo 9. View of roadside ditch/water diversion channel on the eastern side of the access road that is approximately 3 to 4 feet wide and 3 to 4 feet deep.
