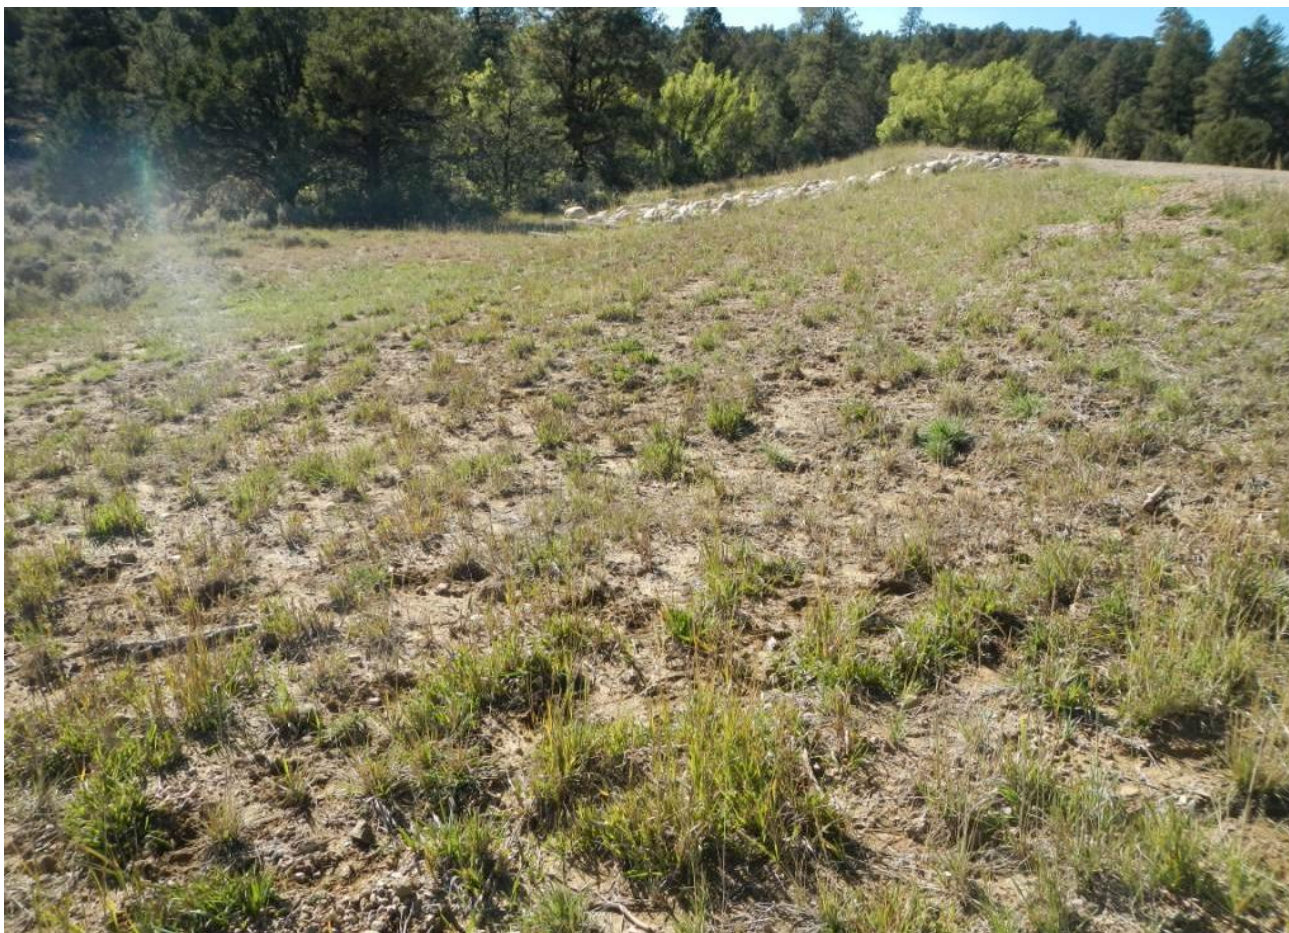
Photo 1. View of southern portion of interim reclamation area from southeastern corner facing westward.

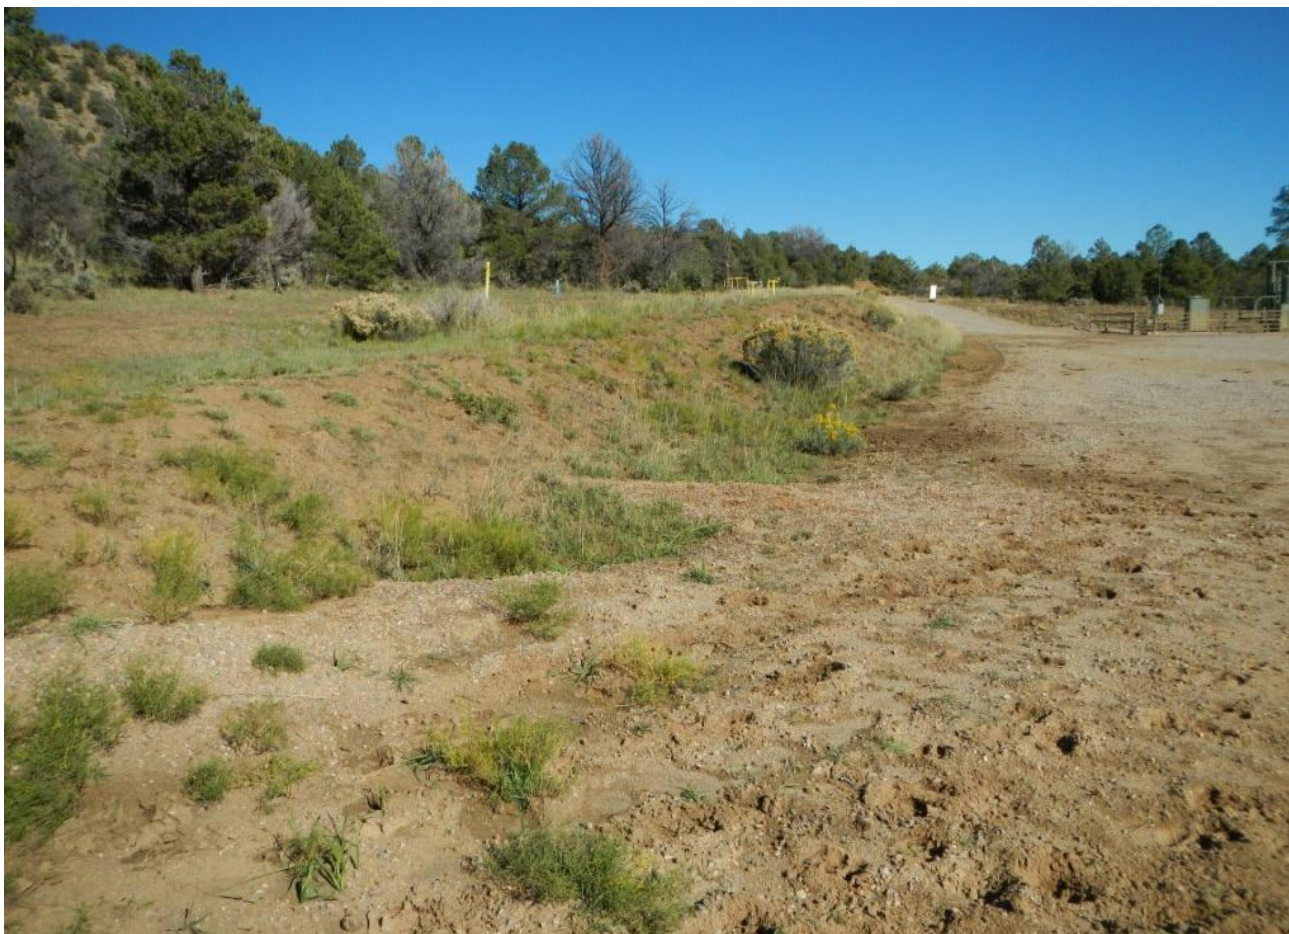
Photo 2. View of northern portion of working area and interim reclamation area from northwestern corner facing eastward.

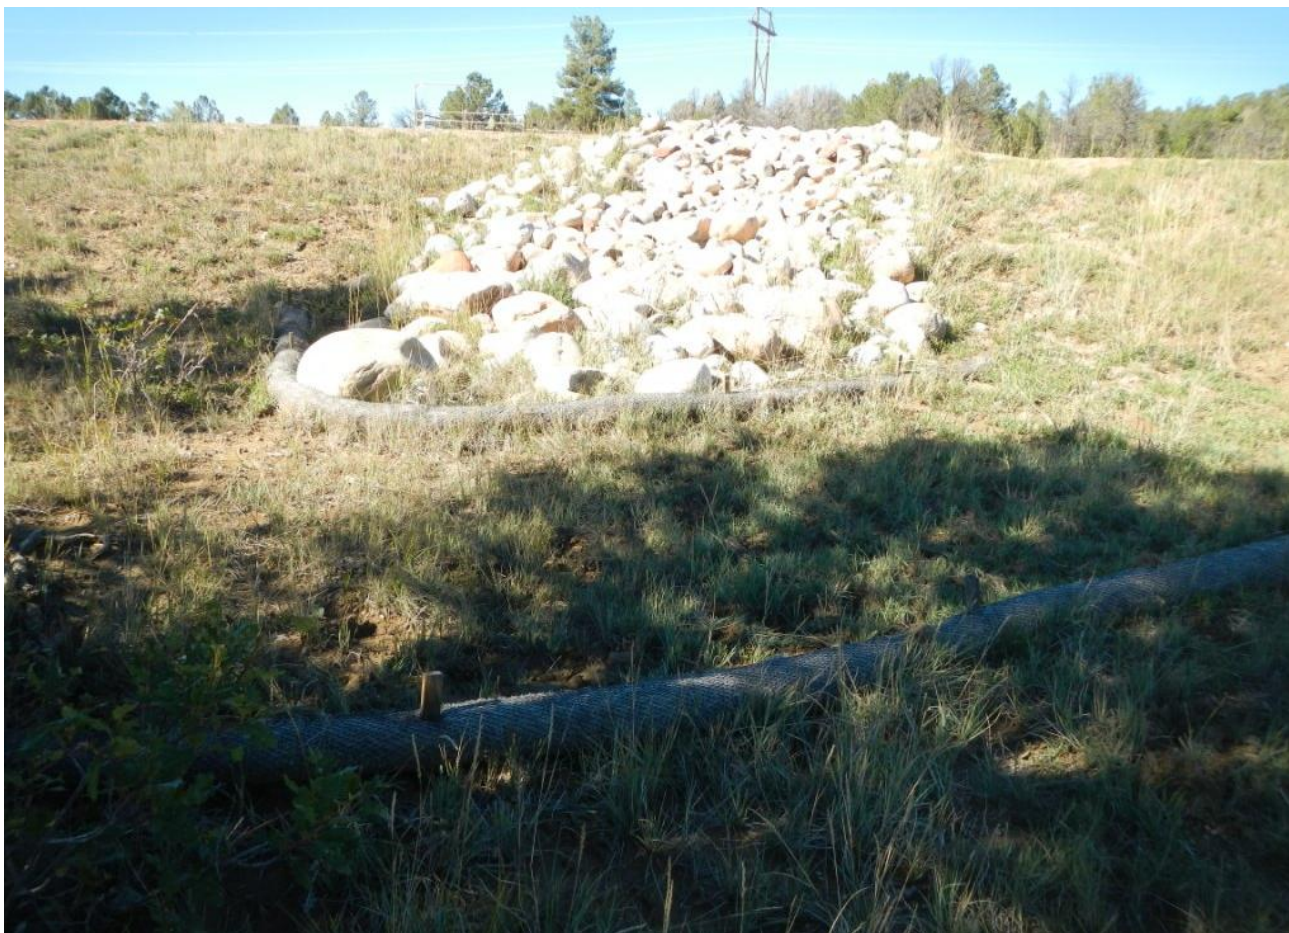
Photo 3. View of large cobble and straw wattle BMP that appears to be effectively de-energizing and filtering stormwater flows.

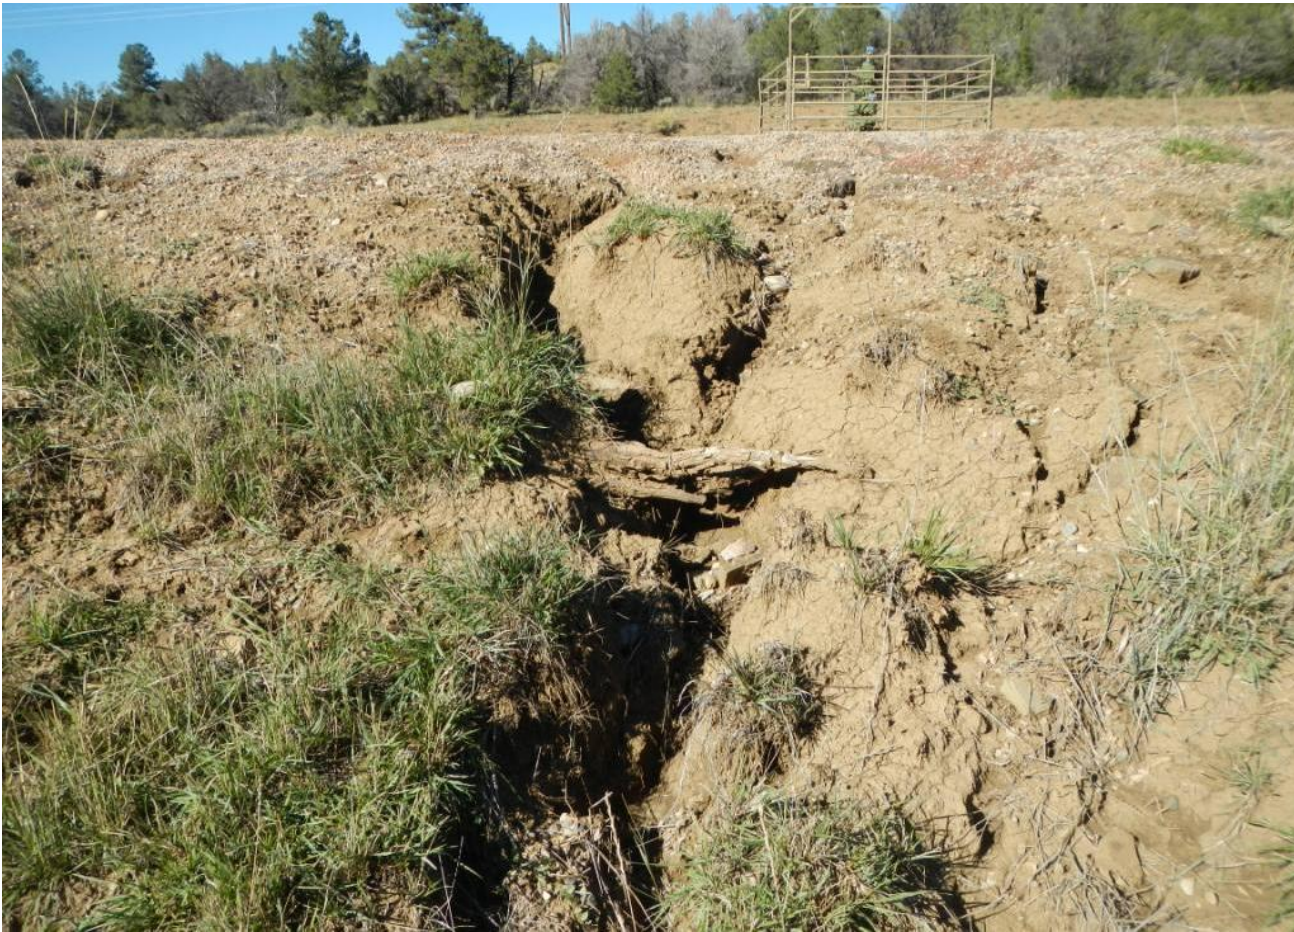
Photo 4. View of rill erosion off of the southern edge of the working area.
