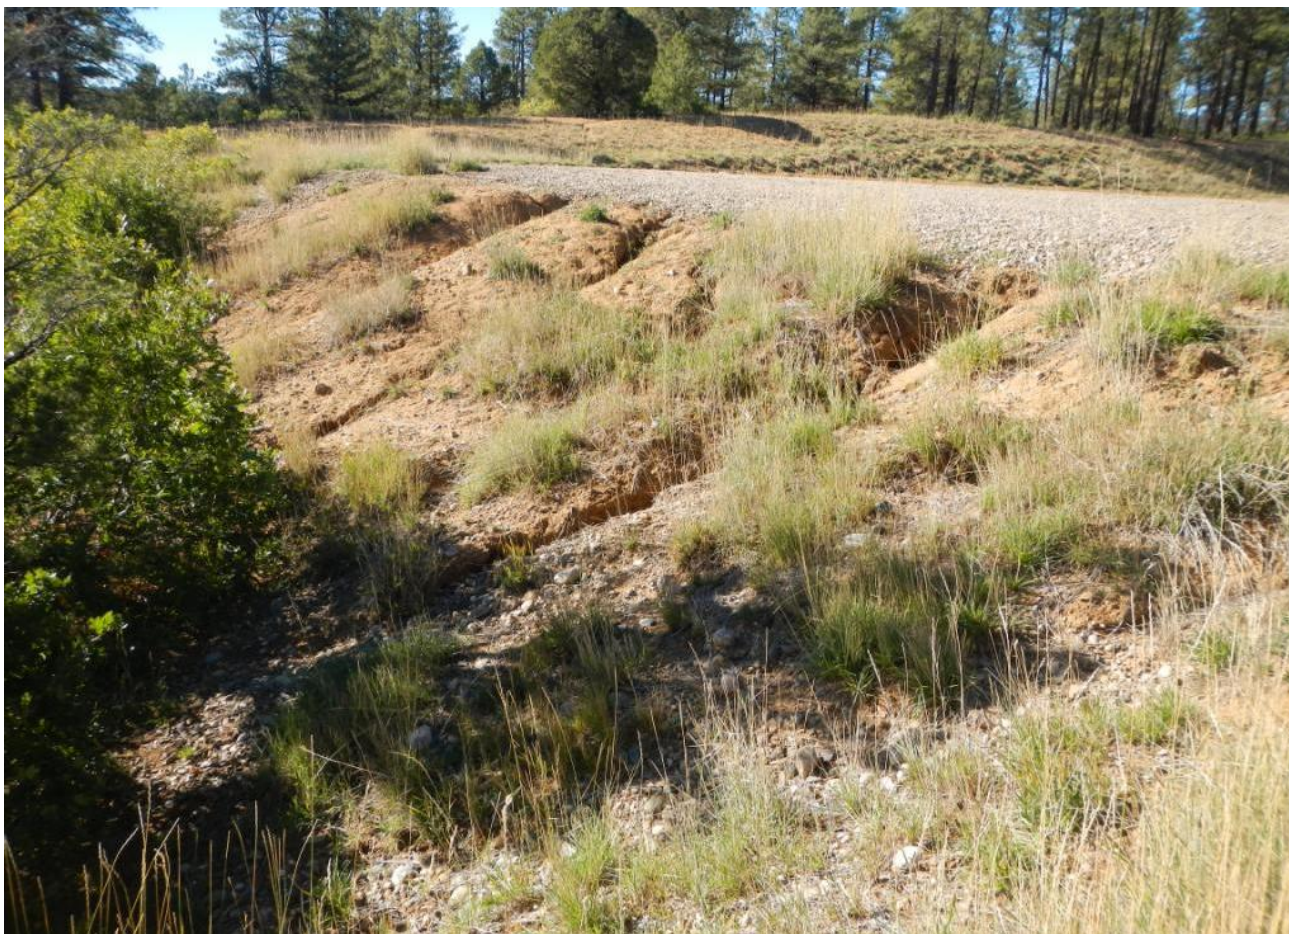
Photo 1. View of erosional channels on the southern edge of the working area of the well pad.

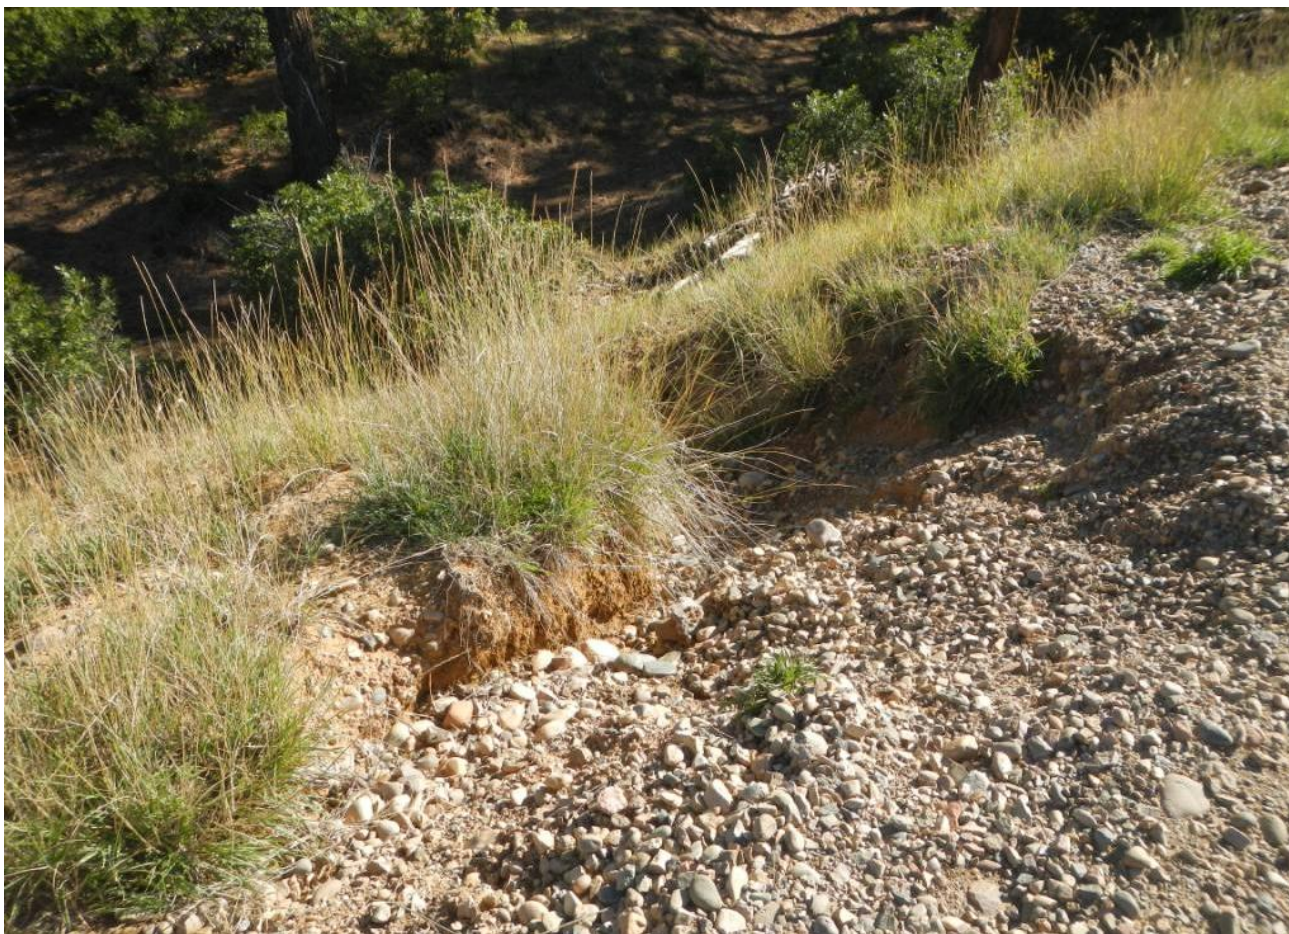
Photo 2. View of erosional channels along the steep edge of the access road near the entrance to the well pad.

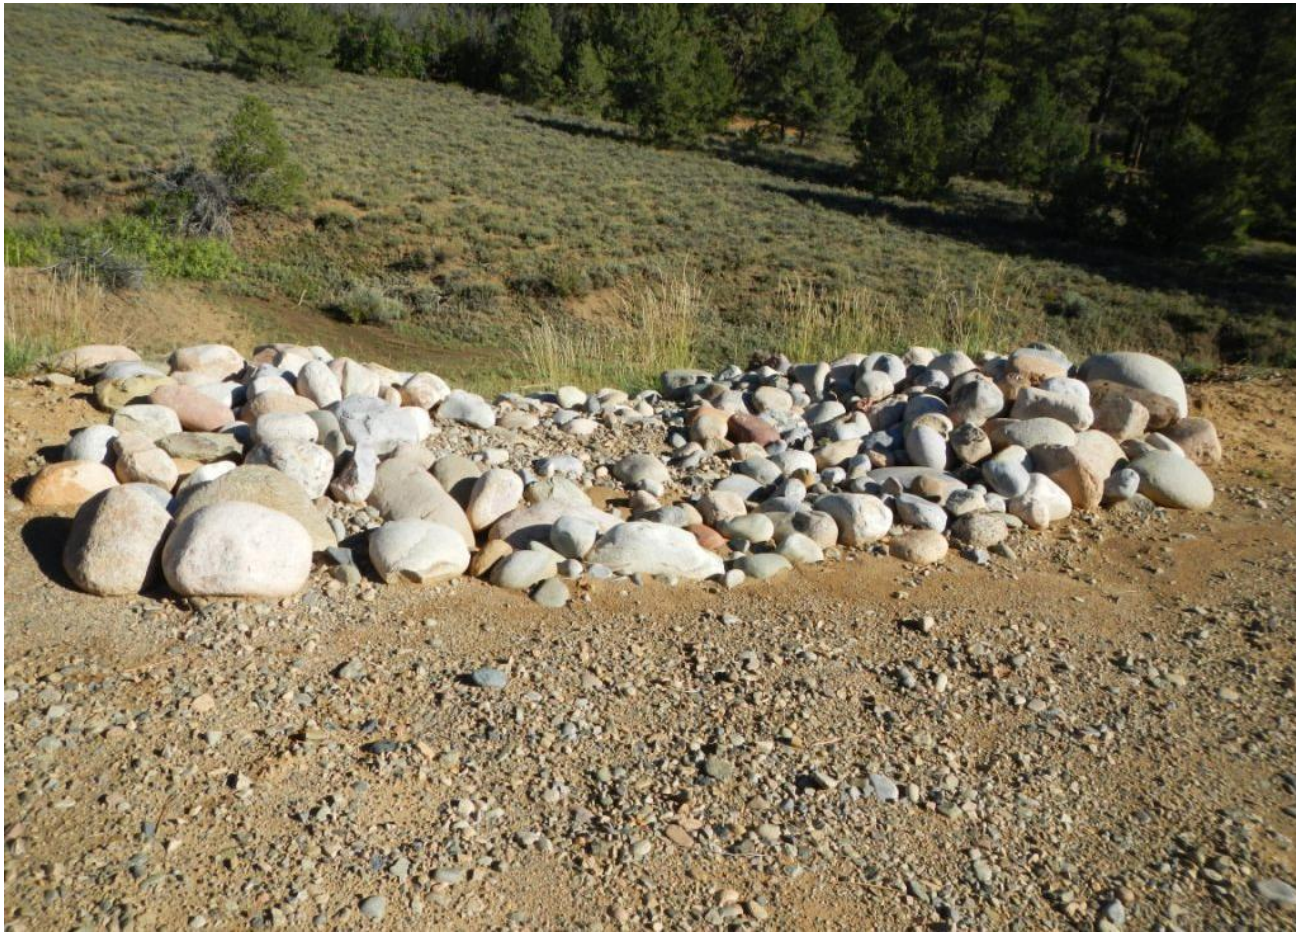
Photo 3. View of cobble BMP on the surface of the well pad that appears to be in good condition and is likely effective at de-energizing and filtering stormwater flows exiting the well pad here.

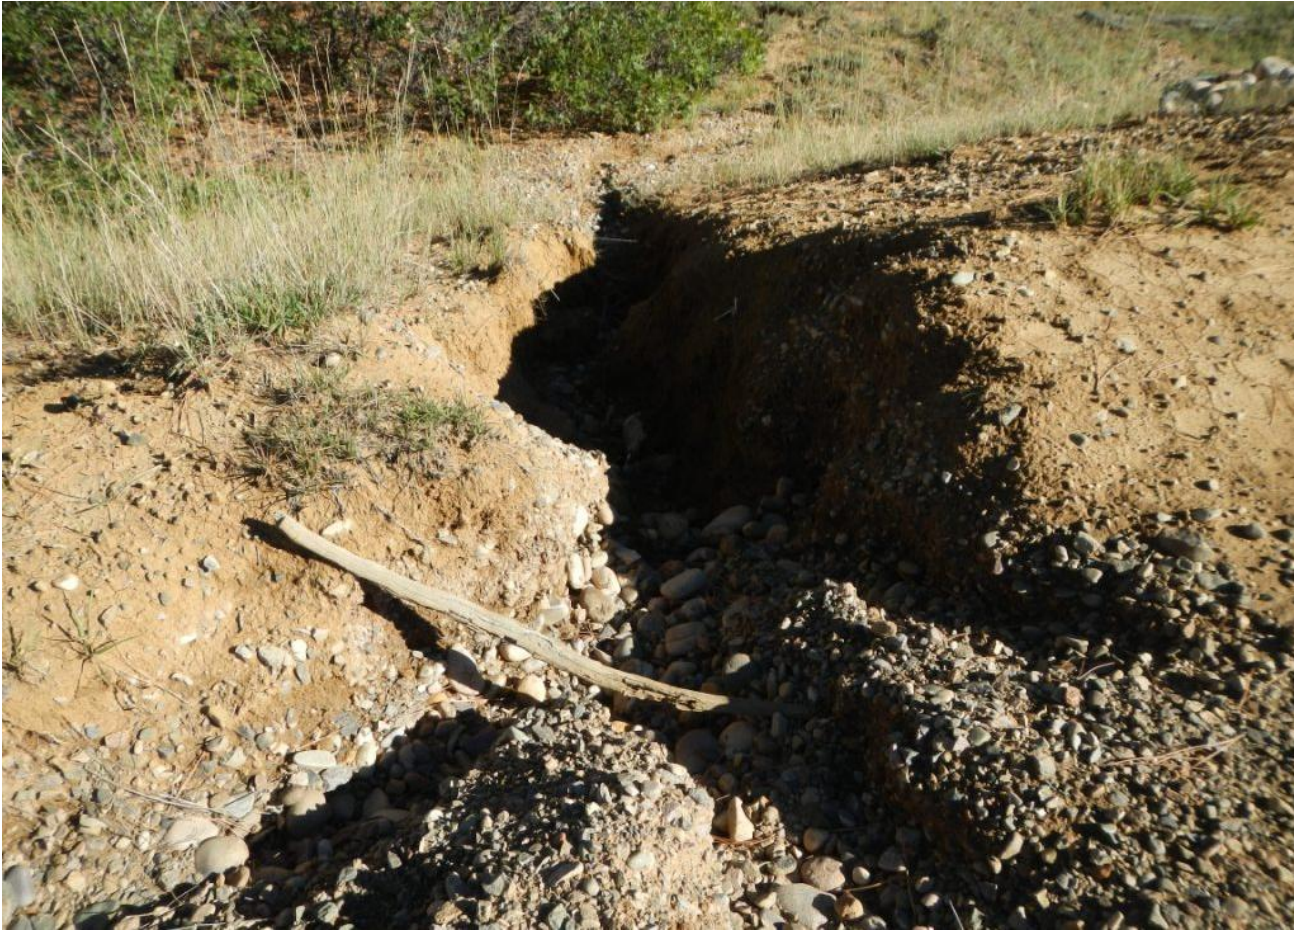
Photo 4. View of erosional gully within the eastern edge of the interim reclamation area.

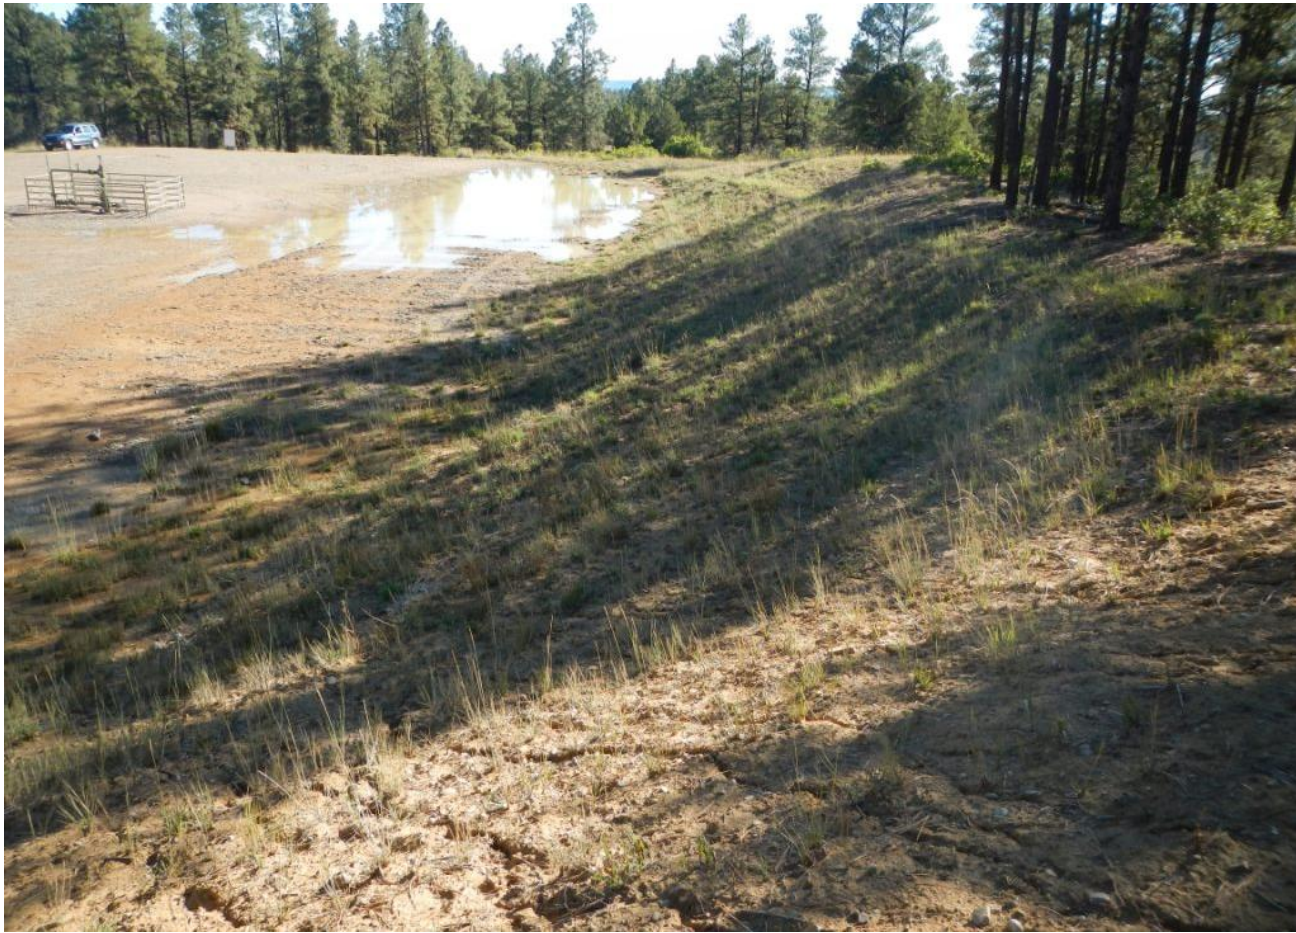
Photo 5. View of cut slope in western portion of the project area. Slope is largely stabilized with vegetation. Minor rill erosion is occurring. Large puddle appears to be contained and is primarily away from driving surfaces.
