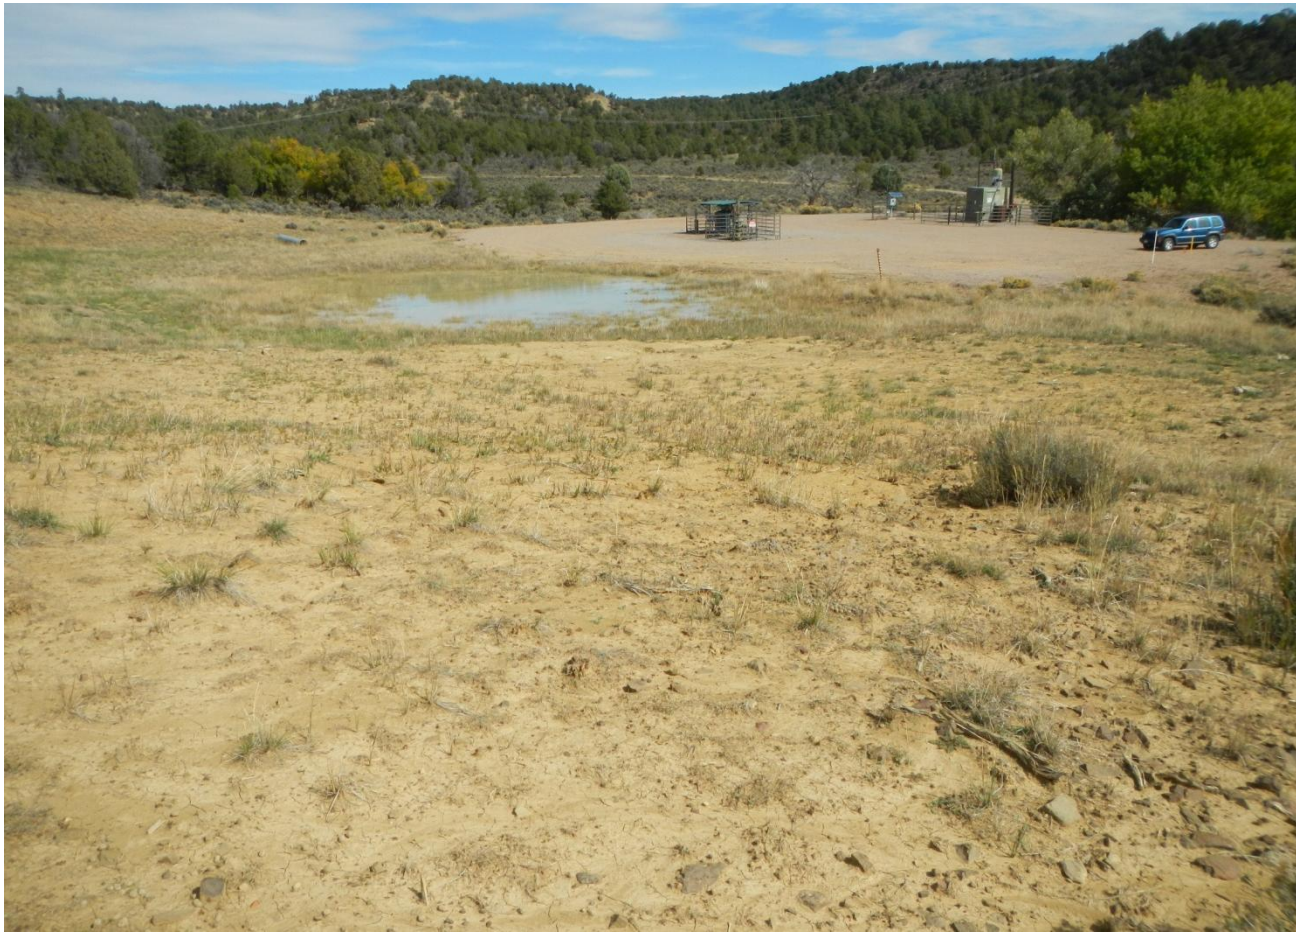
Photo 1. View from southwestern corner of project are facing center. Poned area can be seen in background. Poor revegetation in foreground.

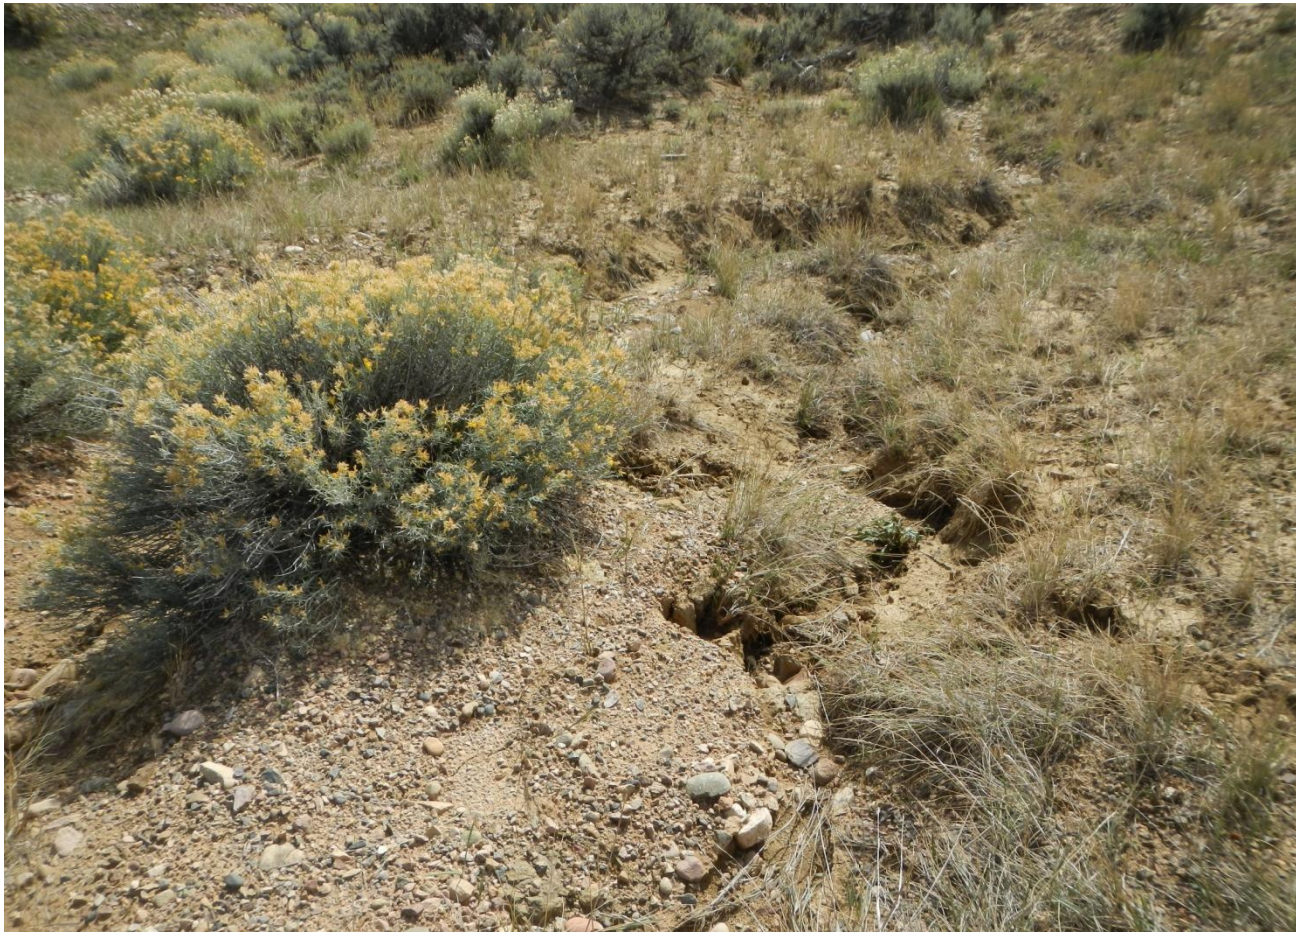
Photo 2. View of erosive feature on southern edge of the project area where it appears stormwater overflows ponded area to this drainage.

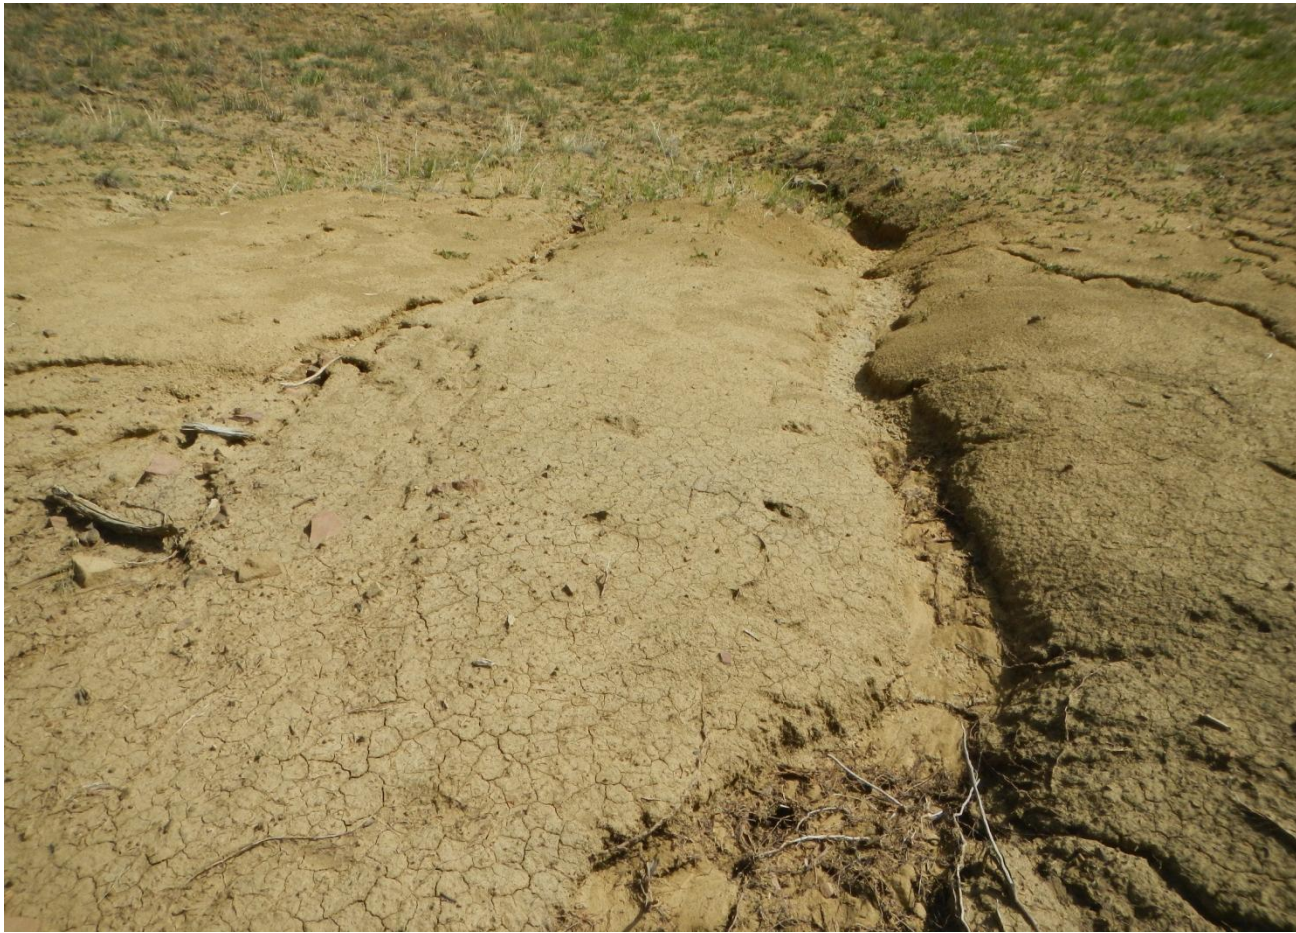
Photo 3. View of erosion and poor revegetation on cut-slope in western portion of the project area.

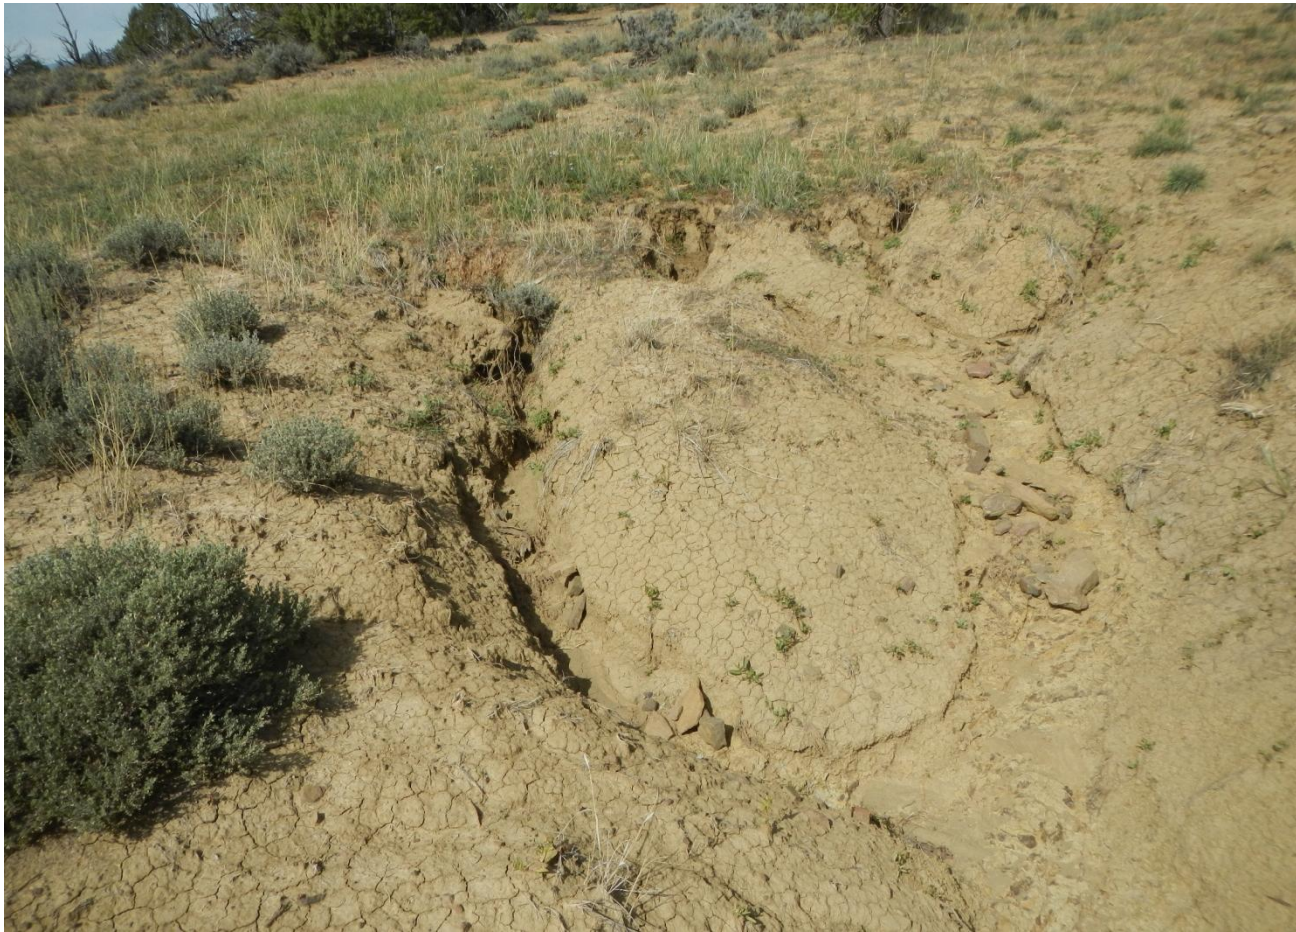
Photo 4. View of more erosion and poor revegetation on cut-slope in western portion of the project area.

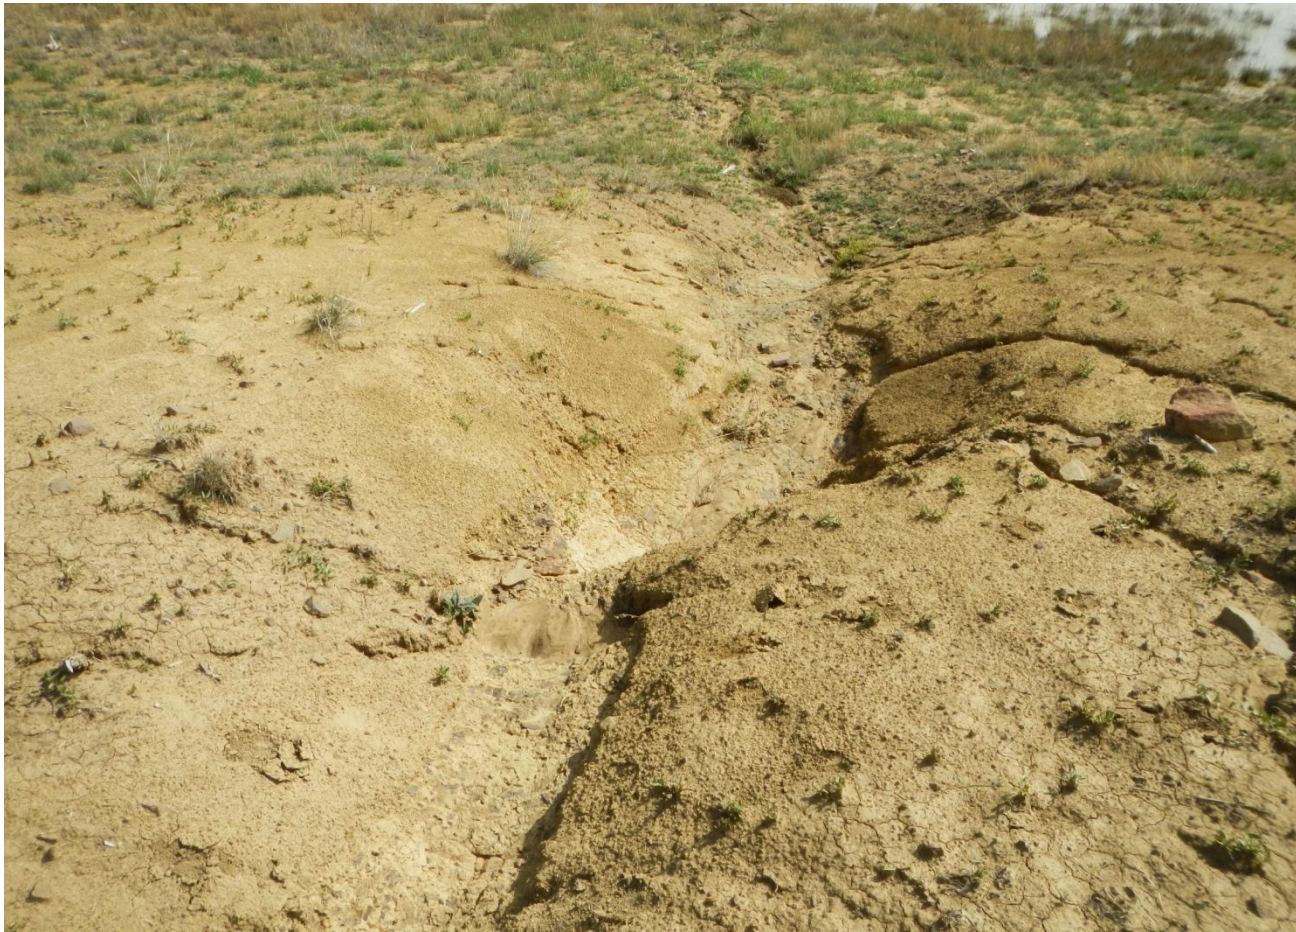
Photo 5. View of gully forming within the cut-slope in the western portion of the project area.

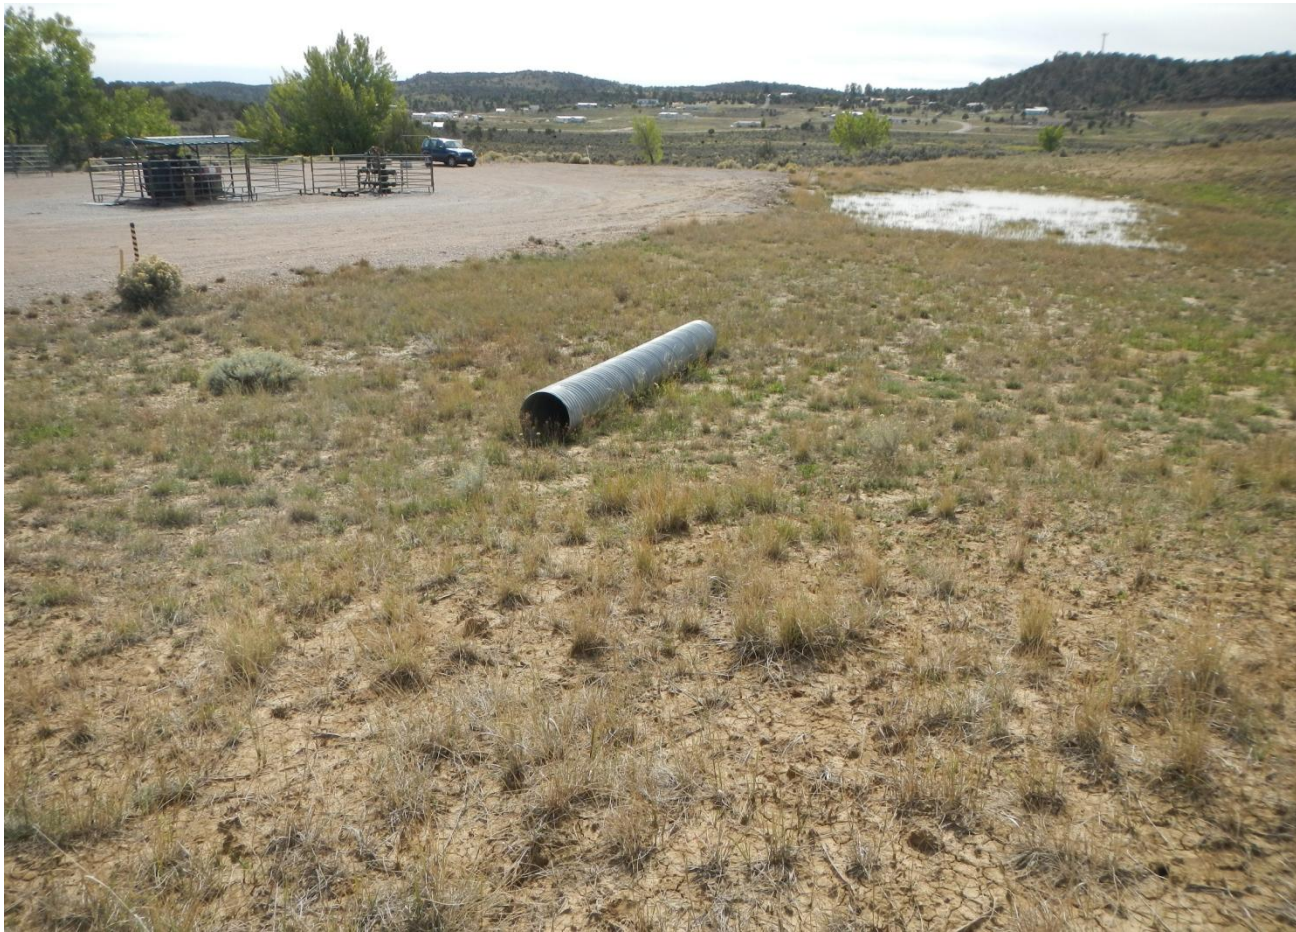
Photo 6. View of unused culvert in project area.
