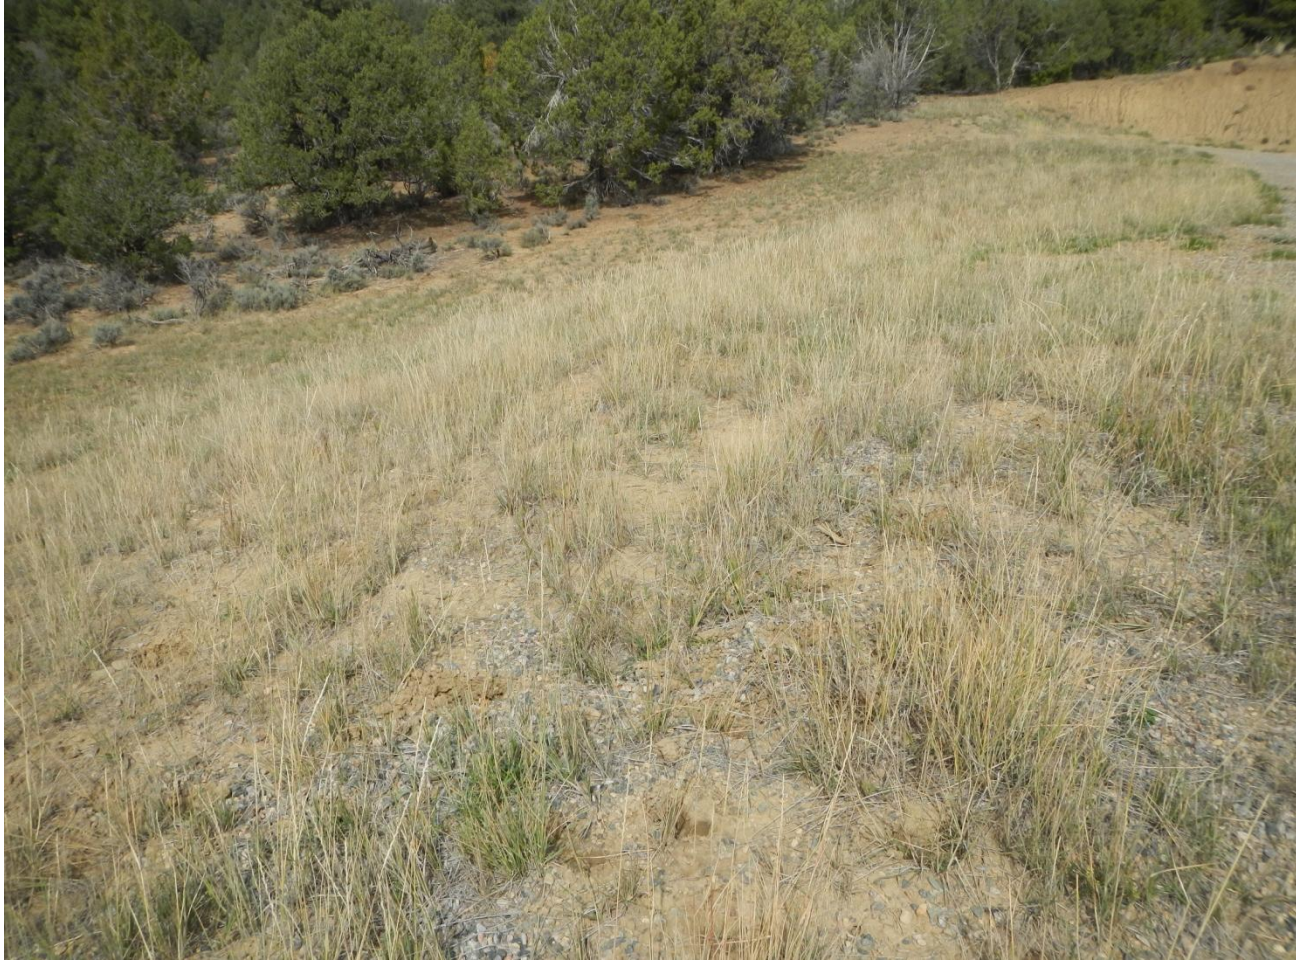
Photo 1. View of revegetation along the western portion of the interim reclamation area.

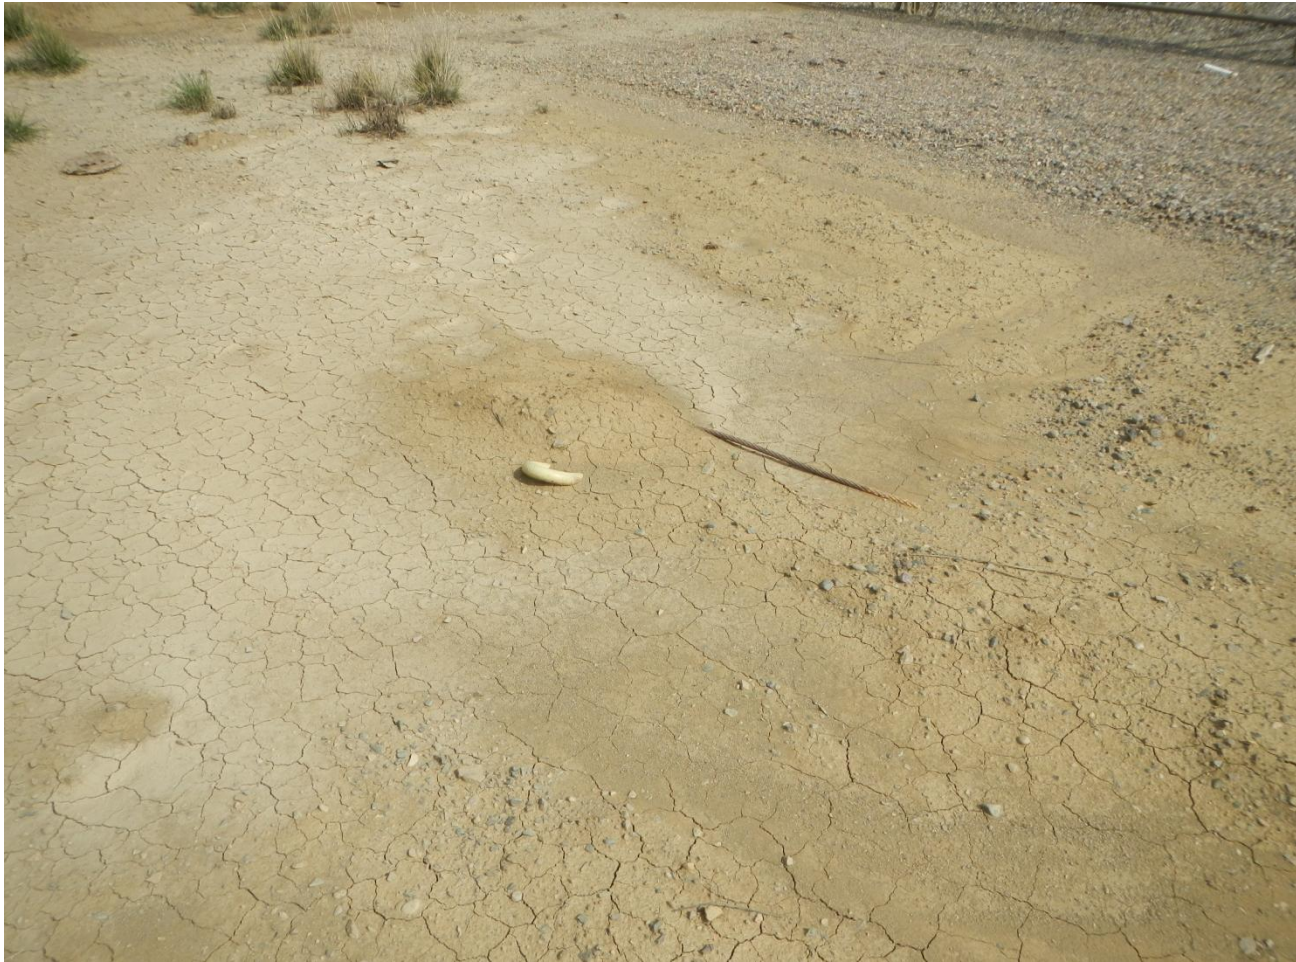
Photo 2. View of partially buried and unmarked guy line anchor as well as partially buried rig cable within the northwestern corner of the project area.

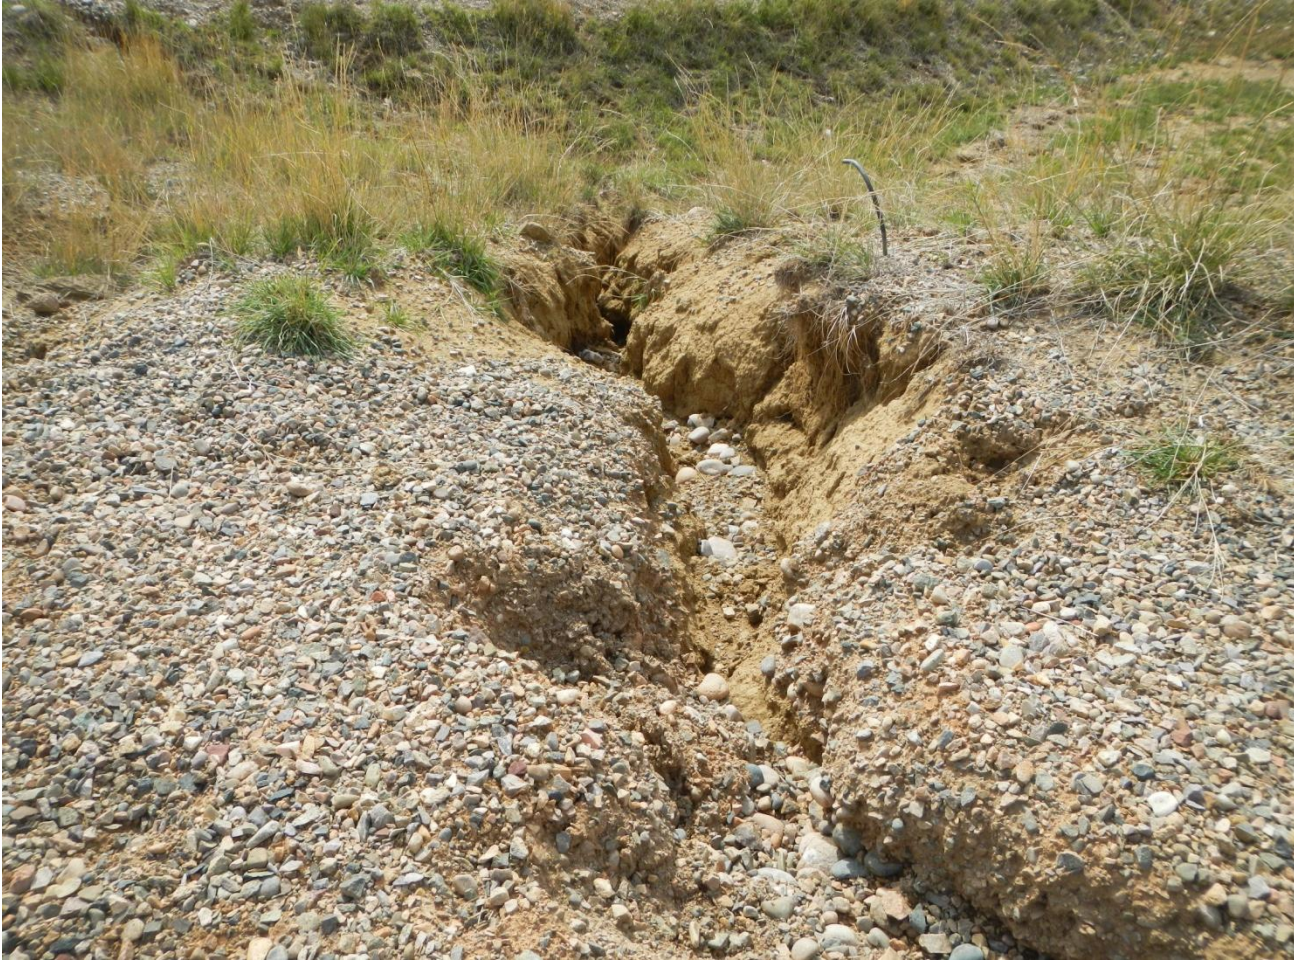
Photo 3. View of gully forming on the southern edge of the well pad near the entrance.

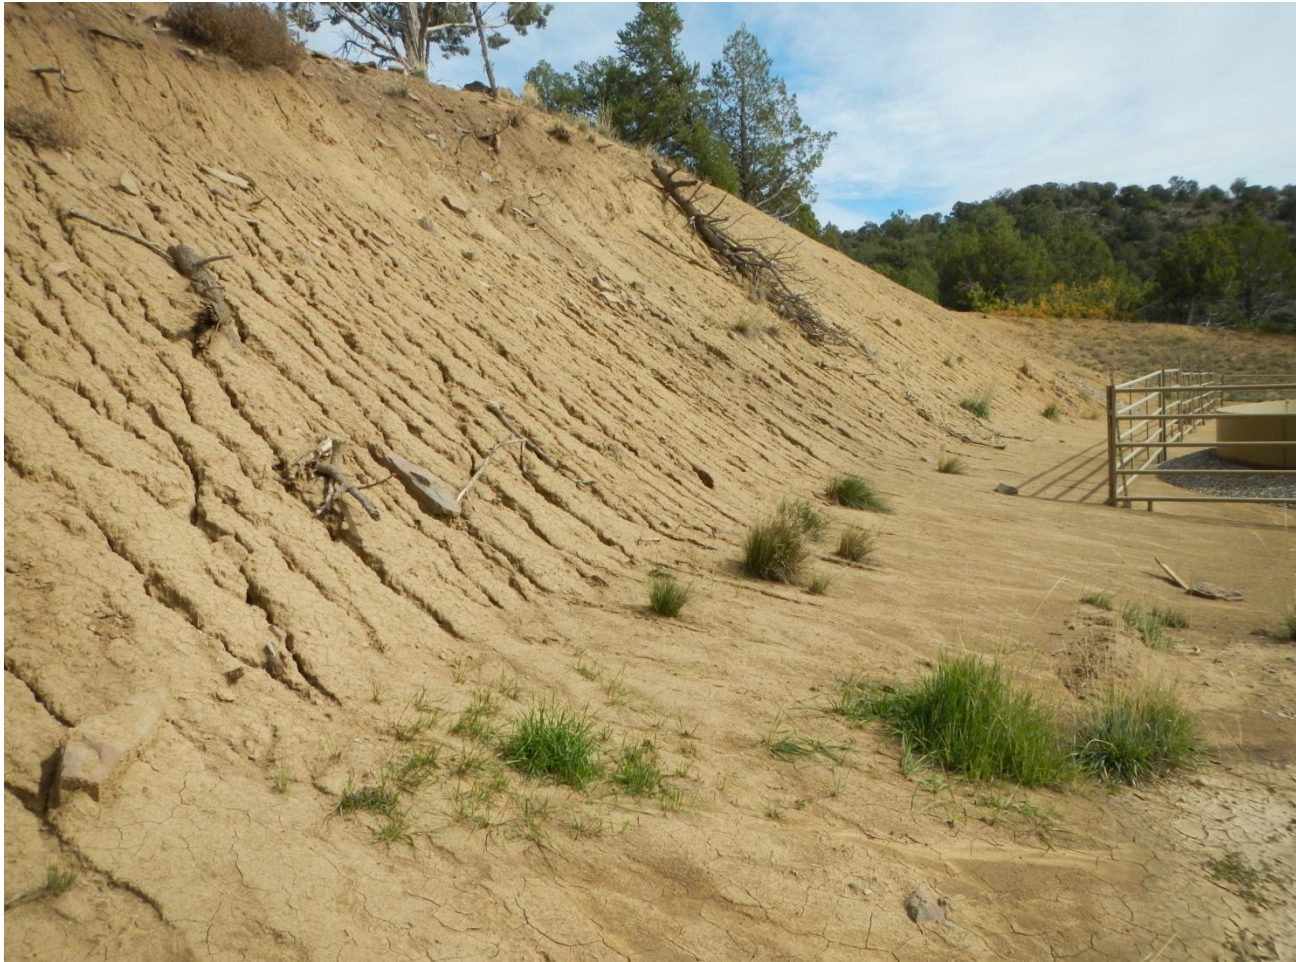
Photo 4. View of rill erosion and sediment run-on along the northern cut-slope for the well pad.
