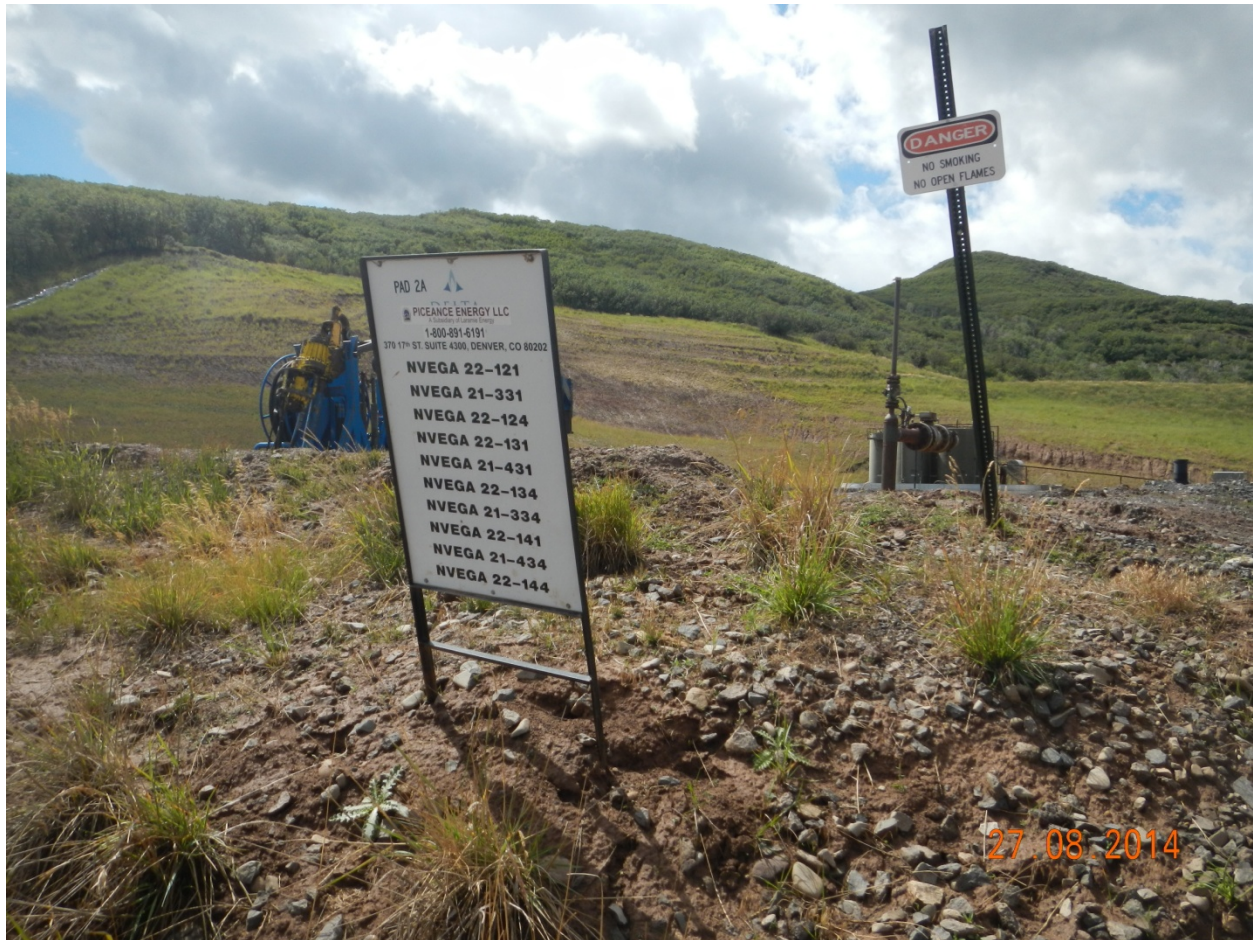
1.) Pad entrance sign.

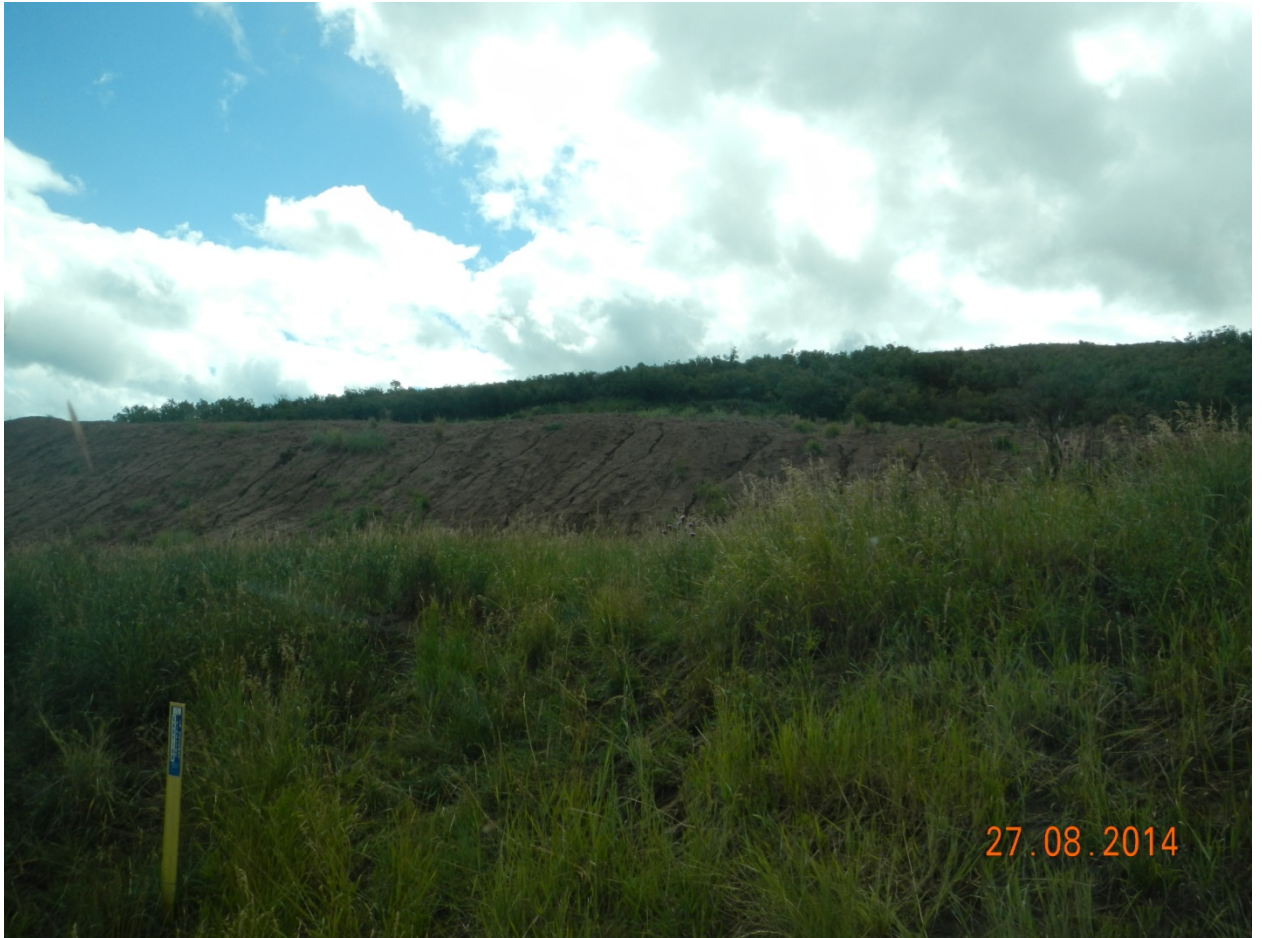
2.) Rilling on Fill below access sign, uphill from access road on South Side.

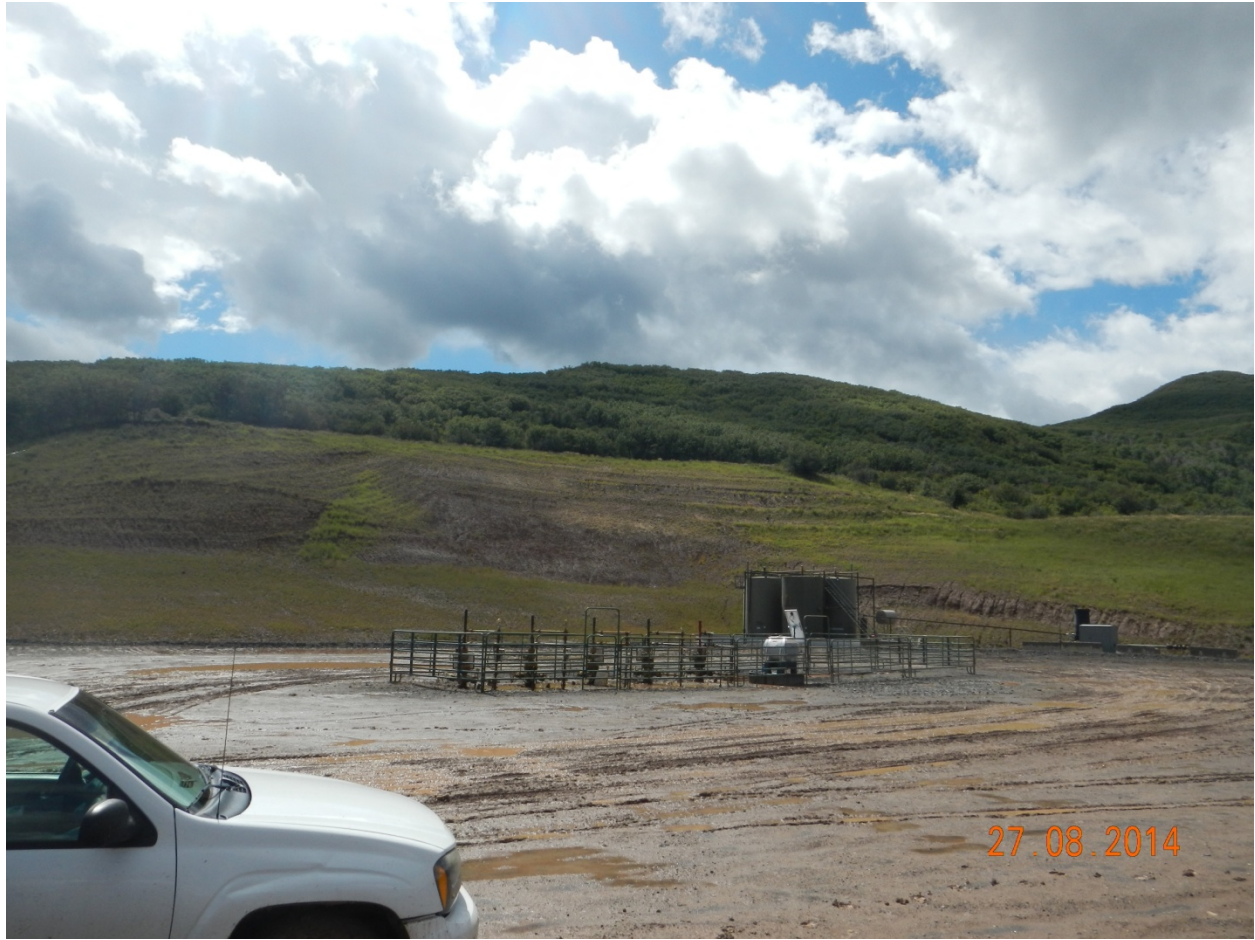
3.) View from North pad corner of Southern cut (vegetation at approximately 20%).

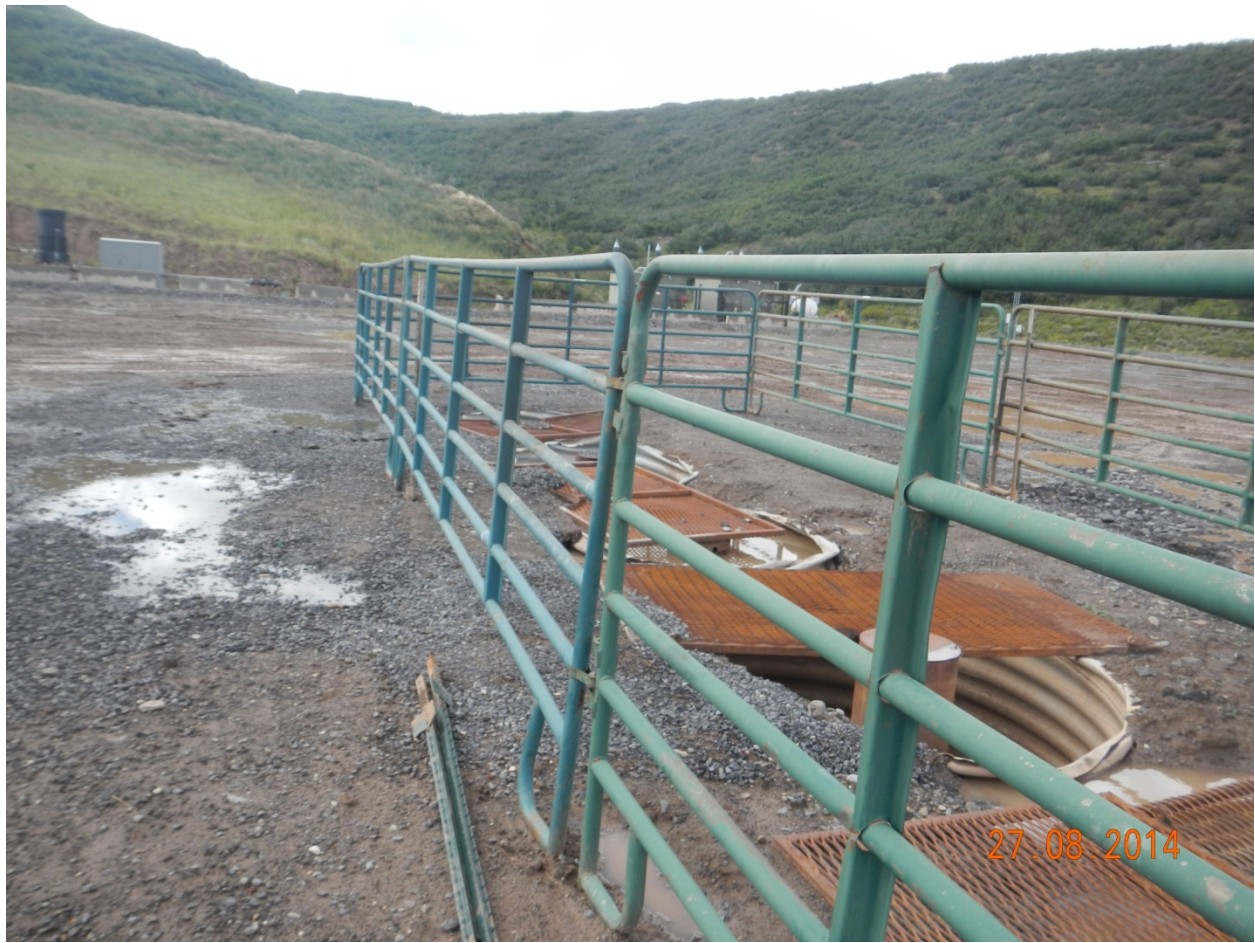
4.) 5 cellar holes/ conductors fenced.

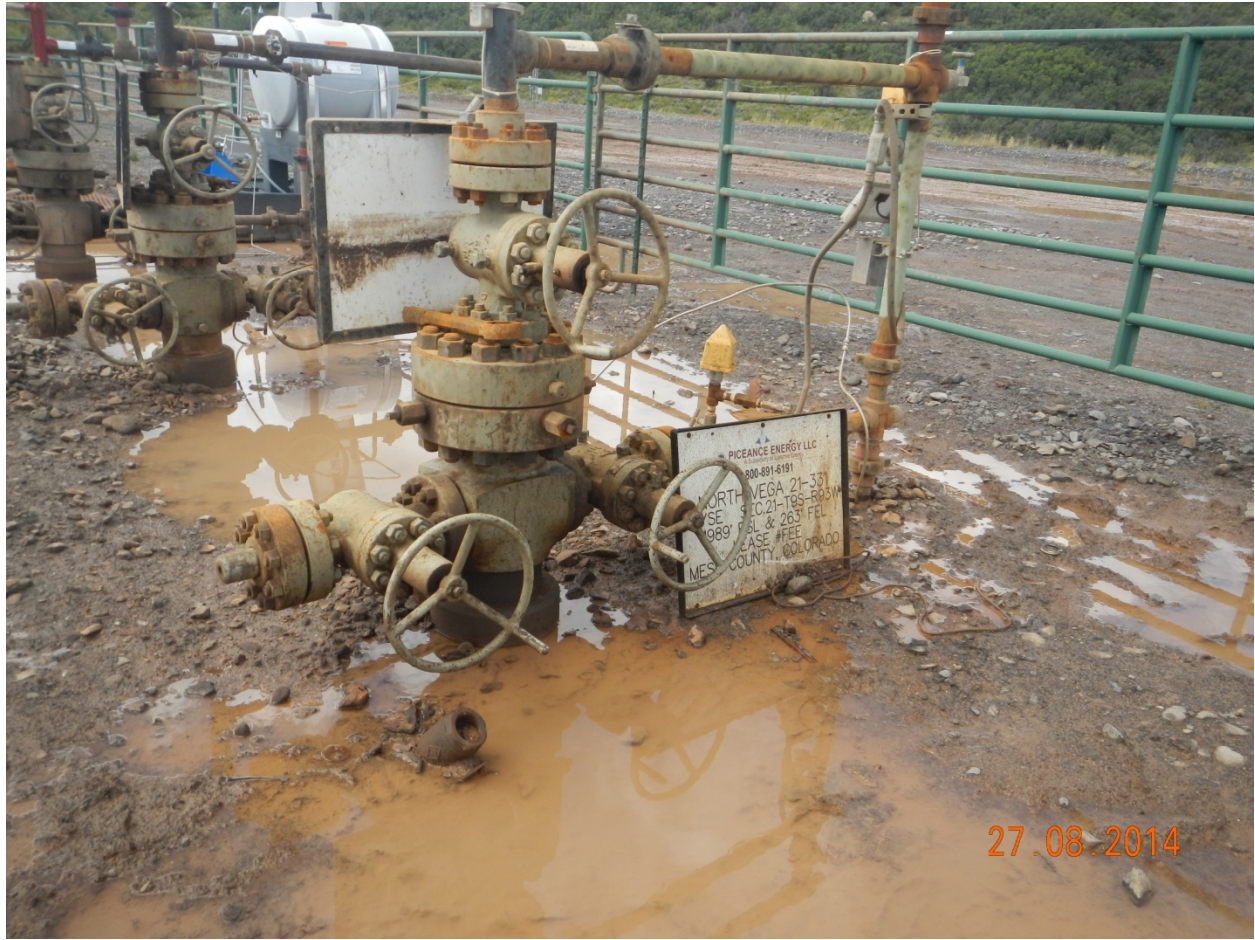
5.) Wellhead sign down and laid against adjacent head.

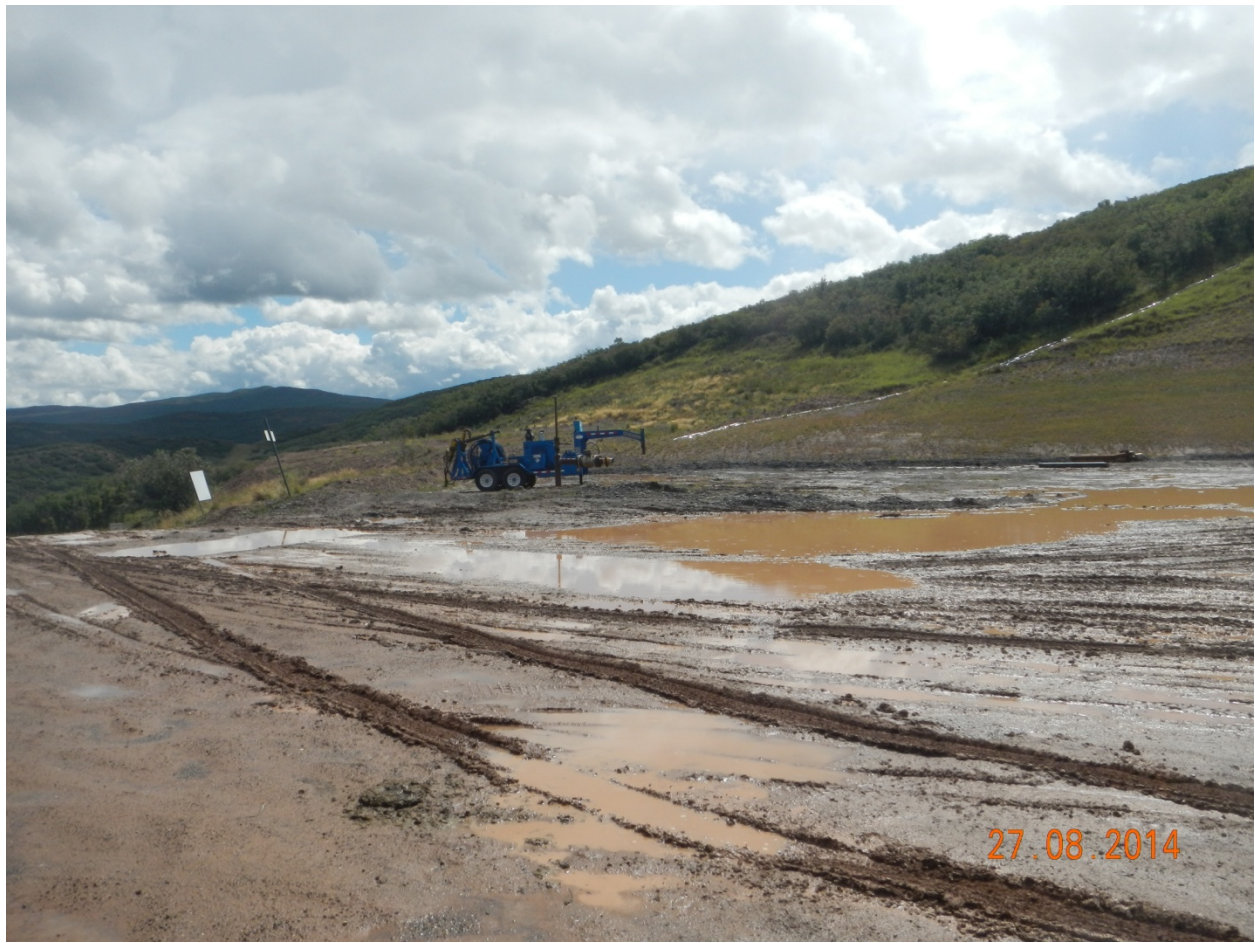
6.) Unused equipment (1) by pad entrance.

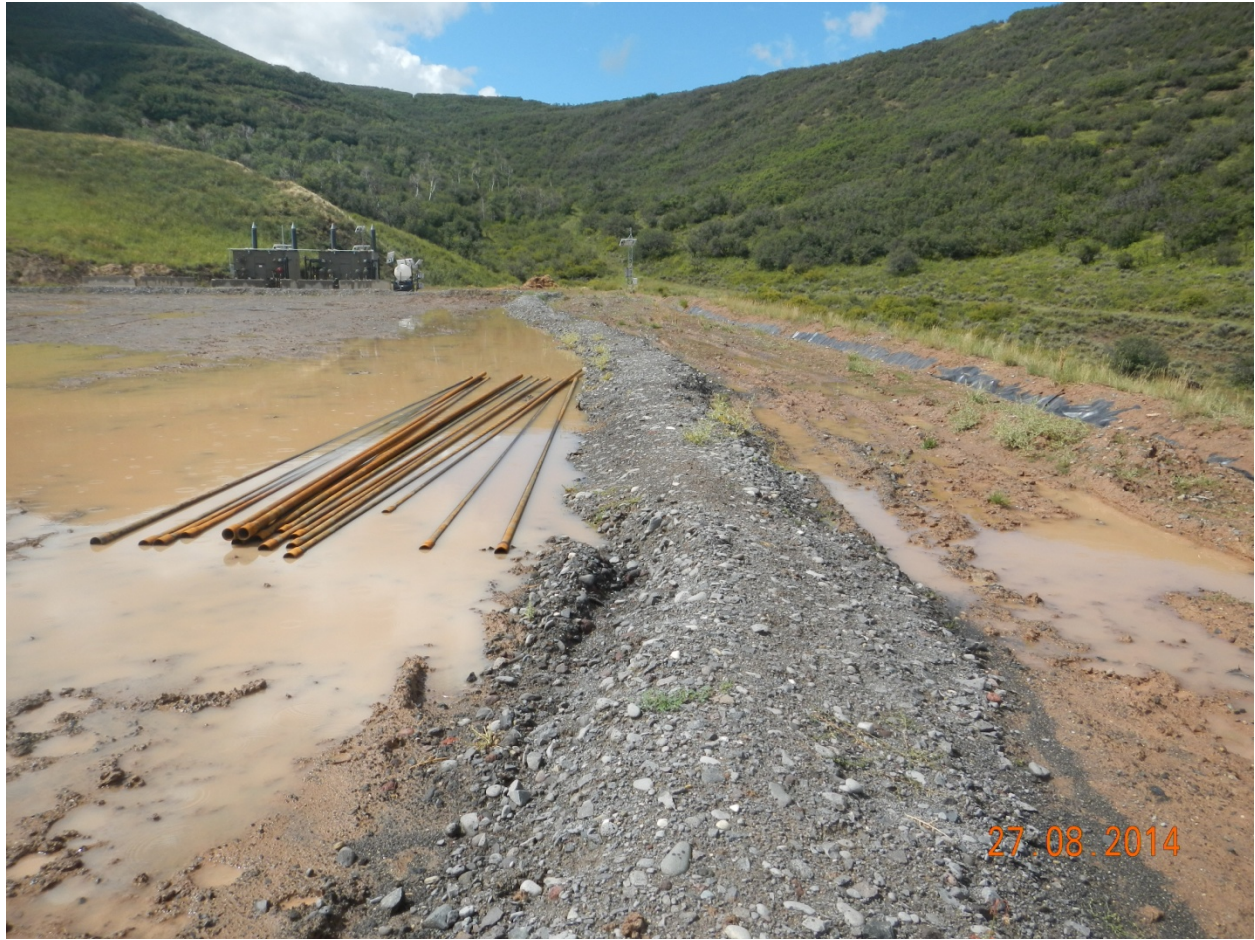
7.) Unused equipment (2) on North perimeter.

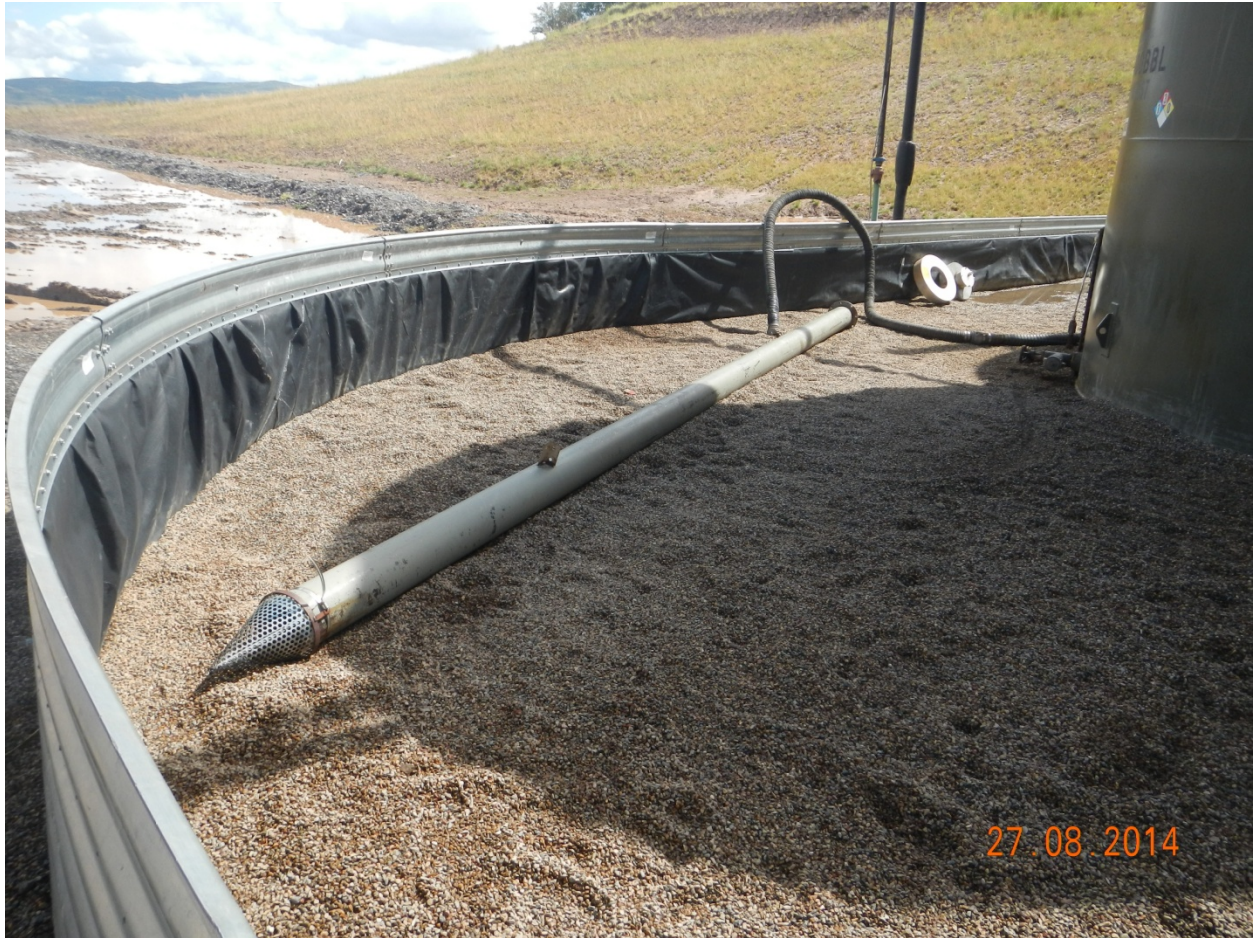
8.) Unused equipment (3) at tanks.

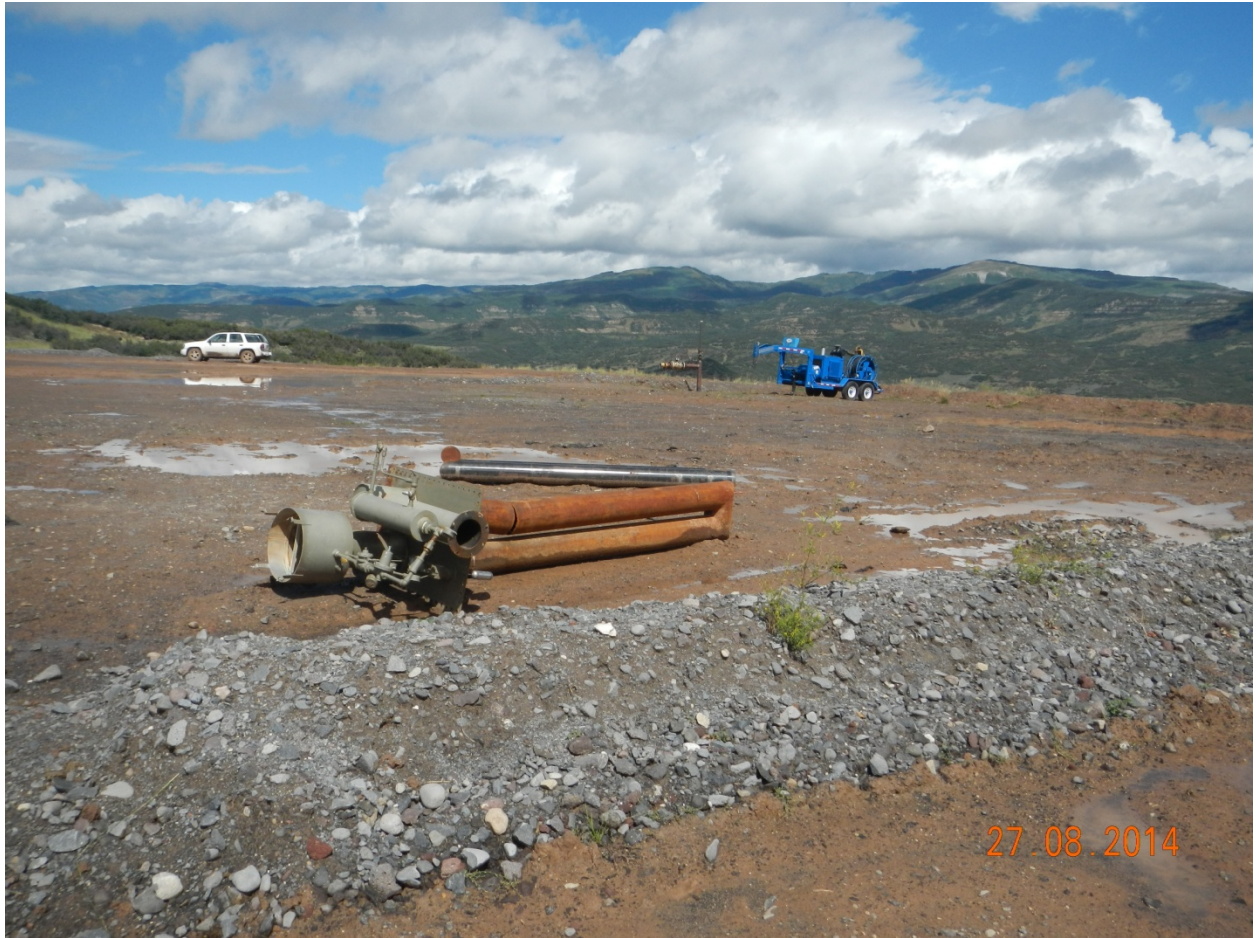
9.) Unused equipment (4) on Southeast perimeter.

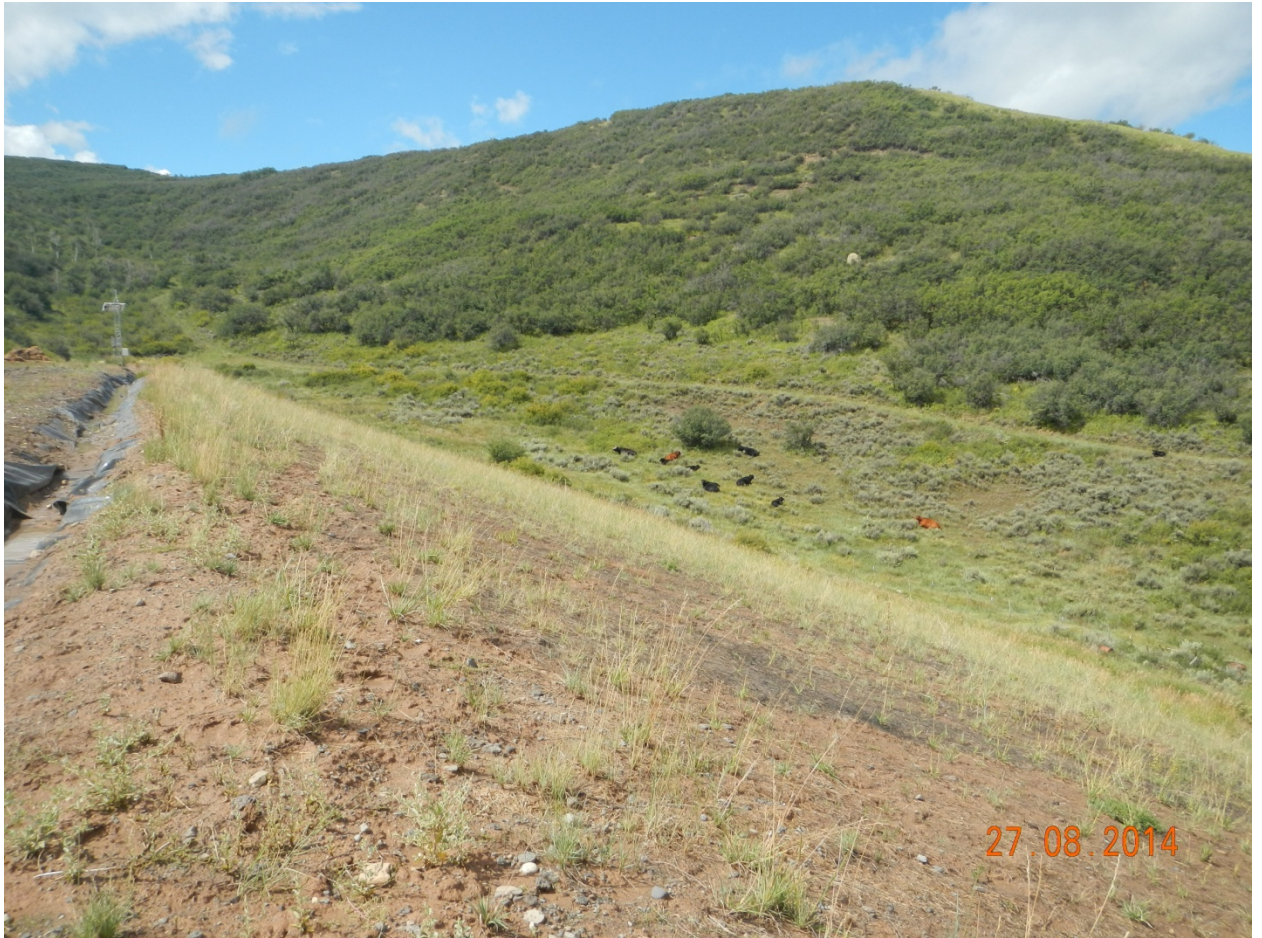
10.) West perimeter fill: re-vegetation at approximately 20%.

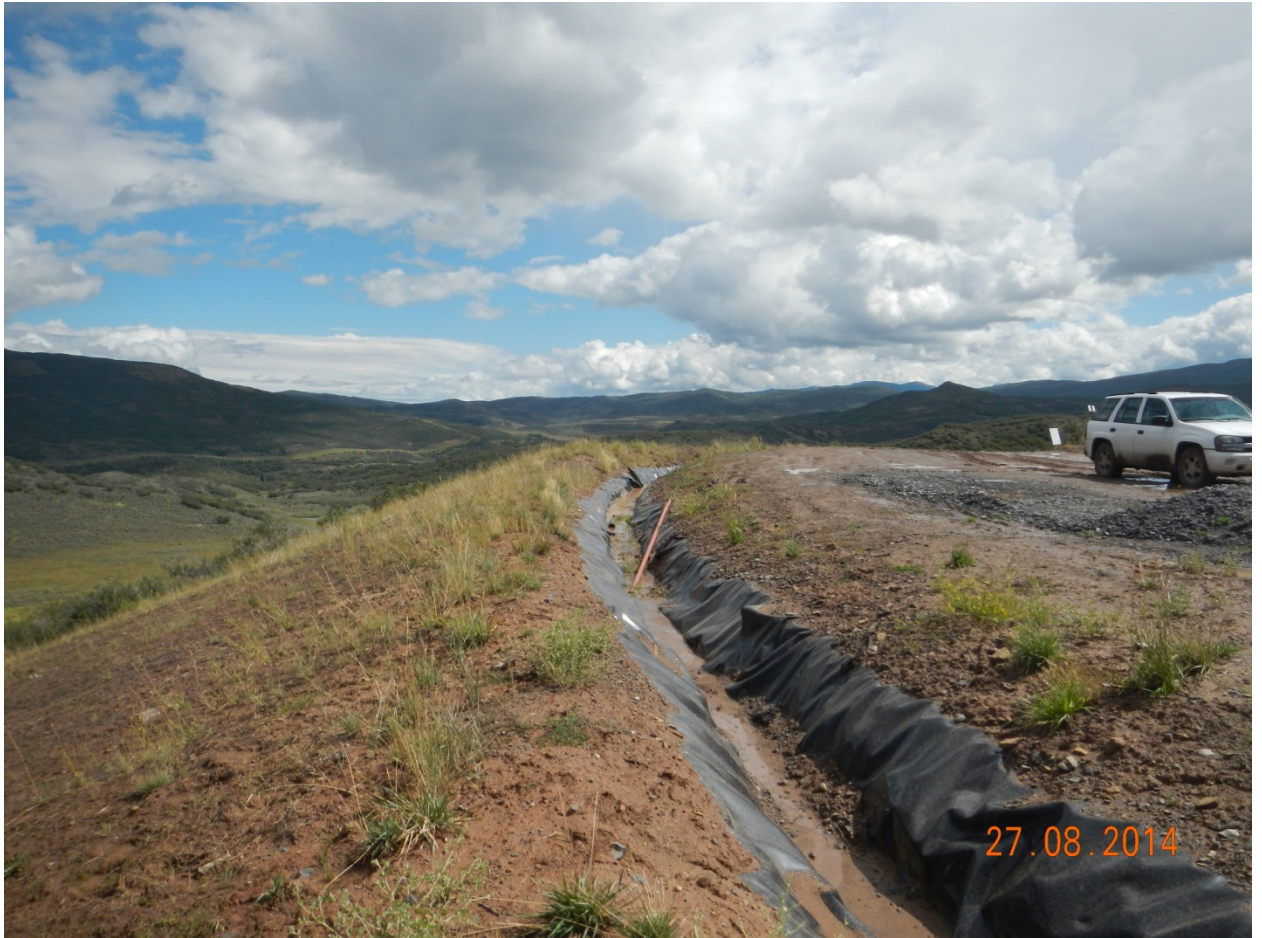
11.) West sediment BMPs acceptable.

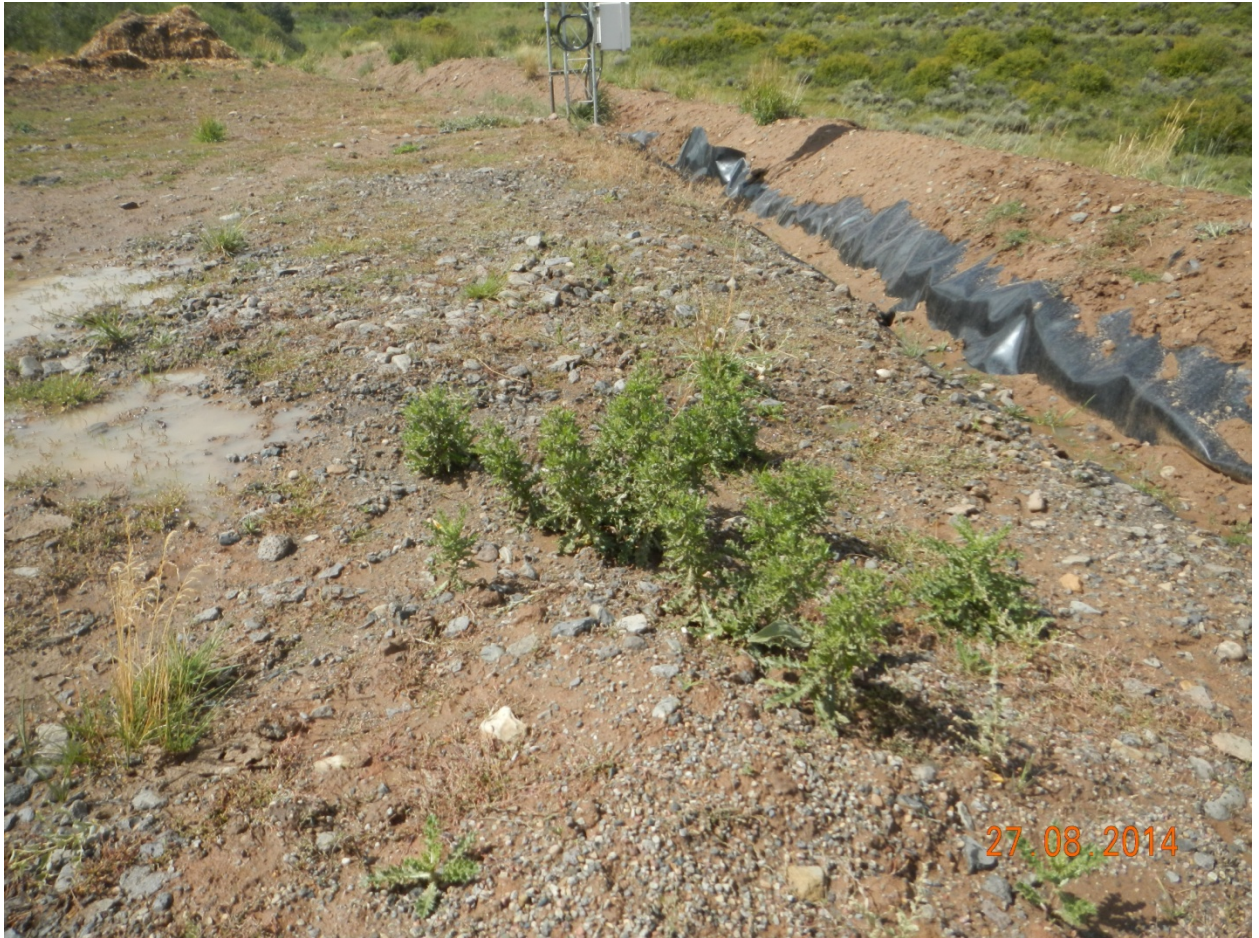
12.) Southwest corner sediment BMP will need velocity reduction/ sediment detention in near future (1).

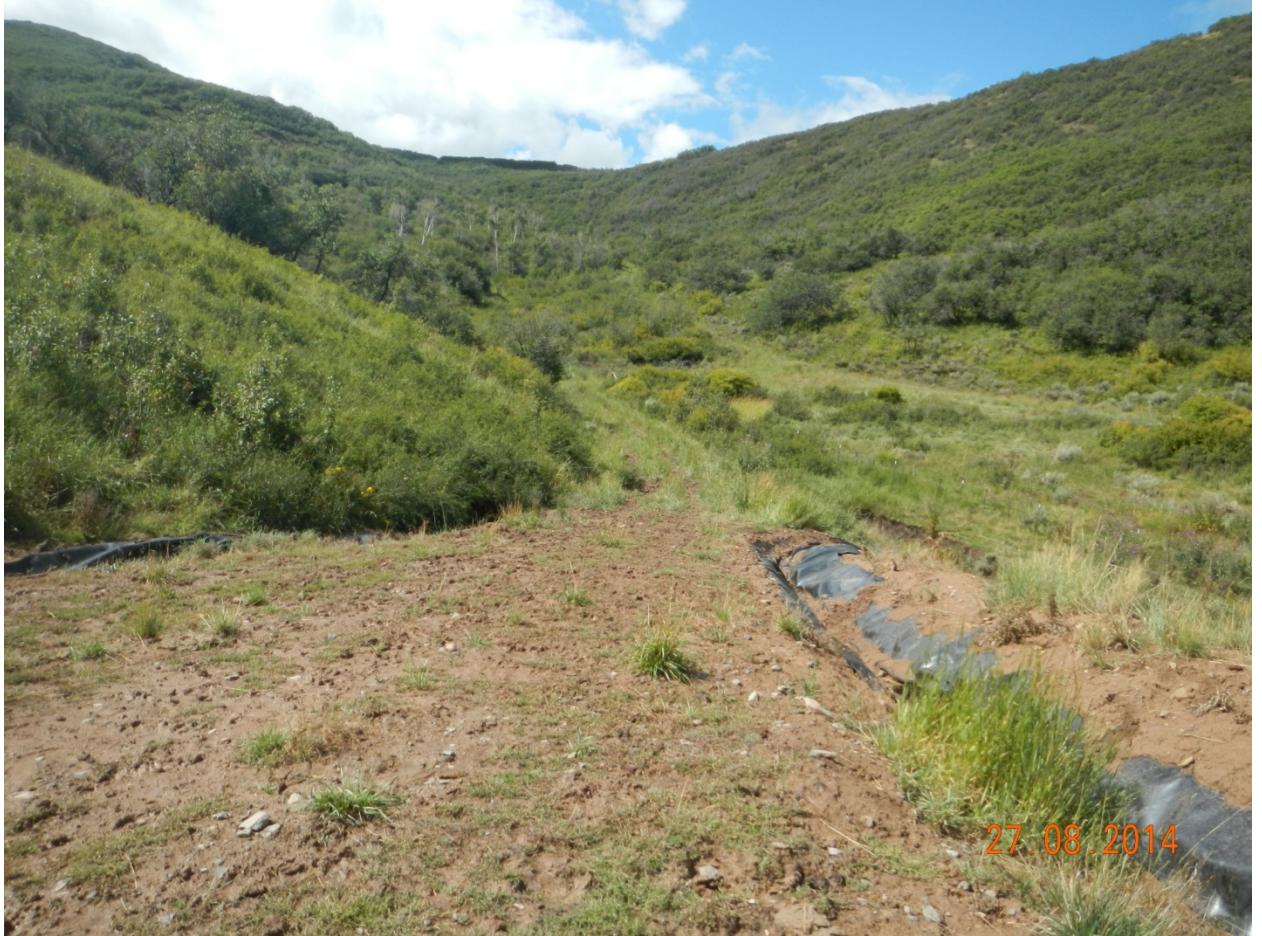
13.) Access road to cattle/ grazing on Southwest corner.

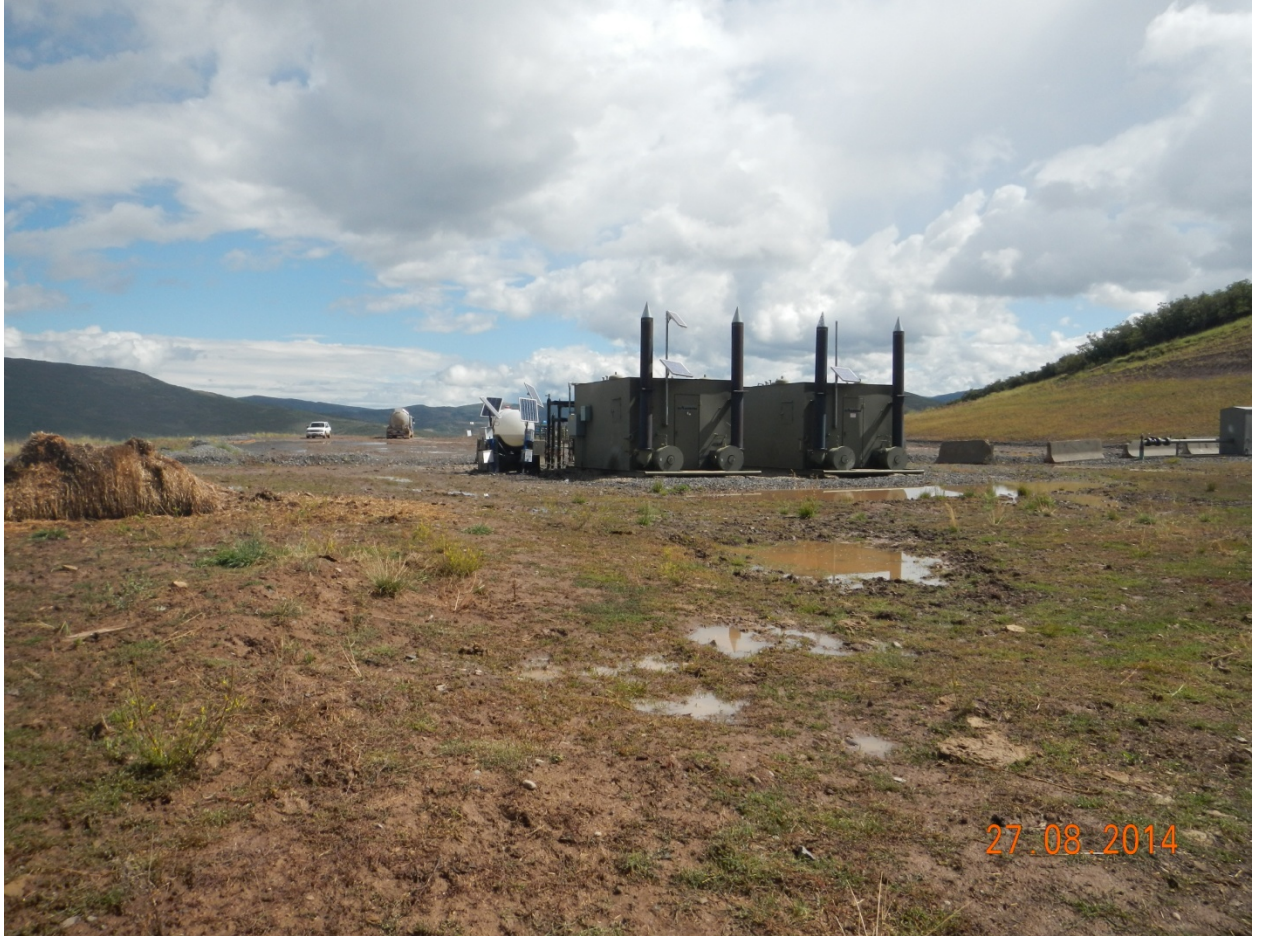
14.) Unused area on Southwest corner not reclaimed.

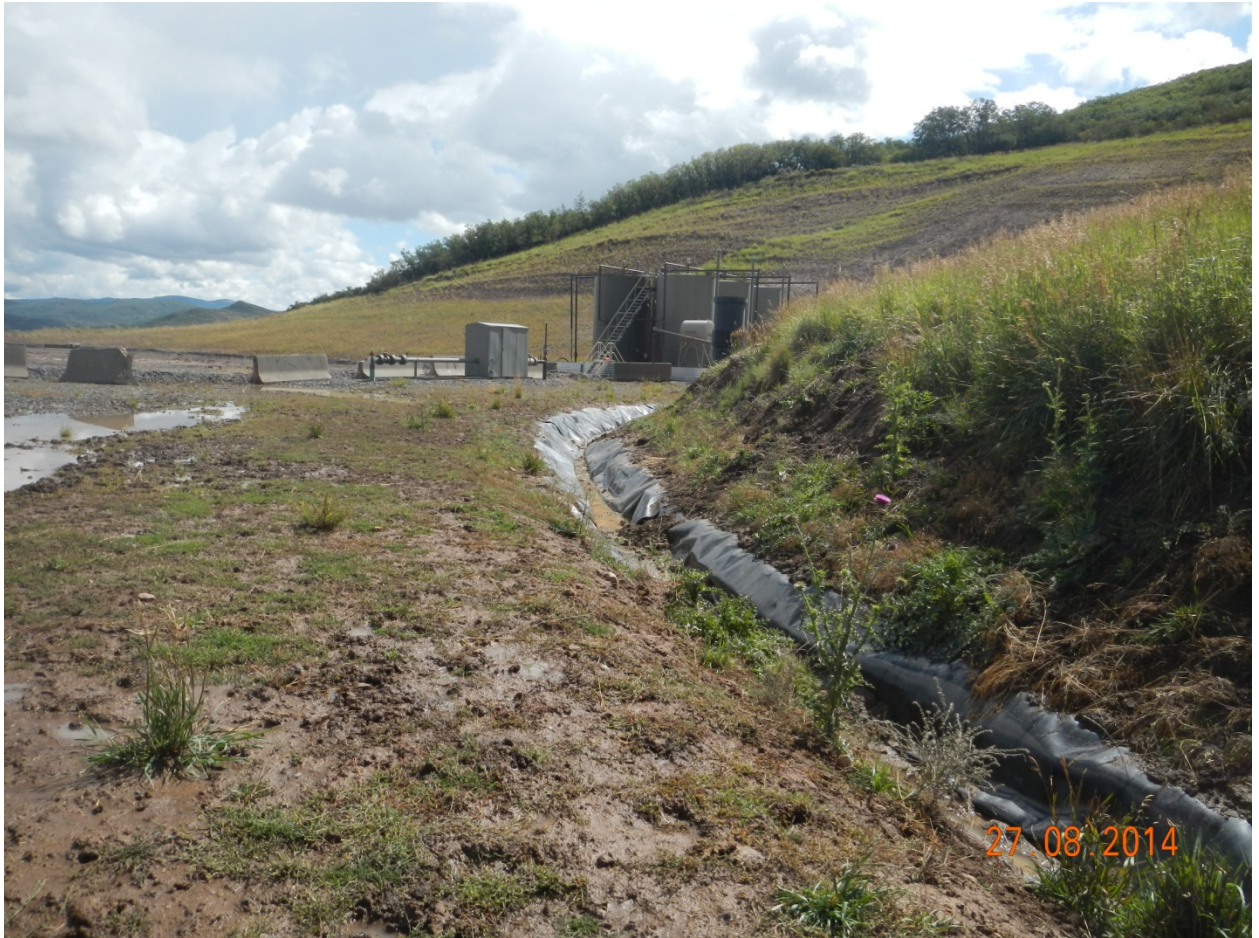
15.) Southwest corner (East side) sediment BMP will need velocity reduction/ sediment detention in near future (2).

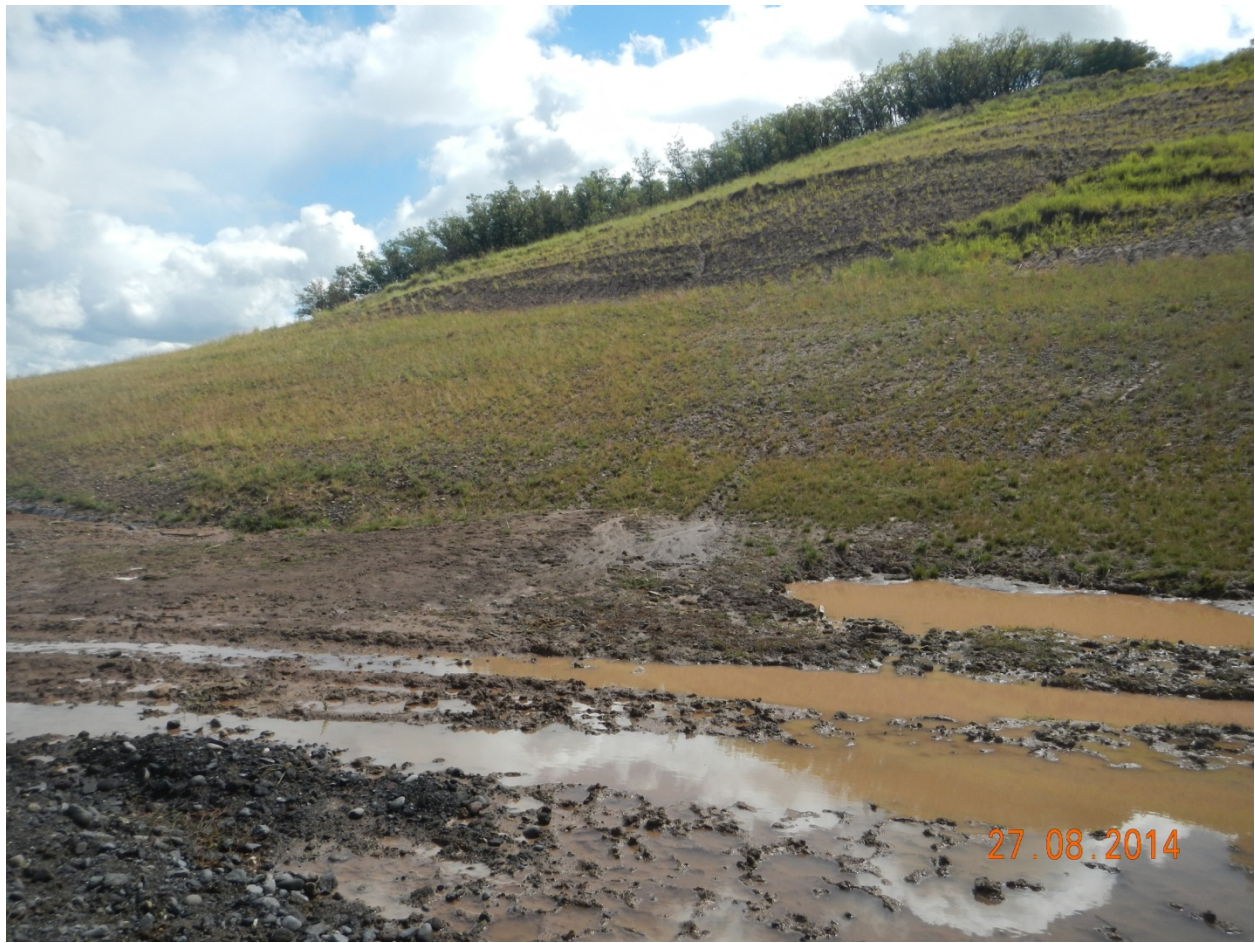
16.) East perimeter BMP needs maintenance.

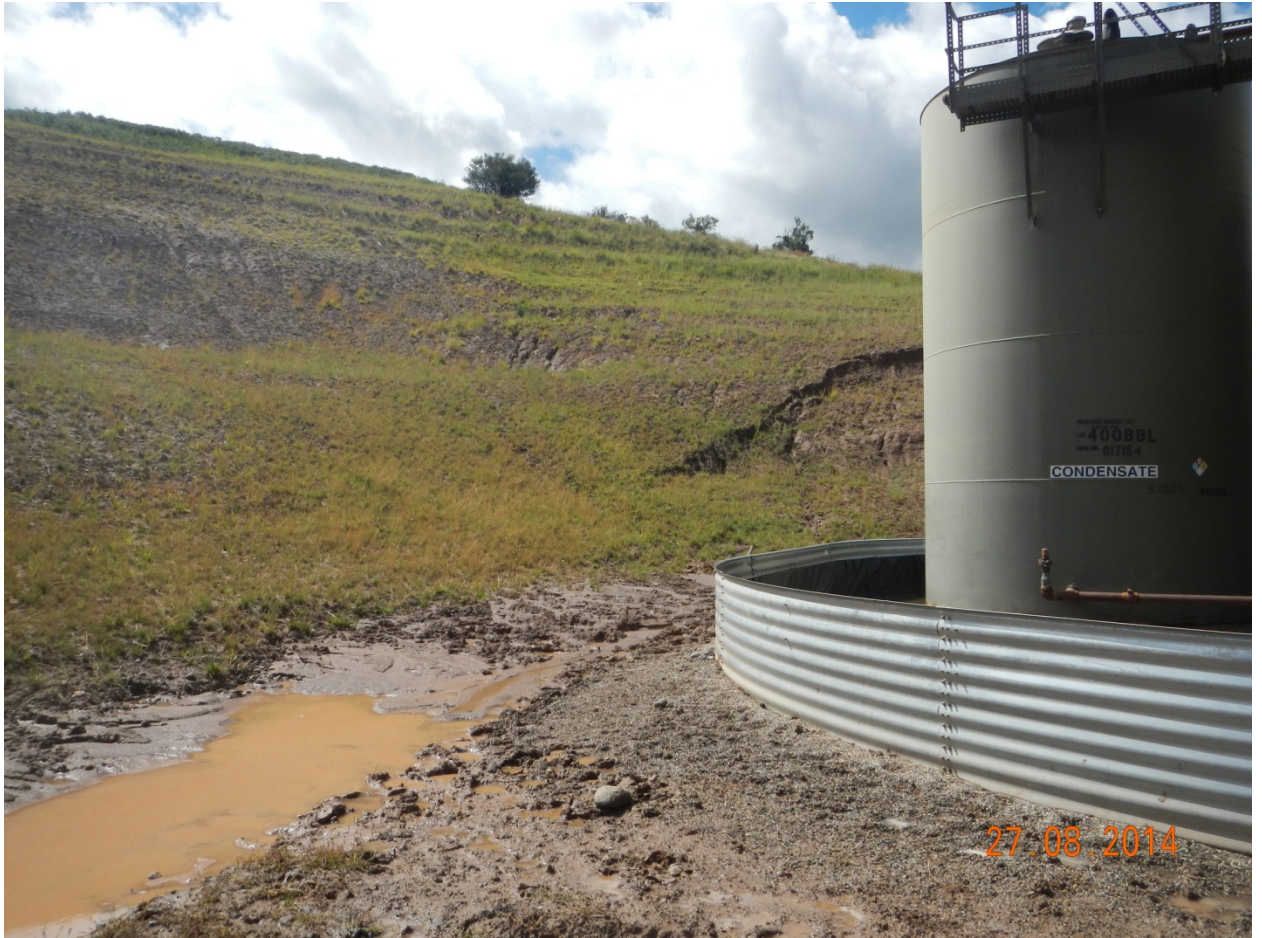
17.) Eastern perimeter cut sloughing, rilling and sediment.

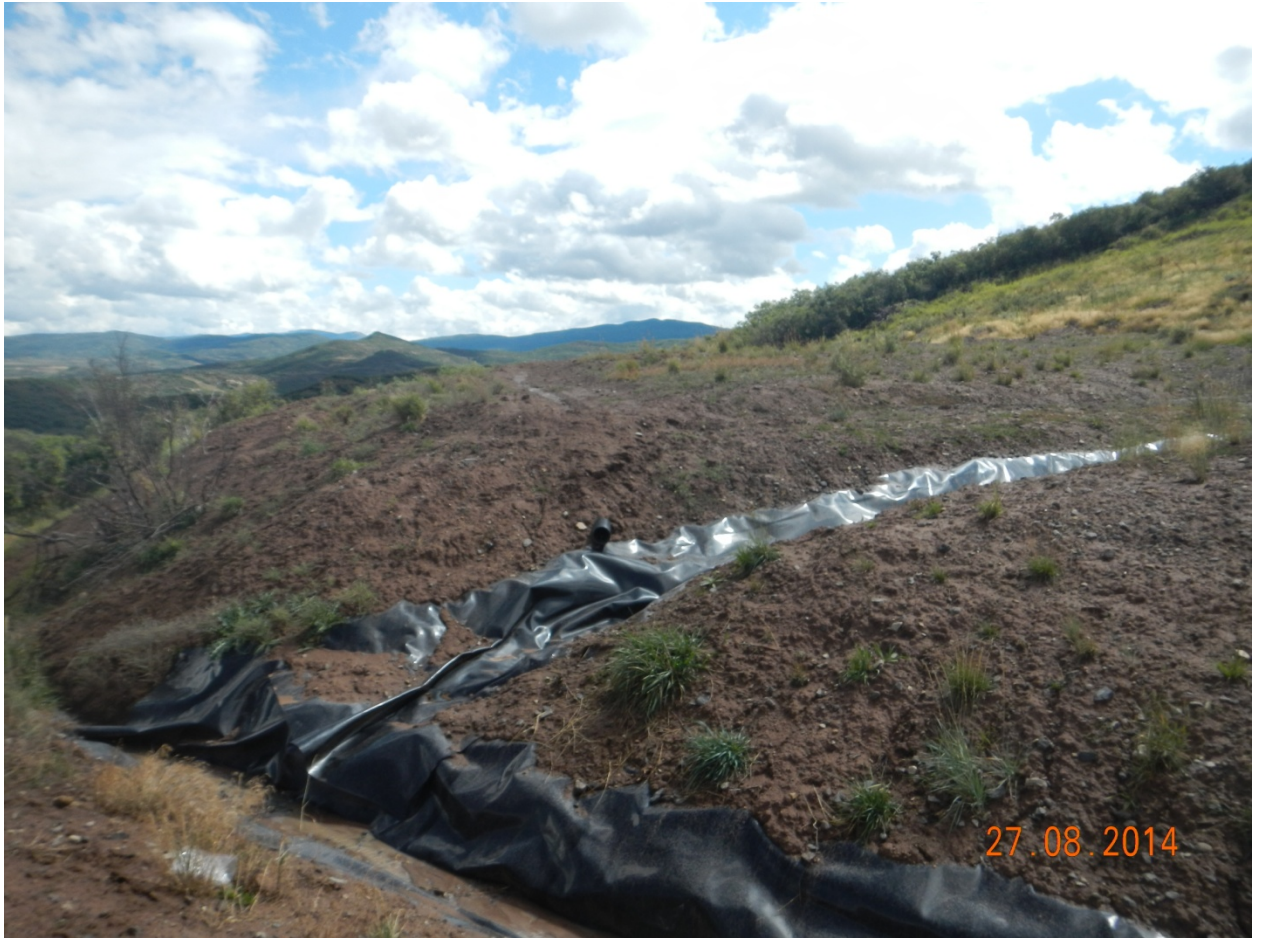
18.) Northeastern BMP needs velocity reduction/ sediment detention.

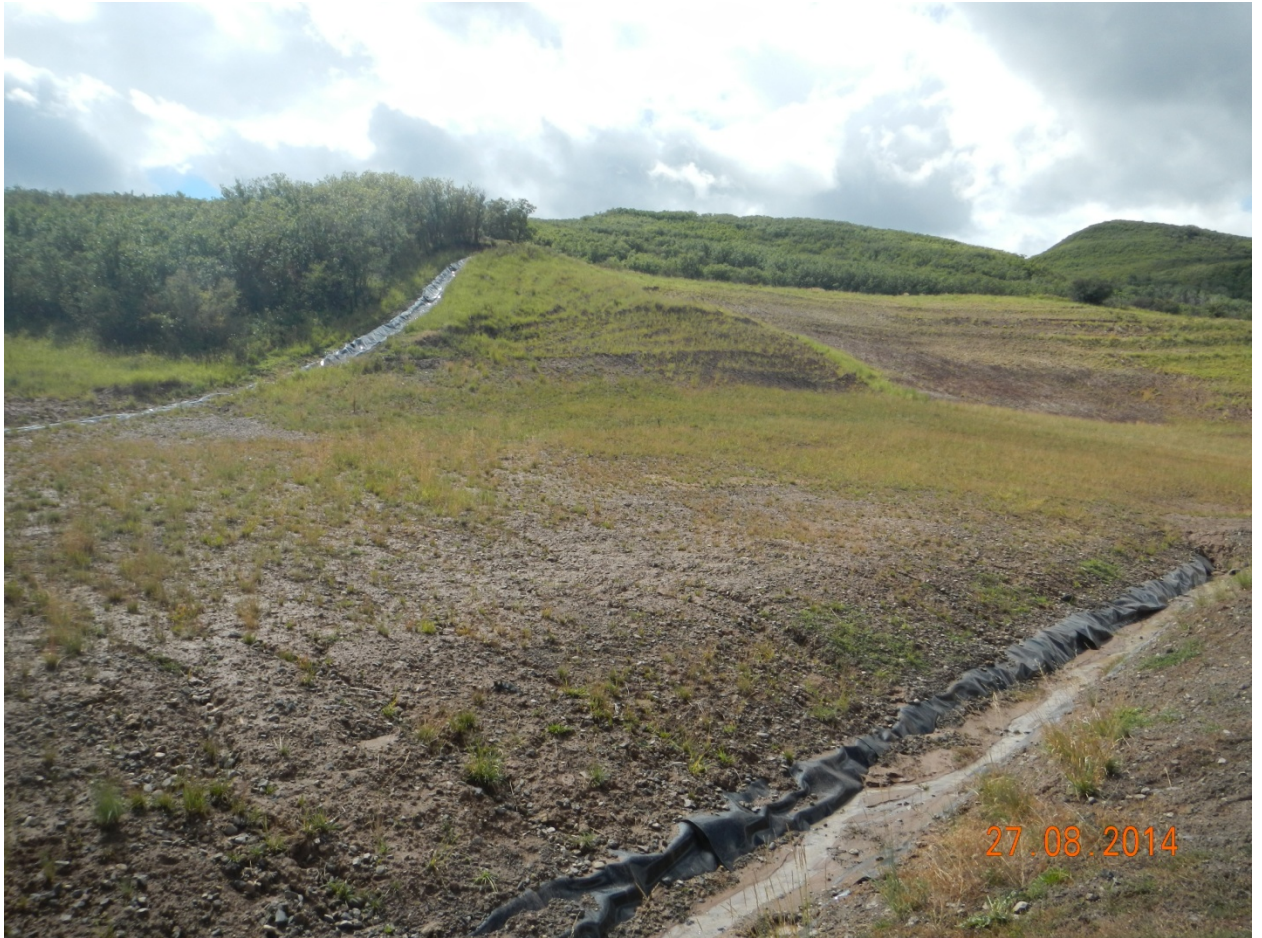
19.) Pad from Northern disturbed appendage looking Southwest. Stormwater BMPs need velocity reduction/ sediment detention.
