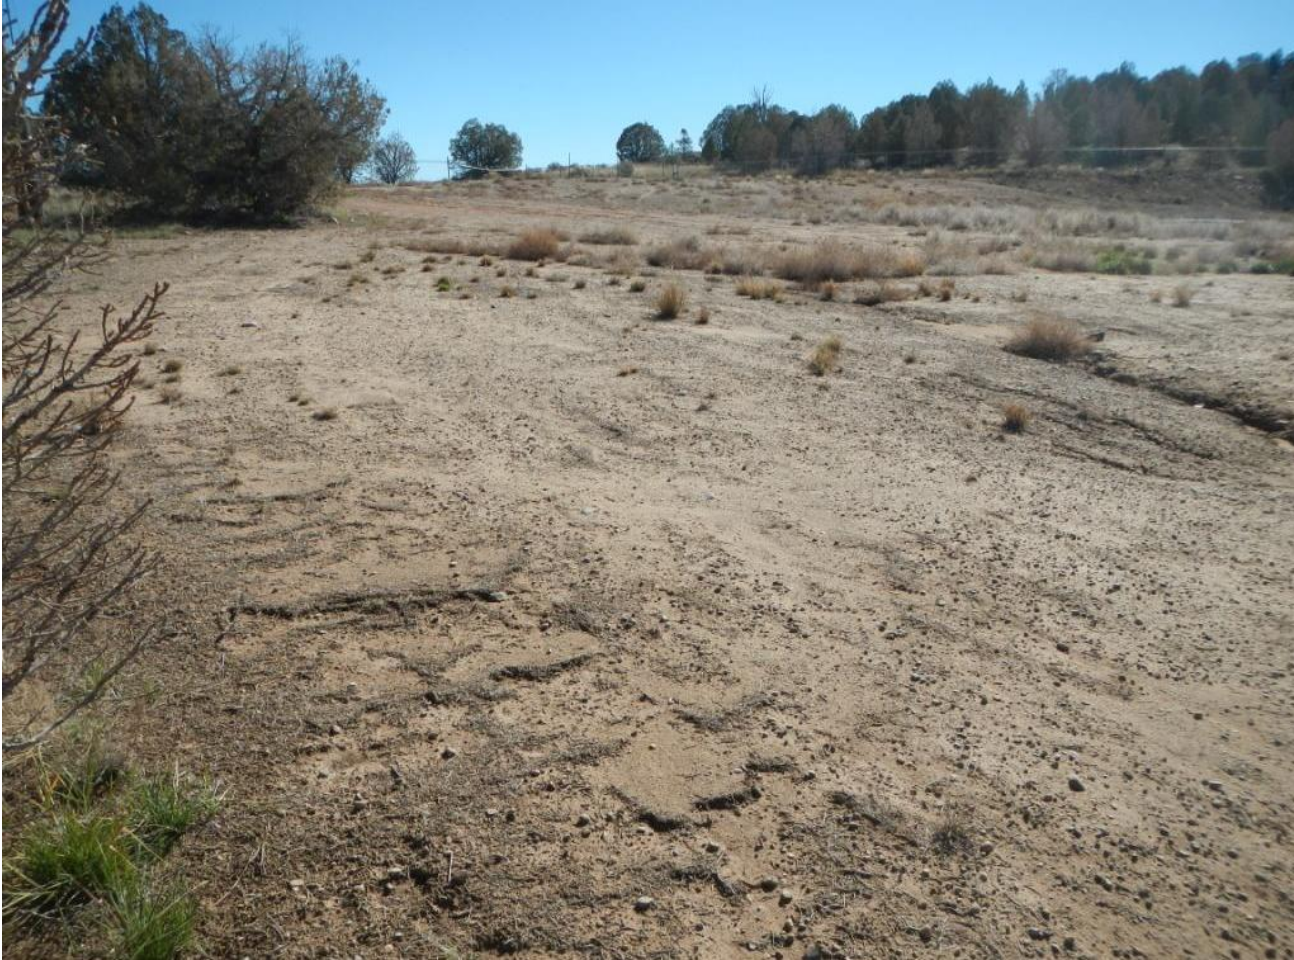
Photo 1. View from western edge of project area facing eastward over northern portion of project area that needs to be revegetated.

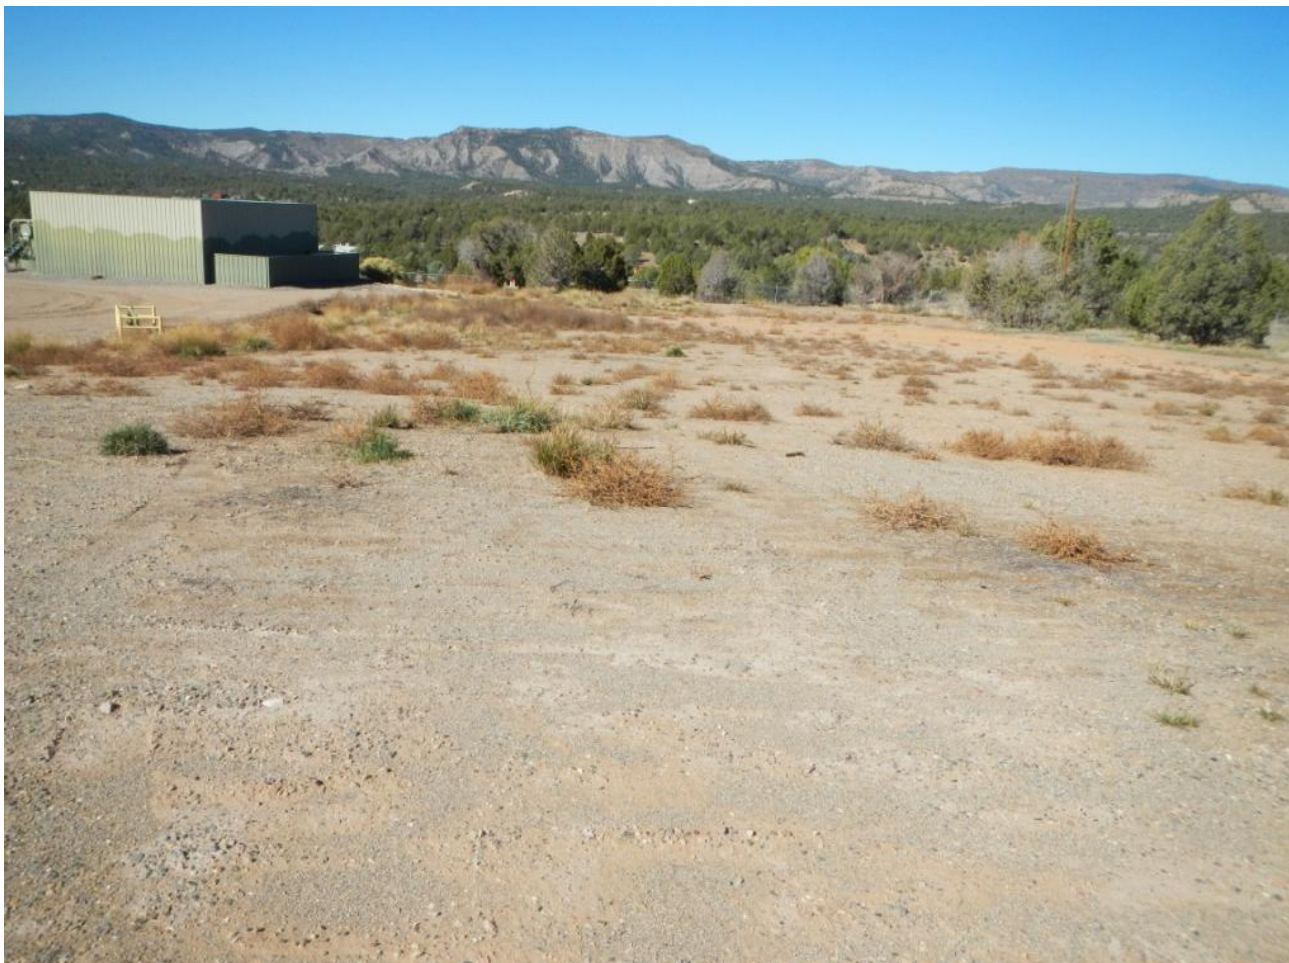
Photo 2. View from eastern edge of project area facing westward over northern portion of project area that needs to be revegetated.

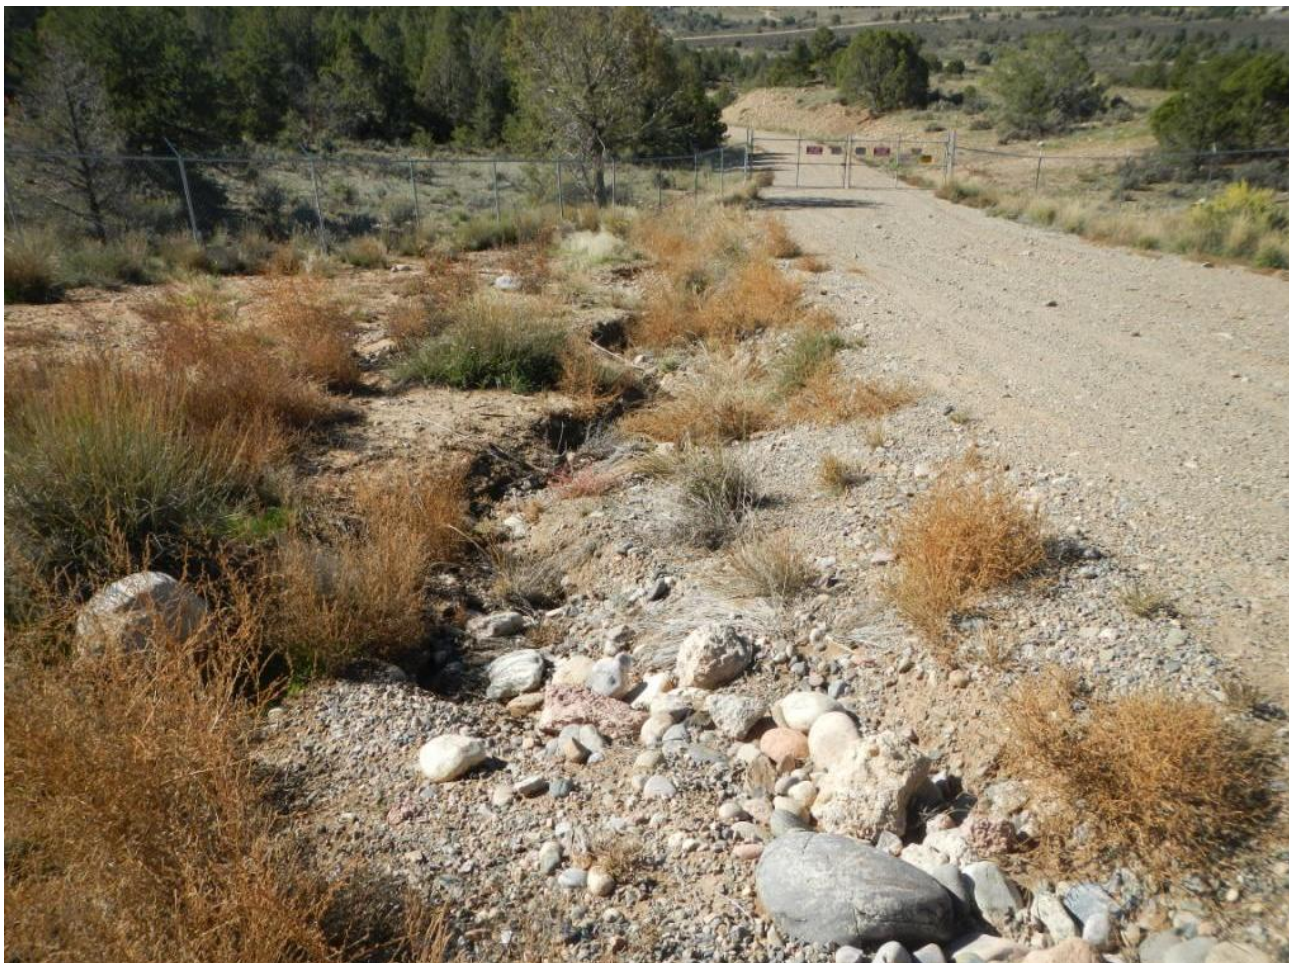
Photo 3. Erosional channel forming along the eastern side of the access road.

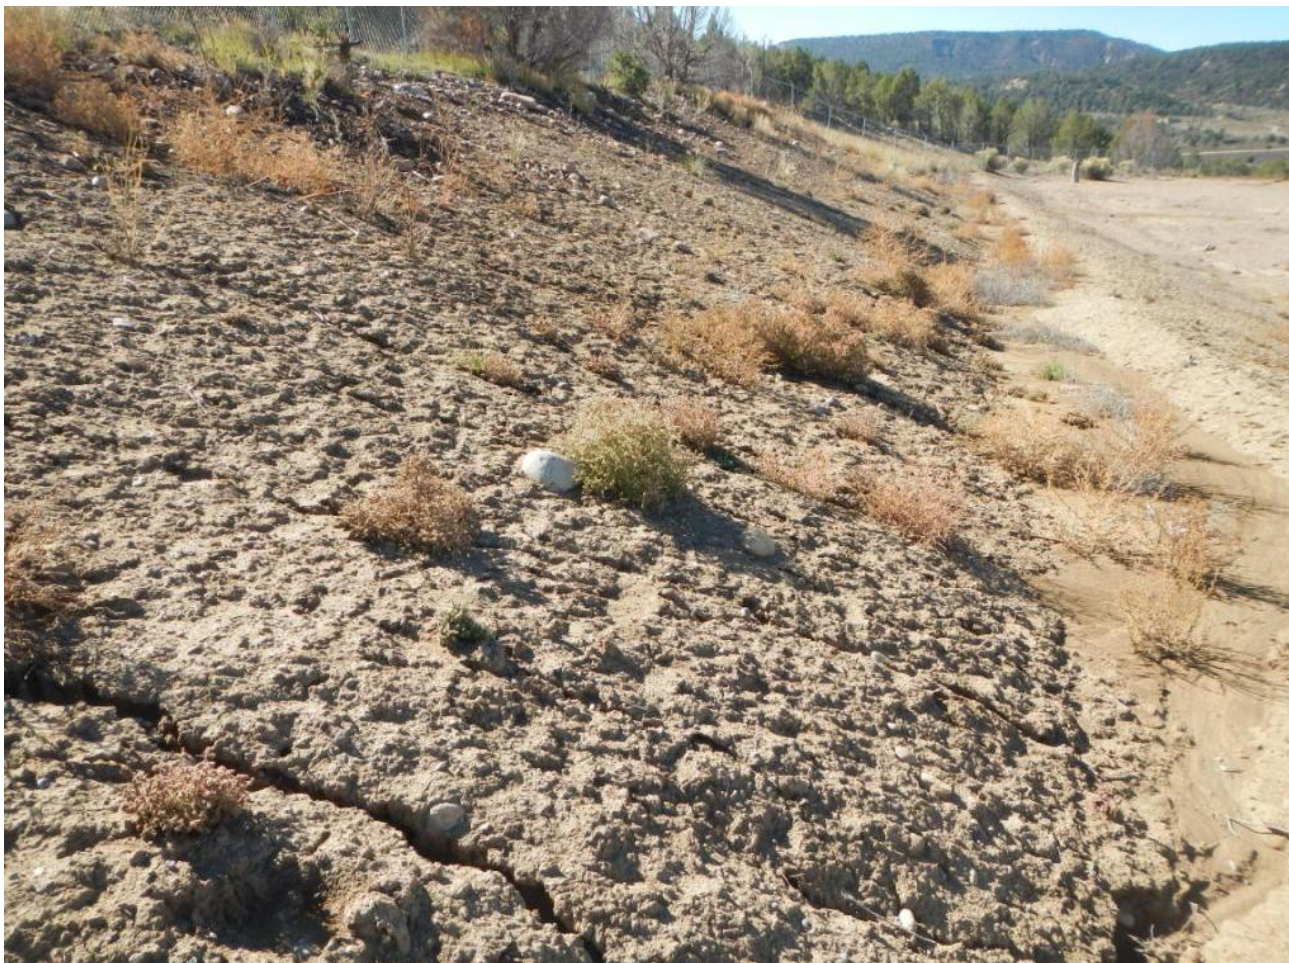
Photo 4. View of poor revegetation and rill erosion on slopes within the eastern portion of the project area.

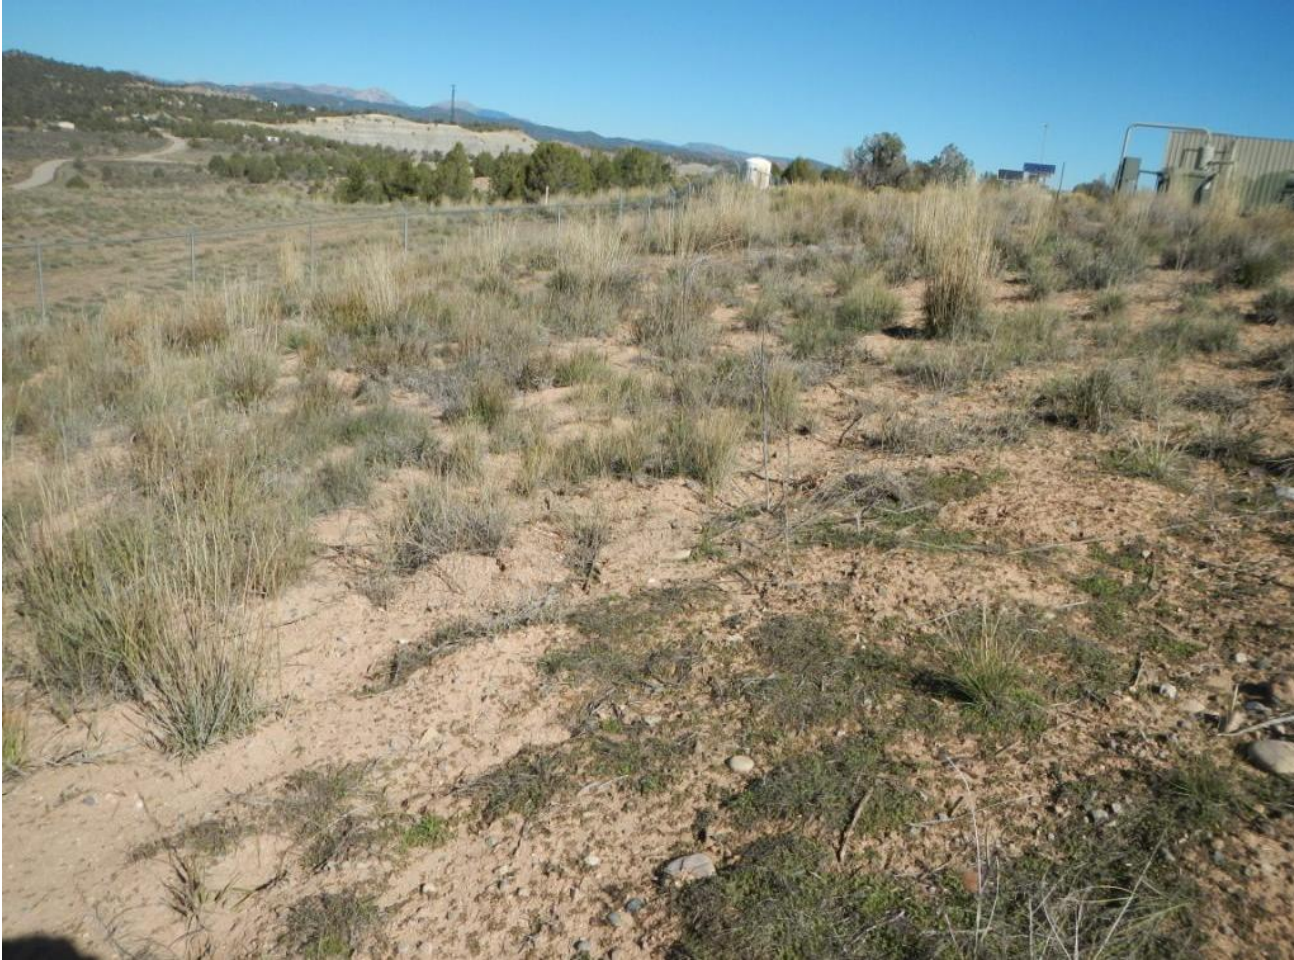
Photo 5. View of grasses becoming established within the western portion of the project area.
