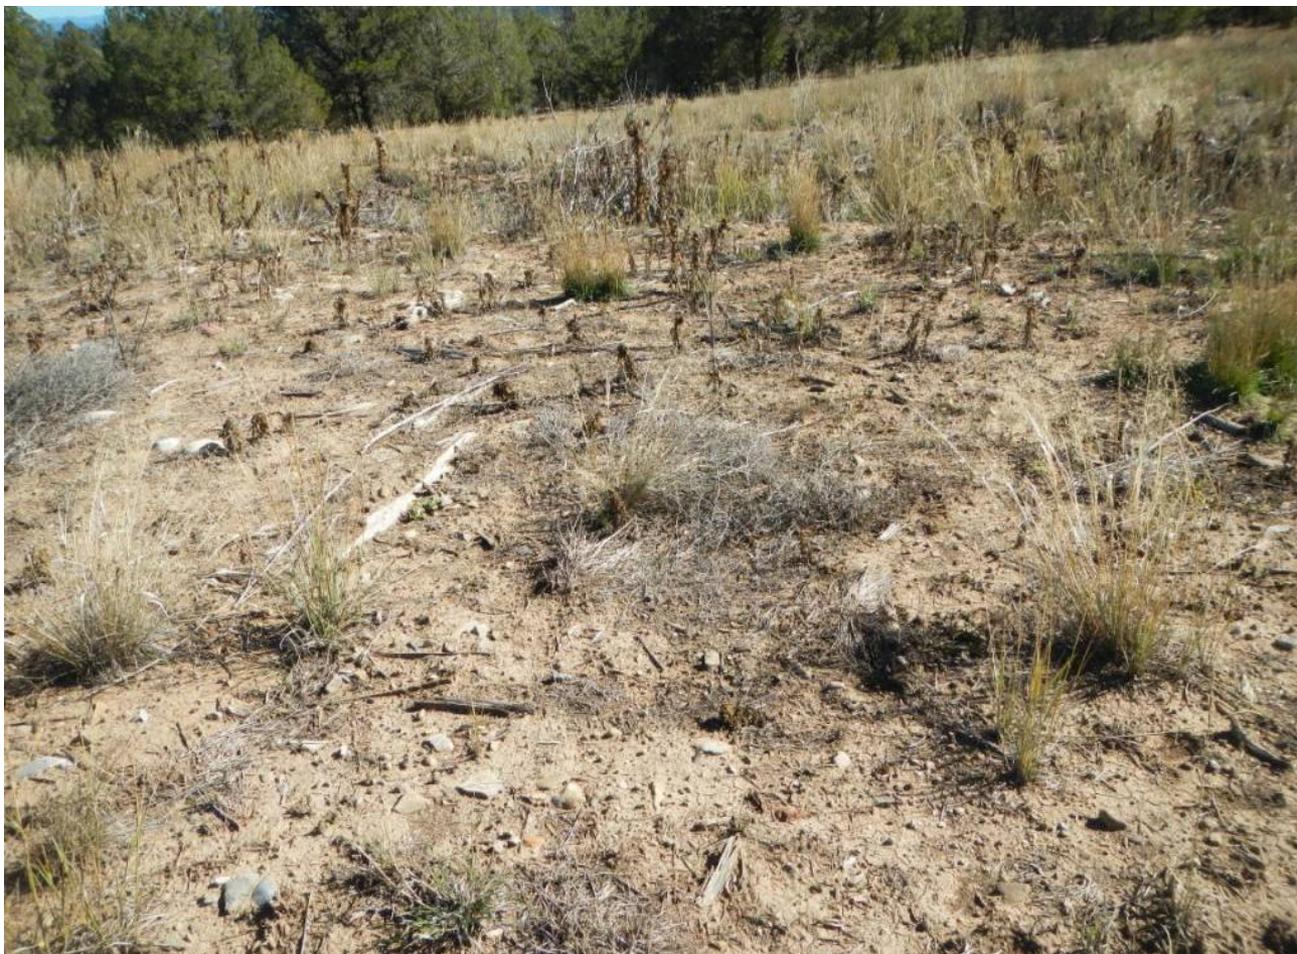
Photo 1. View of dead musk thistle and revegetation within the interim reclamation area.

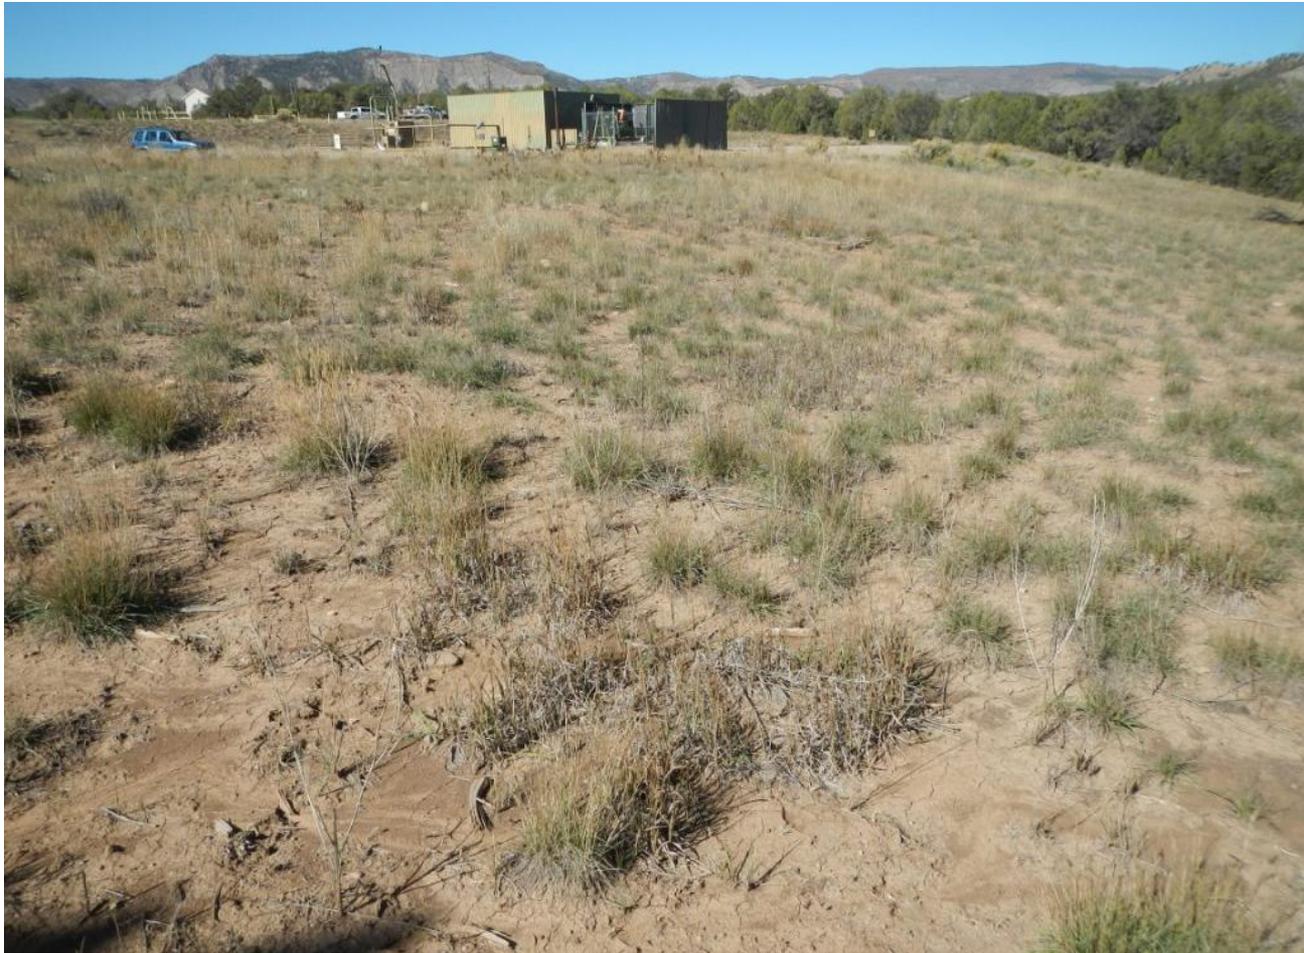
Photo 2. View of revegetation within the eastern portion of the interim reclamation area from southeastern corner facing northward.

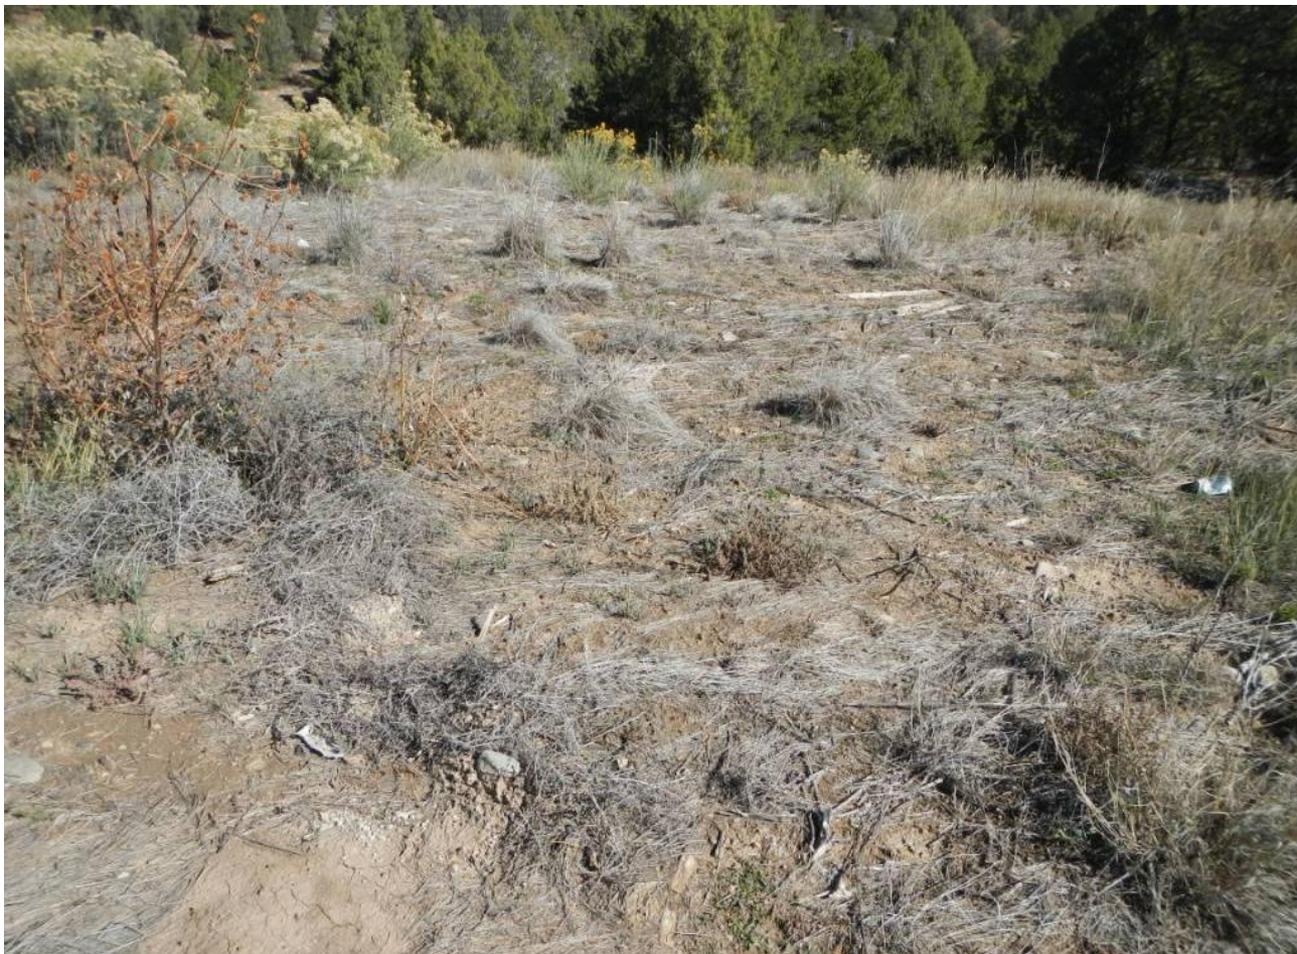
Photo 3. View of dead vegetation within the interim reclamation area on the downslope side of the working area of the well pad.

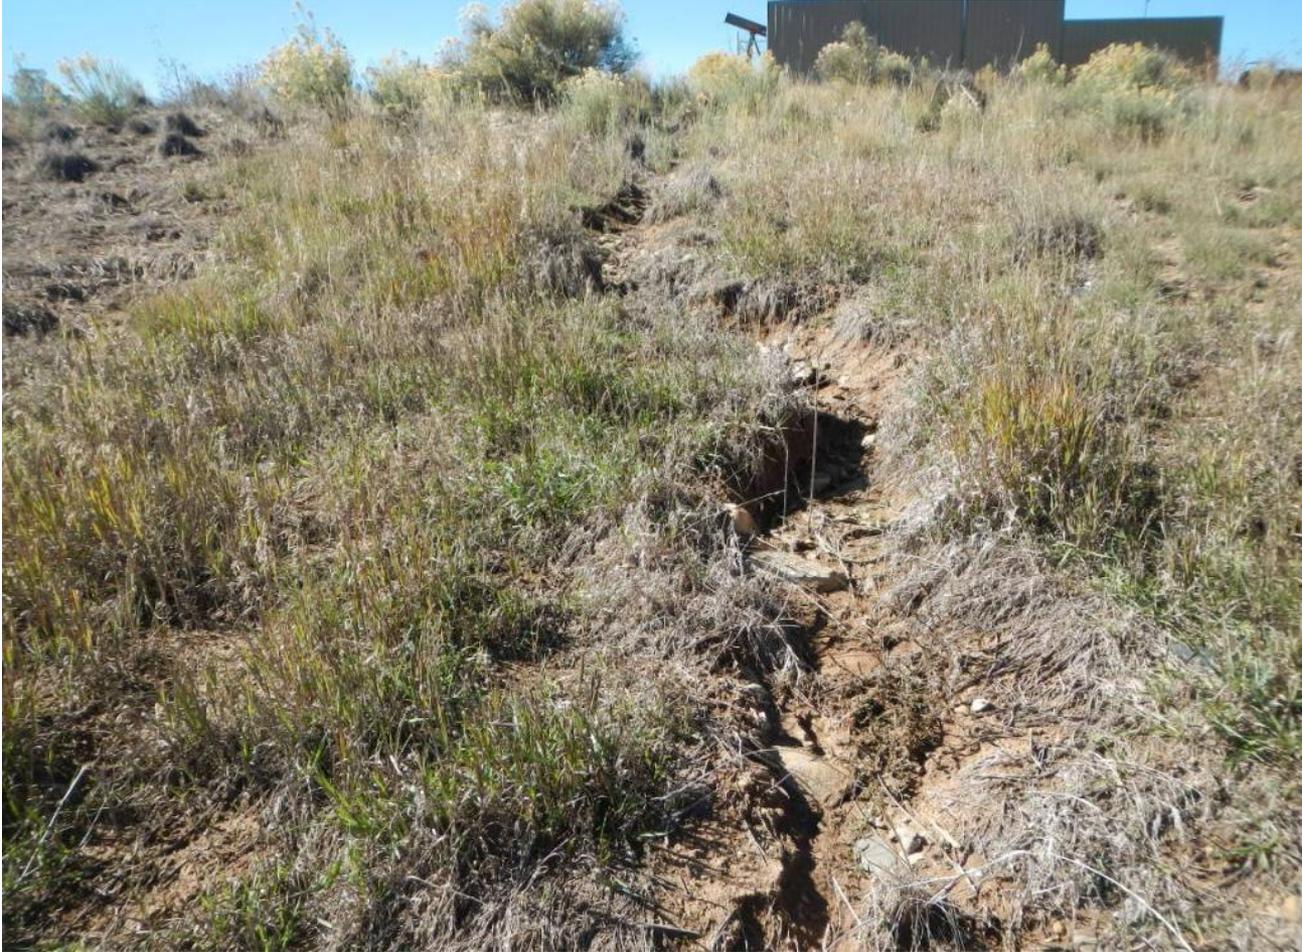
Photo 3. View of erosional channel forming within the eastern portion of the interim reclamation area that needs to be monitored.
