LEAK LOCATION SERVICES, INC.

September 29, 2014

Subject: Report for “Geomembrane Leak Location Survey of the Roan Creek Evaporation Pond at the Maralex Facility near DeBeque, Colorado;”
LLSI Proposal 2126

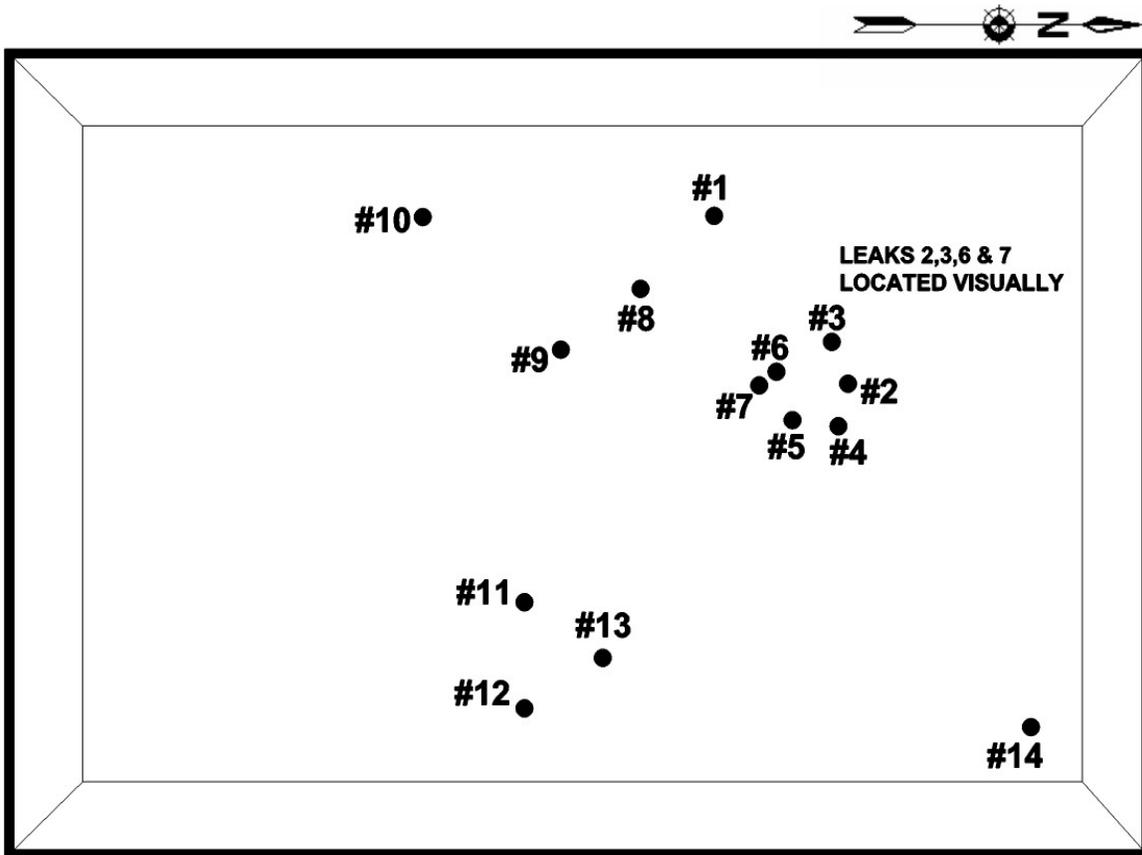
FIGURE 1. APPROXIMATE LOCATIONS OF LEAKS IN THE ROAN CREEK EVAP. POND

Fourteen leaks were found in the geomembrane of the Roan Creek Evaporation Pond. Figure 1 shows the approximate locations of the leaks and Table 1 lists the approximate locations of the leaks found in the pond.

LEAK	LOCATION
1	19 feet from mark on west slope on panel 10
2	65 feet from mark on west slope on seam of panels 10 & 11
3	50 feet from mark on west slope on seam of panels 10 & 11
4	80 feet from mark on west slope on seam of panels 10 & 11
5	80 feet from mark on west slope on panel 10
6	70 feet from mark on west slope on panel 10
7	70 feet from mark on west slope on panel 10
8	40 feet from mark on west slope on seam of panels 9 & 10
9	70 feet from mark on west slope 1 foot north of seam for panels 8 and 9
10	25 feet from mark on west slope on panel 7

11	85 feet from mark on east slope on seam of panels 7 & 8
12	50 feet from mark on east slope on seam of panels 7 & 8
13	60 feet from mark on east slope on seam of panels 9 & 10
14	20 feet from mark on east slope on seam of panels 13 & 14
