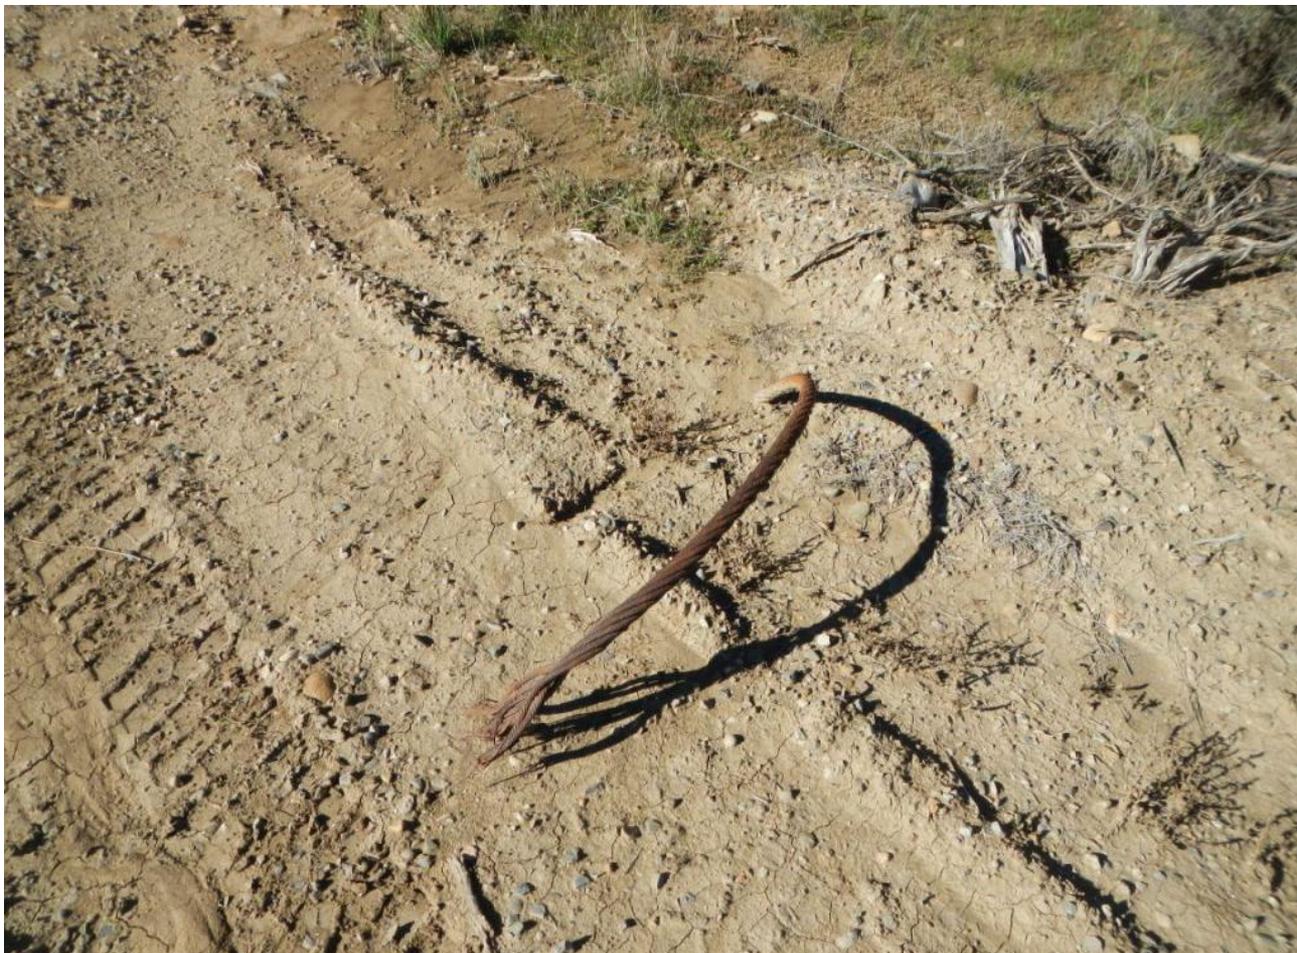
Photo 1. View of rig cable that needs to be removed in northern portion of well pad next to driving surface.

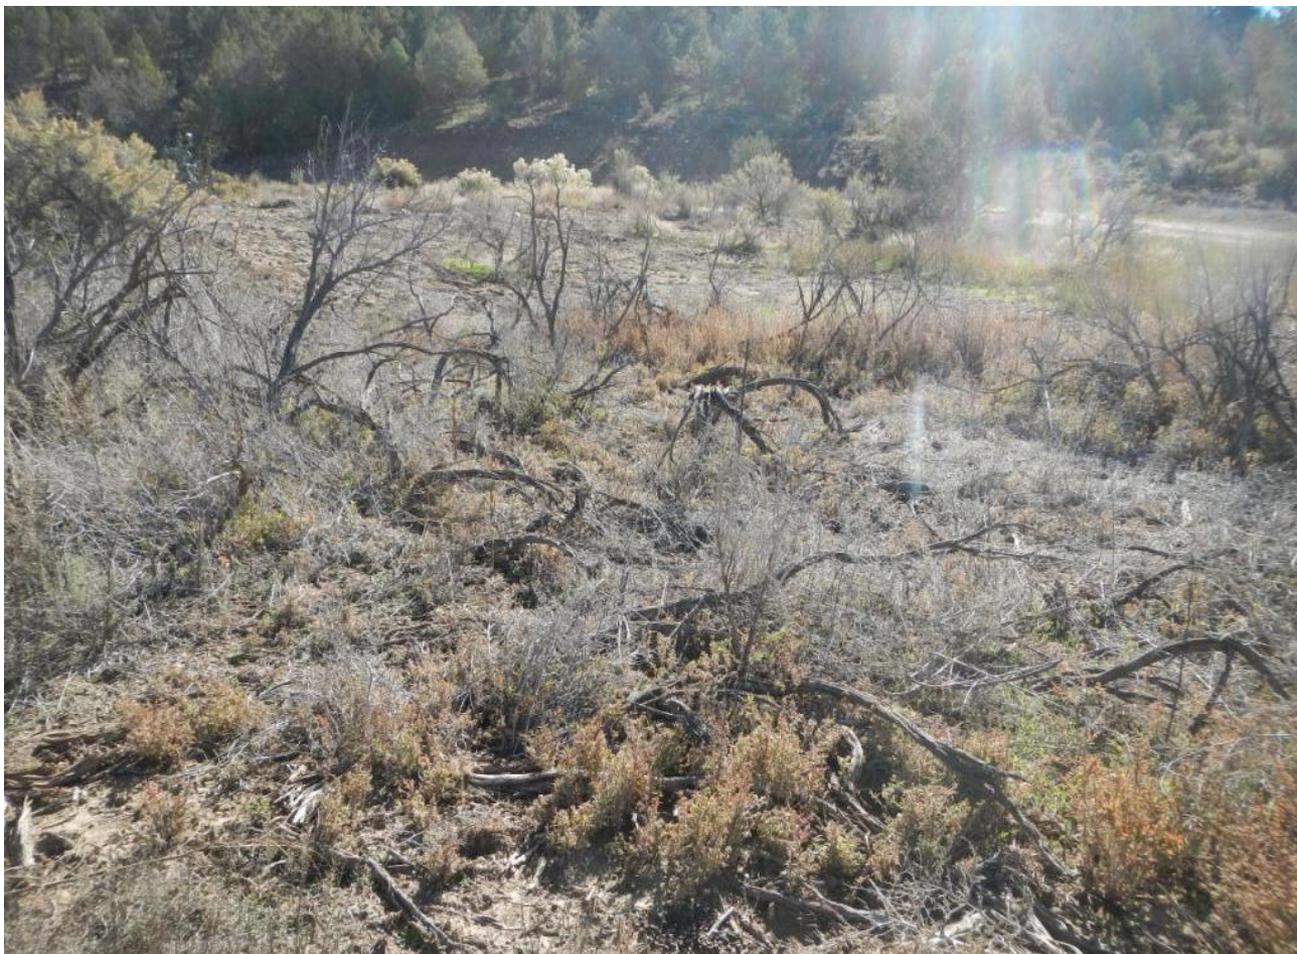
Photo 2. View of dead vegetation with understory of weeds within teardrop of well pad.

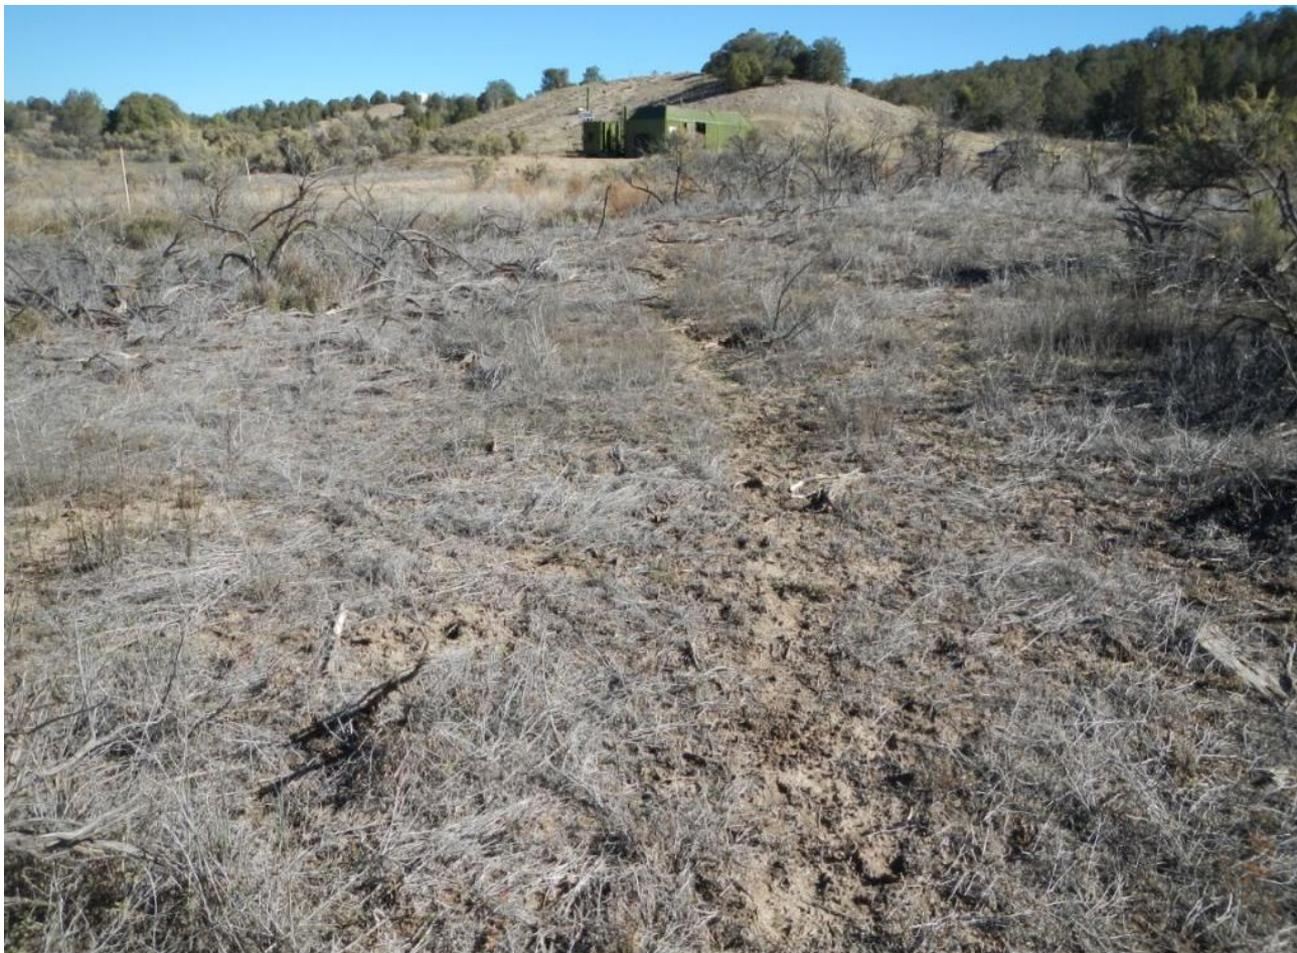
Photo 3. View of dead vegetation within southwestern corner of interim reclamation area.

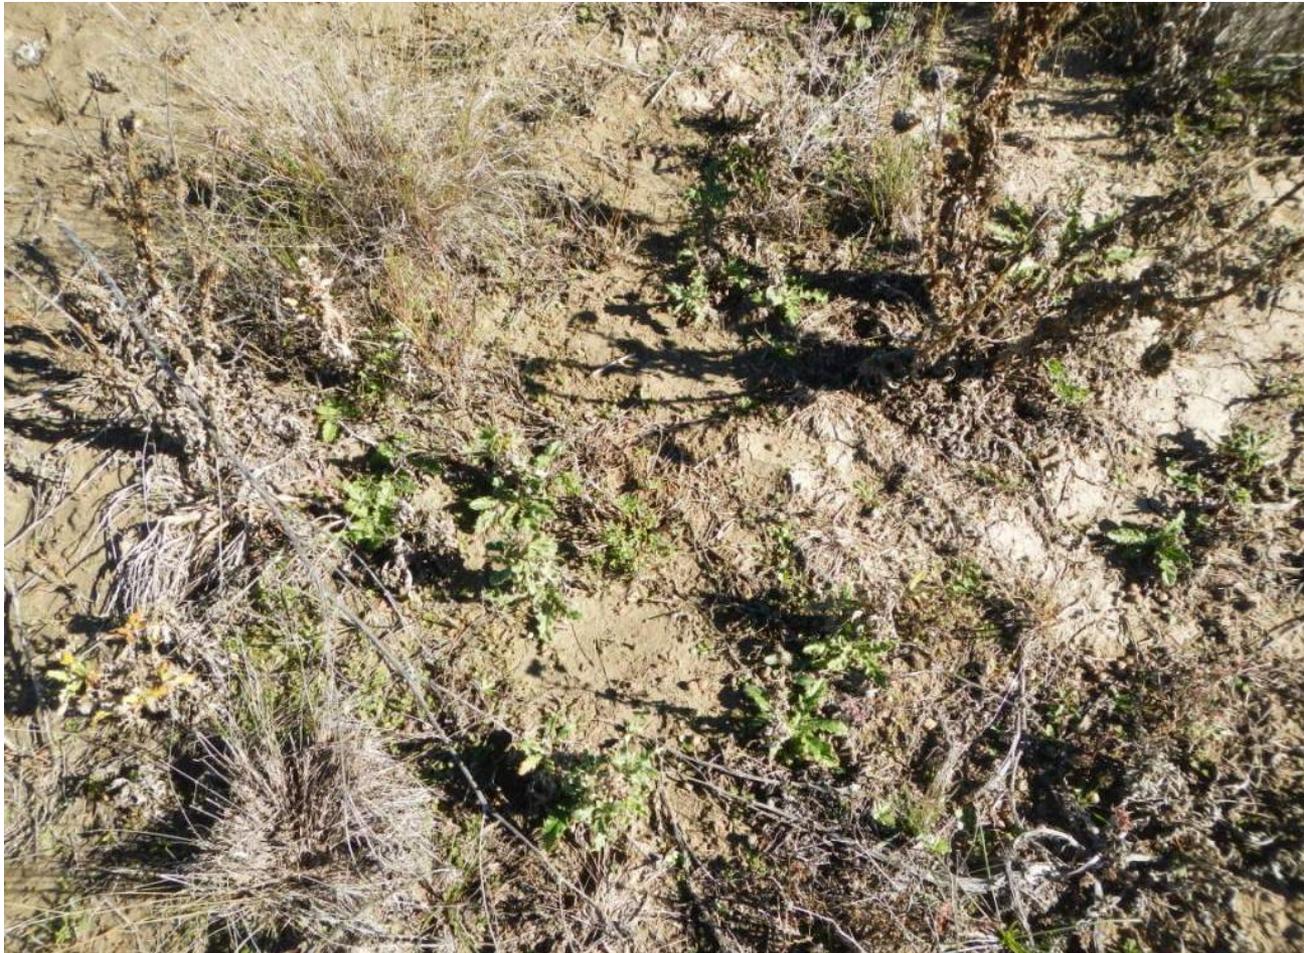
Photo 4. View of Canada thistle and musk thistle rosettes within interim reclamation area.

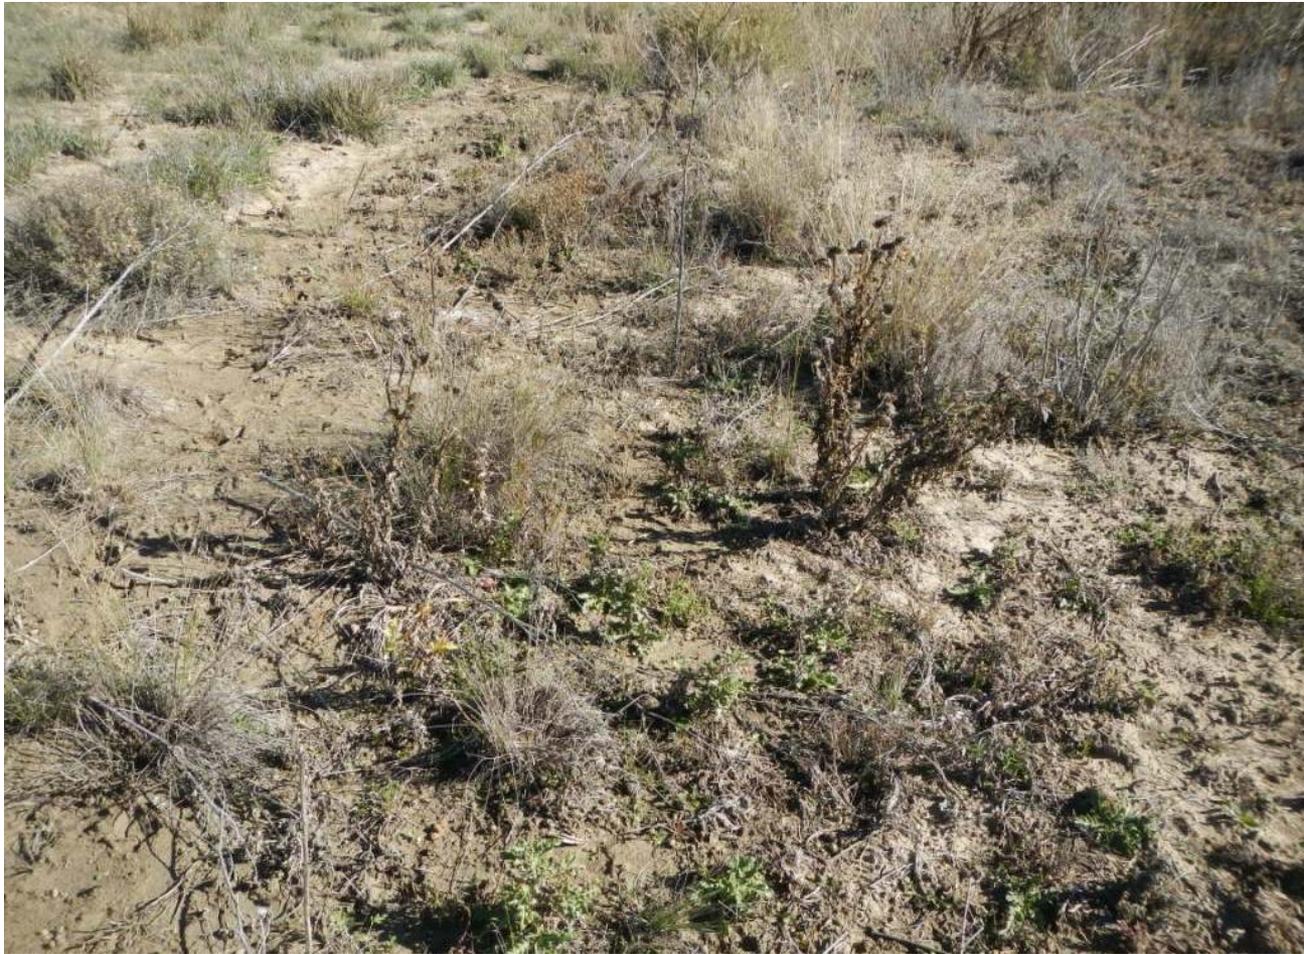
Photo 5. View of musk thistle dying back and rosettes of thistles within northern portion of the interim reclamation area.

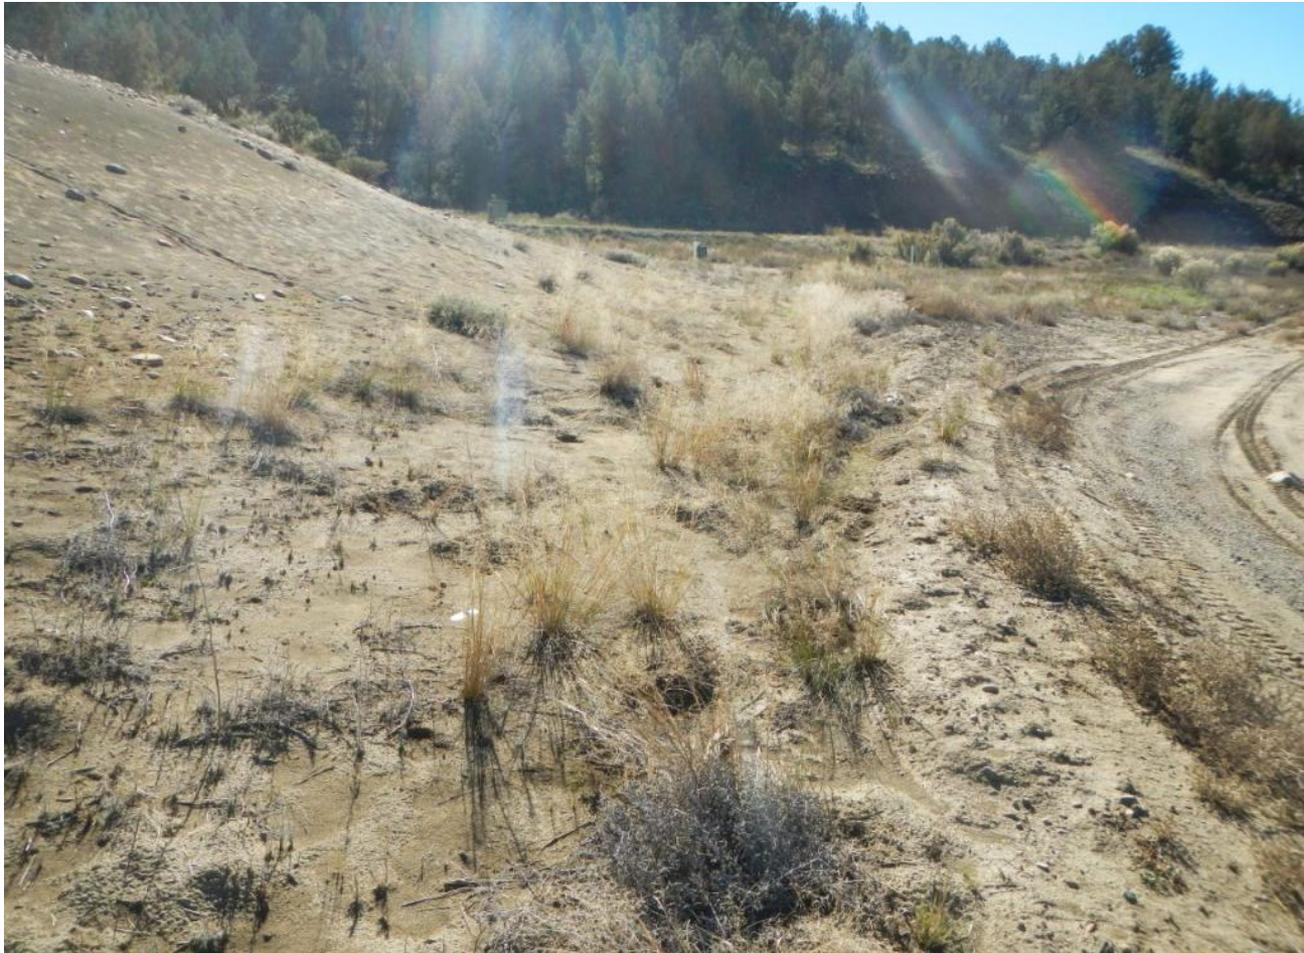
Photo 6. View of sediment deposition from cut slope on the eastern edge of the project area. Appears to be largely contained by the vegetated diversion adjacent to the access road.

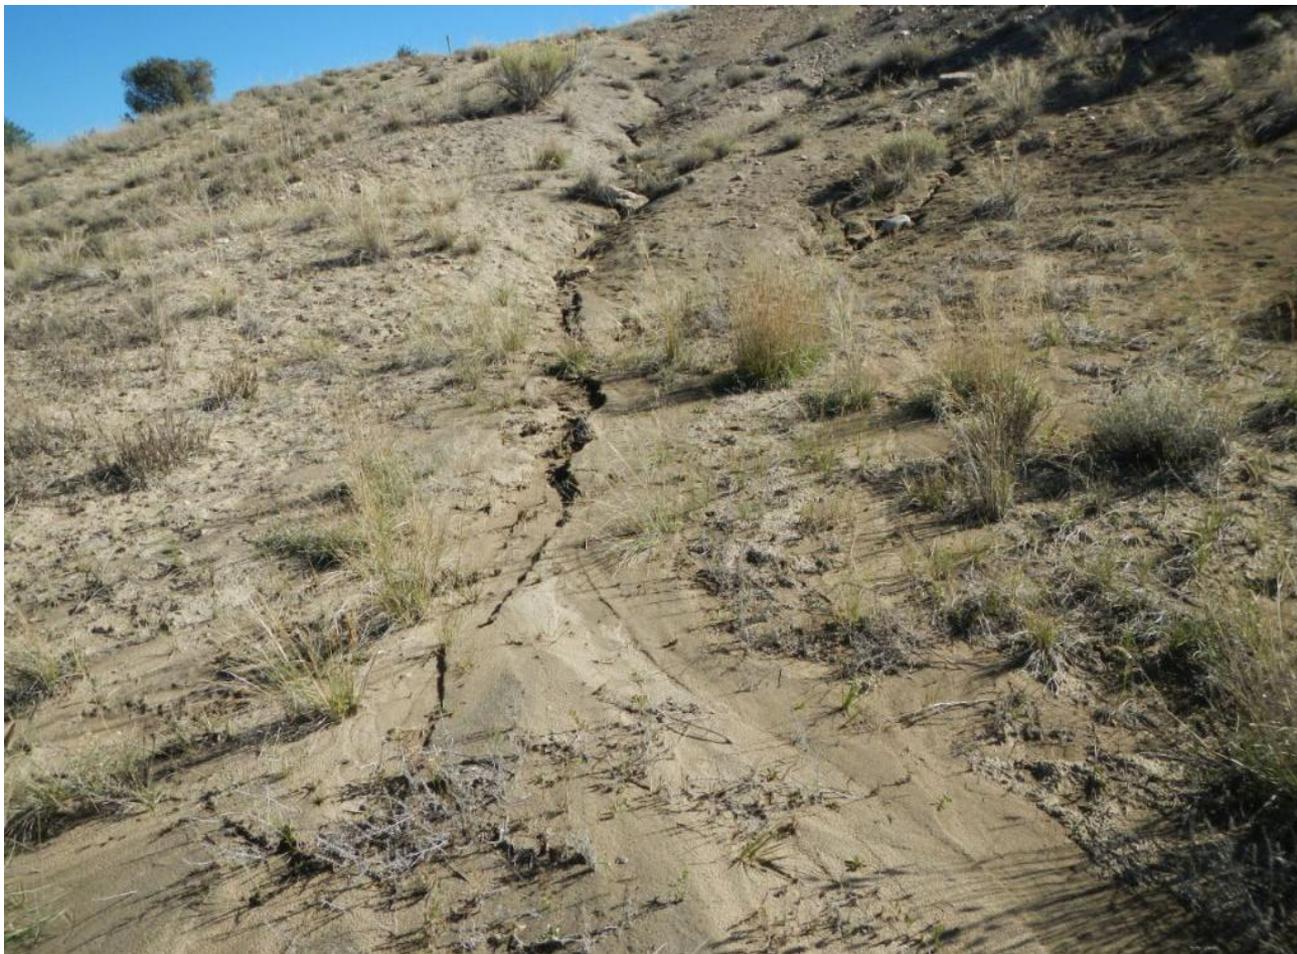
Photo 6. View of large rill within cut slope that needs to be monitored.
