Site Photos (05-099-06868) 10/16/2014

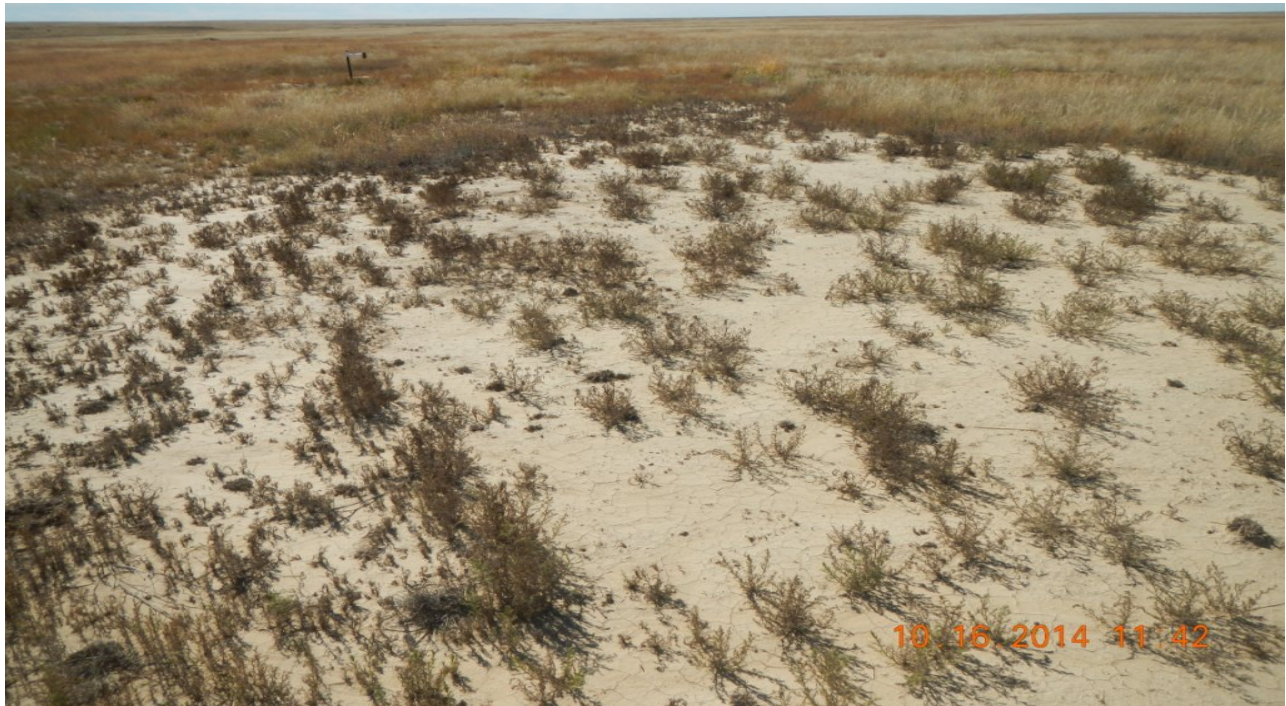
Looking Southwest at location

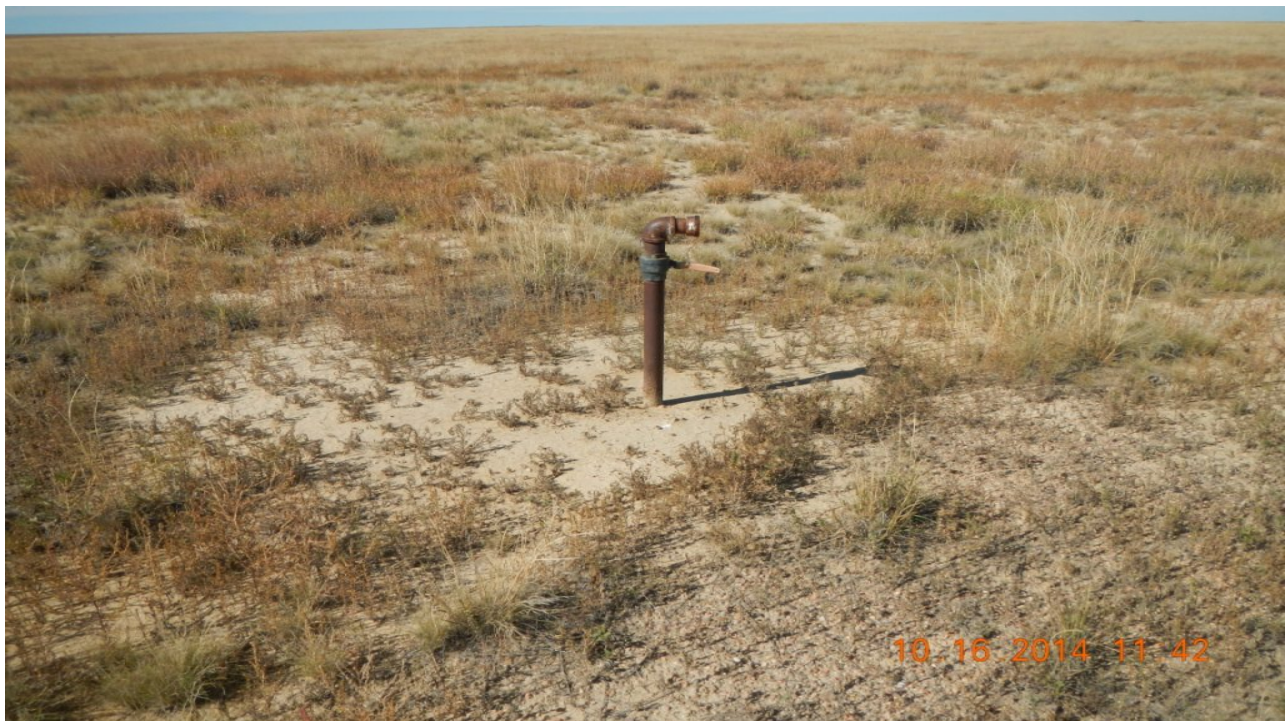
Pipeline riser remains on East side of the location

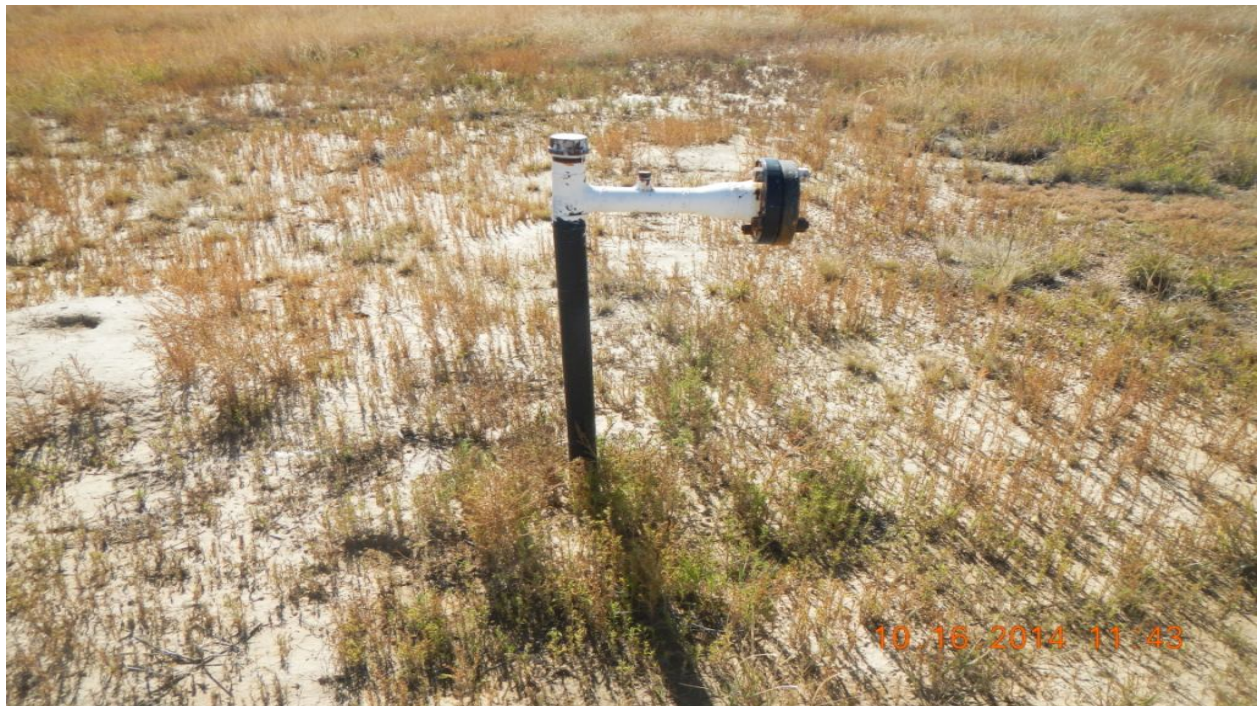
Pipeline riser remains on the South side of location

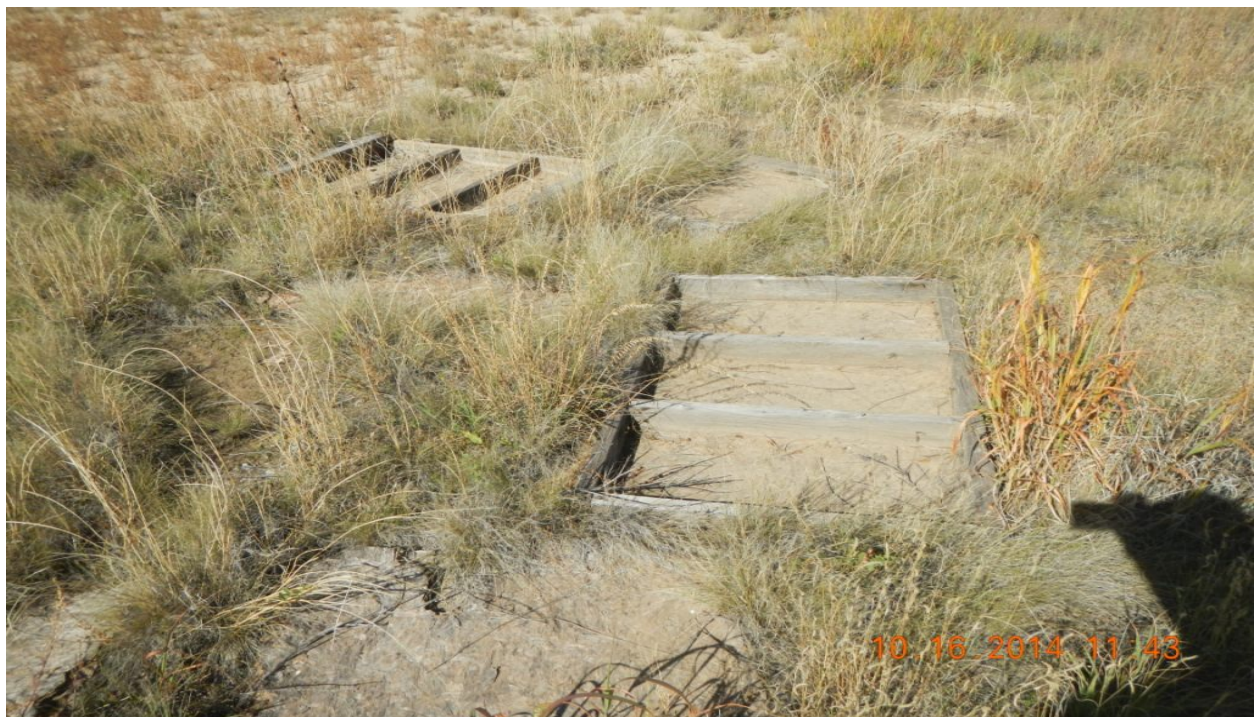
Center of location, wood debris remains

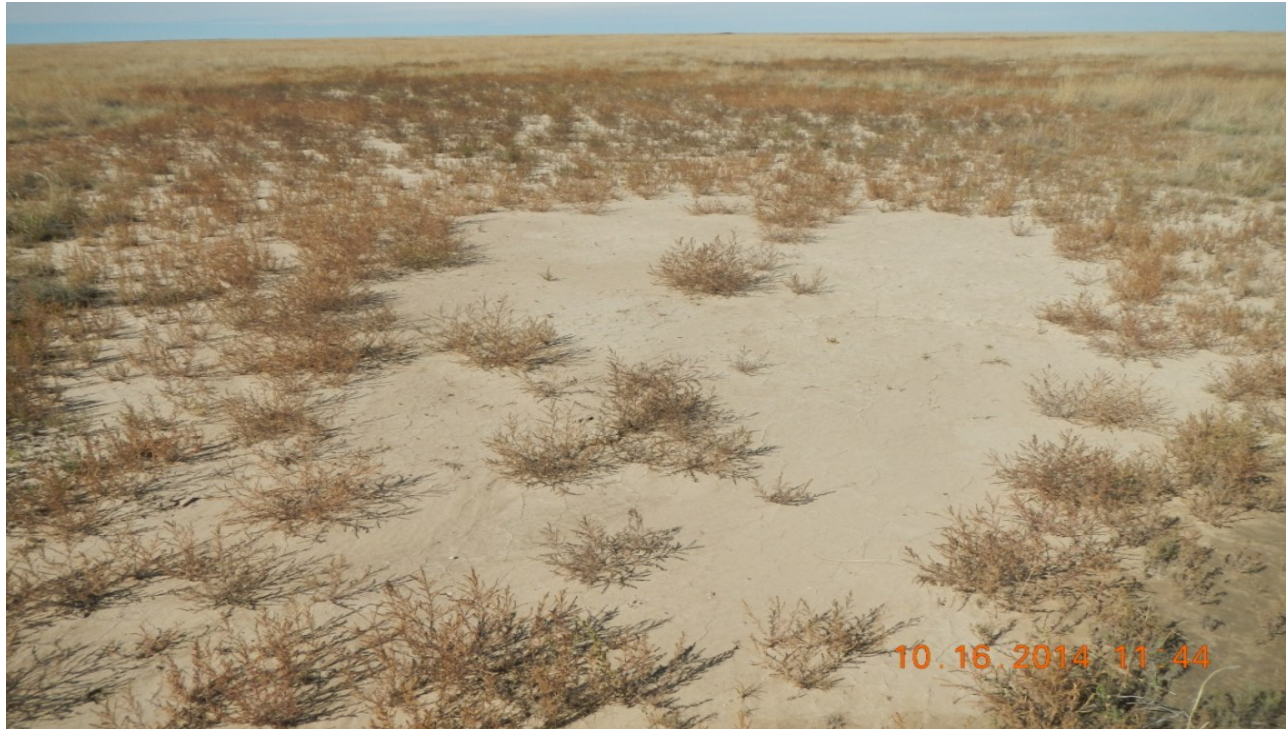
Bare area approx. 30'x30' in center of location

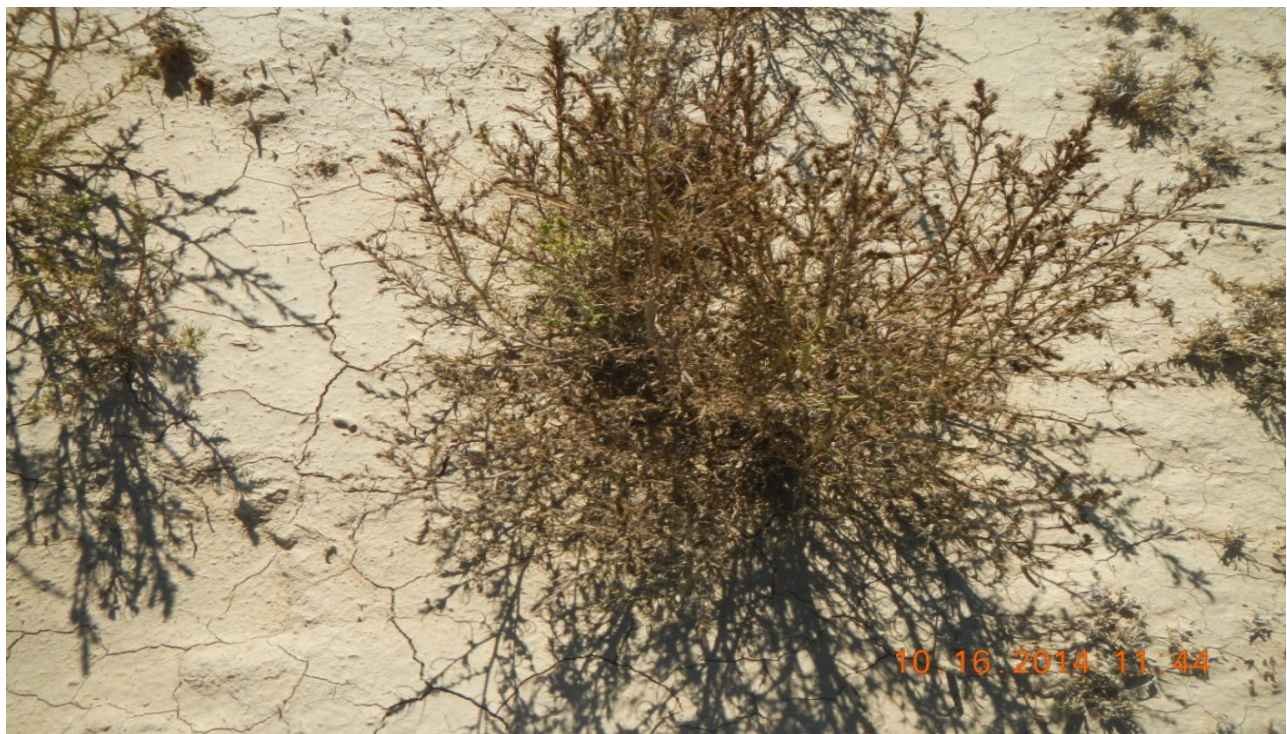
Weed growth on location: Russian thistle
