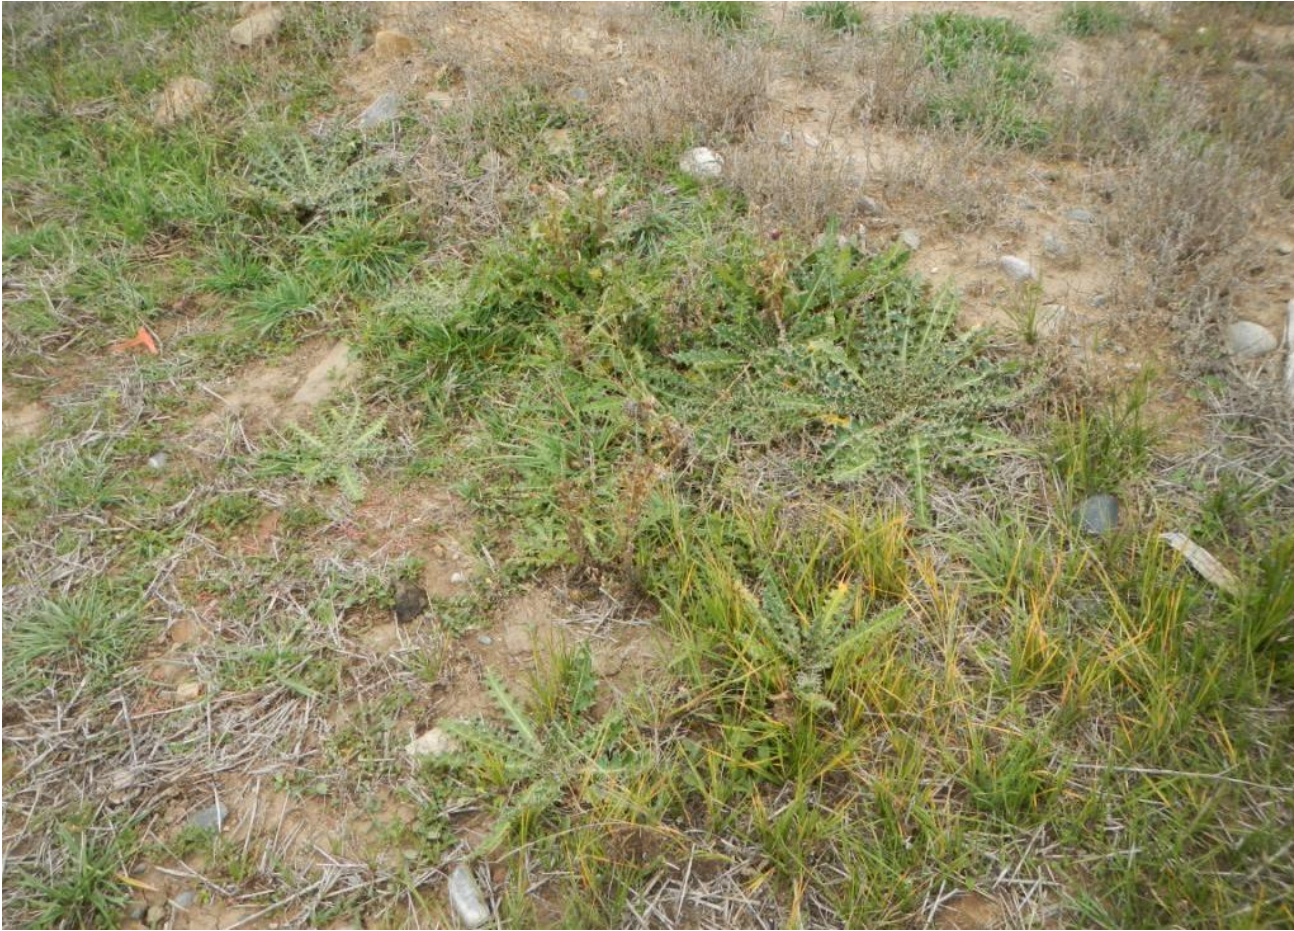
Photo 2. View of musk thistle rosettes within the interim reclamation area.

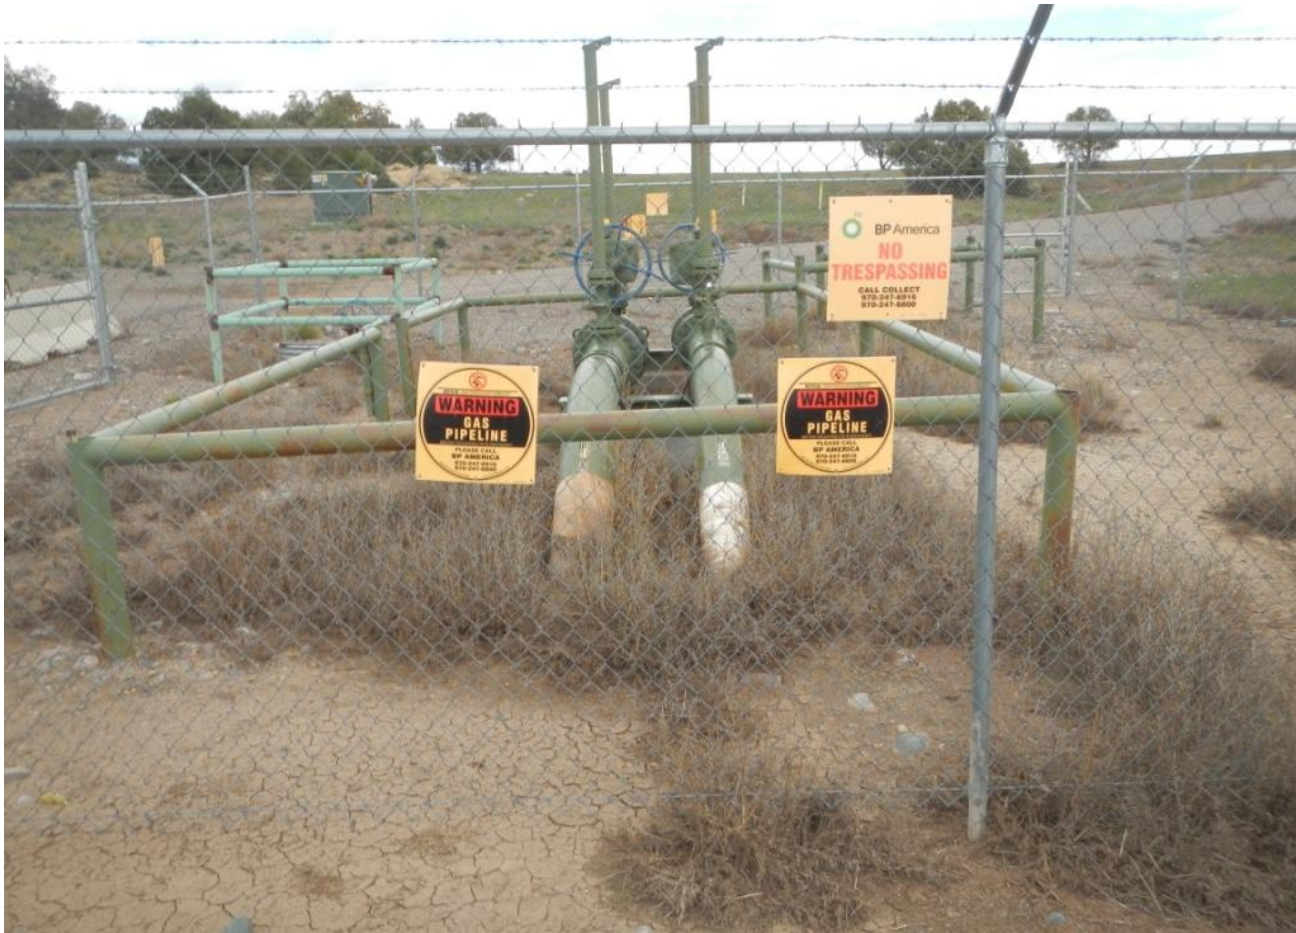
Photo 3. View of large Russian thistle plants growing next to the facilities that needs to be removed.

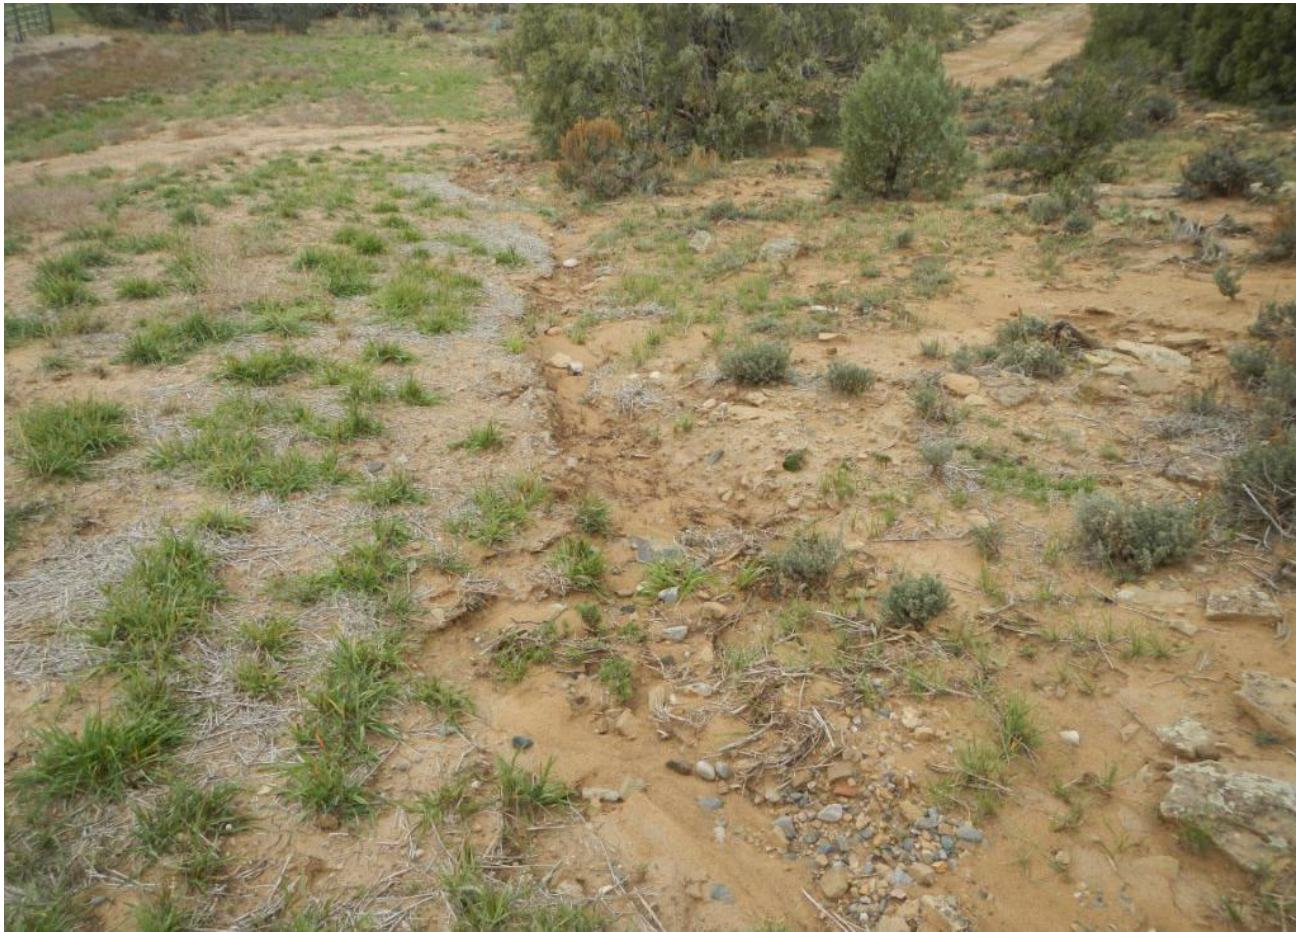
Photo 4. View of erosion from diverted stormwater flows along the northern edge of the project area.

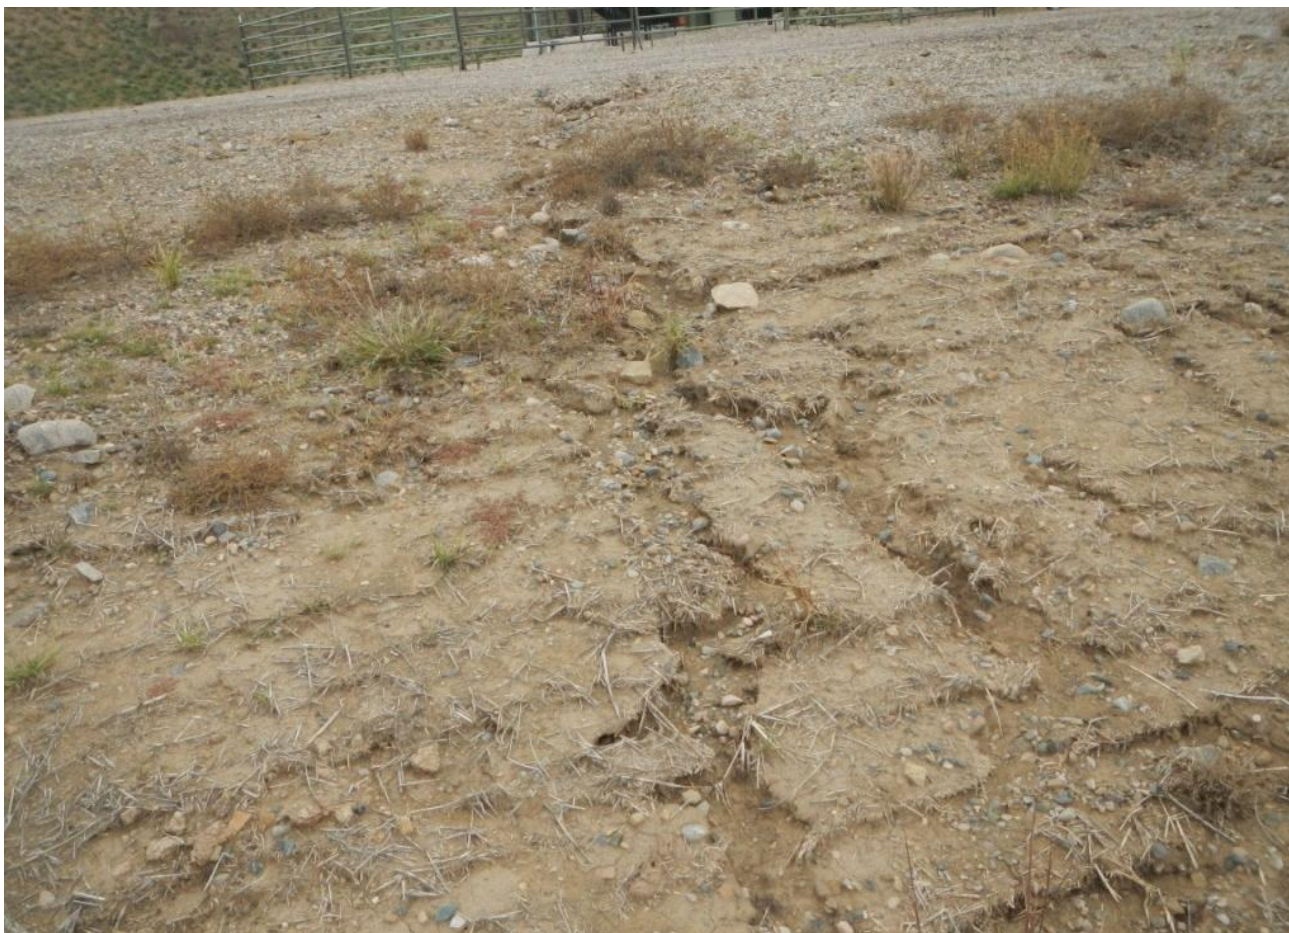
Photo 5. View of rill erosion within the western portion of the interim reclamation area.
