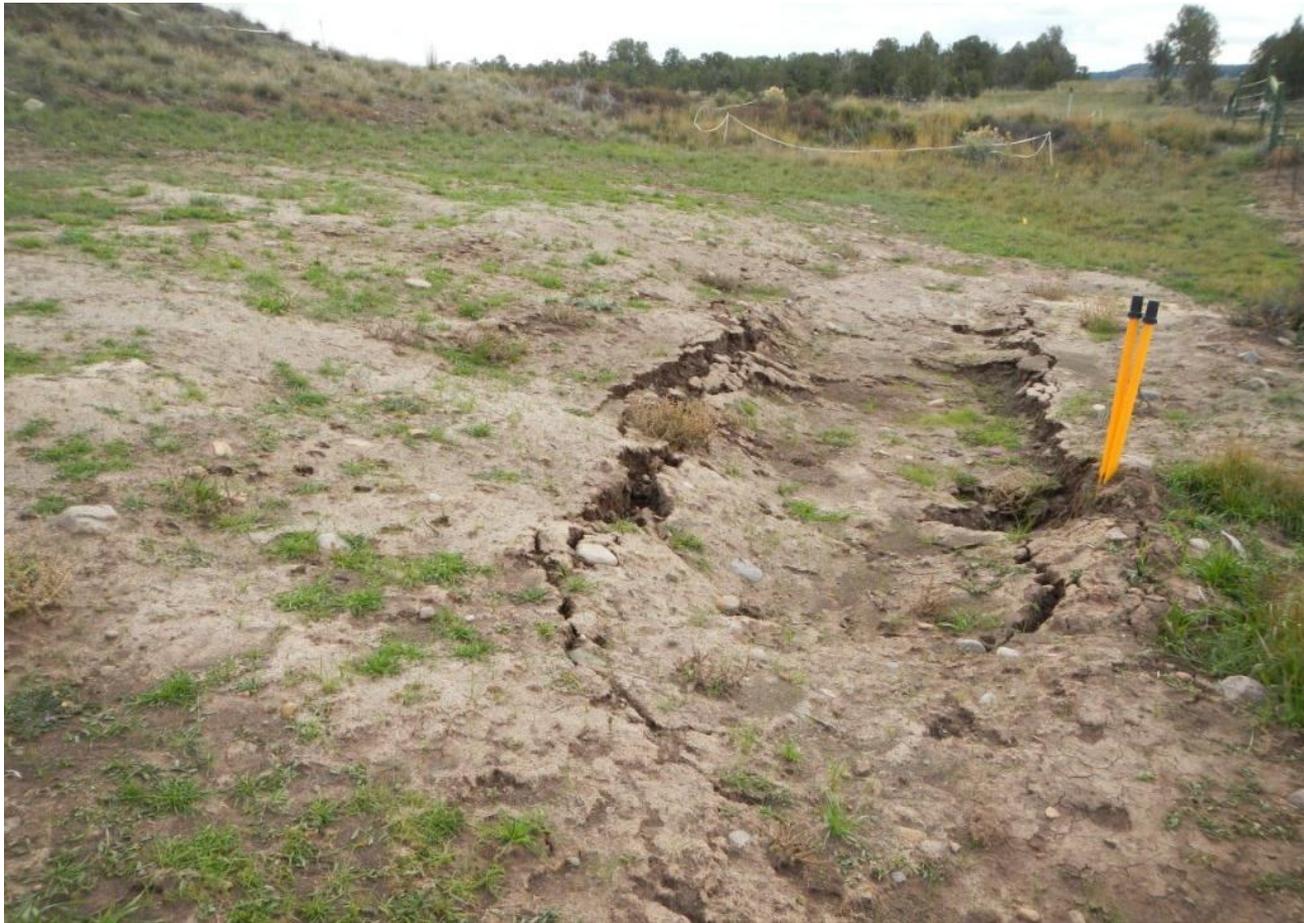
Photo 1. View of subsidence along what appears to be a pipeline tie, from the southern edge of the project area facing southward.

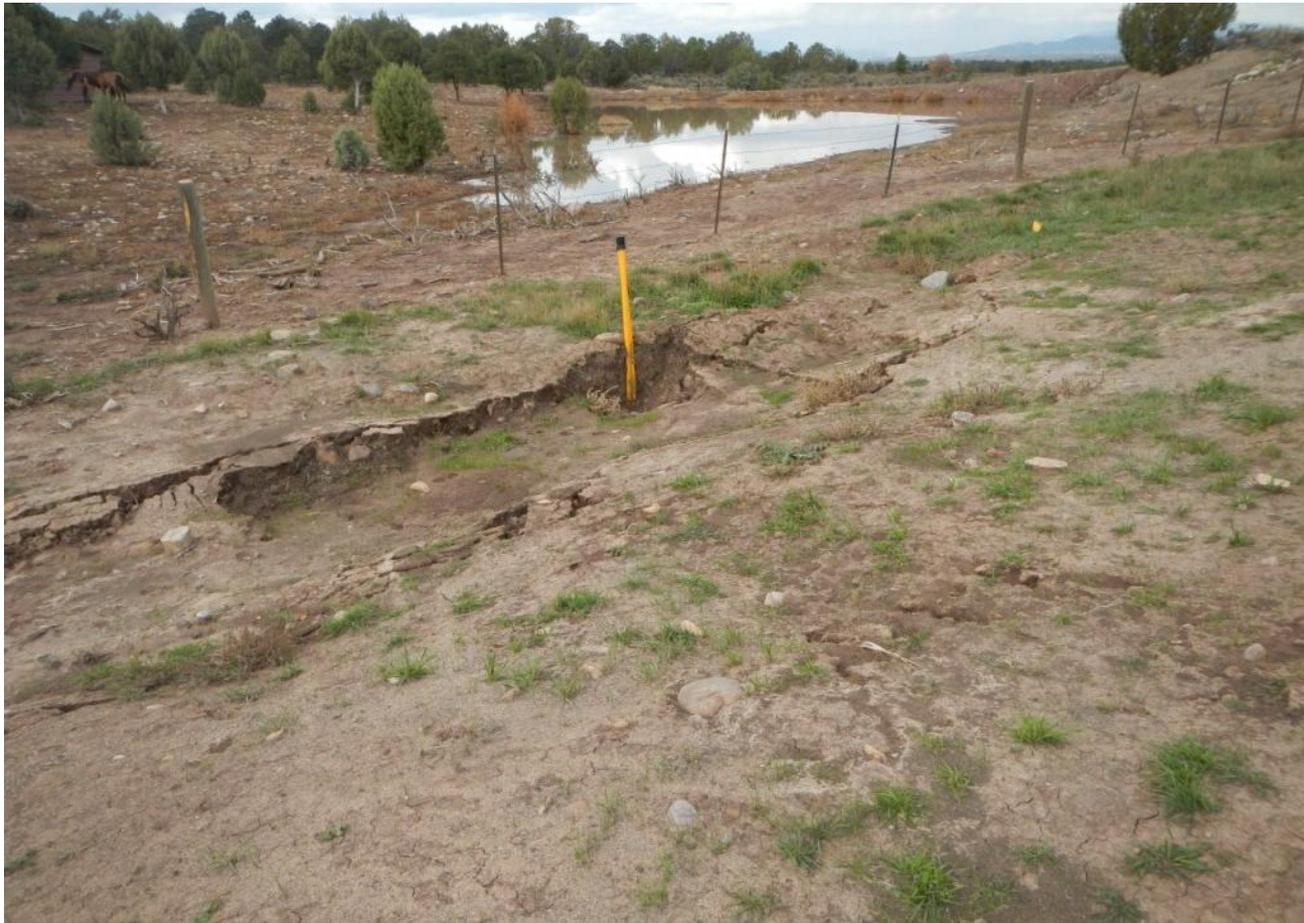
Photo 2. View of subsidence shown in Photo 1 facing westward, perpendicular to what appears to be a pipeline tie.

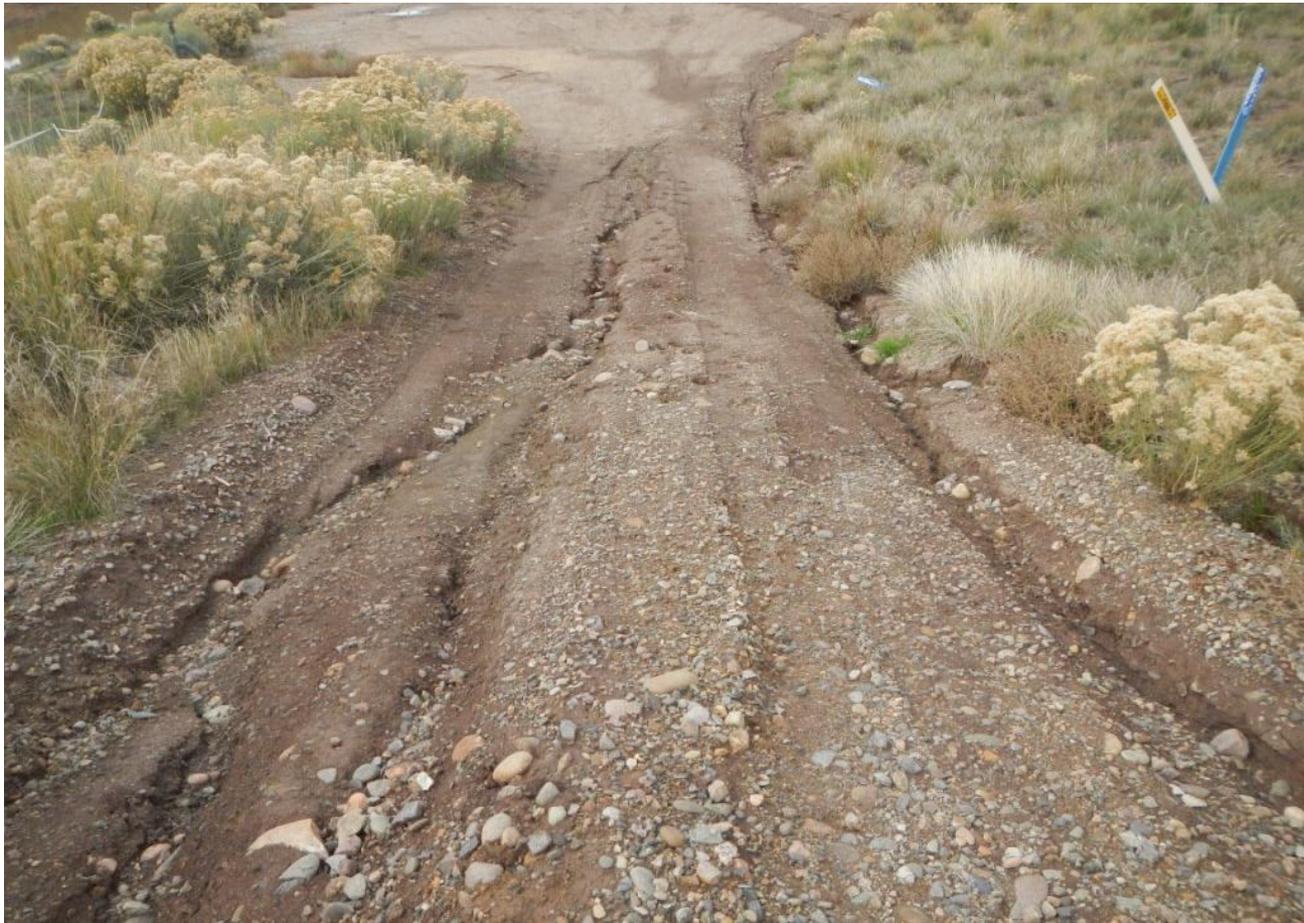
Photo 3. View of erosion on the access road from the edge of the adjacent Samson well pad facing toward the project area.

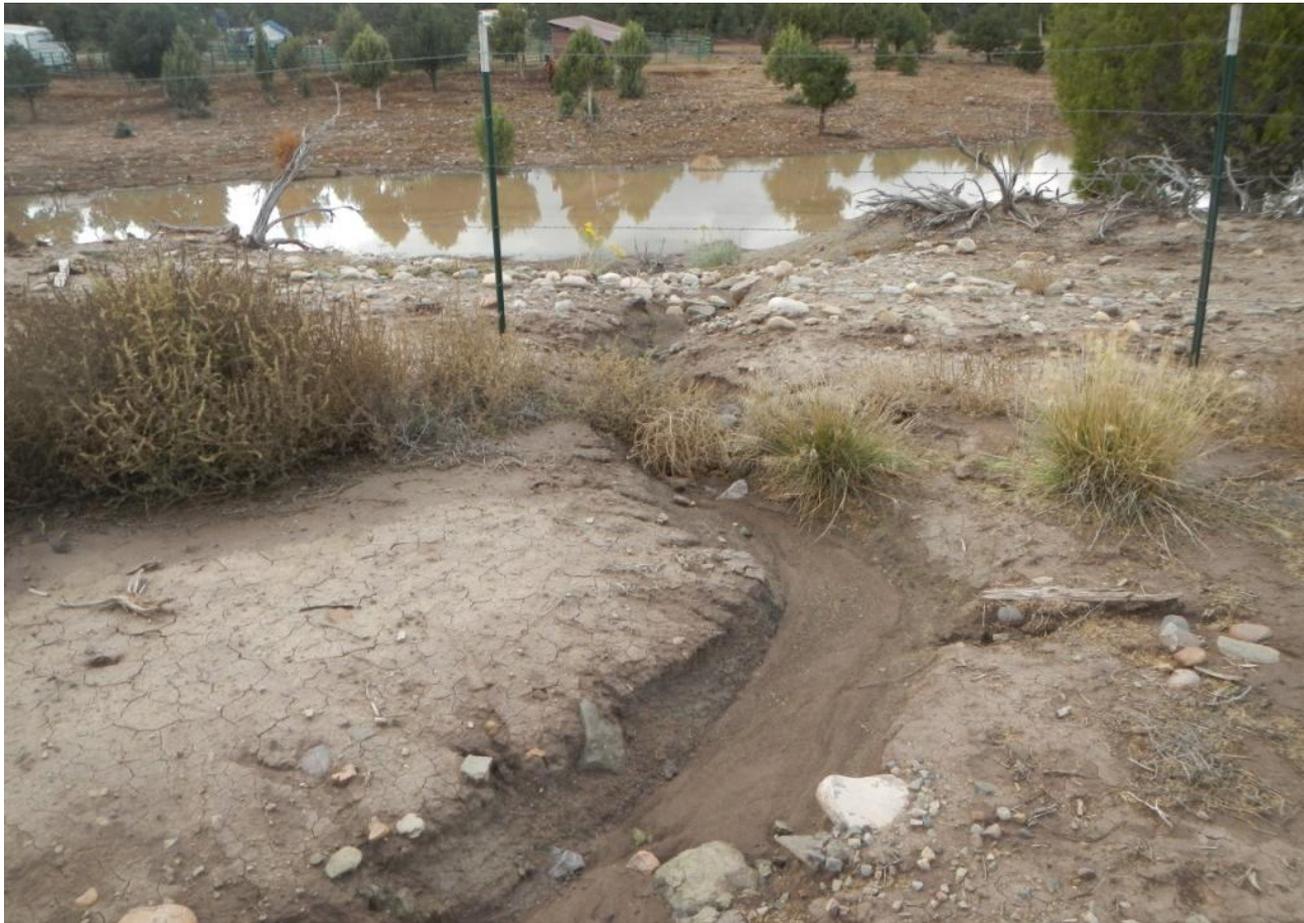
Photo 4. View of stormwater erosion channel flowing off of the project area toward what appears to be a cattle pond.

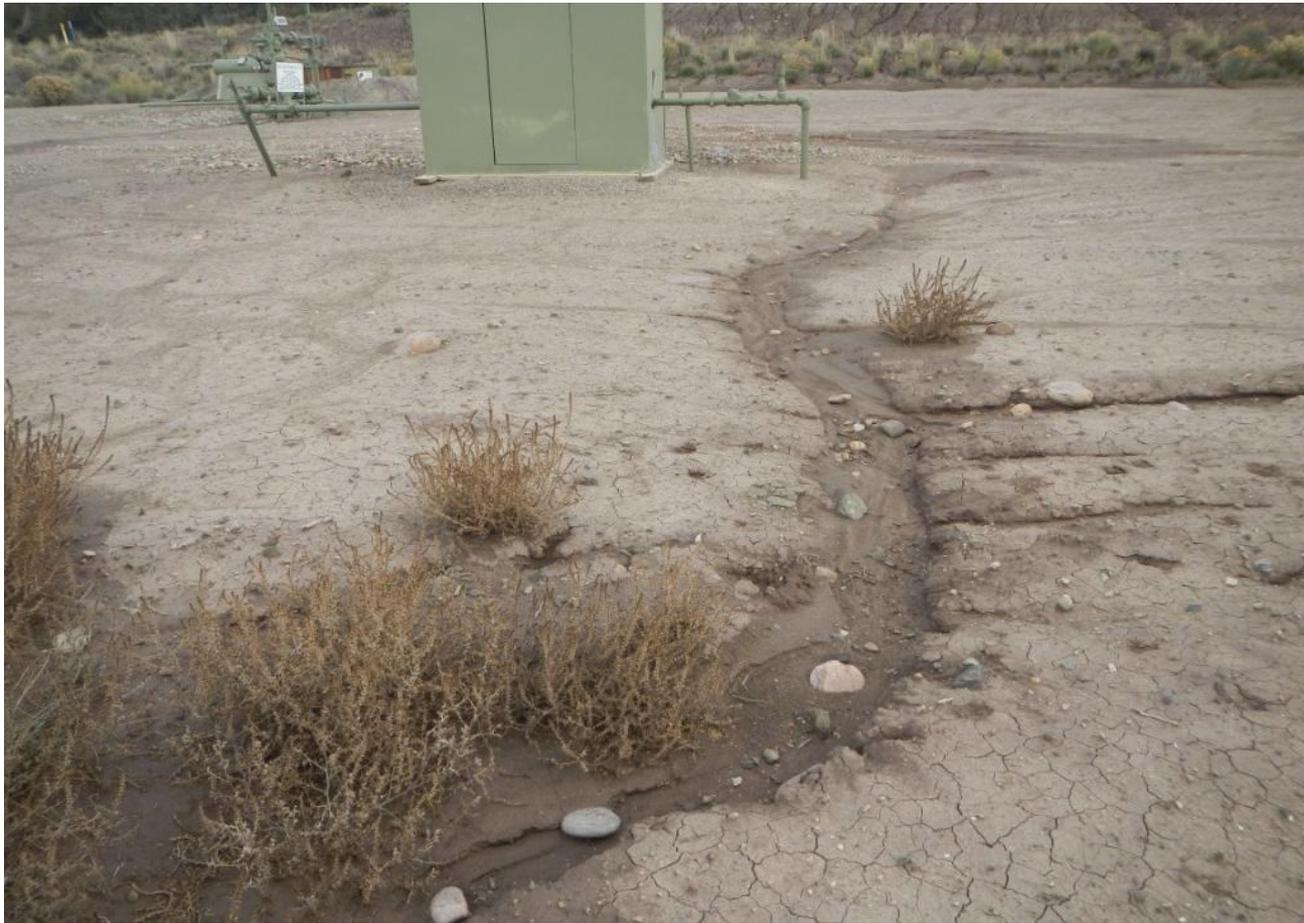
Photo 5. View of erosion on the surface of the well pad flowing toward the southwestern edge of the project area.

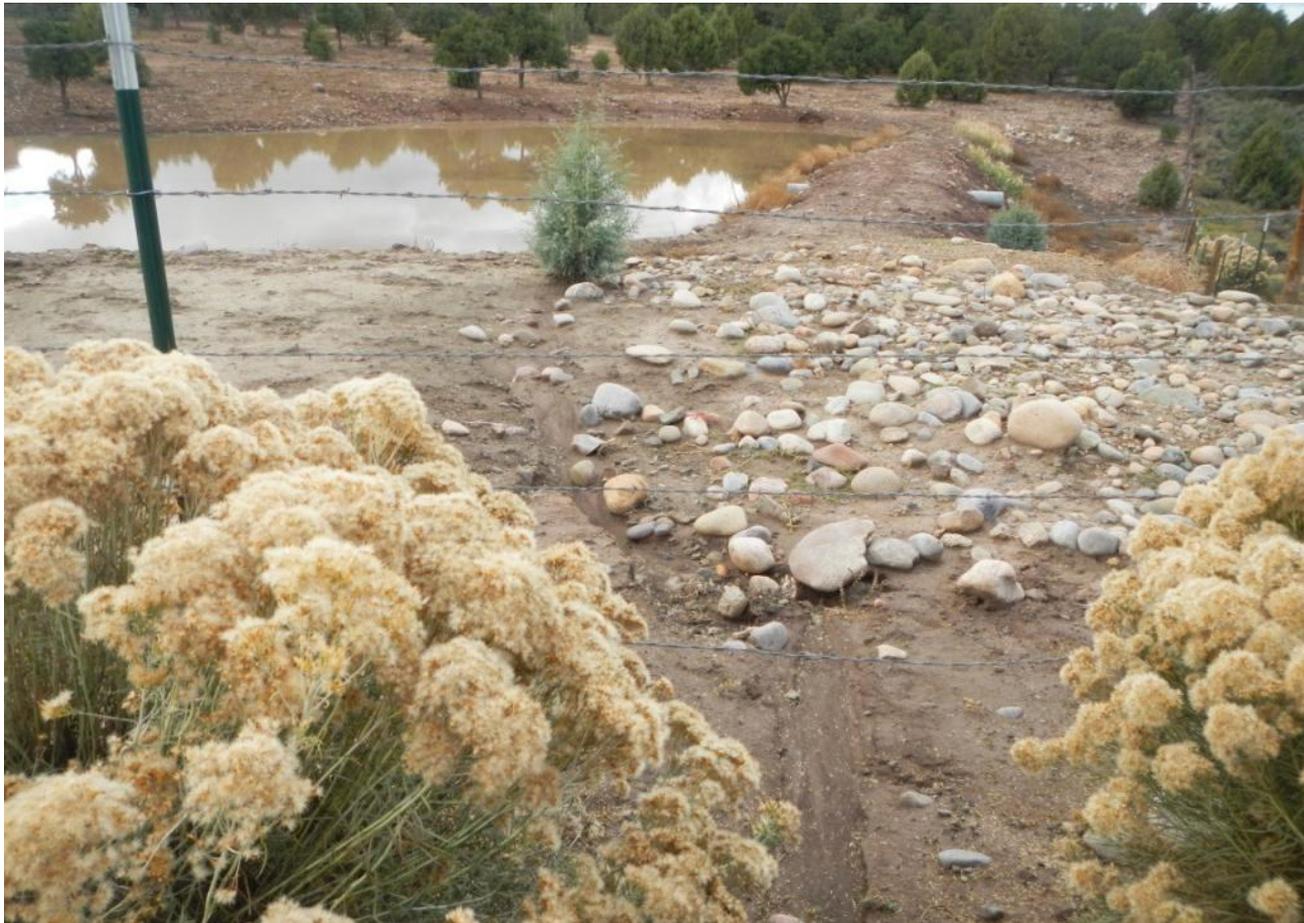
Photo 6. Downstream of the channel shown in Photo 5, an erosional channel is forming and eroding into what appears to be a cattle pond.

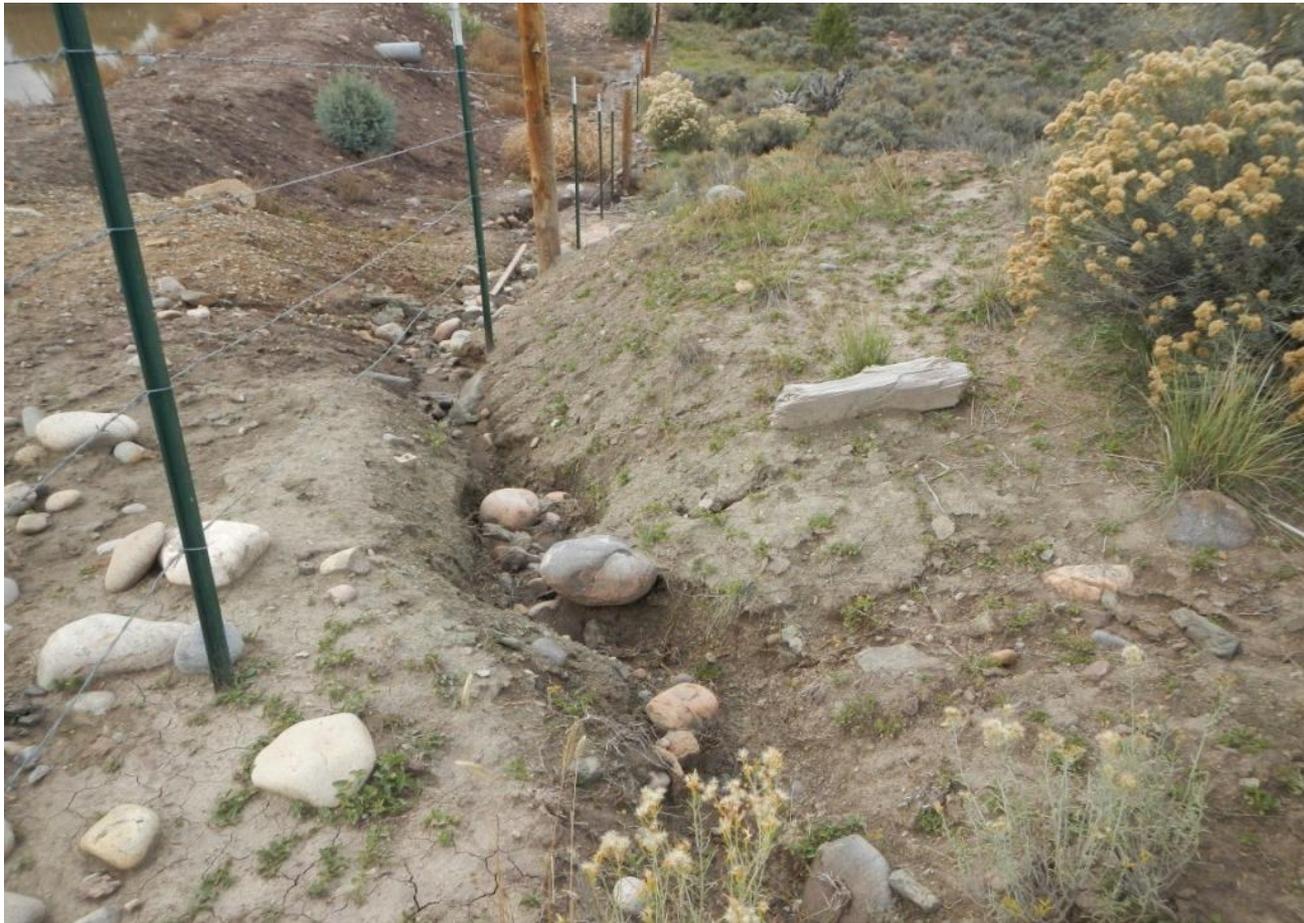
Photo 7. View of erosional channel forming on the southwestern edge of the project area eroding sediment and unfiltered stormwater downstream from the cattle pond.

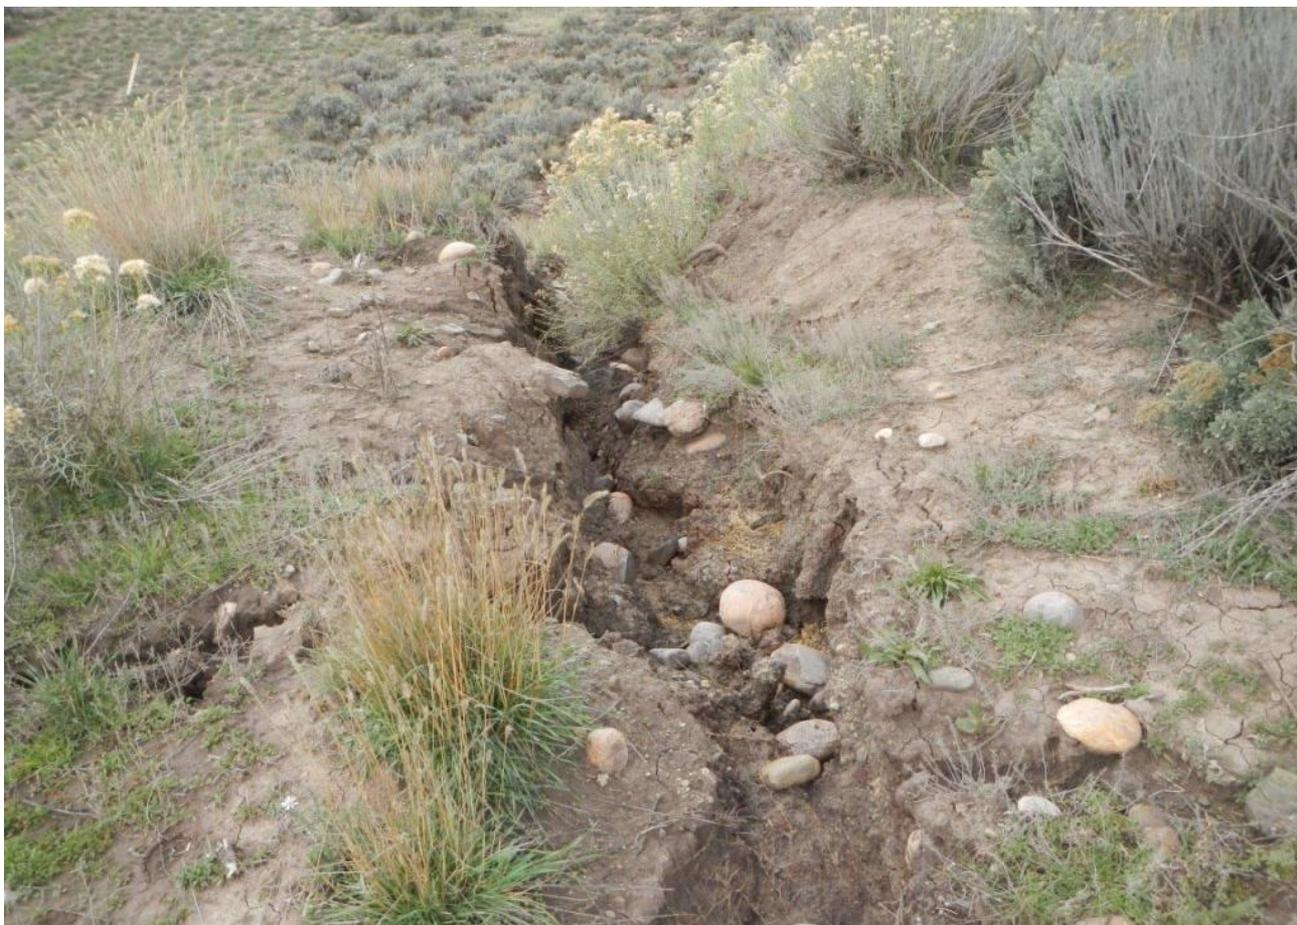
Photo 8. View of erosional channel in the northwestern corner of the project area.

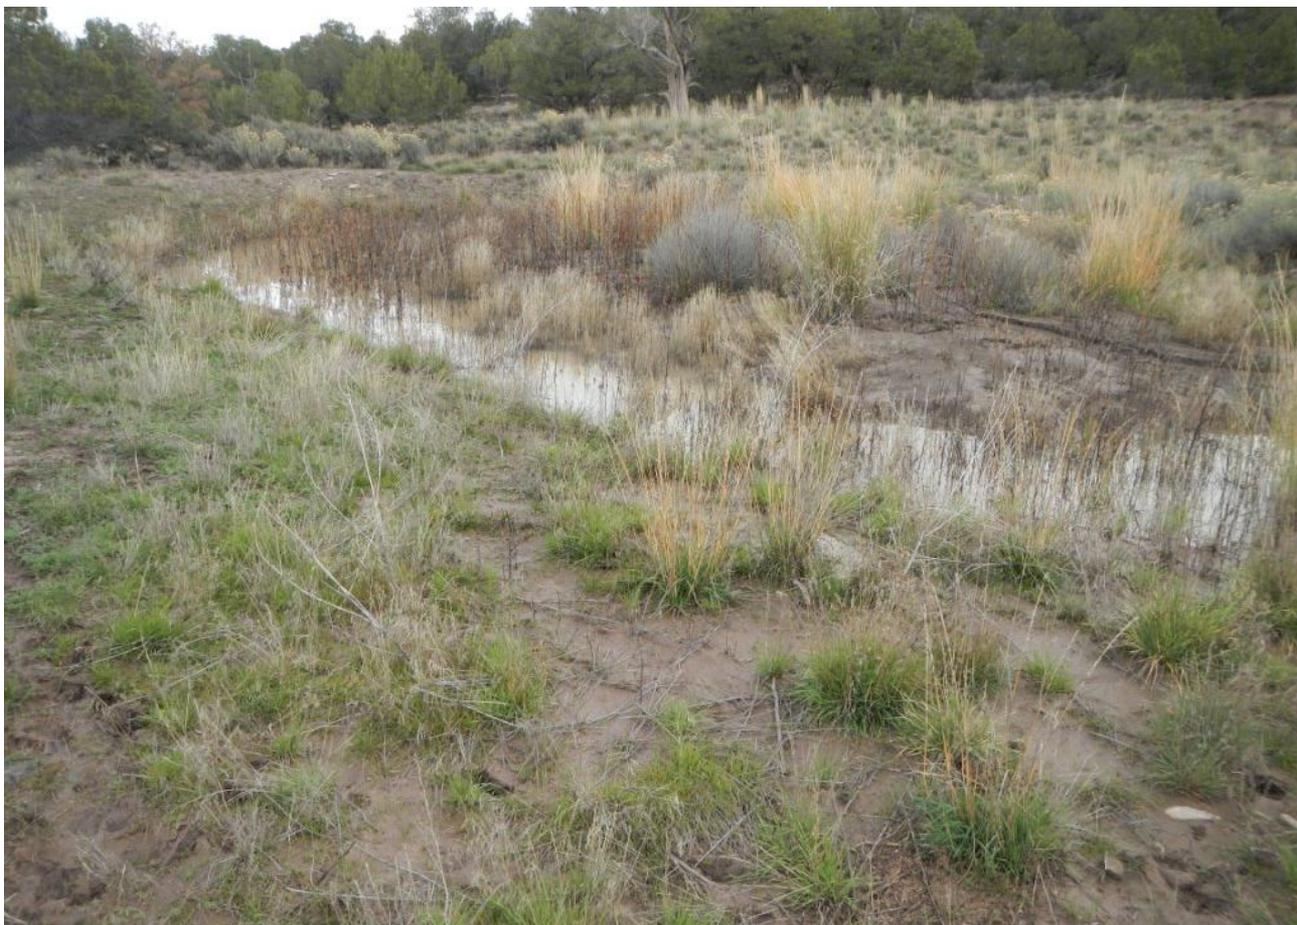
Photo 9. View of pit that appears to be functioning as a silt trap.

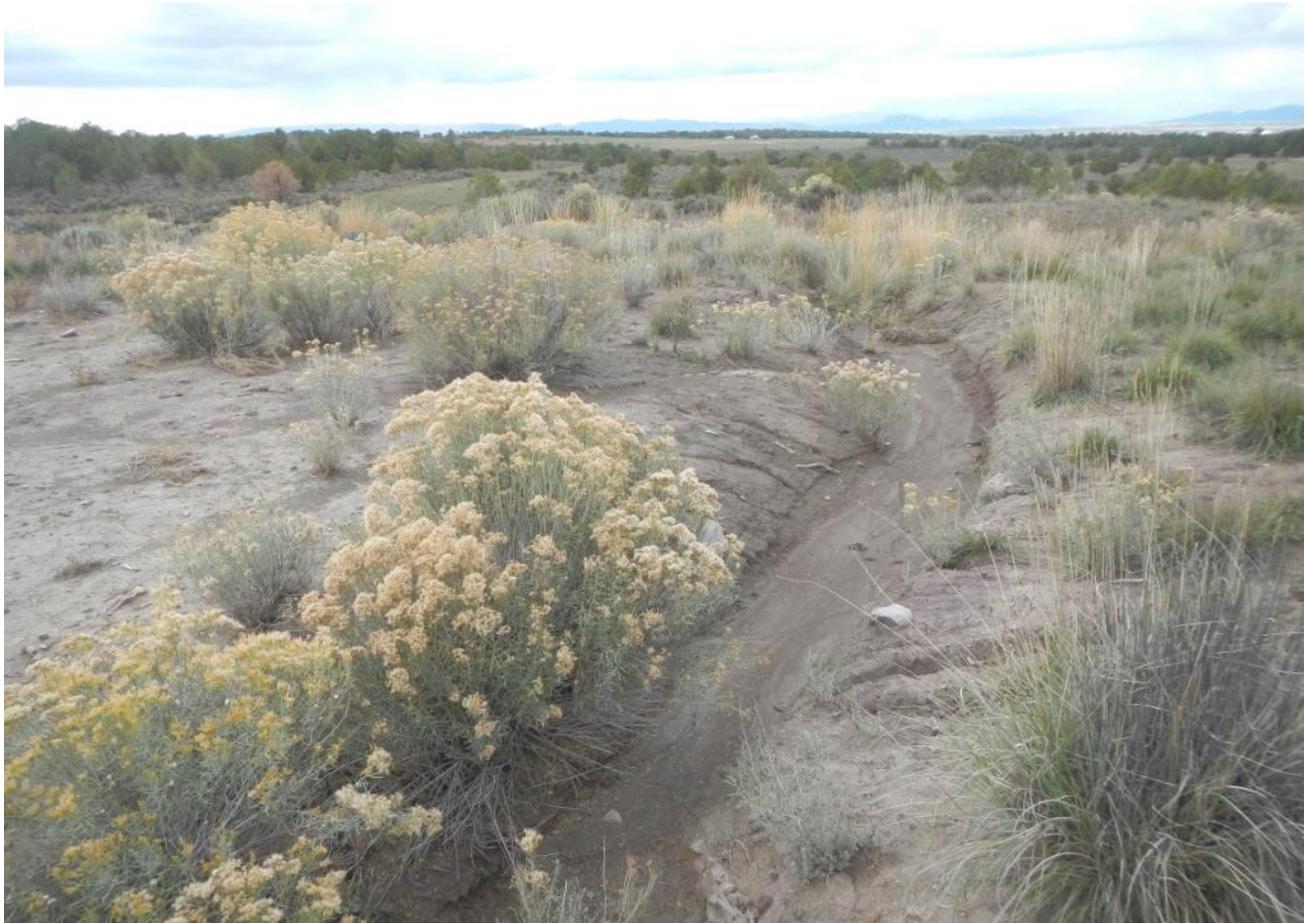
Photo 10. View of diverted stormwater flow channel from cut slopes on northeastern edge of project area flowing toward old pit (facing northward).

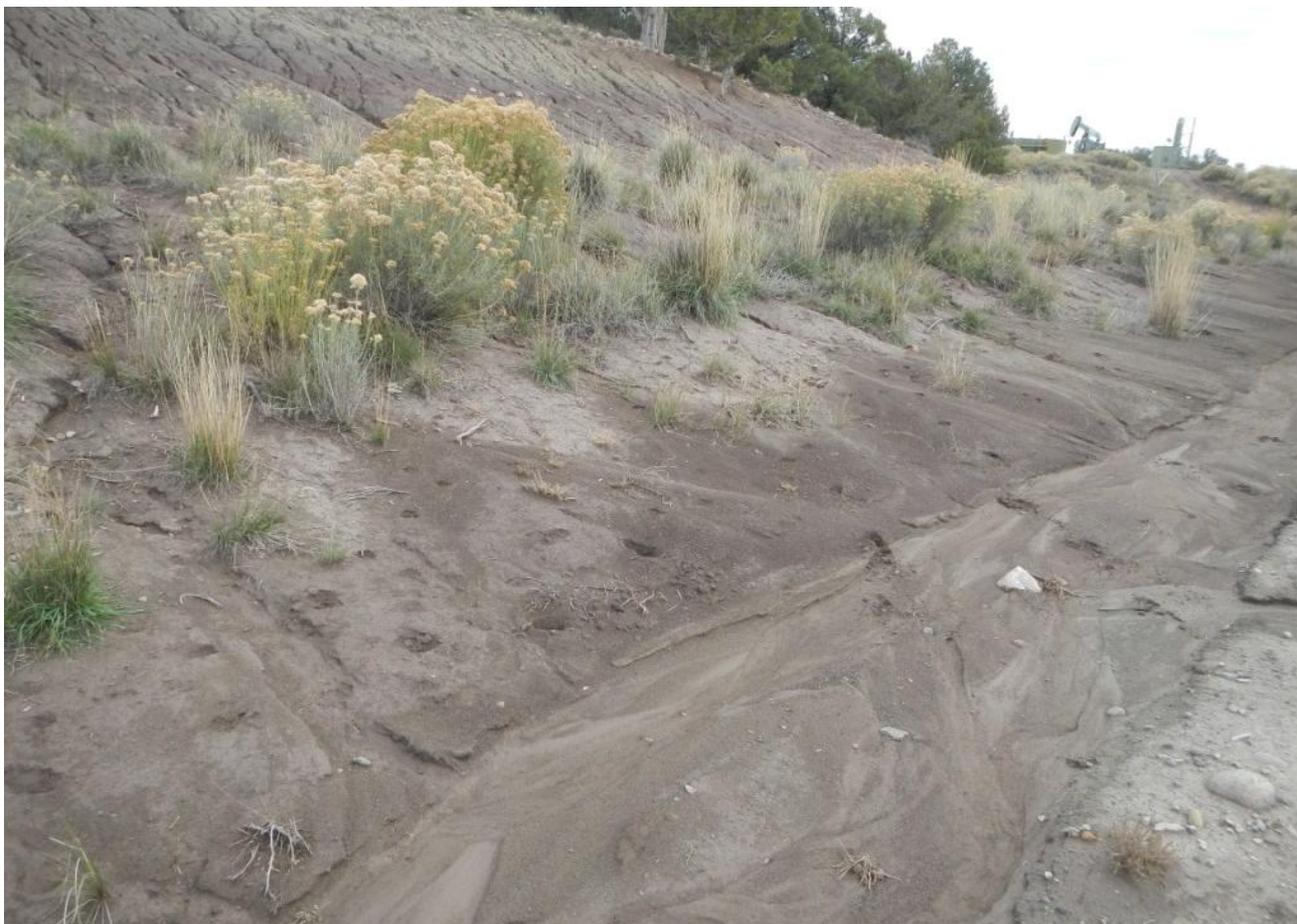
Photo 11. View of stormwater erosion channel upstream from Photo 10 and rill erosion on cut slopes of project area.
