Location # 438312 Operator: URSA OPERATING COMPANY LLC

Inspection Photographs (16 total) 10/23 & 10/28, 2014

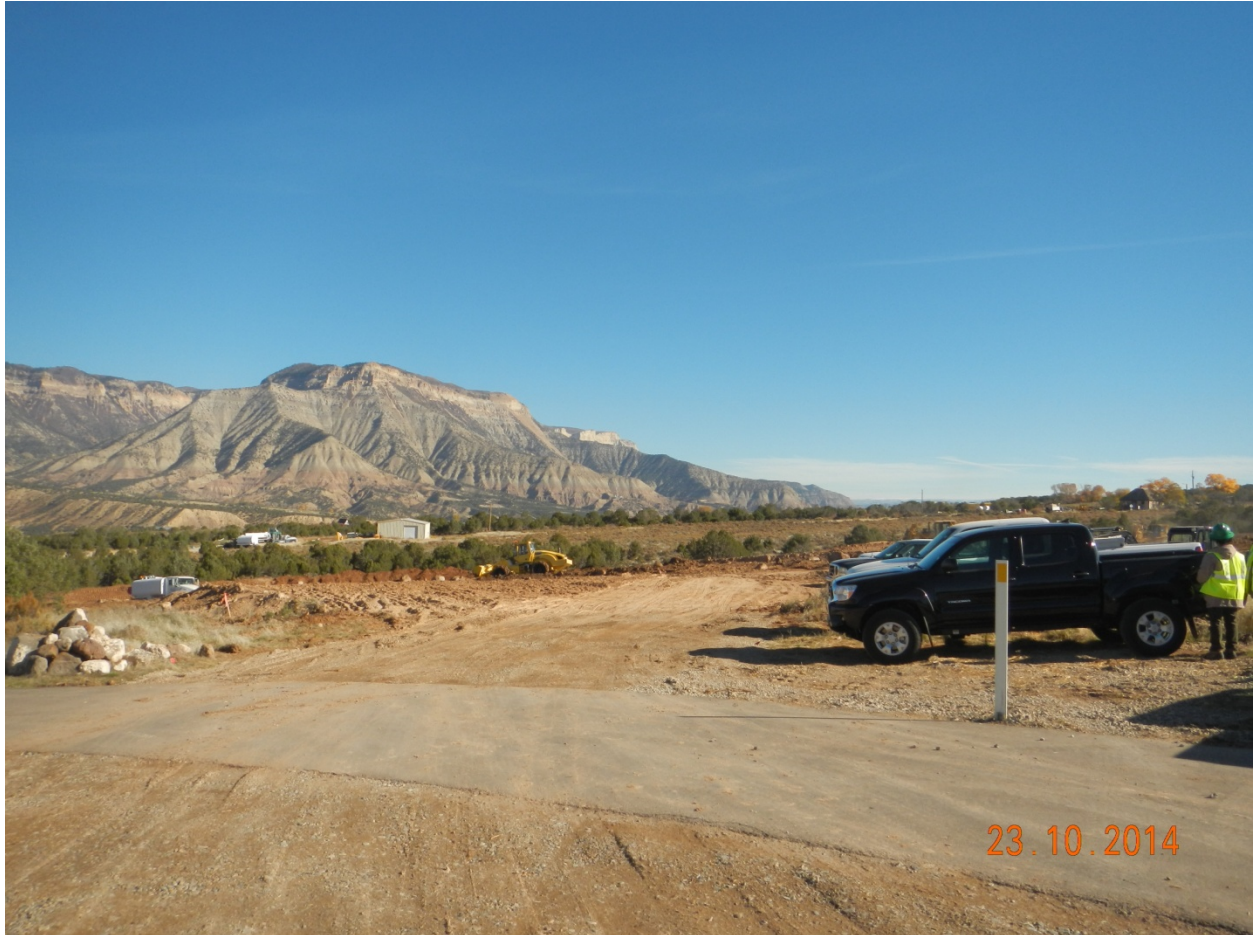
2. Location access road entrance, viewed SW from NE.

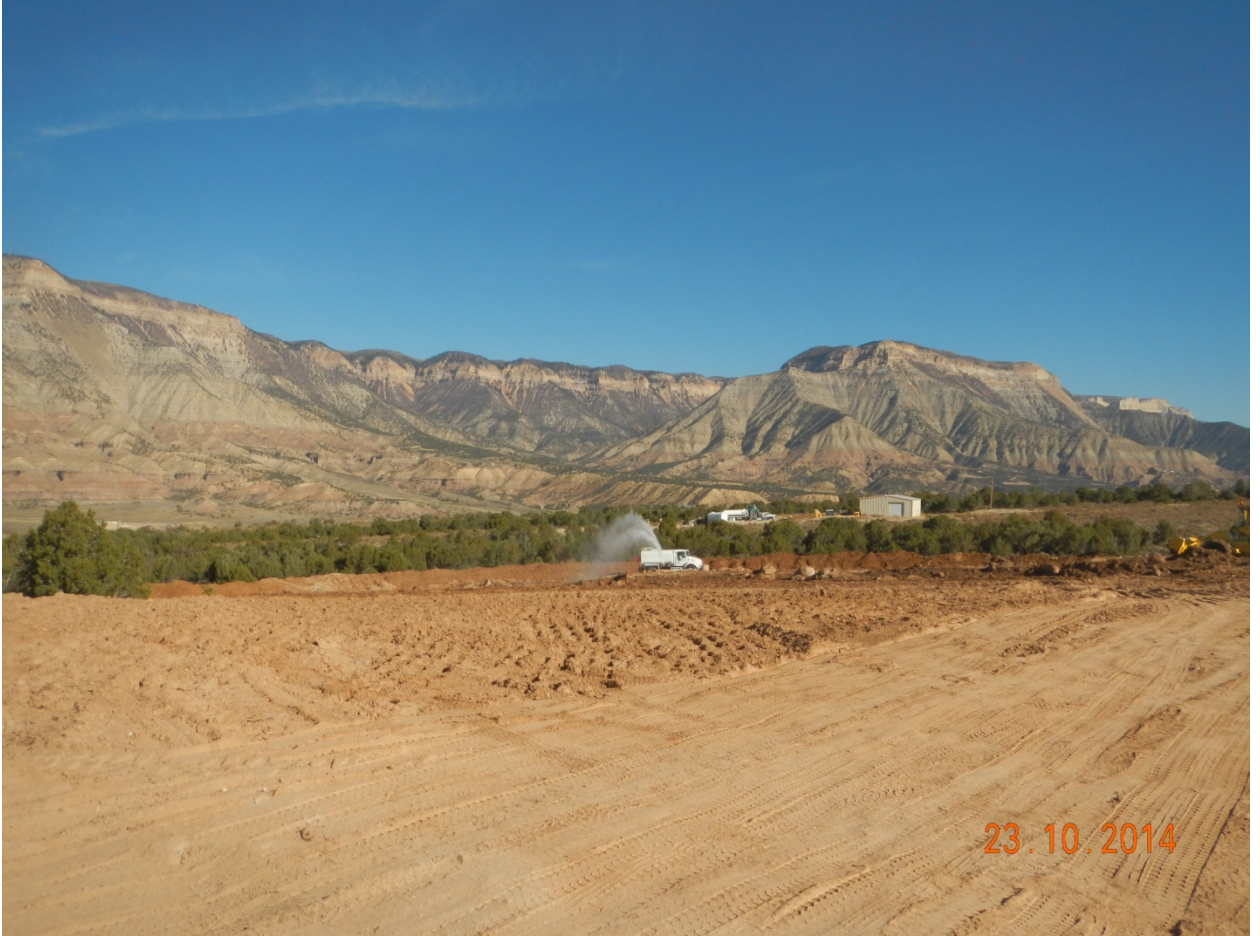
3. Location, viewed NE from entrance.

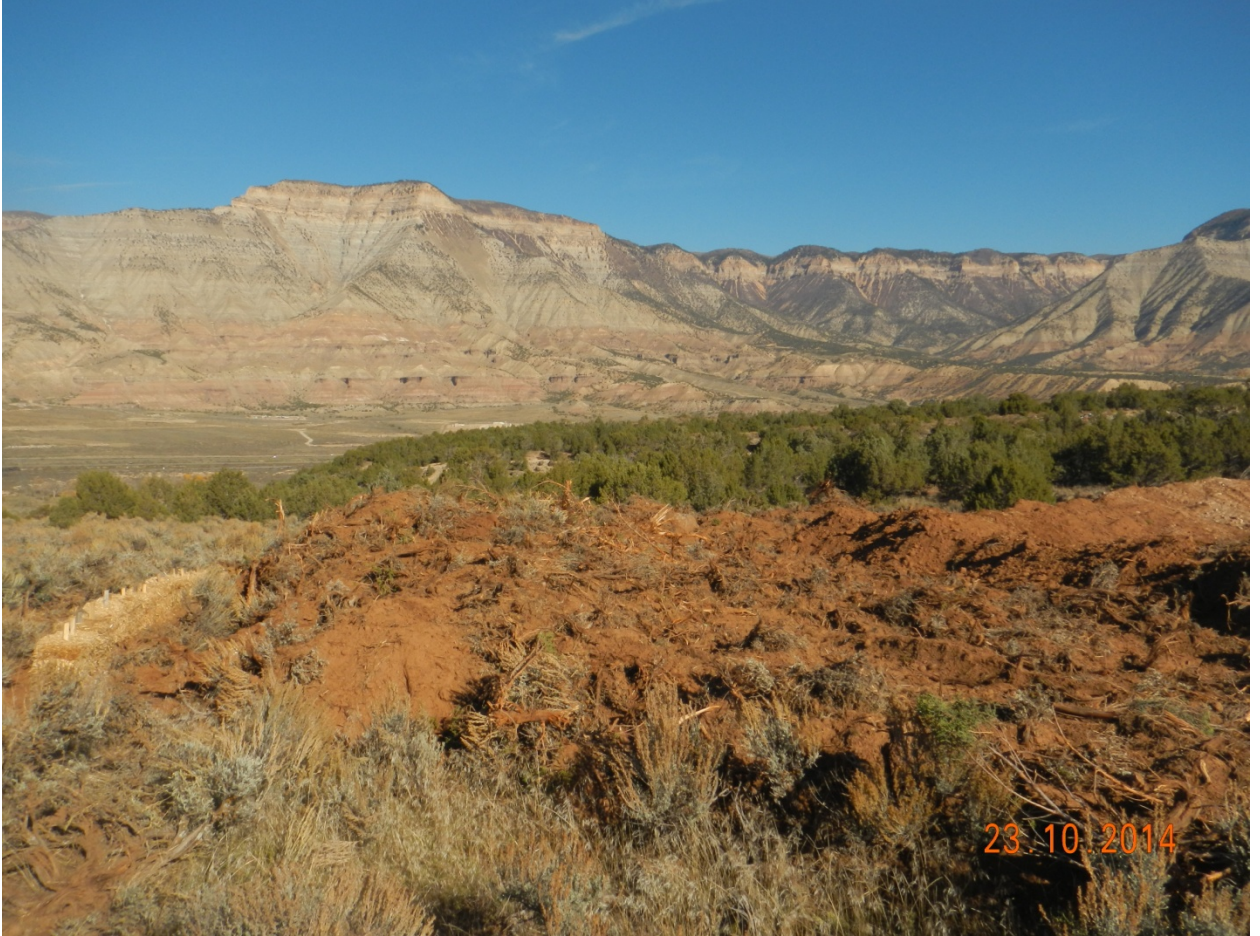
4. Pad Western perimeter, viewed North from Western perimeter.

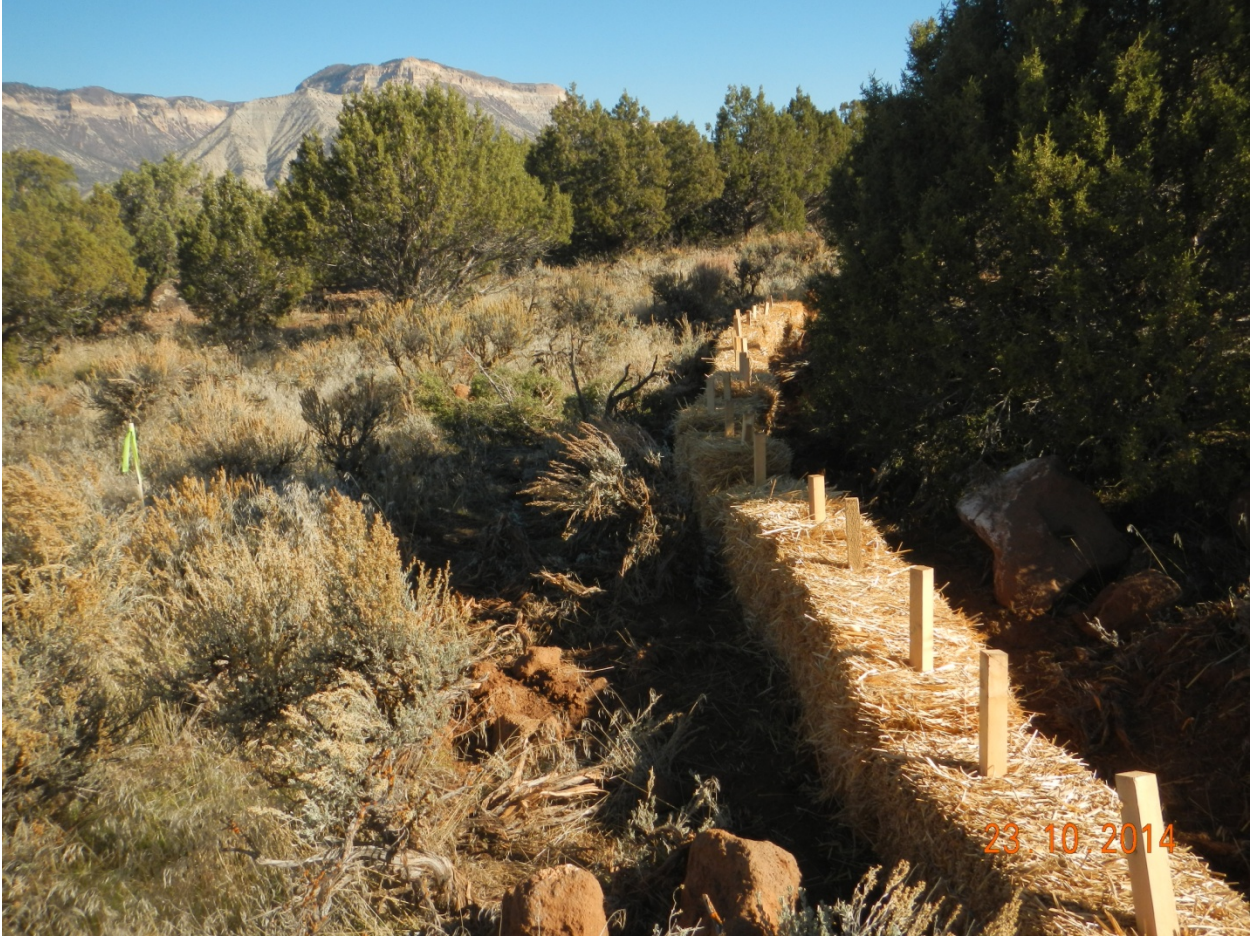
5. Pad Northern perimeter, viewed east from NW corner.

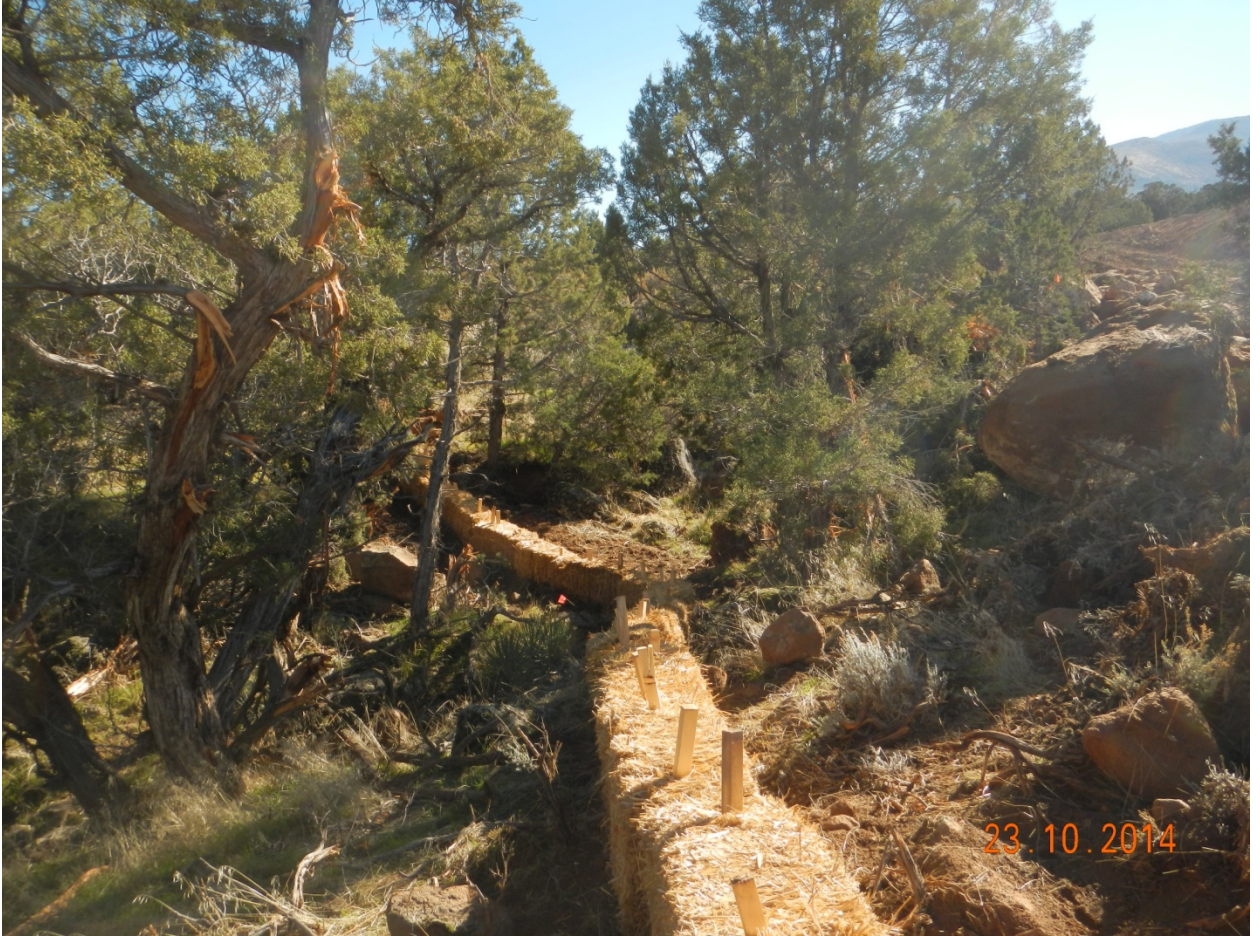
6. Pad Eastern perimeter, viewed South from center of perimeter.

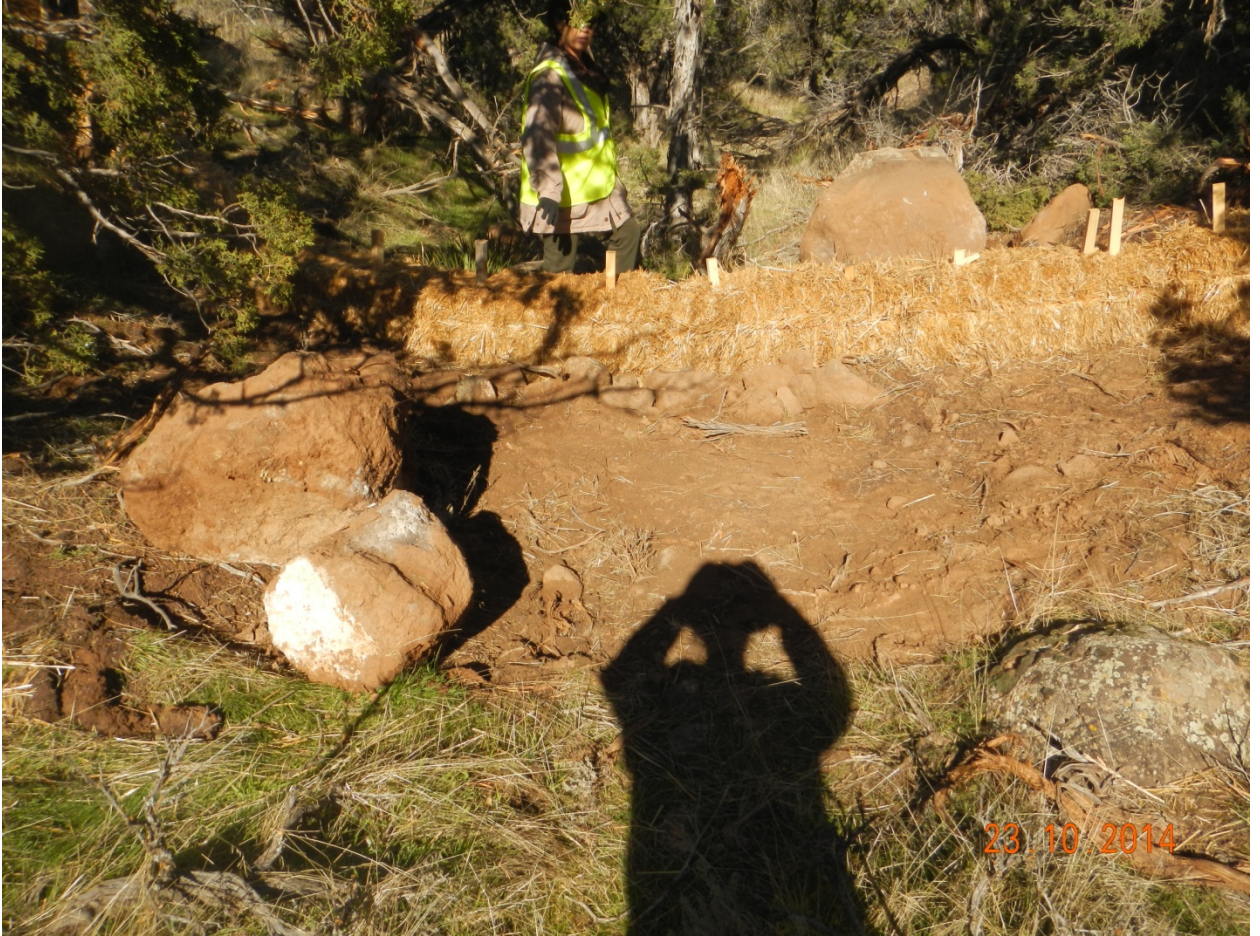
7. Pad Eastern perimeter natural drainage, viewed North from SE quarter along perimeter.

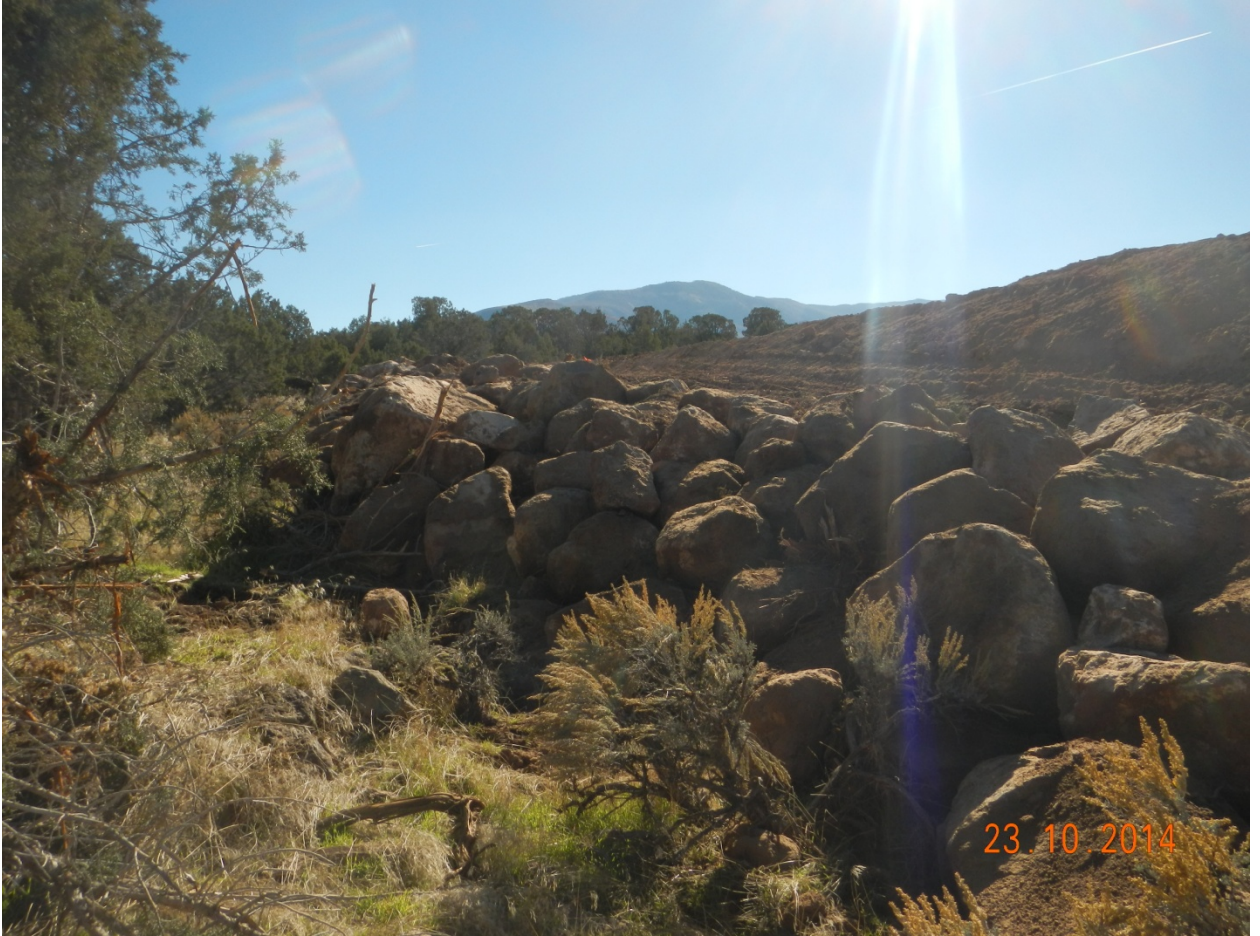
8. Pad Eastern perimeter, viewed South from SE quarter along perimeter.

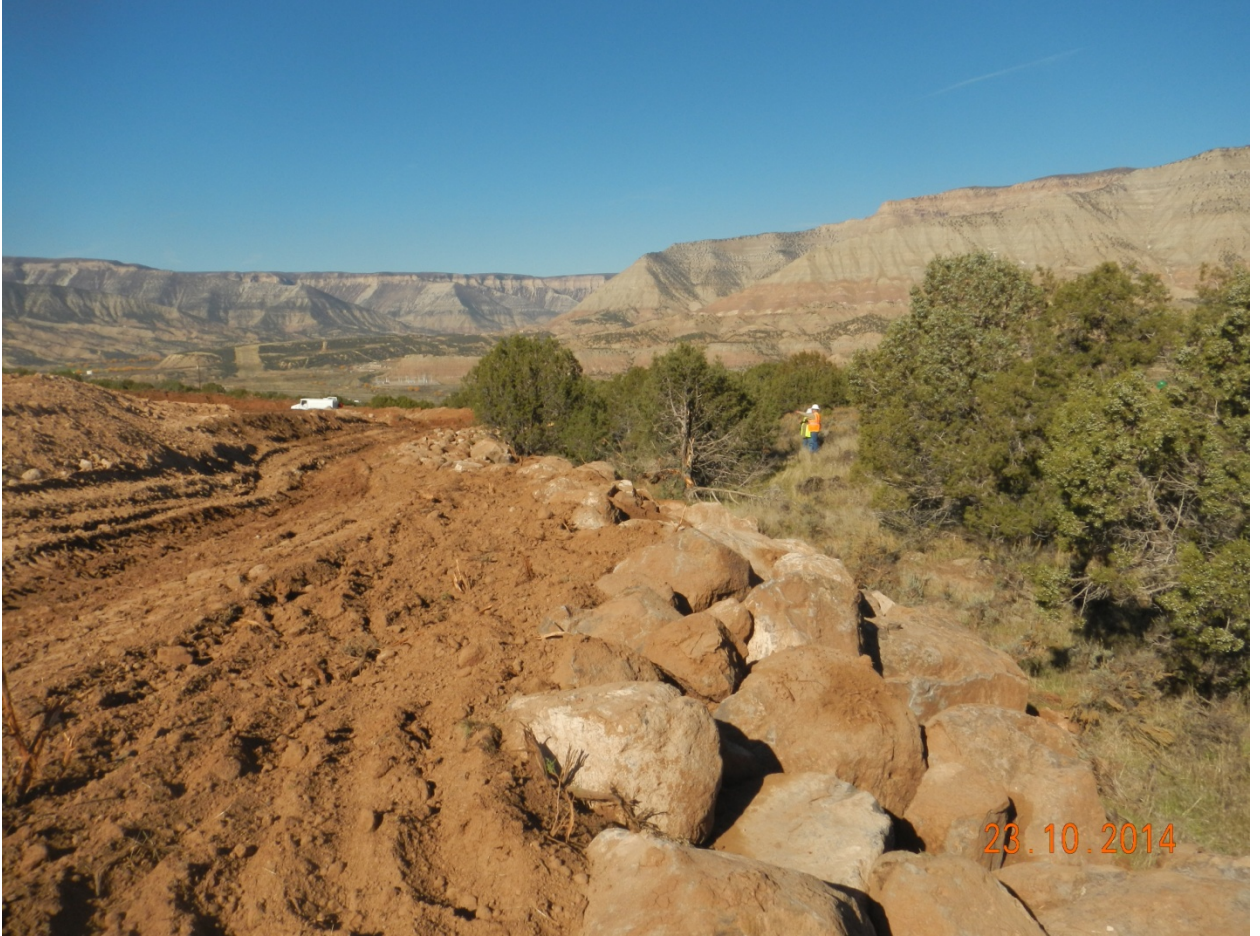
9. Pad Eastern perimeter, viewed North from SE quarter along perimeter.

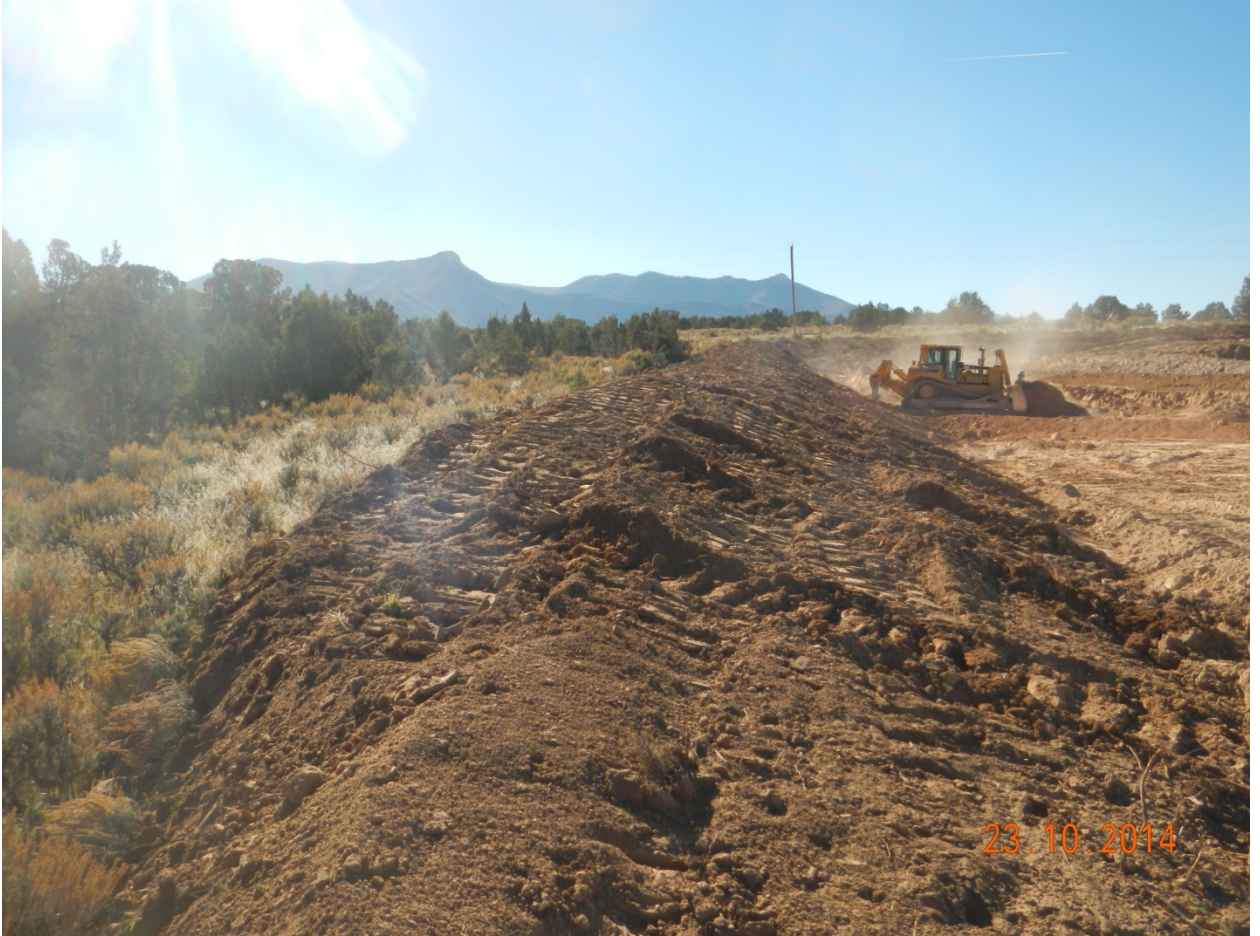
10. Pad Eastern perimeter, viewed South from SE quarter along perimeter.

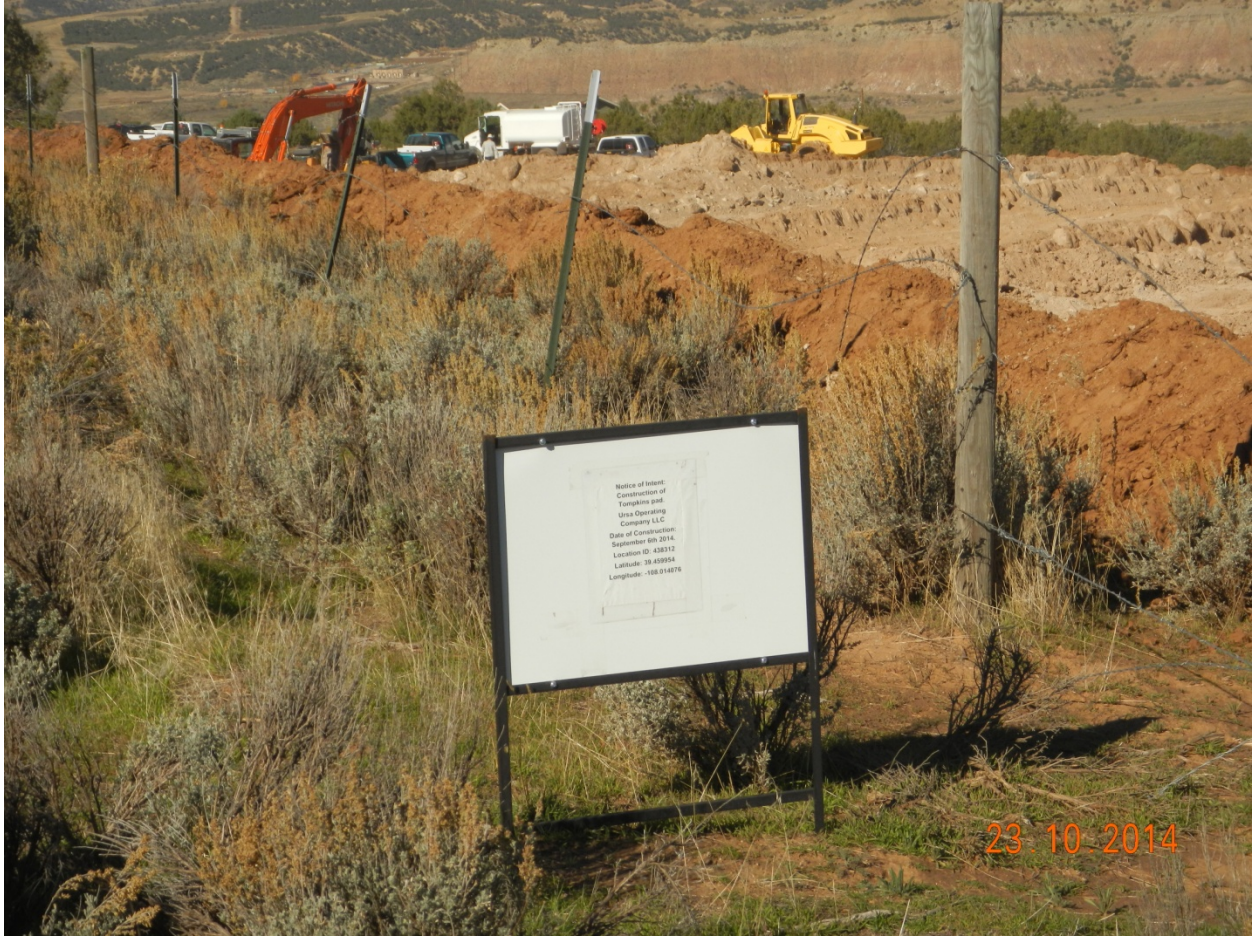
11. Pad Southern perimeter and location sign, viewed West from SE corner.

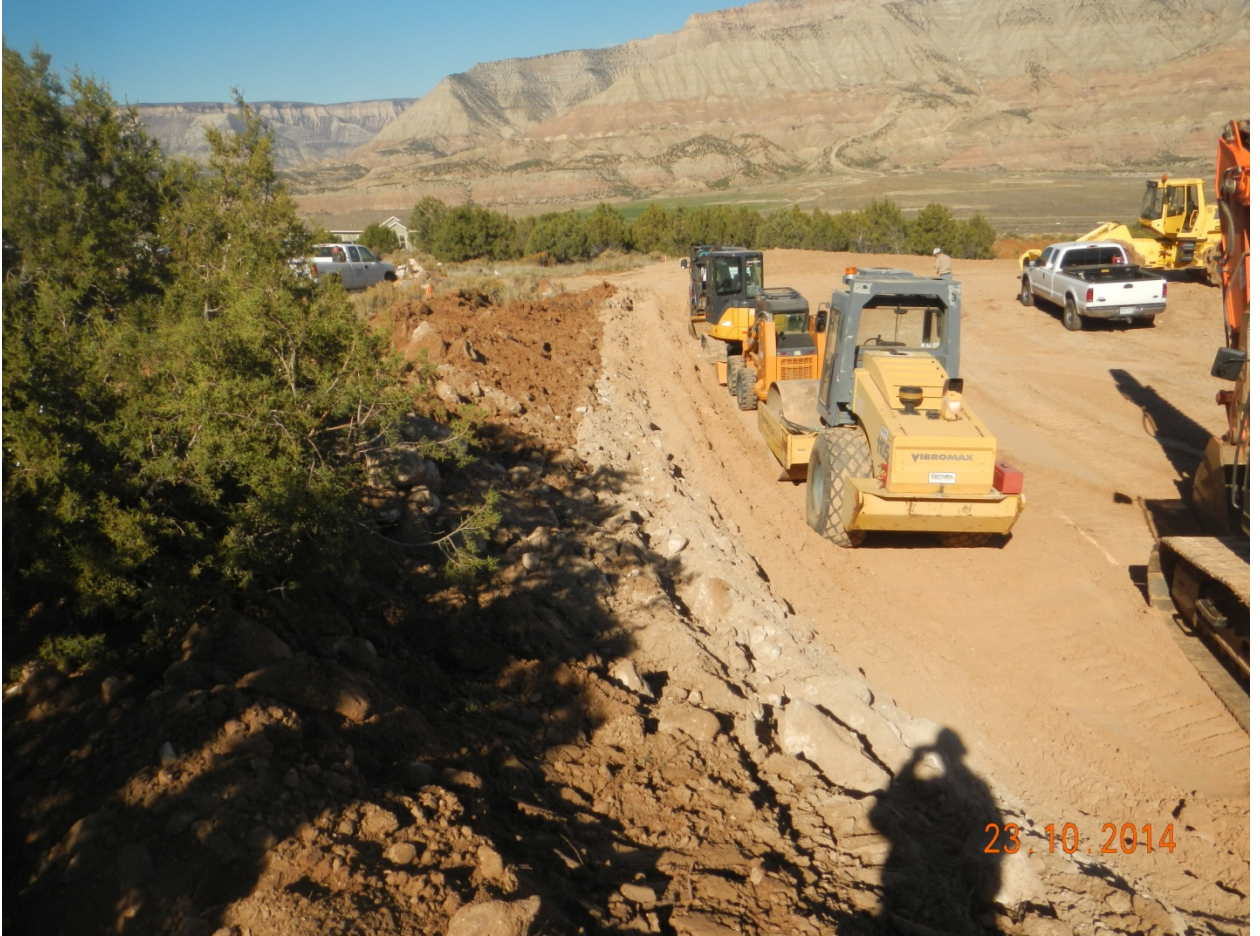
12. Pad Western perimeter, viewed North from SW corner.

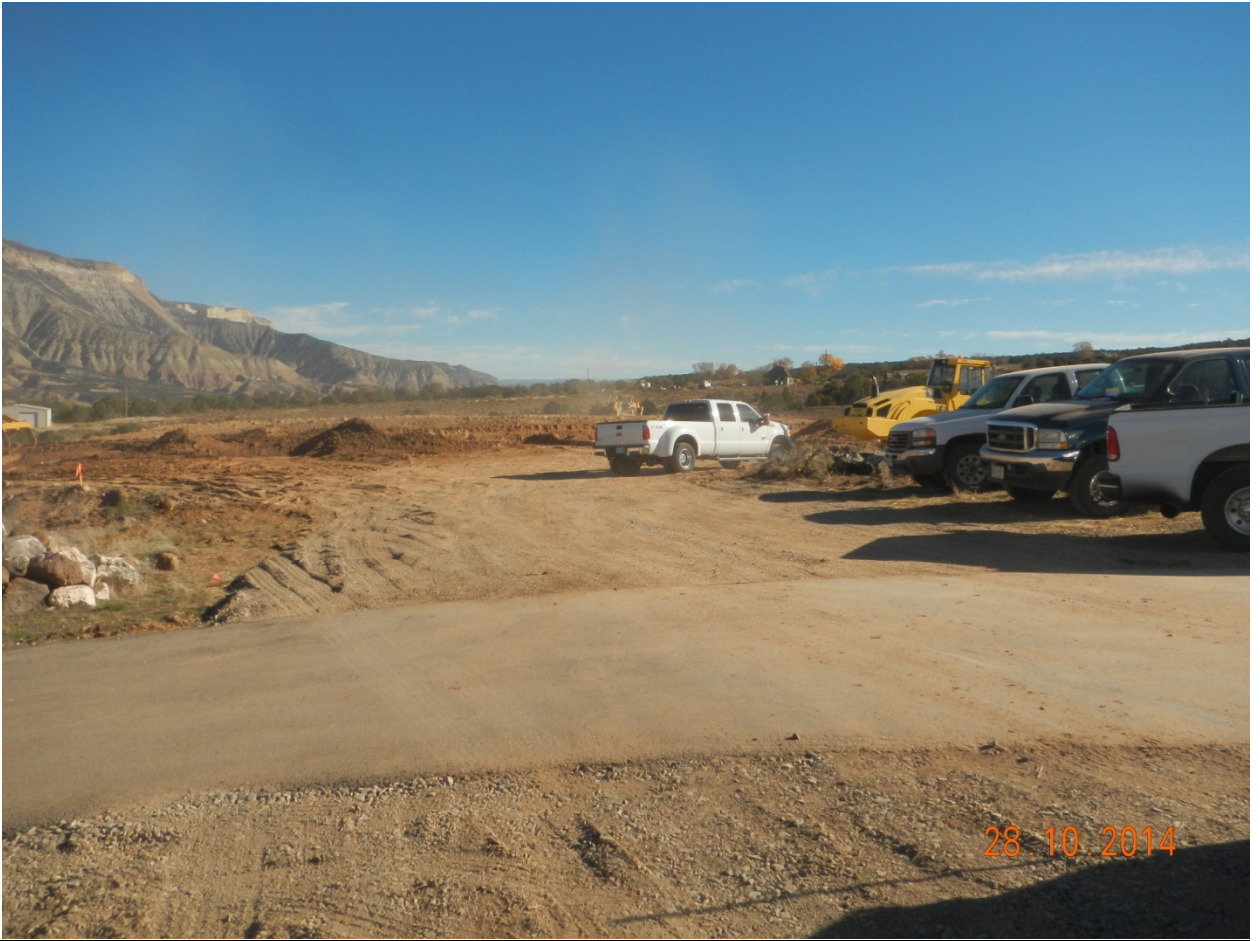
13. Location access road entrance, viewed SW from NE.

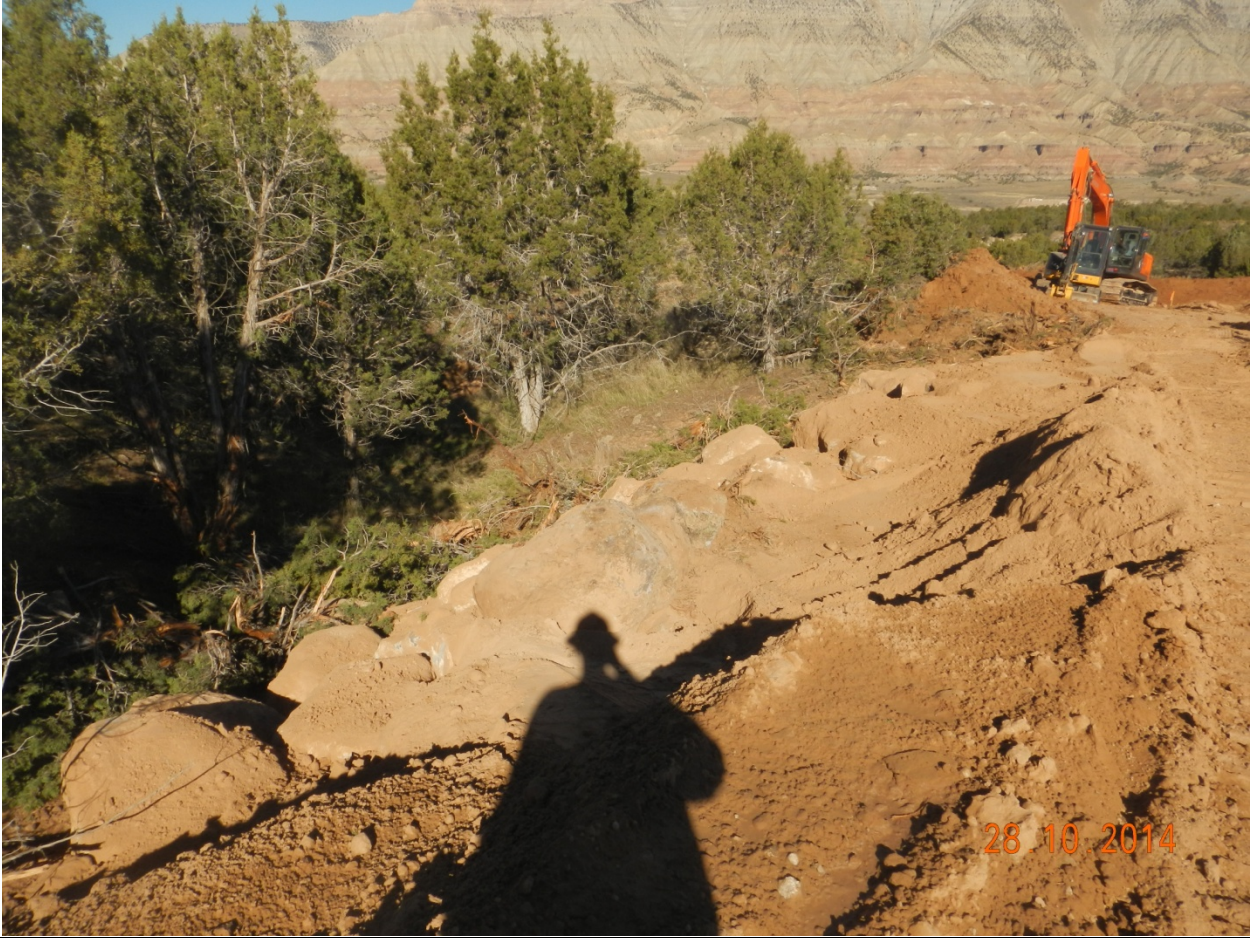
14. Pad Western perimeter, viewed North from entrance.

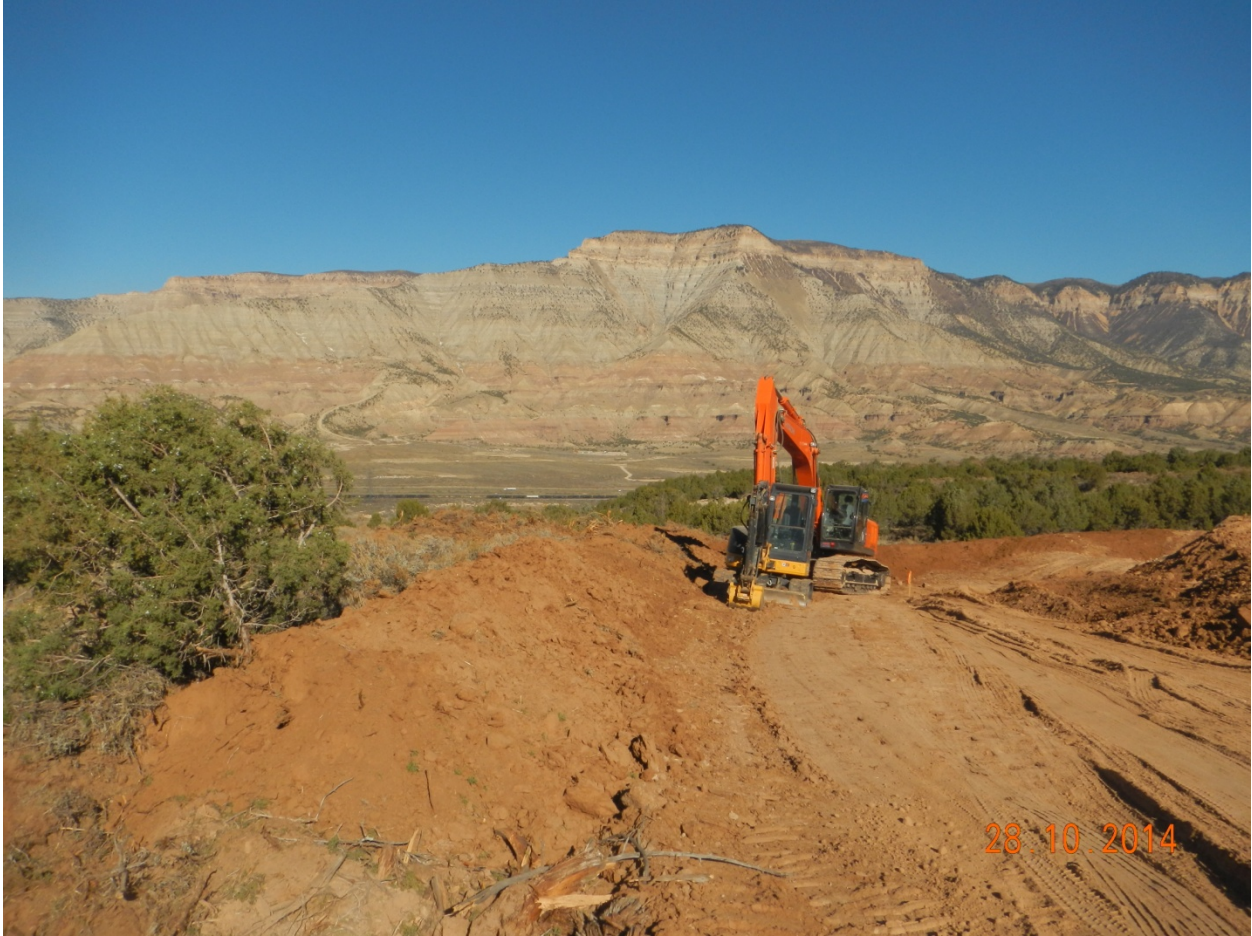
15. Pad Western perimeter, viewed North from center of Western perimeter.

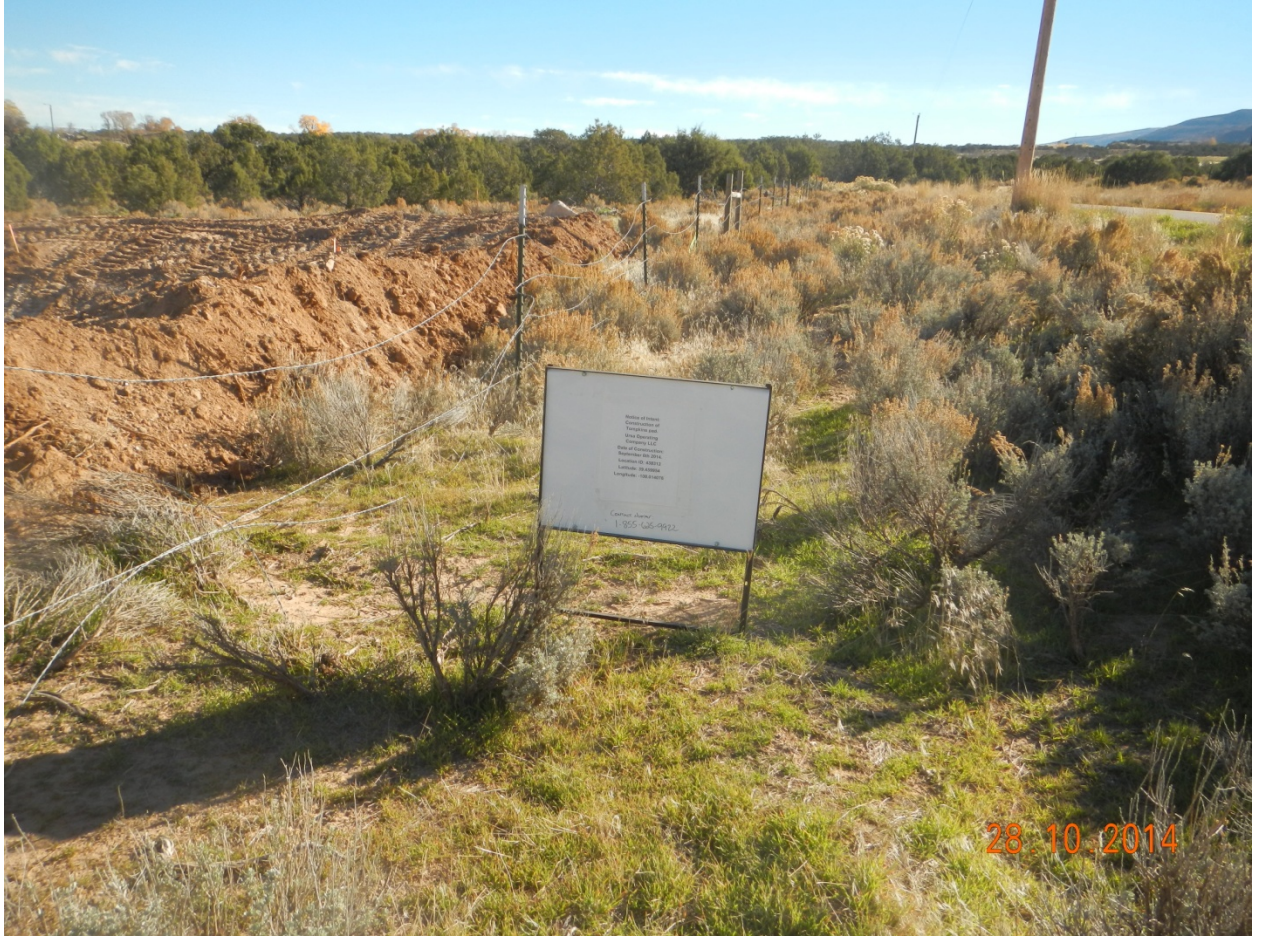
16. Location sign, with contact information, viewed East from center of Southern perimeter.
