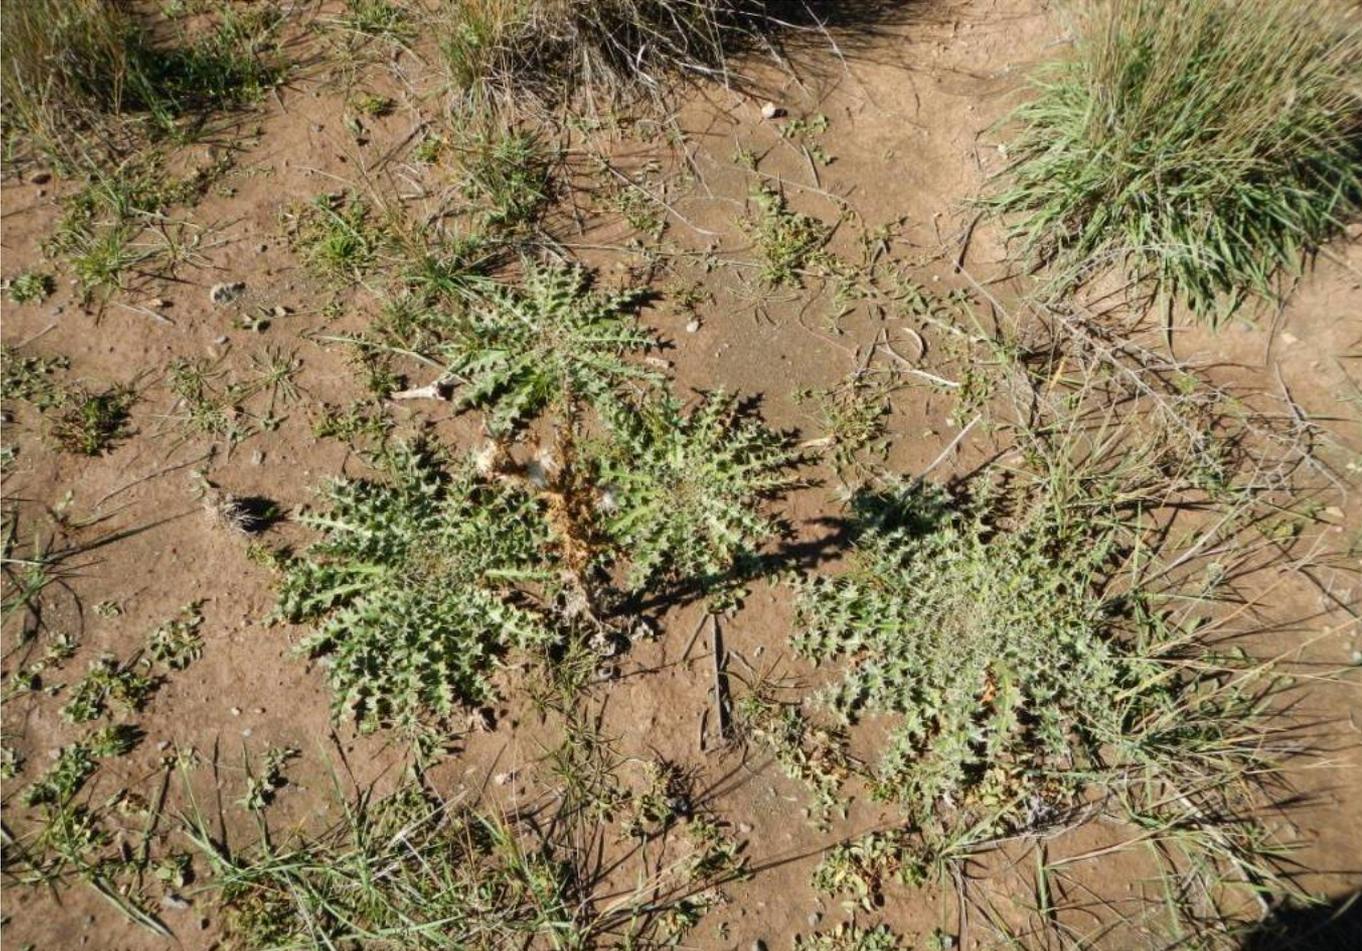
Photo 1. View of Scotch thistle (*Onopordum acanthium*) rosettes within the project area.

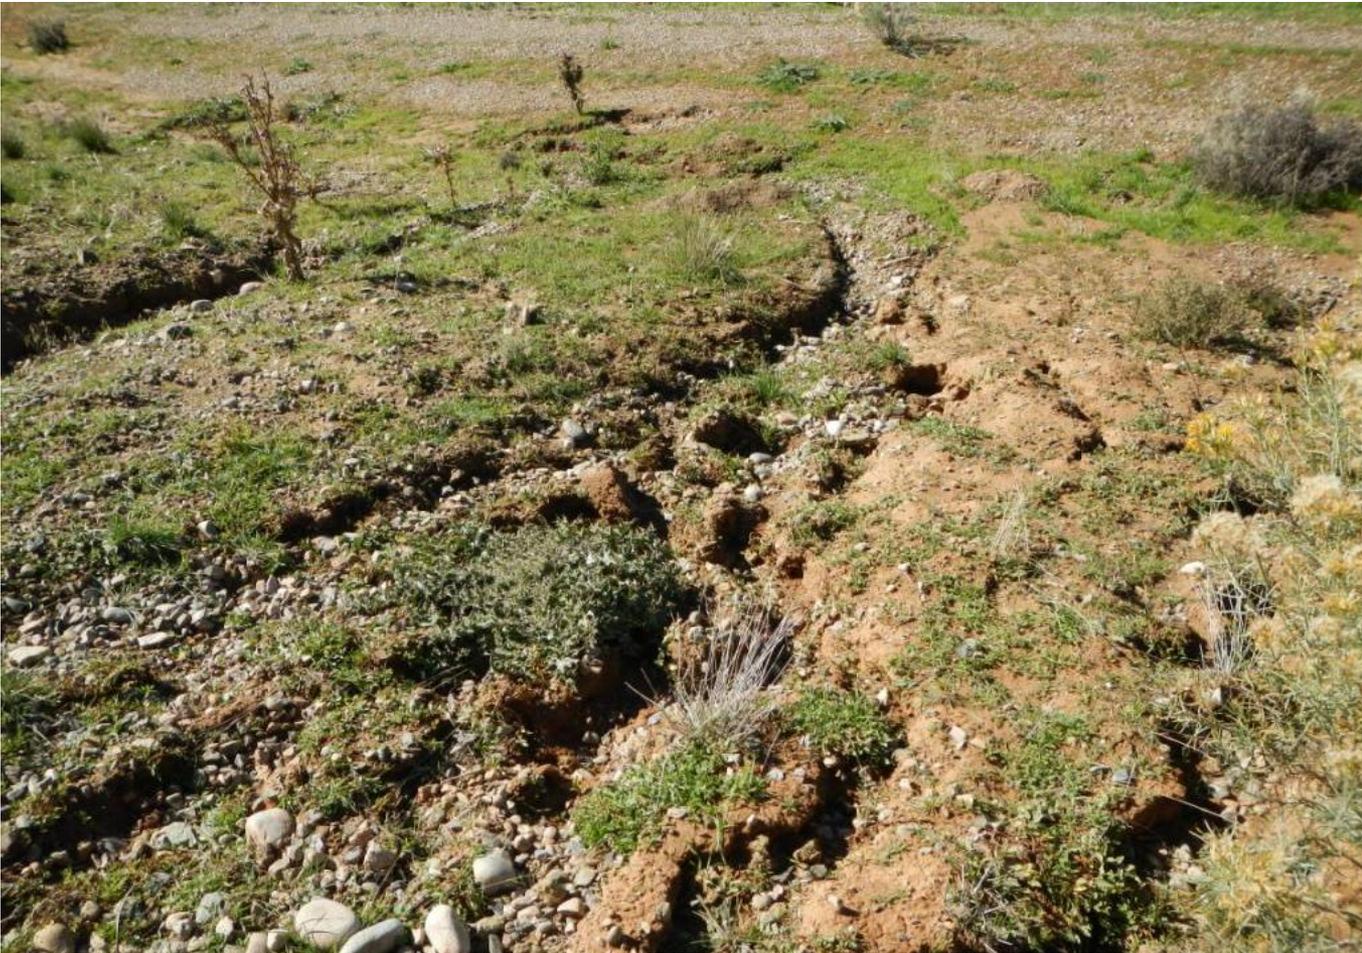
Photo 2. View of rill and gully erosion occurring within the western portion of the project area.

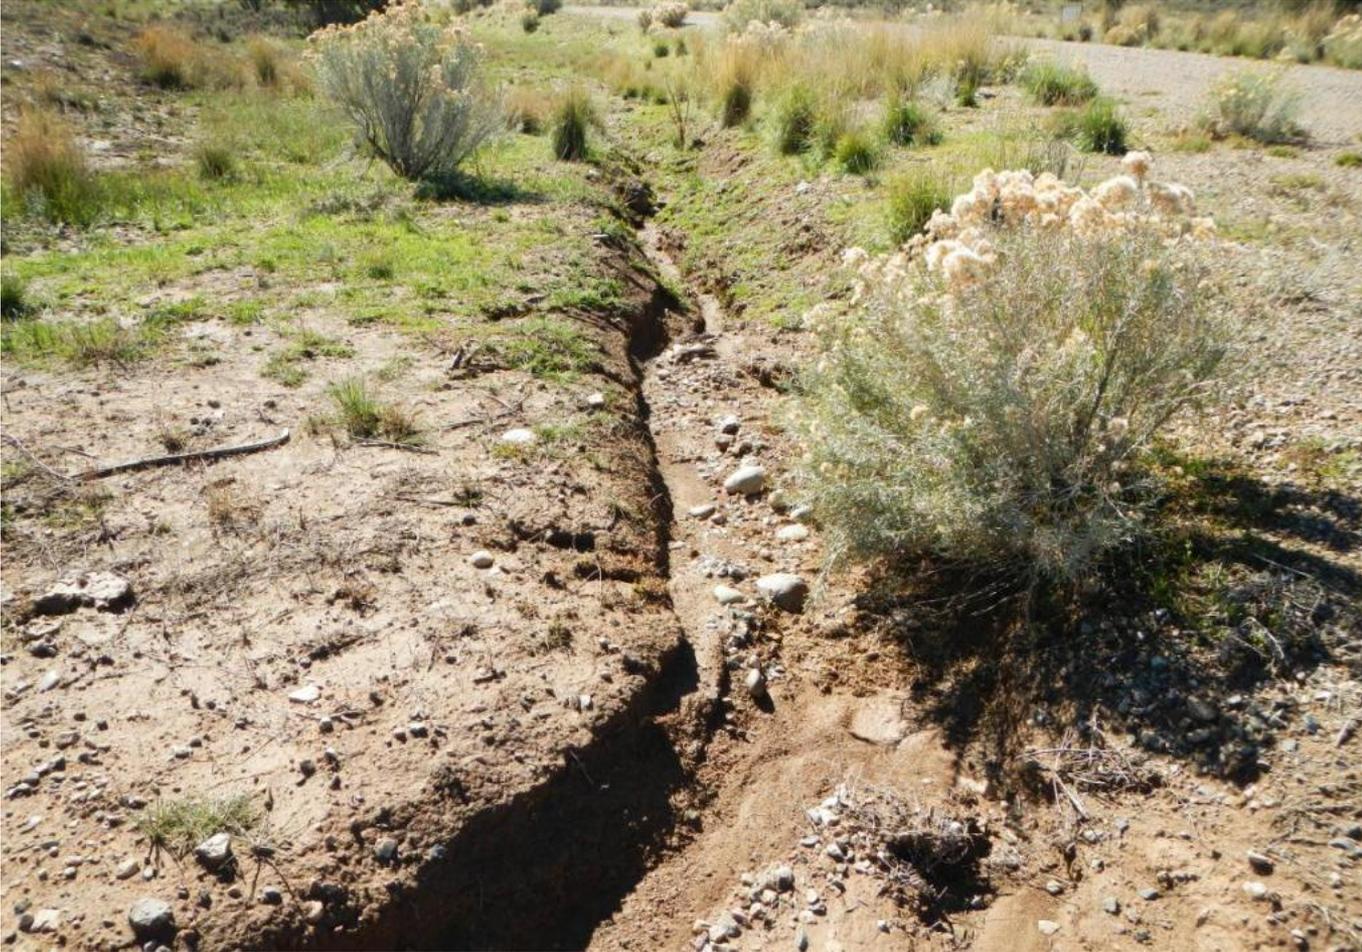
Photo 3. View of erosional drainage forming along the eastern edge of the access road near the entrance to the well pad.

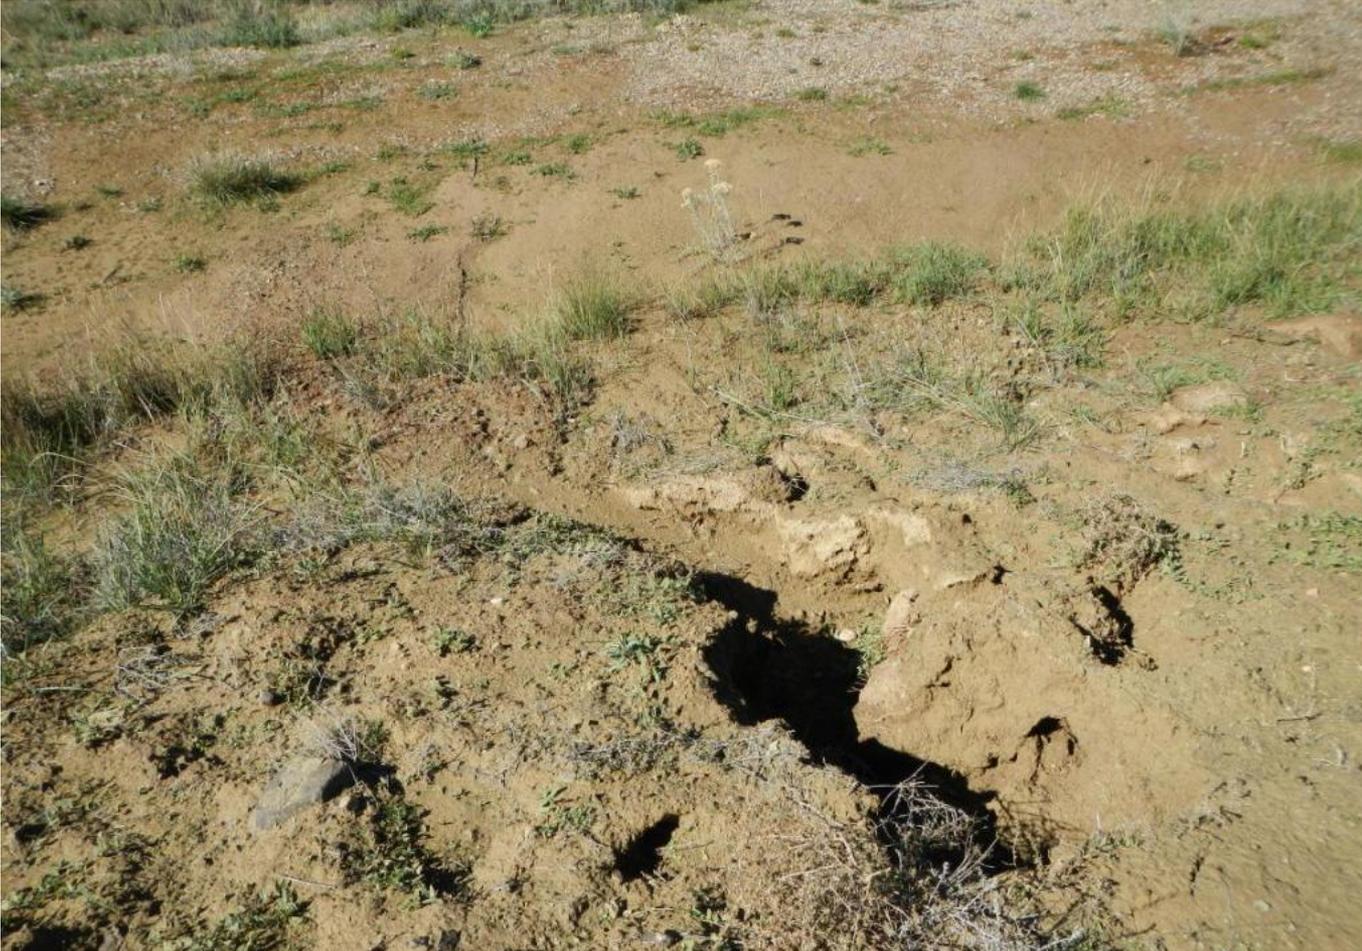
Photo 4. View of erosion occurring along the western edge of the project area.

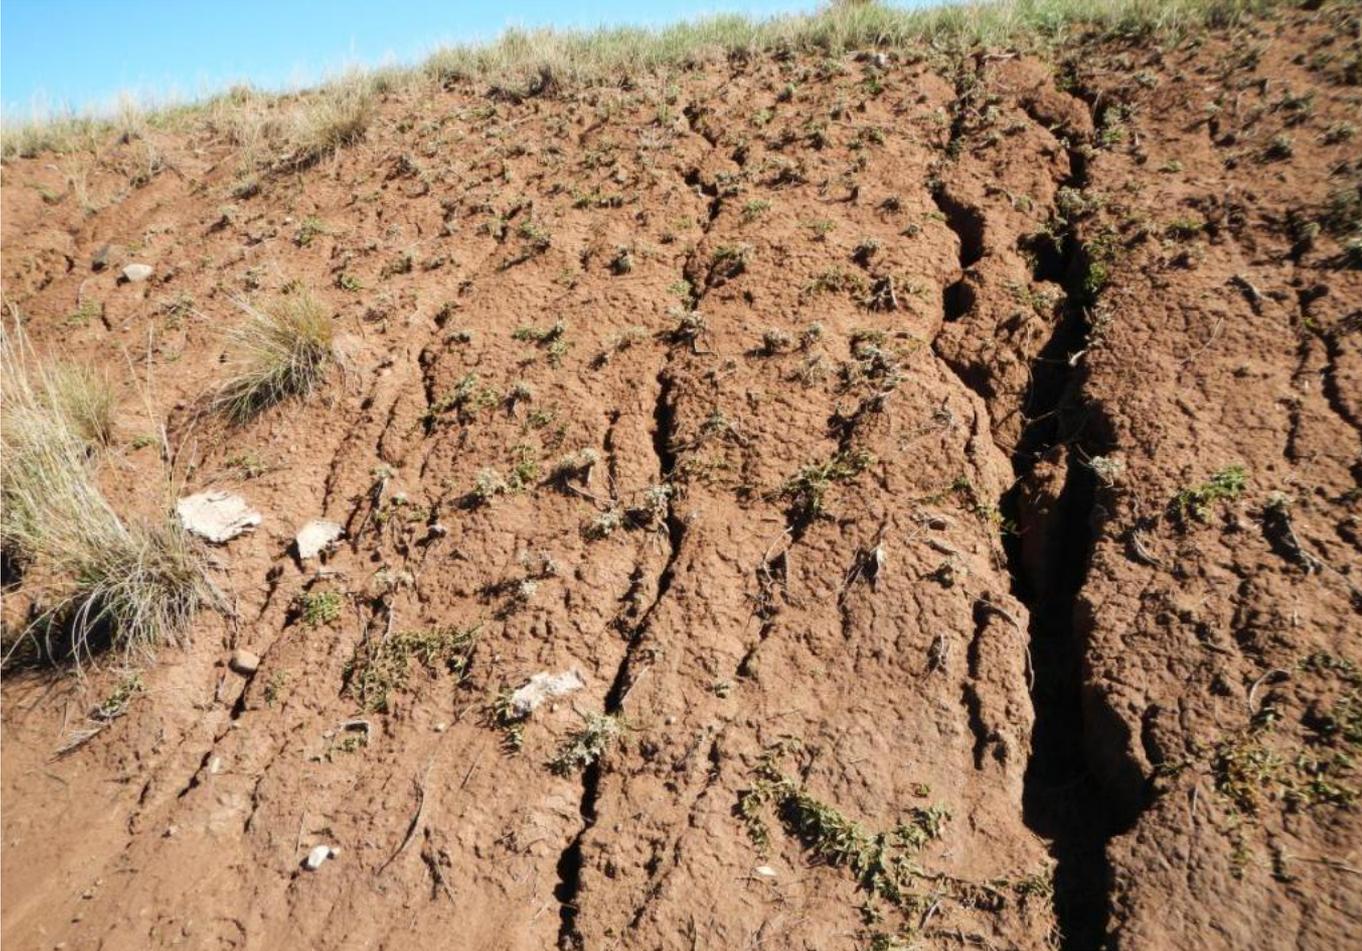
Photo 5. View of rill erosion on one of the cut slopes within the project area.

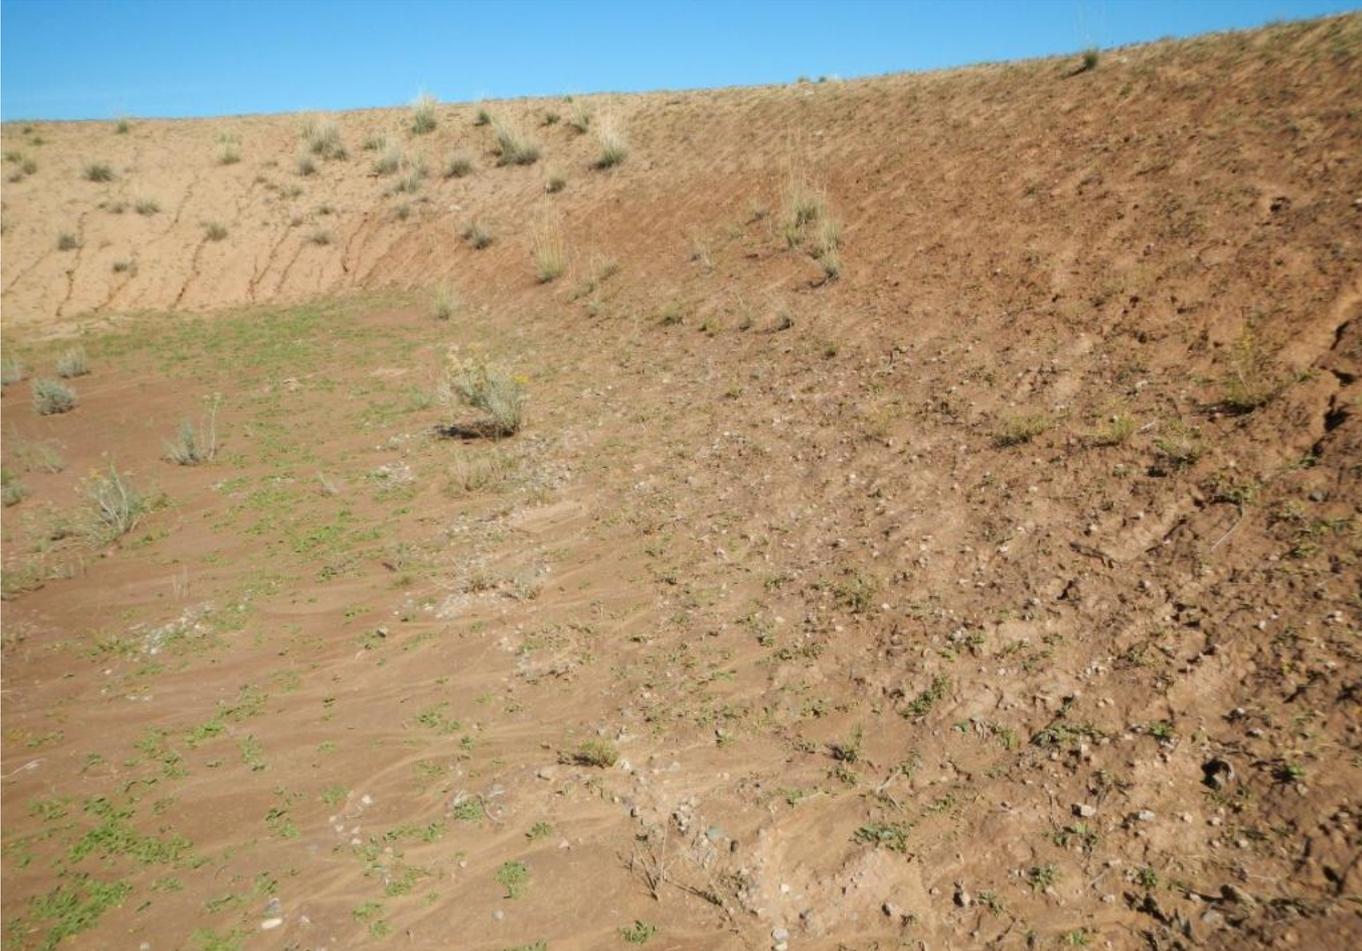
Photo 6. View of rill erosion and sediment deposition below cut slopes within the project area.
