November 7, 2014

LOCATION 391314
FACILITY 116525
FACILITY 433509
DOC 2142521

Re: Final Summary Report, Roan Creek Evaporation Pond

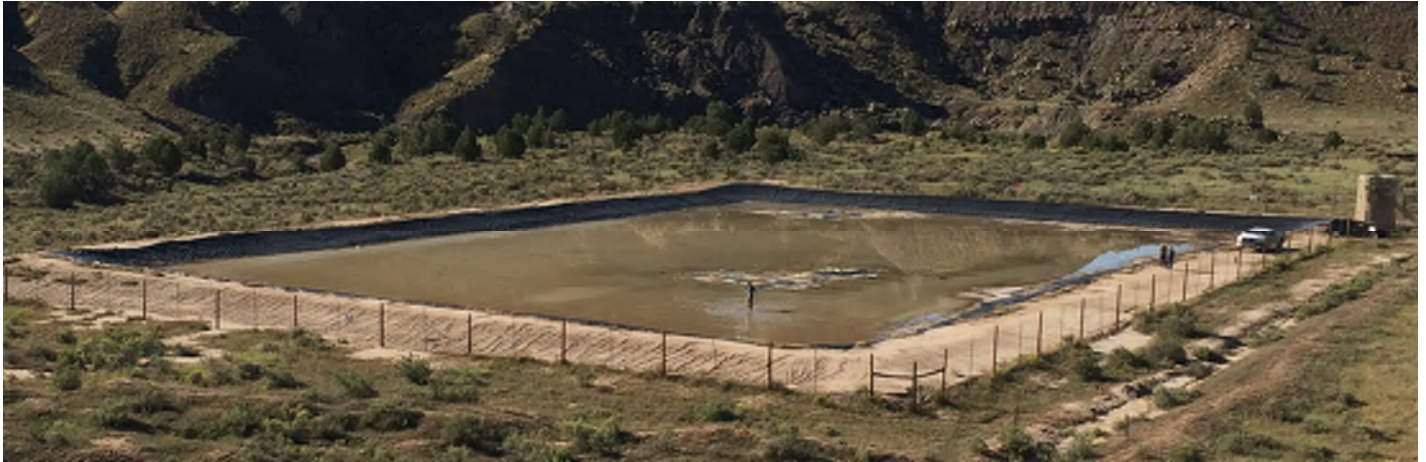
Photograph 1: View looking south of pit during leak testing. Note the LLSI testing person and exposed liner in the central portion of the pit and along the southern boundary.

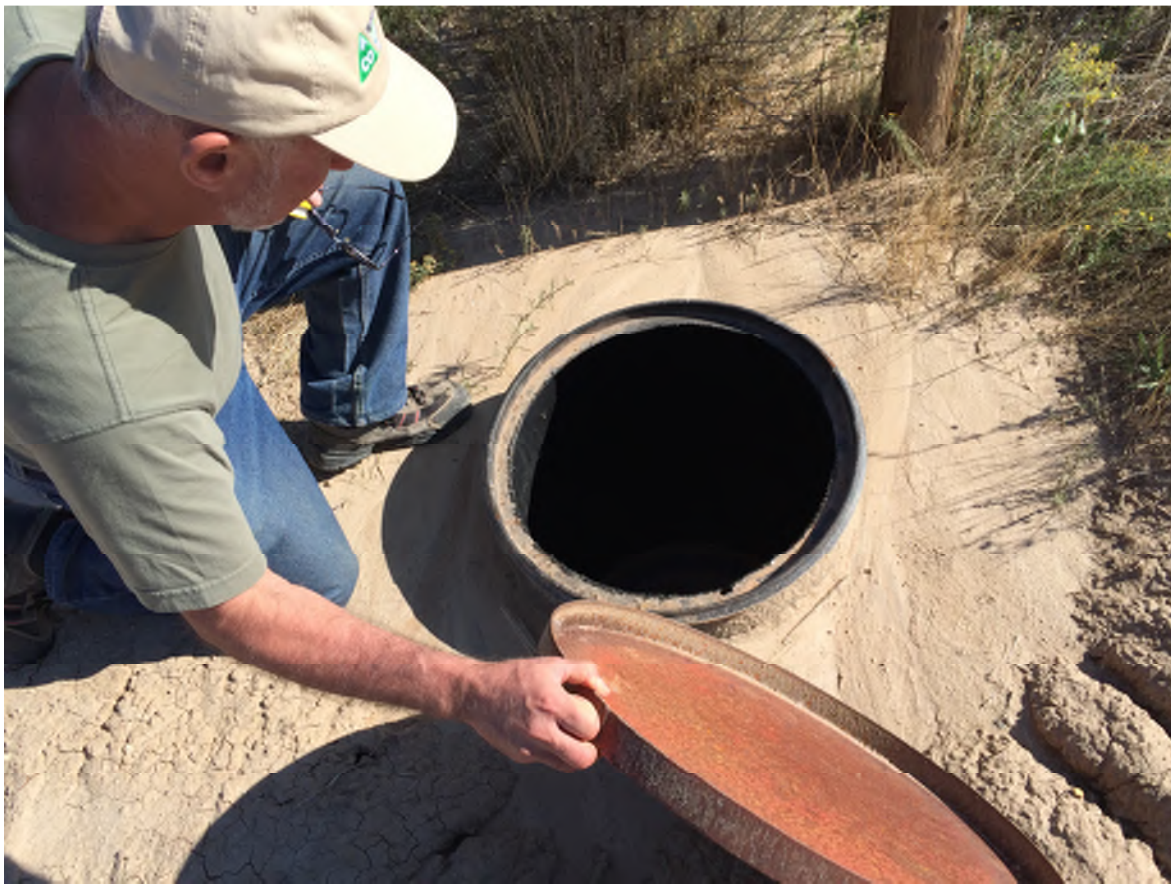
The LDS manhole was observed at the north end of the site. No water was present in the LDS manhole even though at least ten holes were marked by LLSI below standing water.

Photograph 2: Leak Detection Manhole

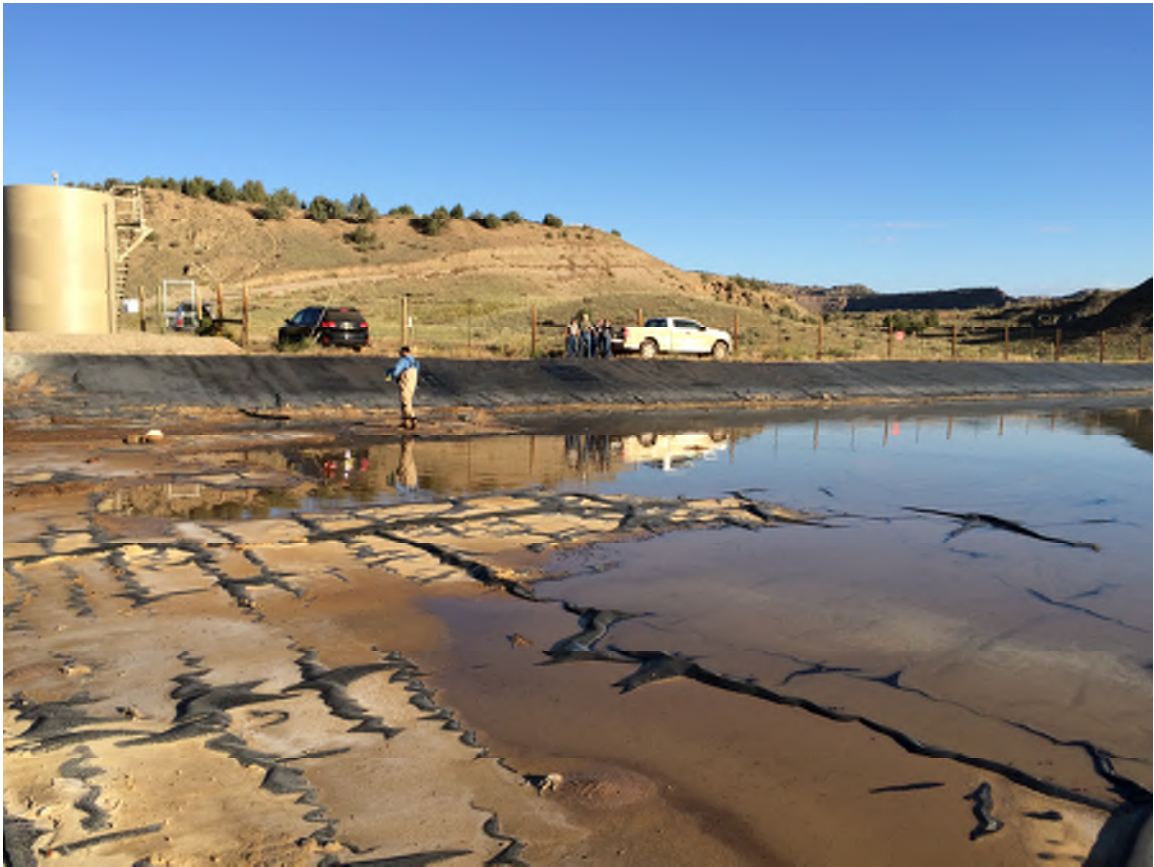
The geomembrane panels extend east to west and had previously been labeled Nos. 1 through 14 by Maralex. LLSI performed their survey from about 8 am to 2pm with a ½ hour break for lunch. Holes were marked by wrapping rocks in brightly colored rags and placing them over the hole. A total of 14 holes were marked by LLSI, including holes visually seen on the "island". Panels 1 and 2 were not tested because insufficient standing water was present (see Photographs 3 and 4). LLSI field measured the hole locations.

Photograph 3: View looking west at exposed liner on south side of pit

2. If the pond is filled as recommended in No. 1 above, then bring LLSI back to test the non-tested areas so that holes in those locations can be identified and repaired. All areas of the liner should either be cleaned enough to be thoroughly visually inspected or be covered with water and leak tested.

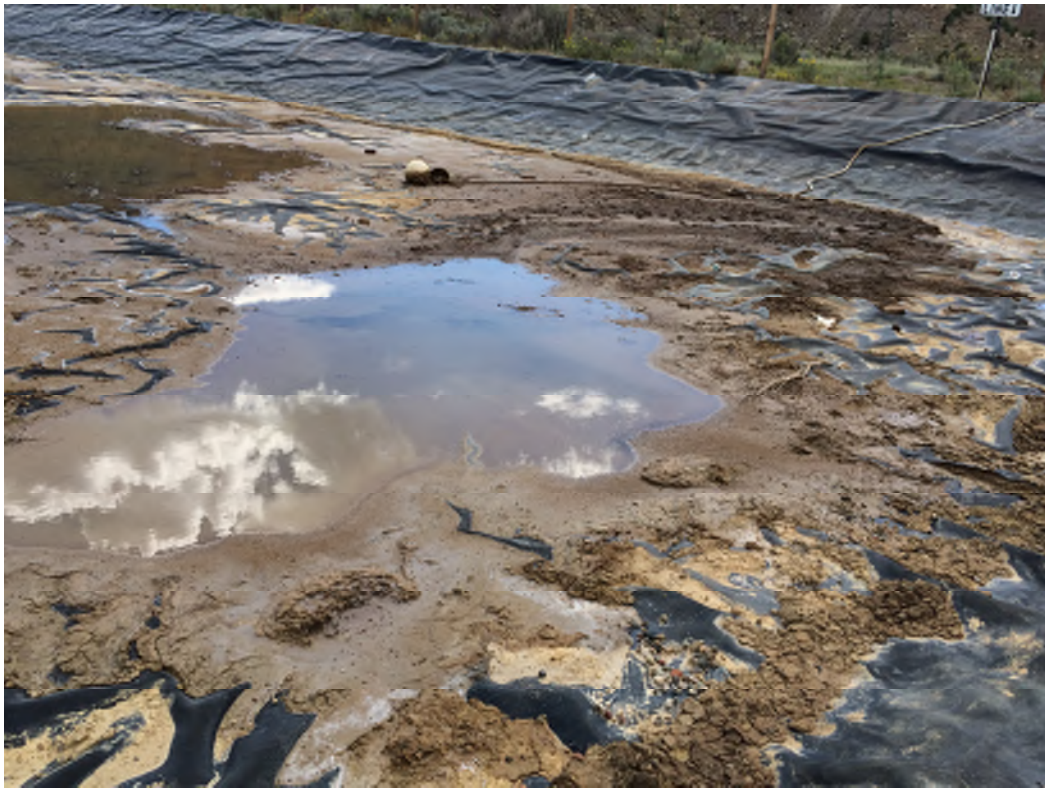
Photograph 4: Close up view of the area not covered by water in the southwest corner of the pit.

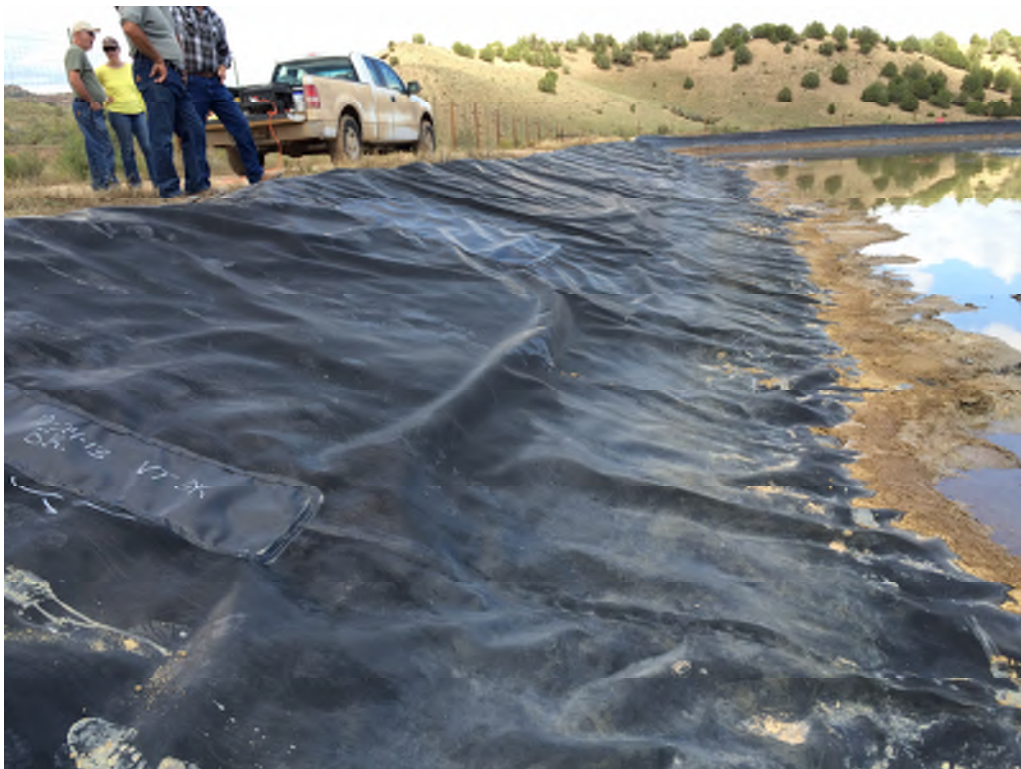
The exposed portions of the liner were walked several times. Uneven and soft subgrade was observed beneath the liner at several locations along the toe of slope. The locations where samples of the geomembrane panel and seam were removed and sent to a lab for strength testing were observed (Photograph 5). Also the badly deteriorated Panel 14 reported in Maralex' documentation was observed (Photograph 6). It was noted that the deterioration, which consisted of continuous lines of vertical brittle cracks spaced about one inch apart and about two feet in length. The cracks occurred where the liner was stained a whitish color on the bottom half of the northern side slope, which is assumed to be the level where water previously covered the liner. The cracks appeared to be chemical in nature and not physical scratches or striations. This deterioration was not observed in areas above the high water mark based on a whitish stain. It was also noted that the geomembrane panel and seam samples previously tested by TRI Environmental, Inc. (TRI) in late 2013 were removed from locations above the high water mark.

2. TRI's cover letter to their test report also noted that the "onset of degradation is likely in the next few months and years as the antioxidant package is completely consumed." This means that geomembrane above the high water mark is already showing evidence of degradation.

Photograph 5: View of location where a geomembrane samples were removed for testing by TRI Laboratories. Note the locations are above high water mark denoted by the lighter stained liner to the right.

3. Geomembrane panel and seam samples from an area at or below the high water mark should be removed and sampled in the same manner as the previous samples taken above the high water mark. Preferably, these samples would be taken on the same panel and seam as the previous ones and tested for the same parameters as the original TRI tests to note any difference in values.

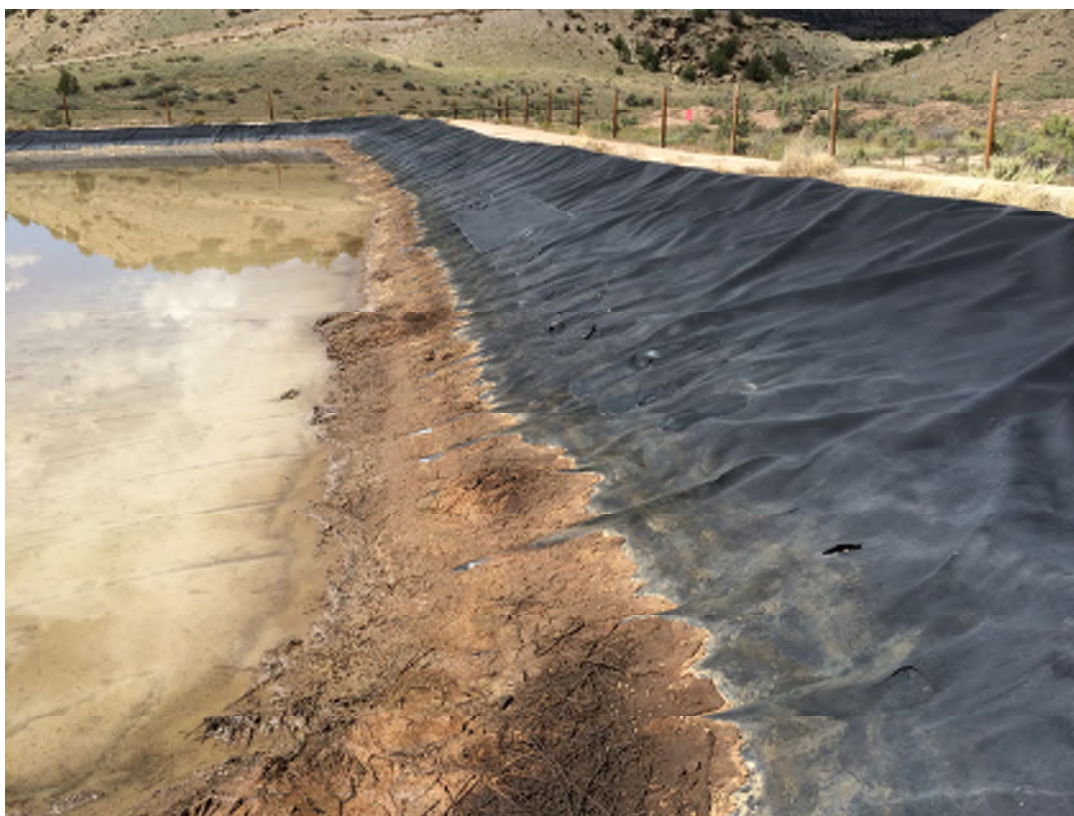
1. It is suspected that something in the pond contents, possibly hydrocarbons, *may* have leached the carbon black from the geomembrane and made the geomembrane more susceptible to ultraviolet ray deterioration, resulting in the brittleness and cracking beneath the high water mark. If this theory is correct, all the panels are deteriorating – not just Panel 14. Panel 14, which is oriented with a southern aspect, receives the most sunlight and thus is just deteriorating at a faster pace than the other panels.

Photograph 6: View of deteriorated Panel 14 along north side of pit. Note the holes and patches are all generally located at or below the high water mark.

It is Burns & McDonnell's opinion, based on the data reviewed and observations described above, that Panel 14 cannot be simply replaced and the remaining identified holes repaired and the liner meet the requirements of its planned future use or life expectancy. This is exemplified by TRI's remark that "degradation is likely in the next few months and years". We do have the following recommendations:

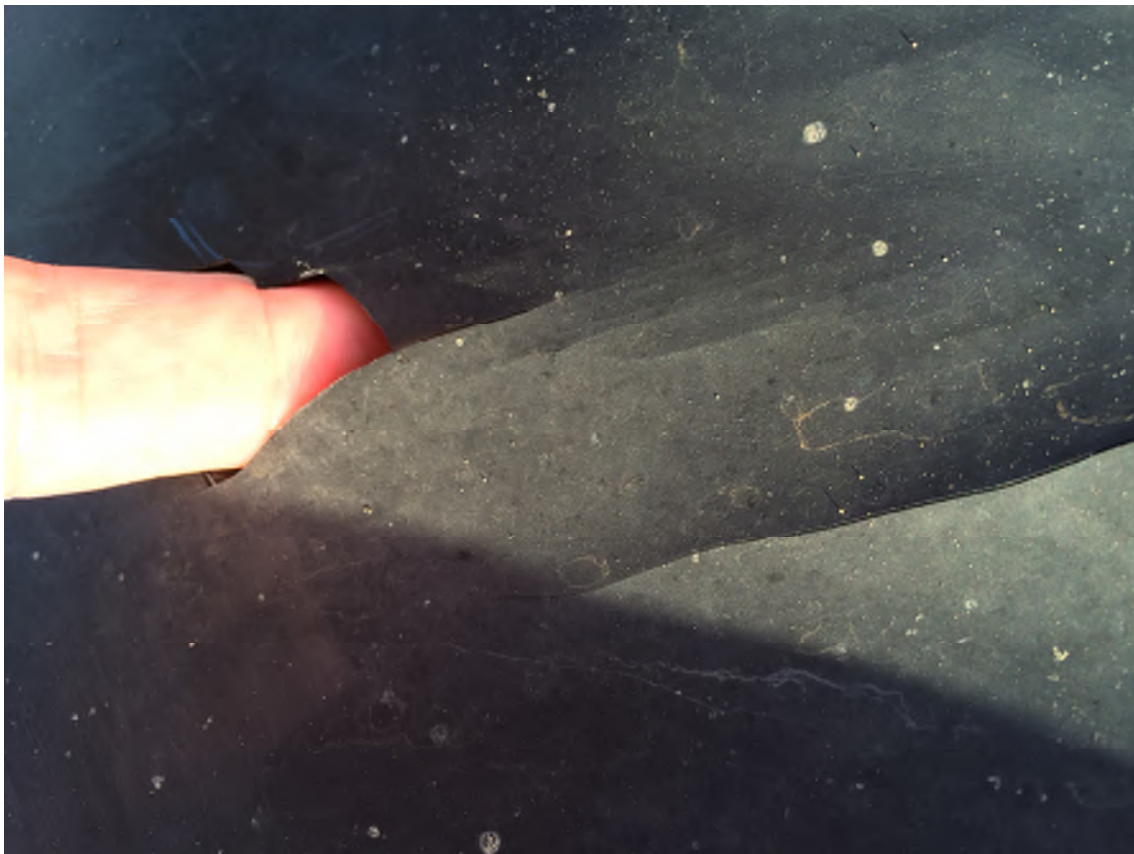
Photograph 7: Close-up of deterioration in Panel 14. Finger punctured through liner with little pressure.

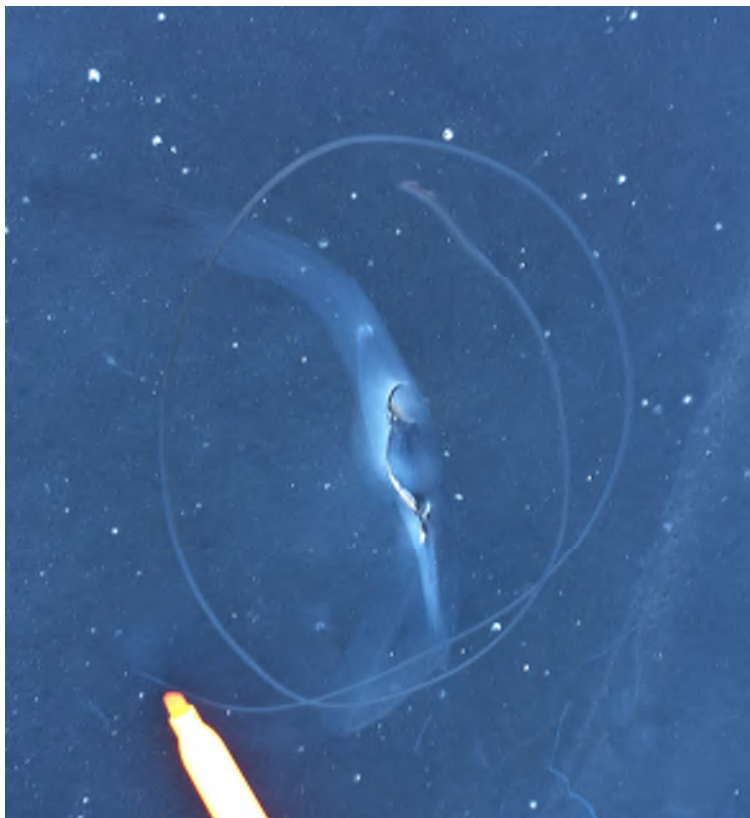
Numerous non-industry standard geomembrane patches were observed at several locations along the pond side slopes. Some were extrusion welded and some were not. Some of the patches utilized HDPE and some didn't. Some extrusion welds appeared to be professionally made to industry standards while others appeared to be of poor quality done by poorly trained and/or equipped technicians. Some patches were only partially welded. Most holes outside of Panel 14 had been marked for repair. Also some additional holes were observed (see Photographs 8 and 9).

Photograph 8: 2-inch long tear observed on Panel 5 east side slope.

3. All holes need to be repaired to geosynthetics industry standards by professional HDPE geomembrane installers and the repairs documented by qualified CQA personnel.

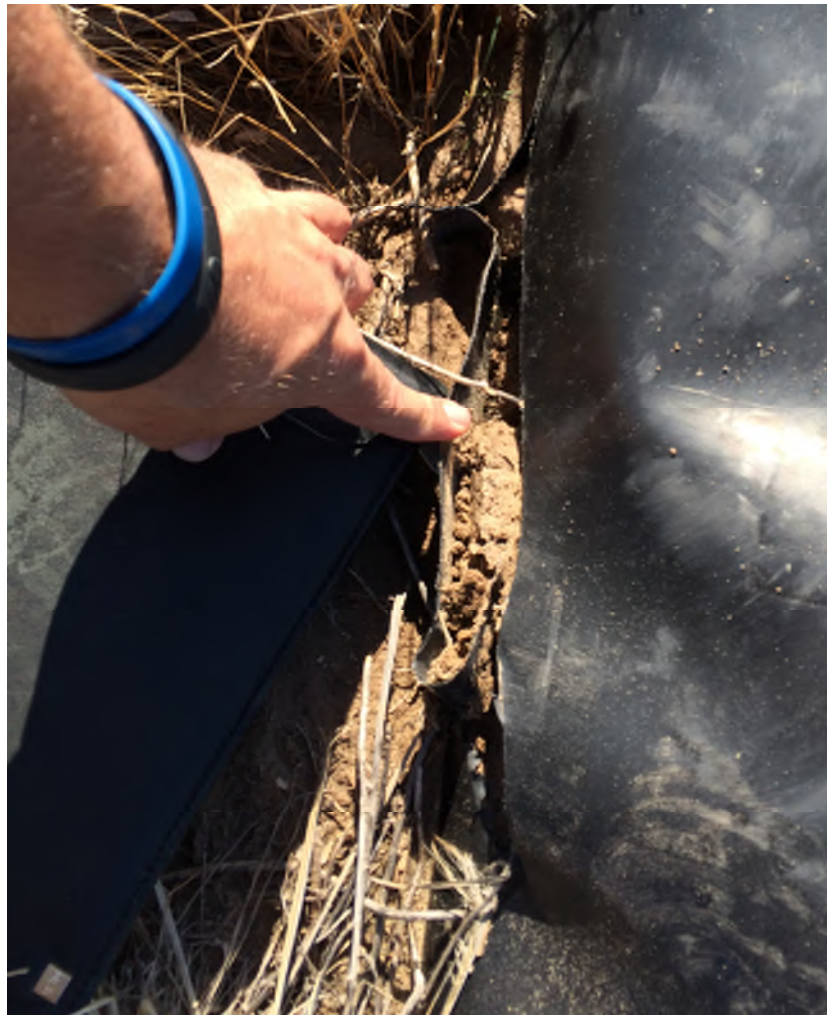
Photograph 9: 6-inch long rip observed along anchor trench in northwest corner.
