Federal 26-3 API#045-06213 Inspection performed 11/7/2014

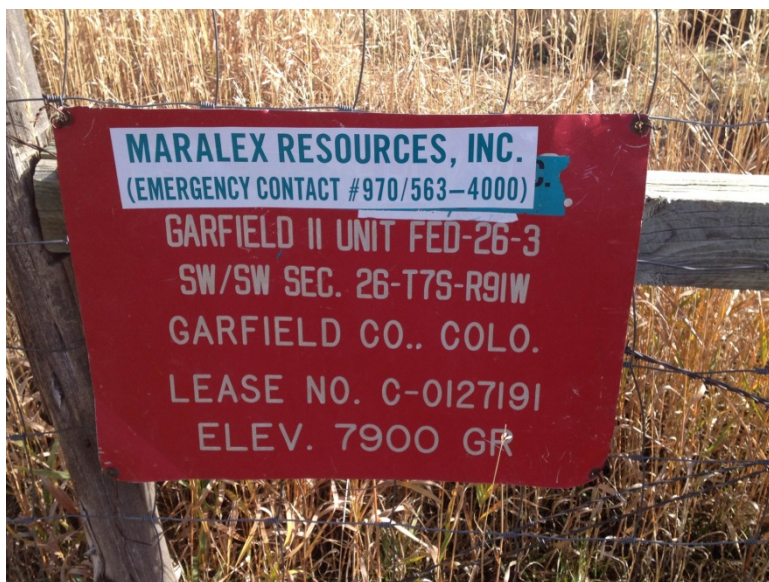
Wellhead sign is on the fence at the tank battery.

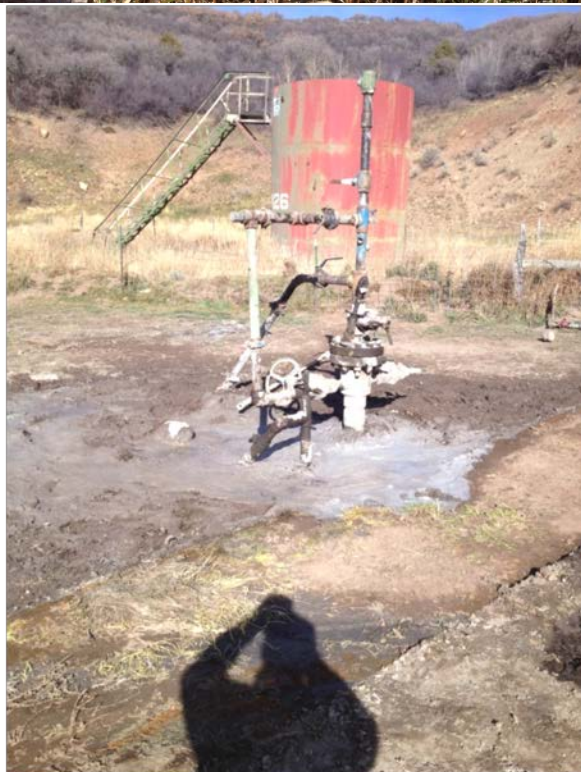
Fluids around wellhead appear to be from workover operation to repair casing.

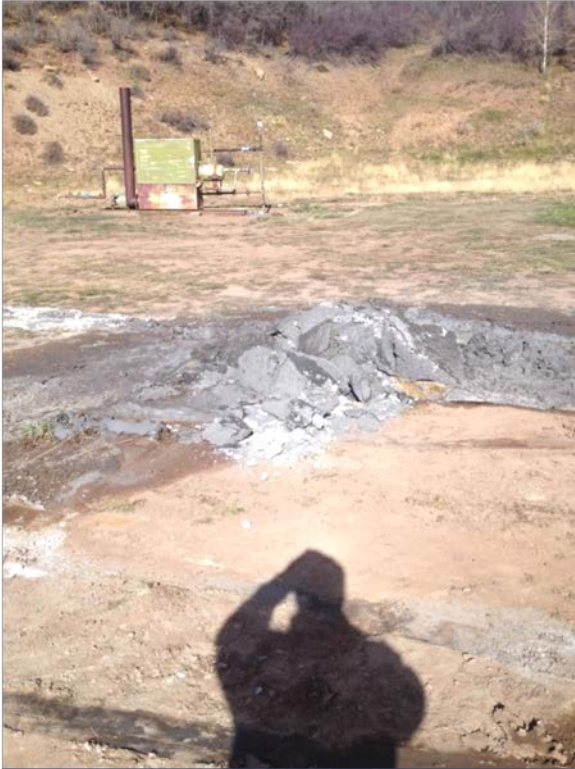
Appears to be cement drilled out following casing repair operation.

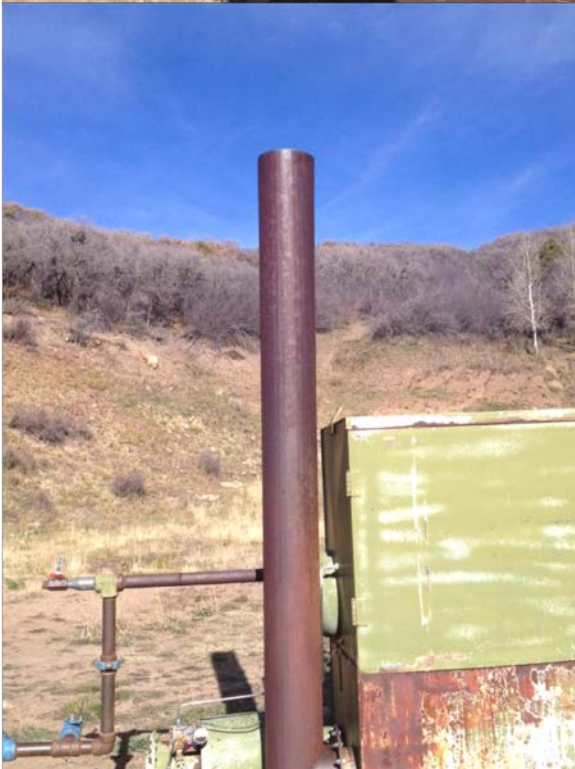
Separator stack is not equipped with a bird protector.
