Site Photos (05-055-06315) 10/30/2014

West side of location SMU 7-15-I

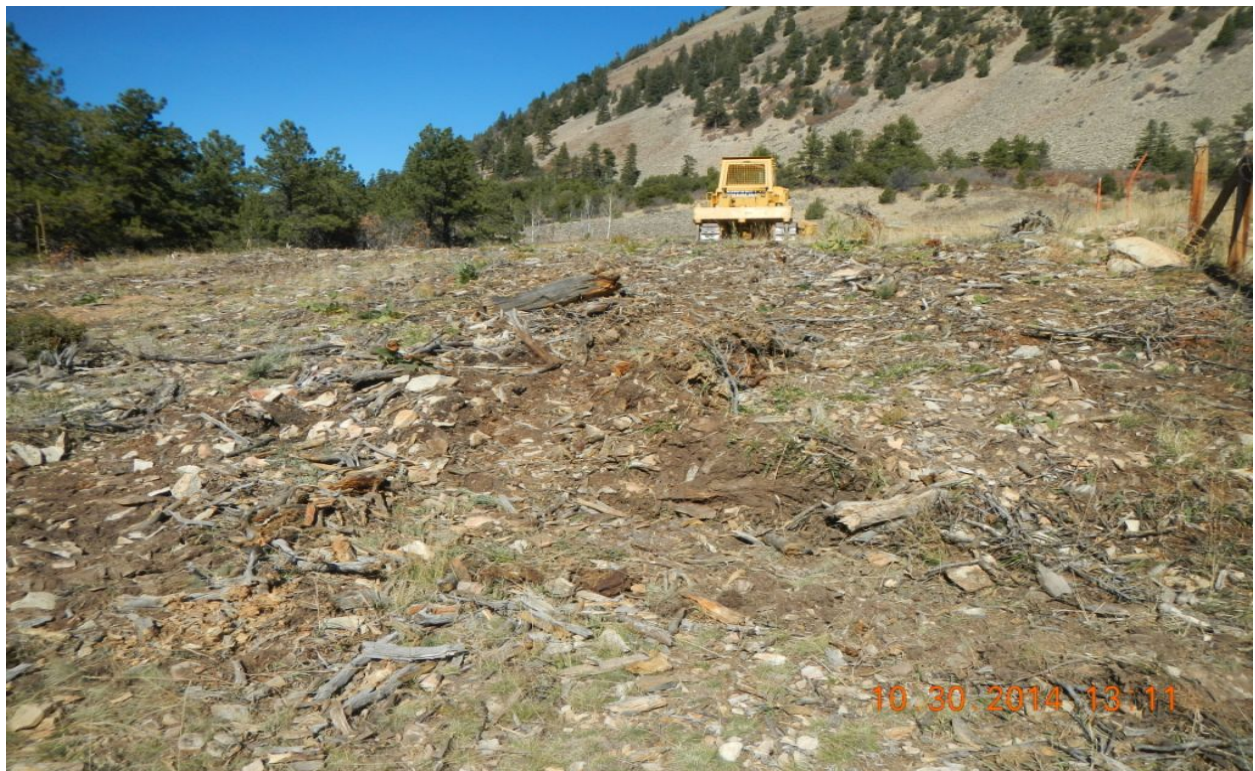
photo #2

Northwest side of location facing west where timber was cut

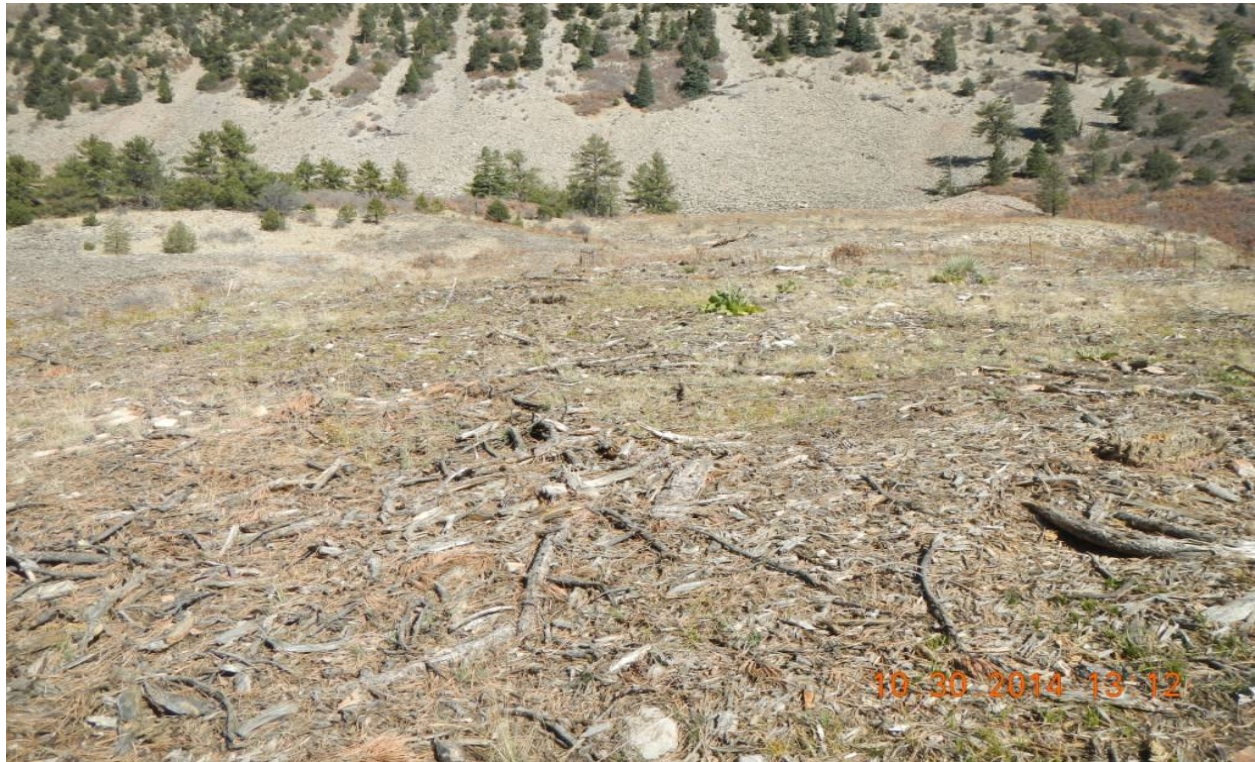
photo #3

Facing west where timber was cut

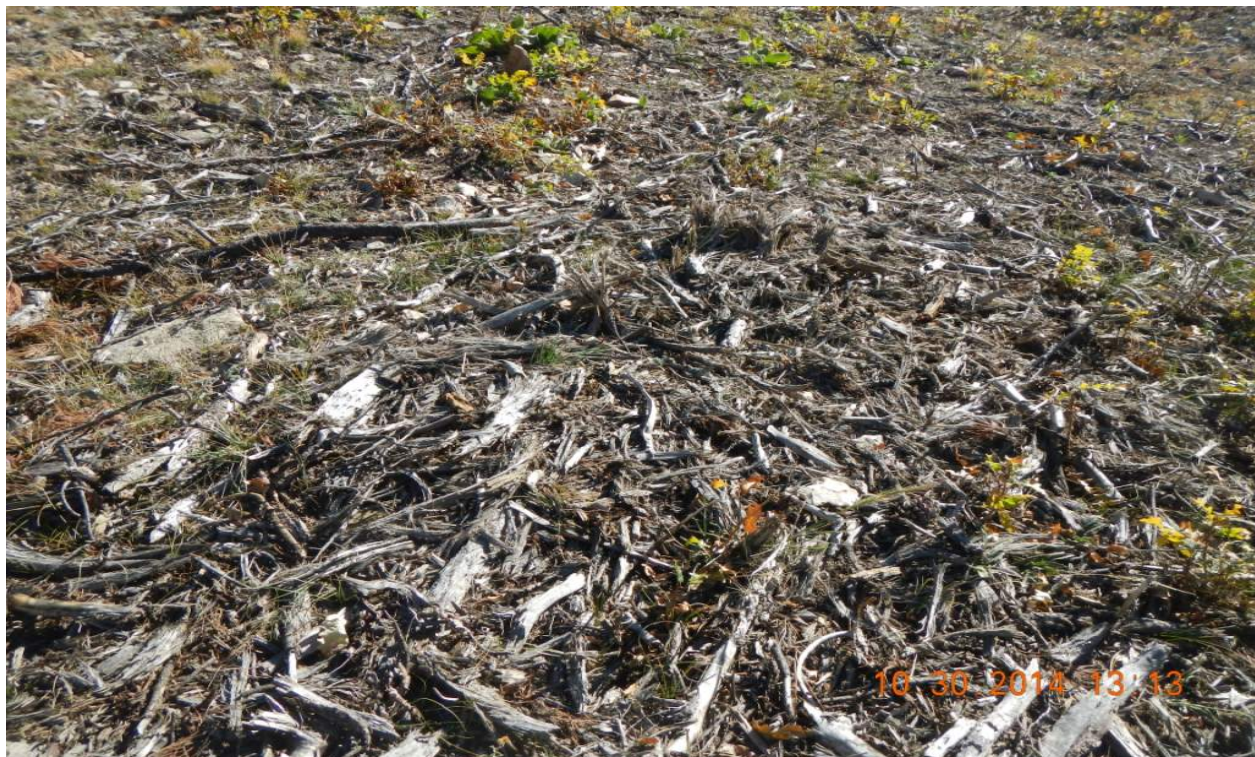
photo #4

Thick wood debris remains impeding plant vegetation growth

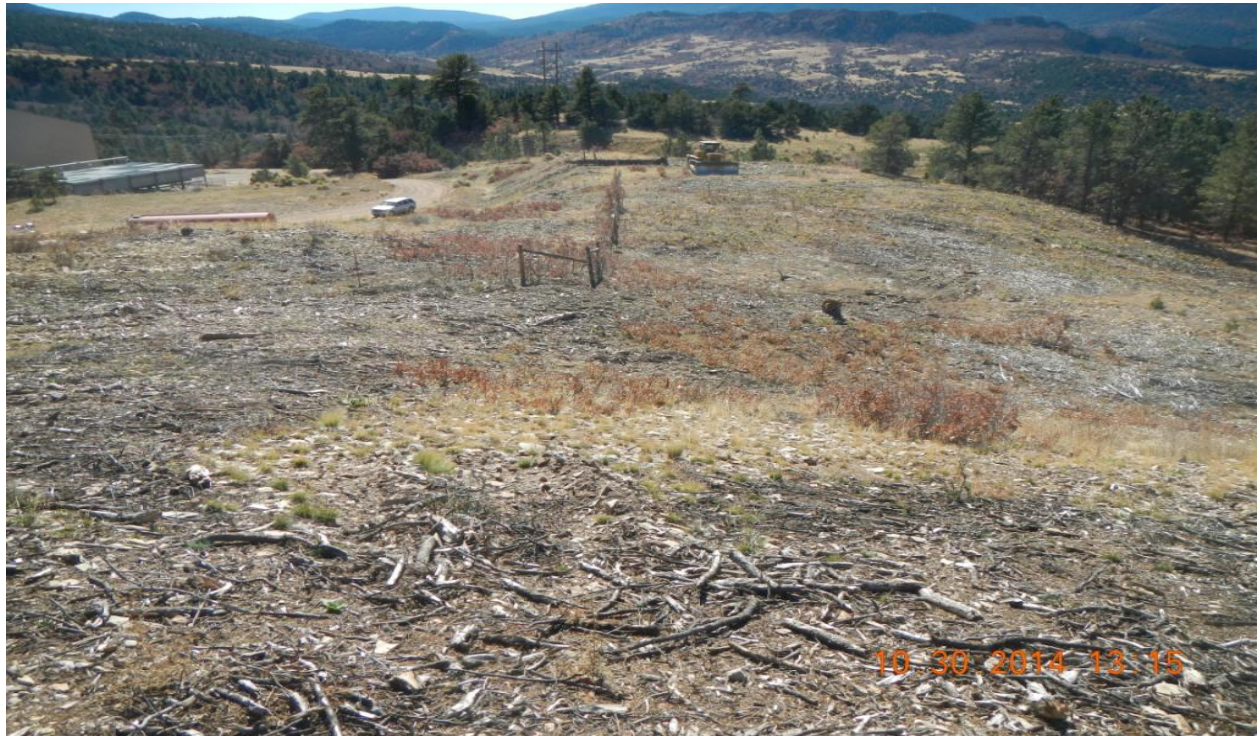
photo #5

East side of location looking West

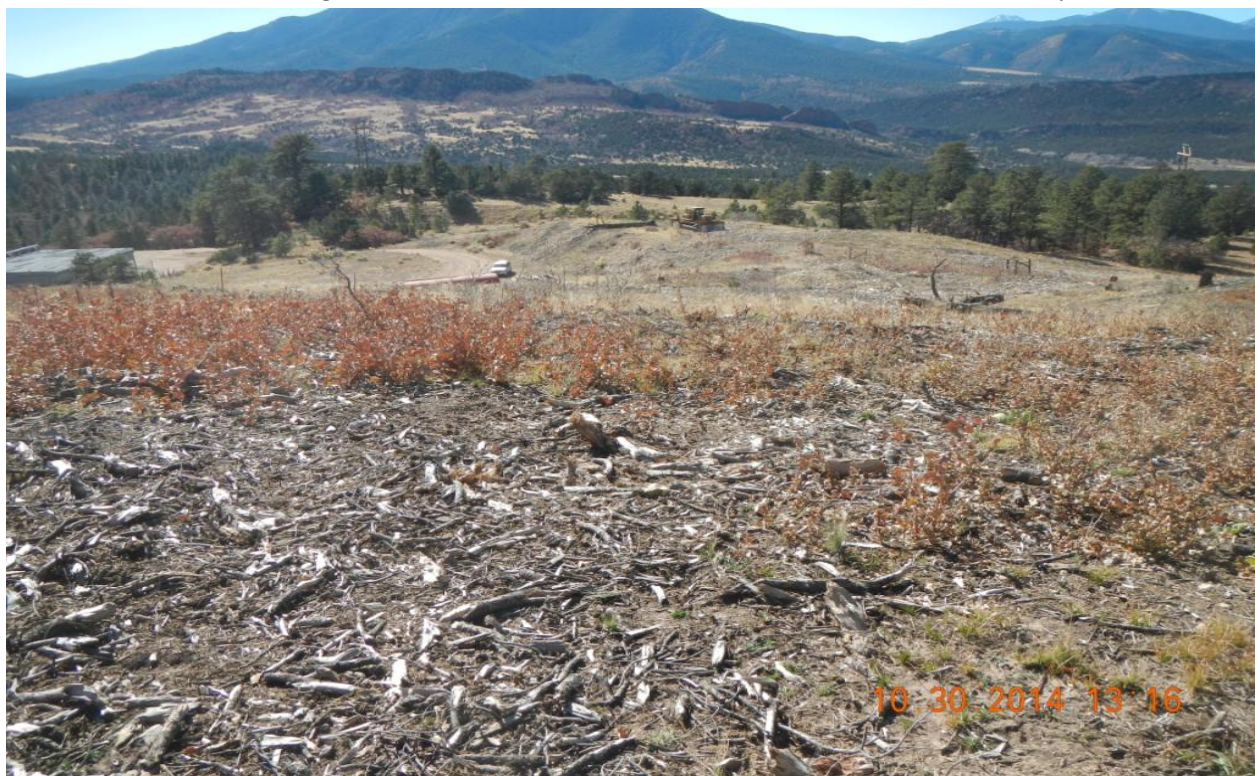
photo #6

East side of location looking West

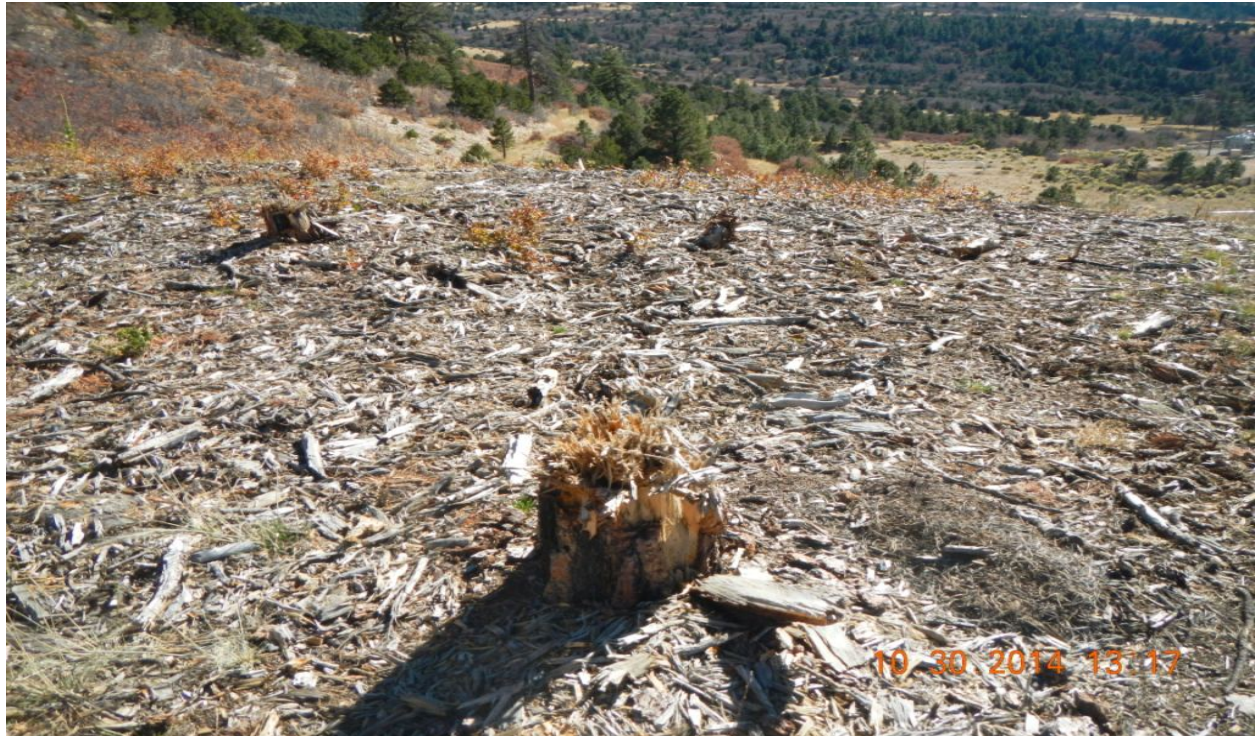
photo #7

Stumps remain from tree cutting

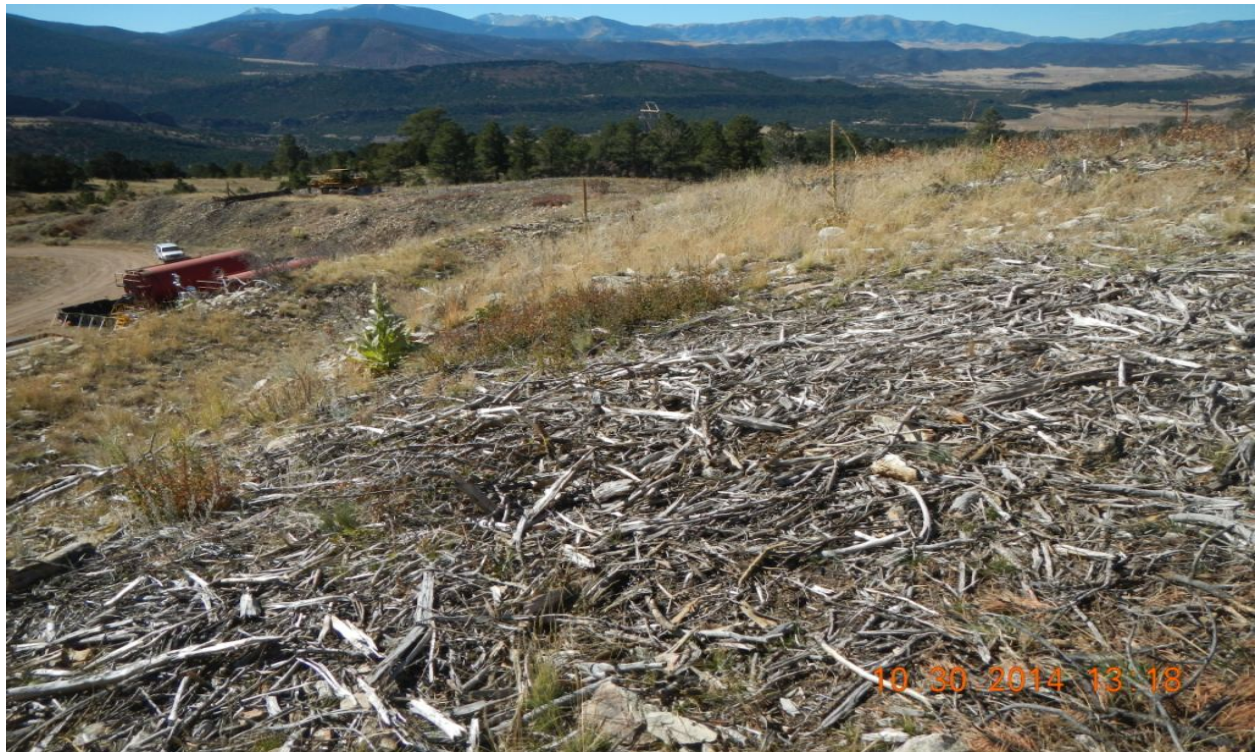
photo #8

Southeast corner of the location looking Northeast

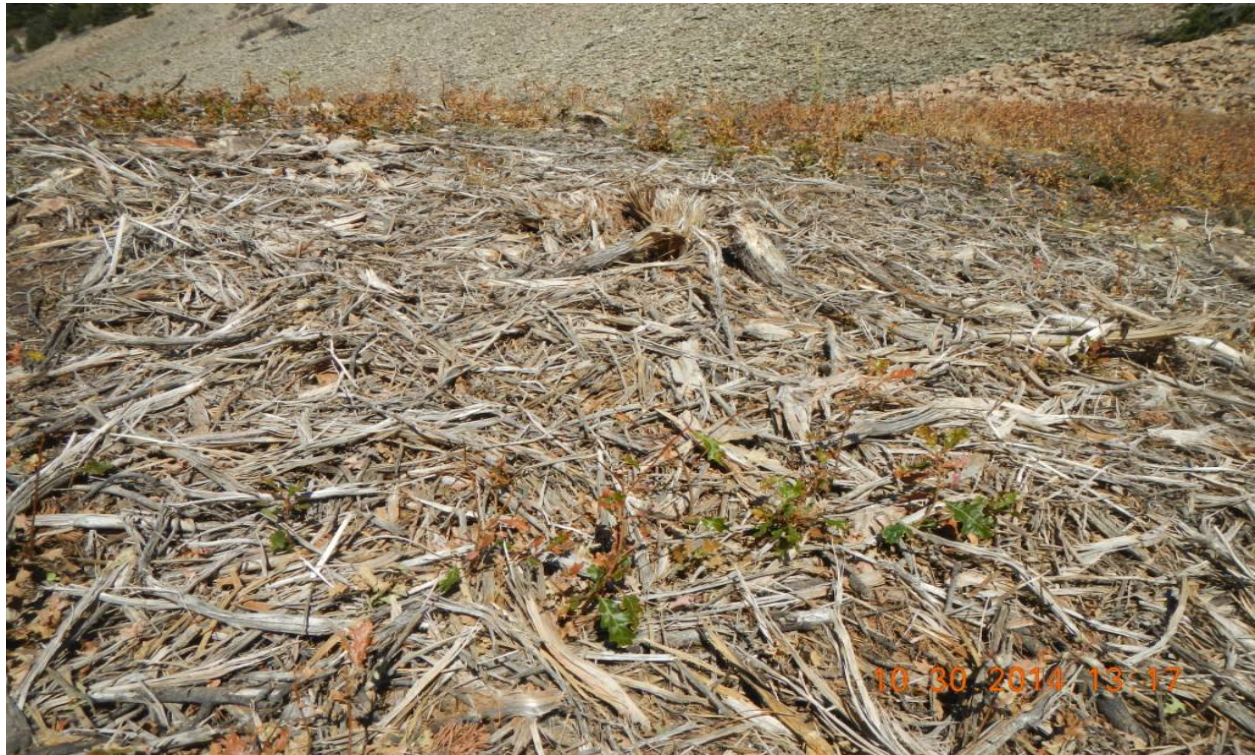
photo #9

Thick layer of wood debris remains

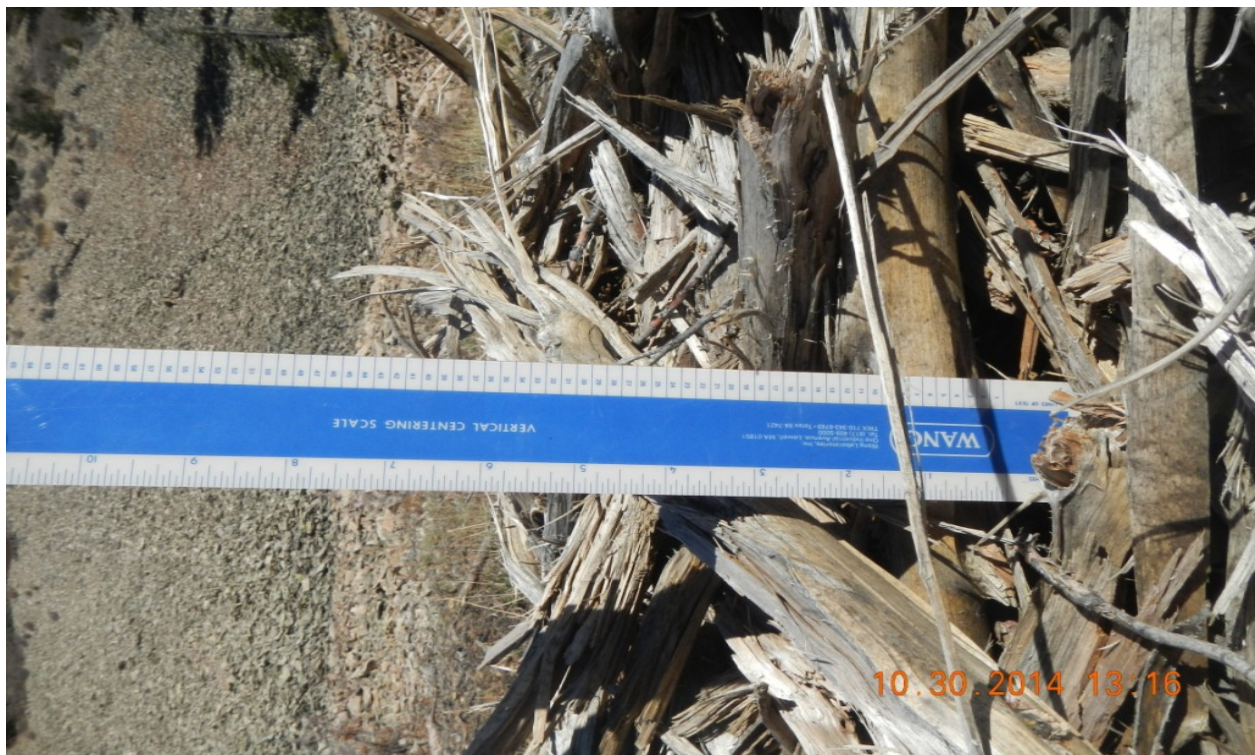
photo #10

Wood debris 5" thick in areas

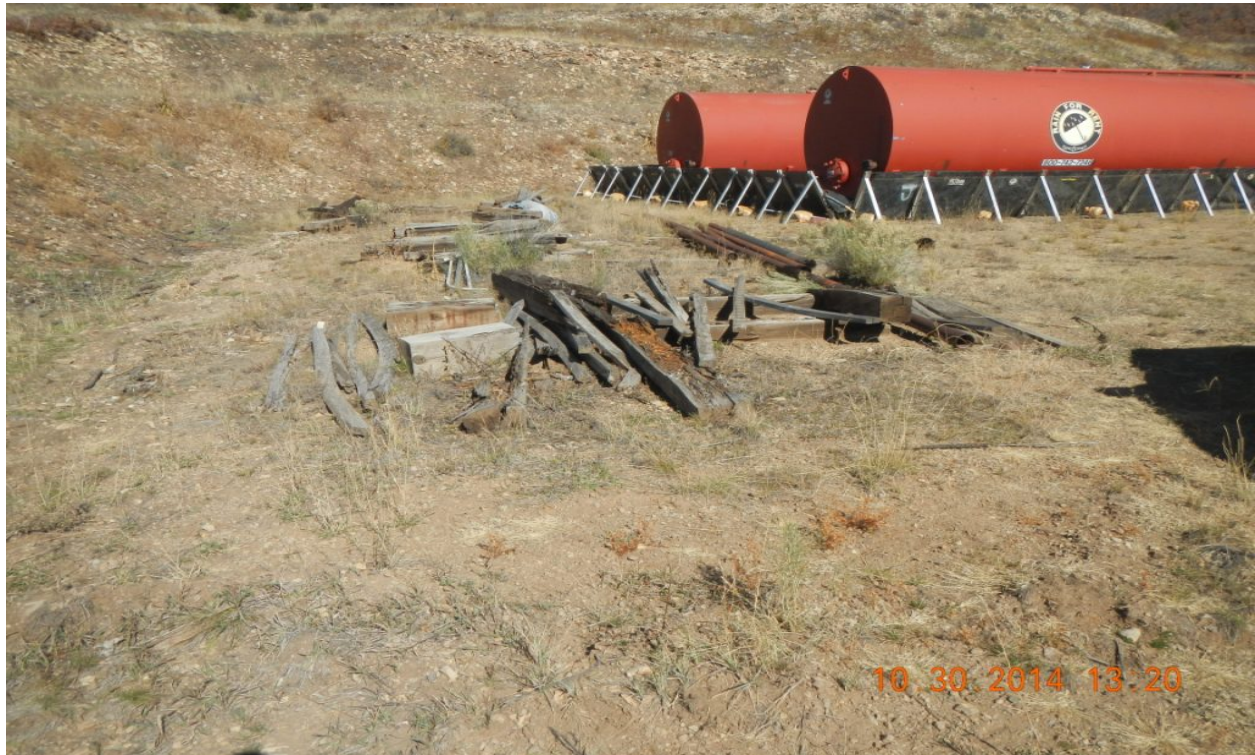
photo #11

Wood debris on location

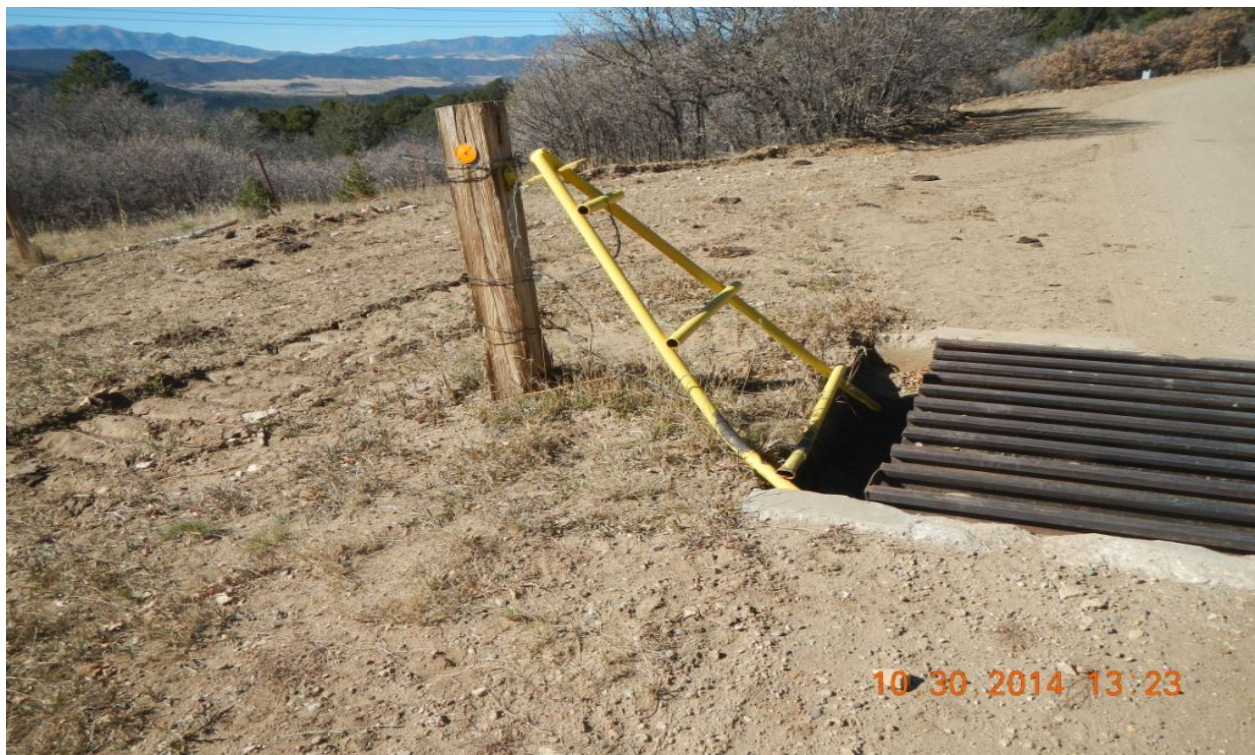
photo #12

Cattle guard to this location is damaged
