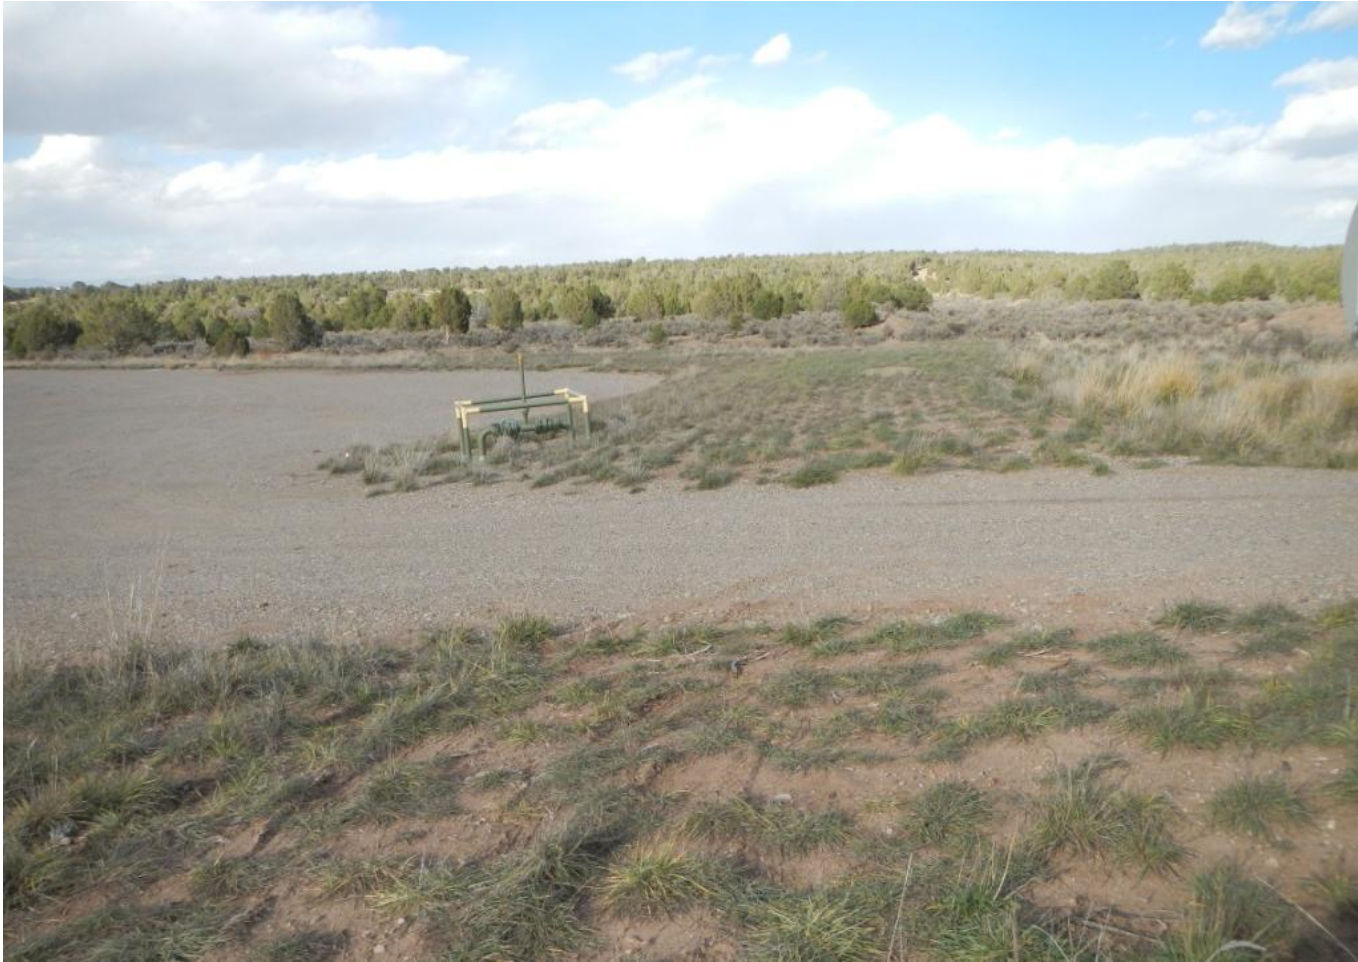
Photo 1. View of southeastern portion of project area from southern corner facing north-northeastward.

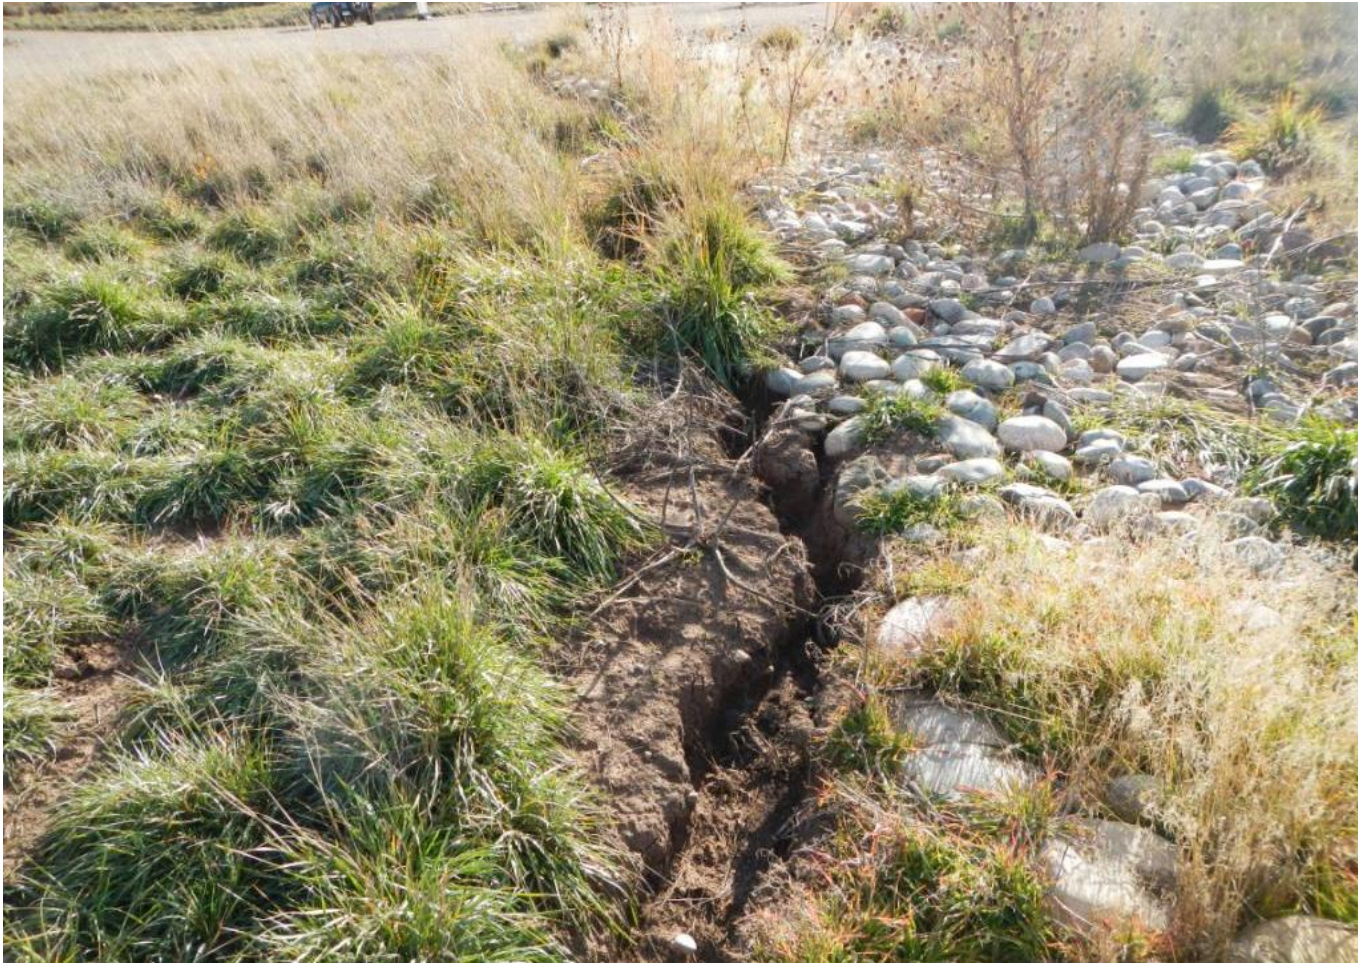
Photo 2. View of rill erosion adjacent to cobble BMP in northeastern portion of project area.

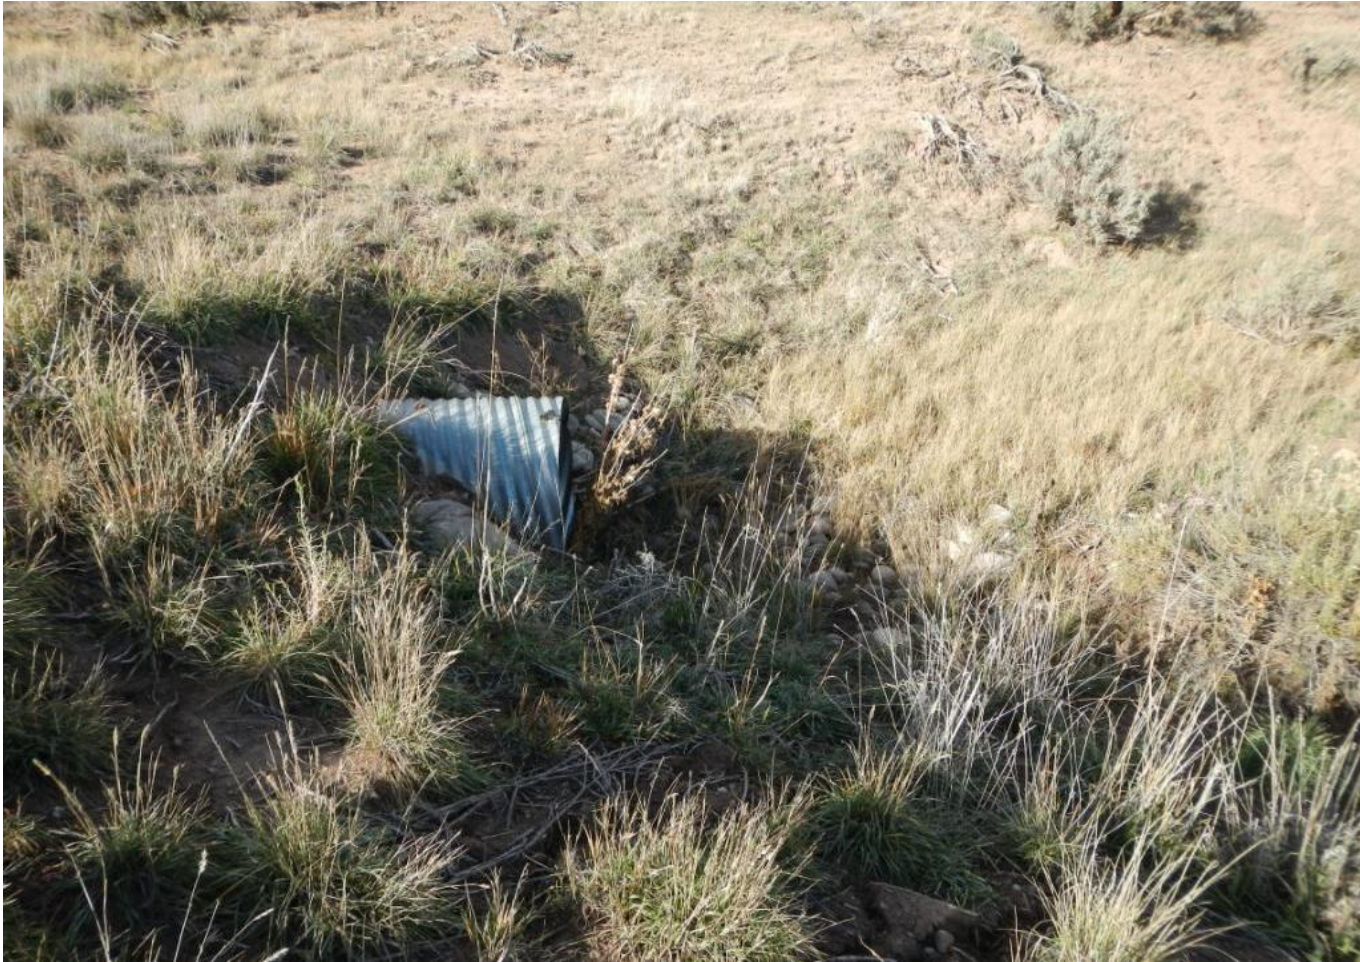
Photo 3. View of good revegetation and stabilization around culvert inlet.

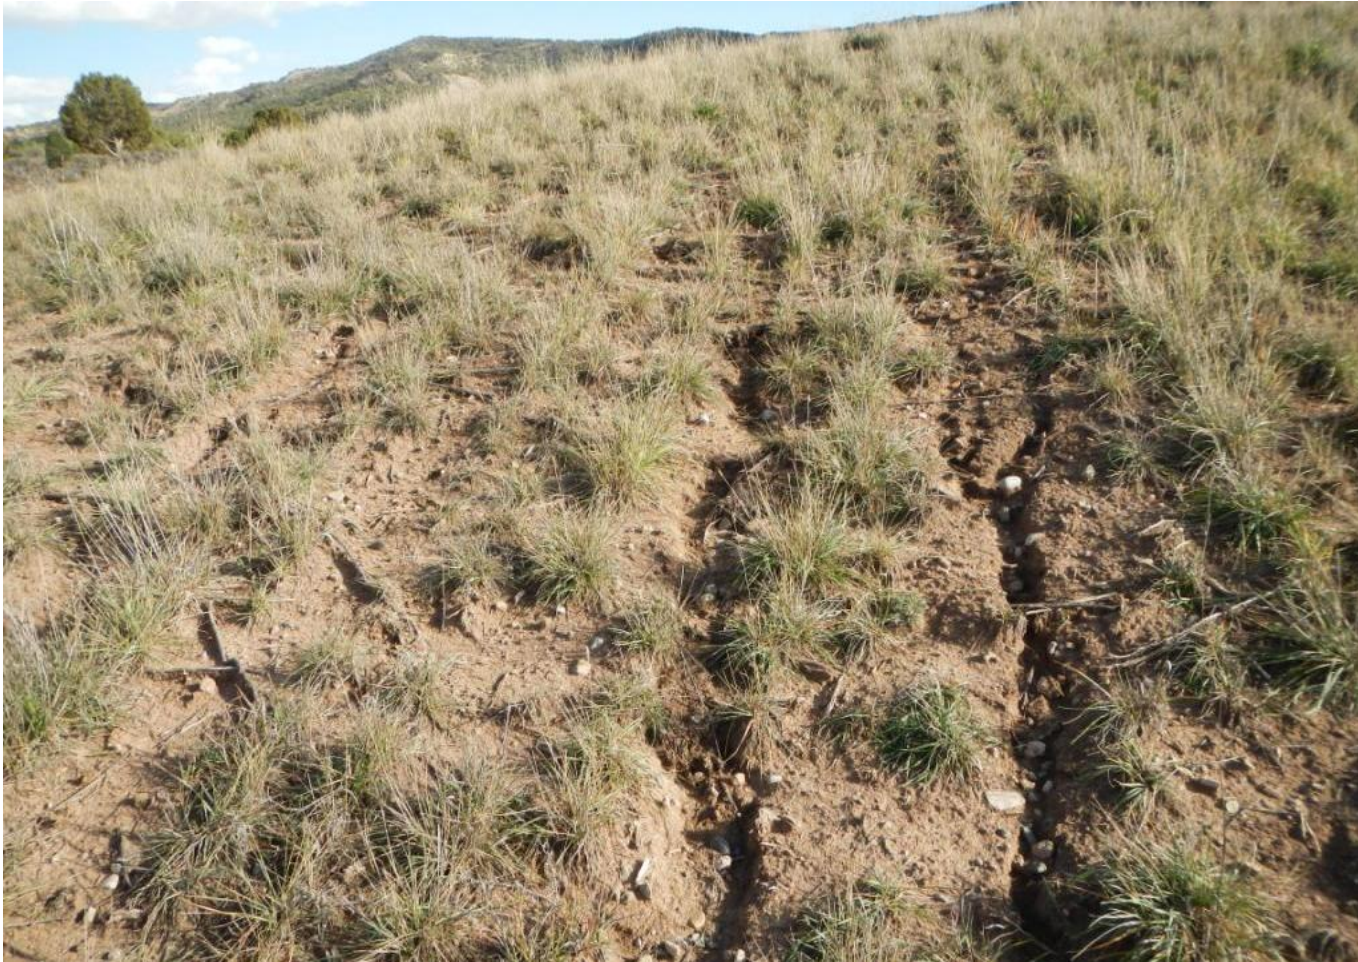
Photo 4. View of rill erosion along drill seed rows within interim reclamation area.

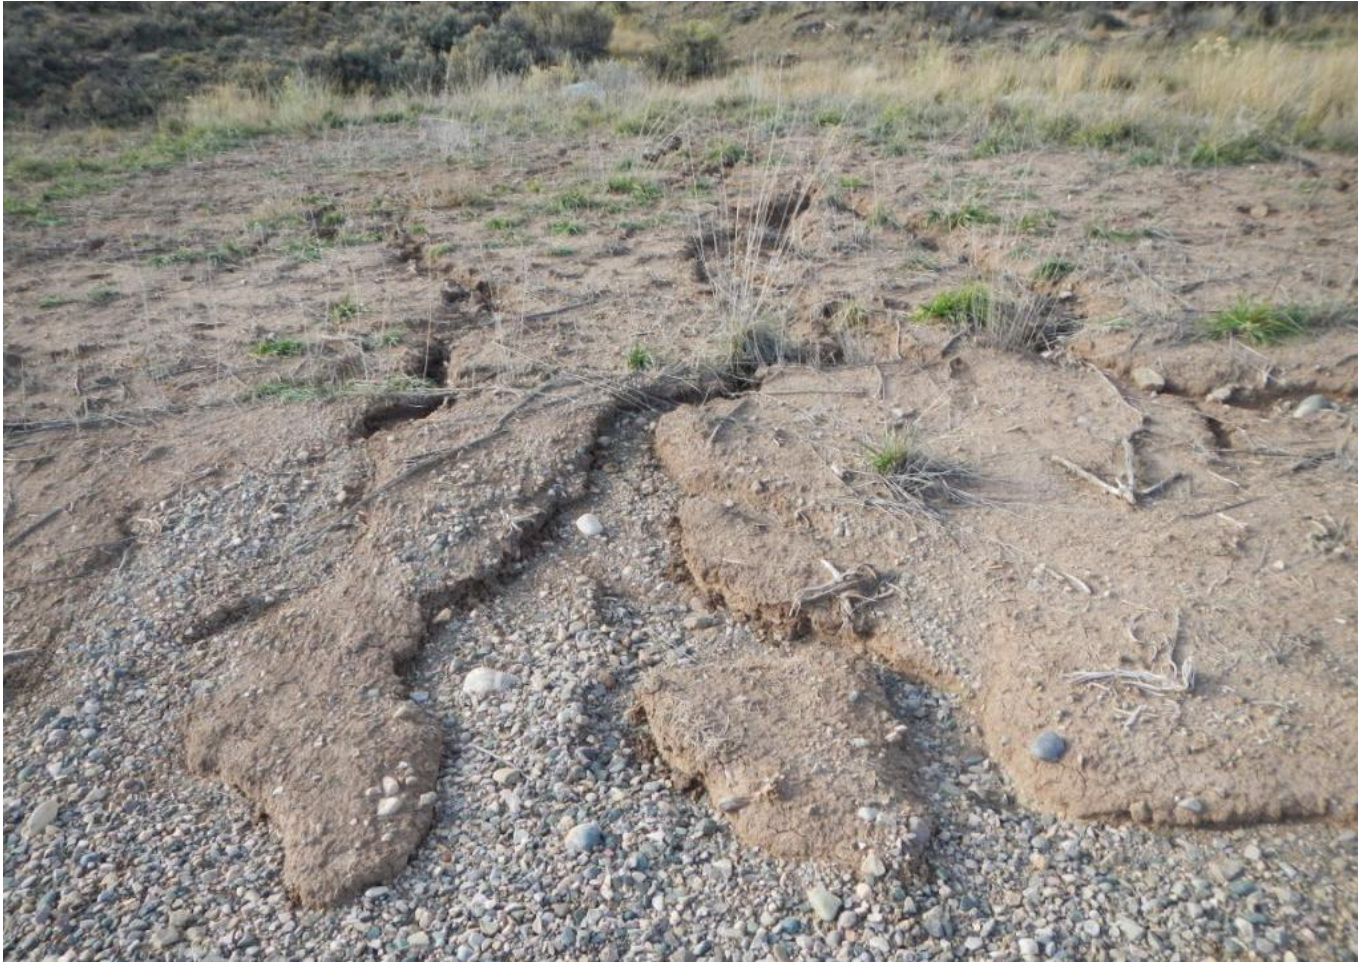
Photo 5. View of rill erosion where there is little revegetation within the interim reclamation area and stormwater exiting the well pad.

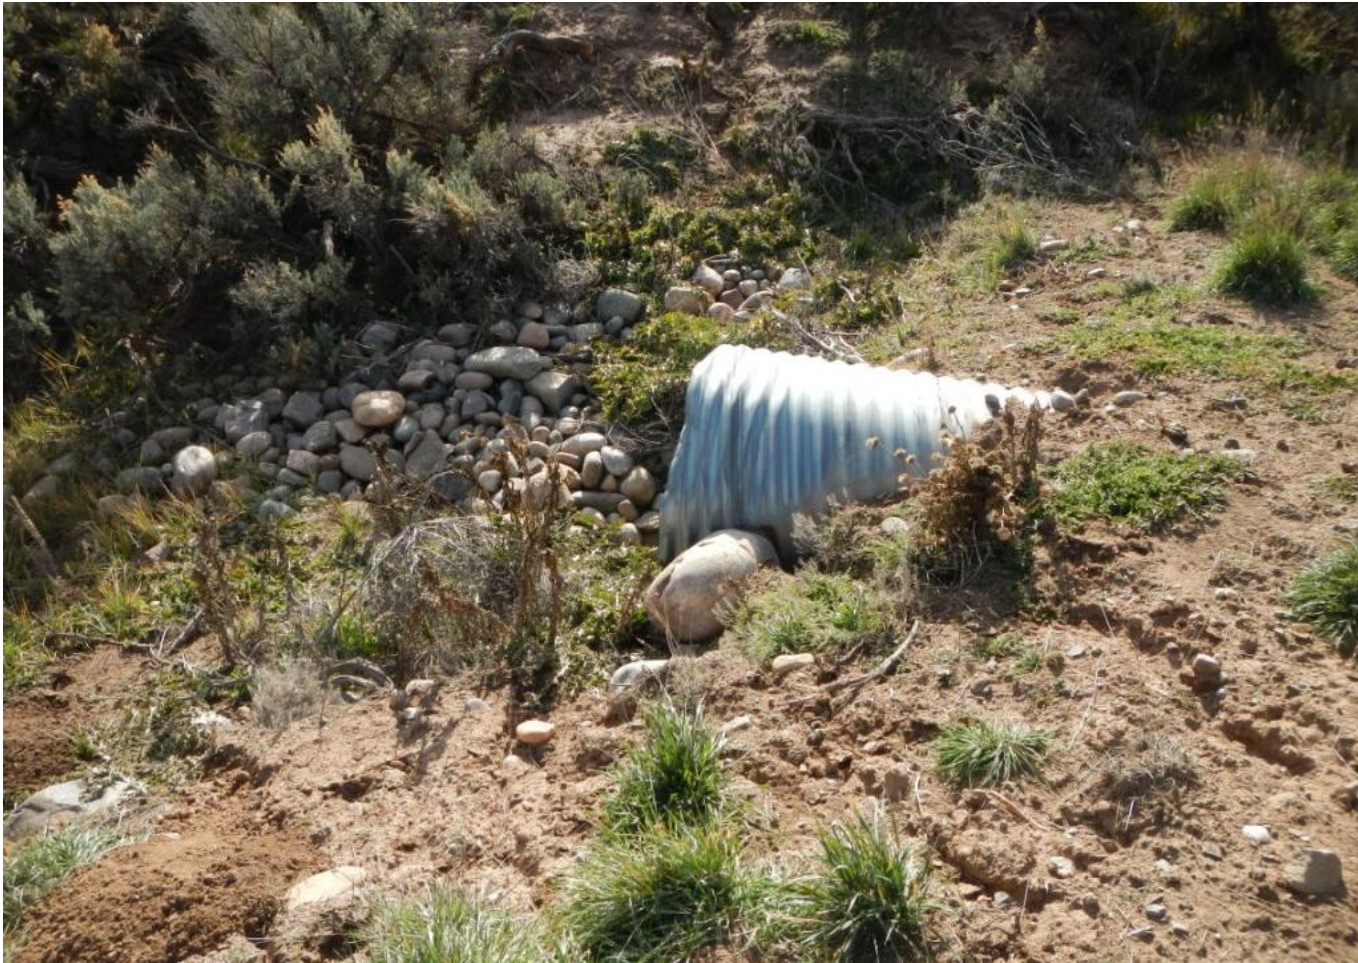
Photo 6. View of rill erosion and thistles around culvert inlet.
