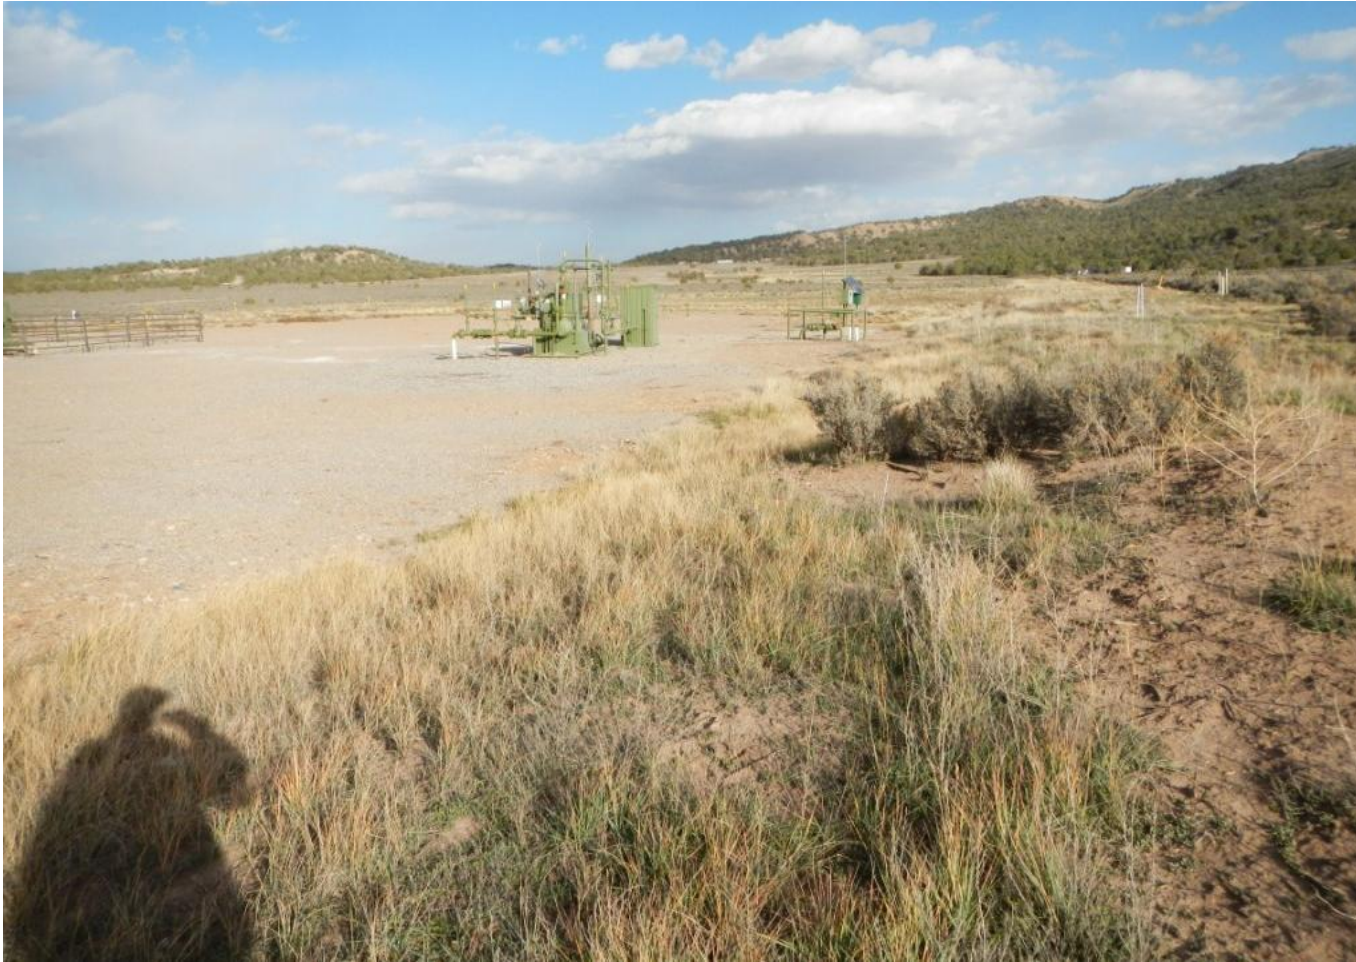
Photo 1. View of revegetation within the southern portion of the project area from the southwestern corner facing westward.

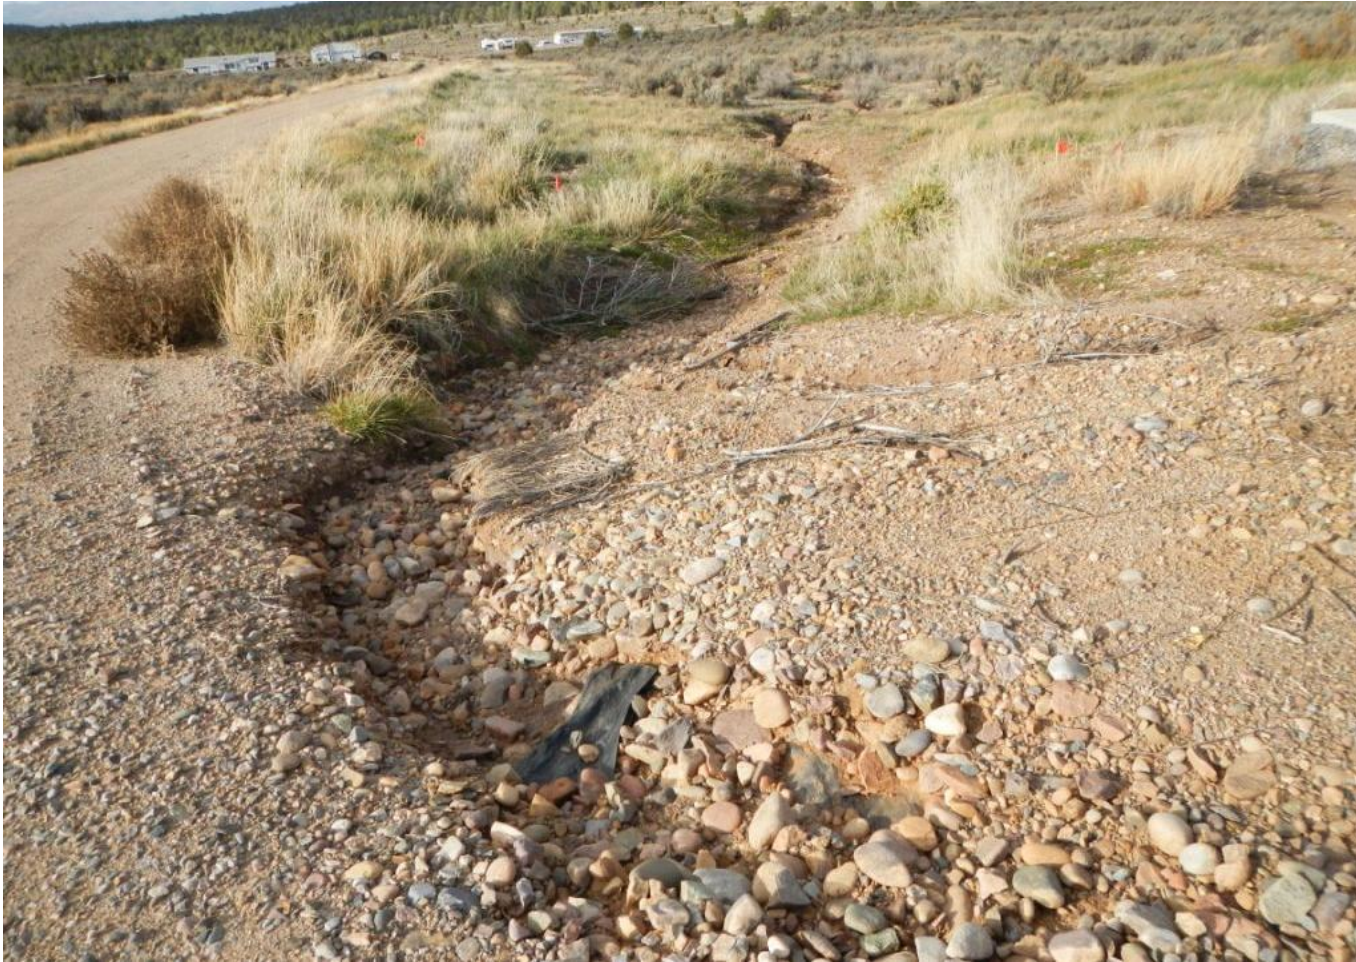
Photo 2. View of diversion drainage (approximately 2 feet wide and 1 foot deep) near well pad entrance that appears to be down-cutting. This drainage should be monitored and BMPs applied if down-cutting/erosion worsens.

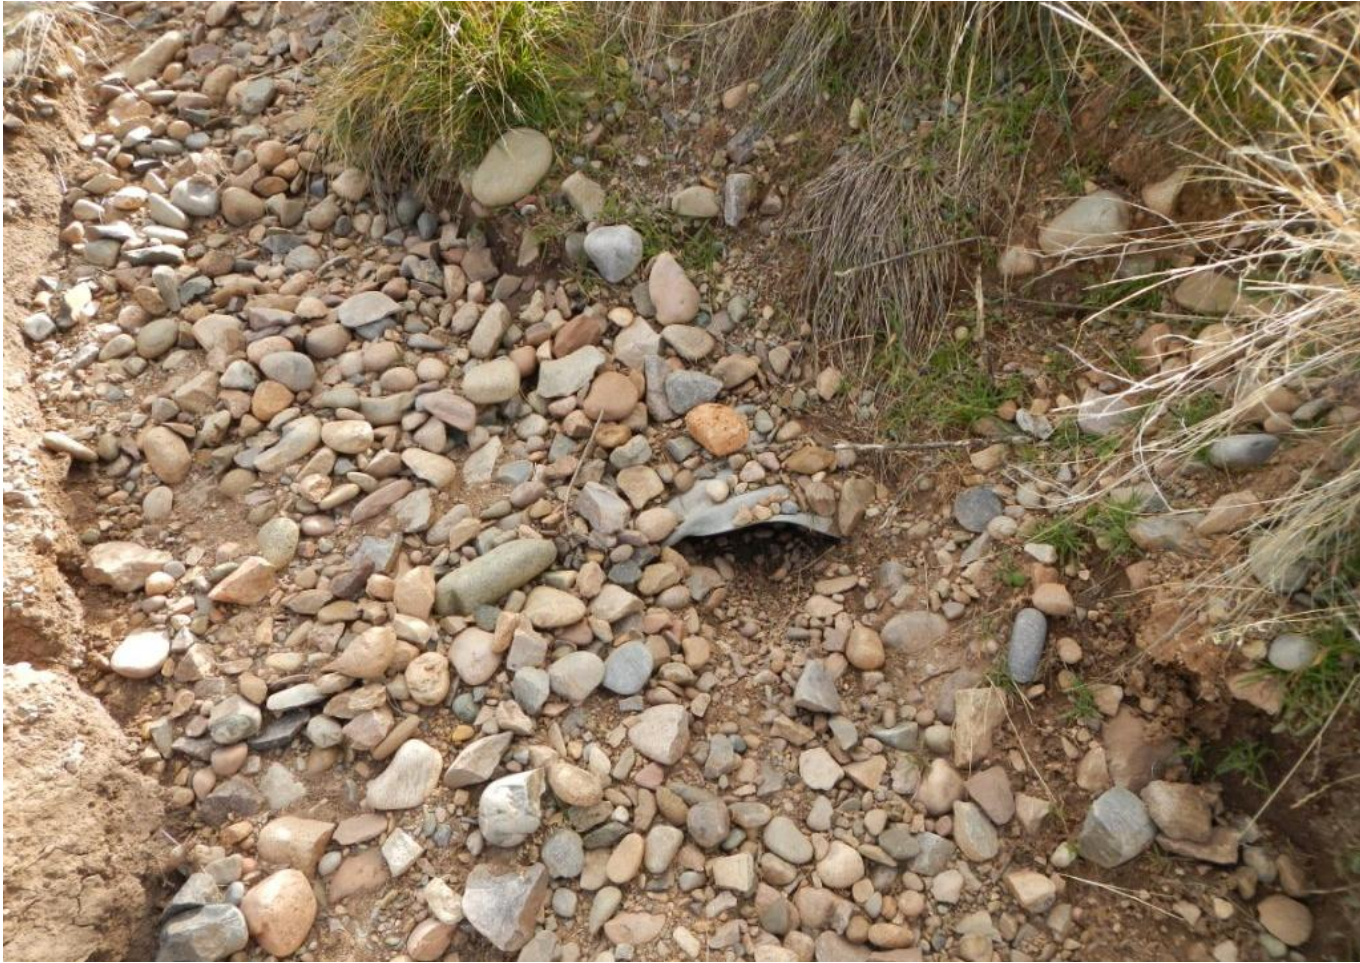
Photo 3. View of culvert outlet at well pad entrance that is full of sediment and rocks.

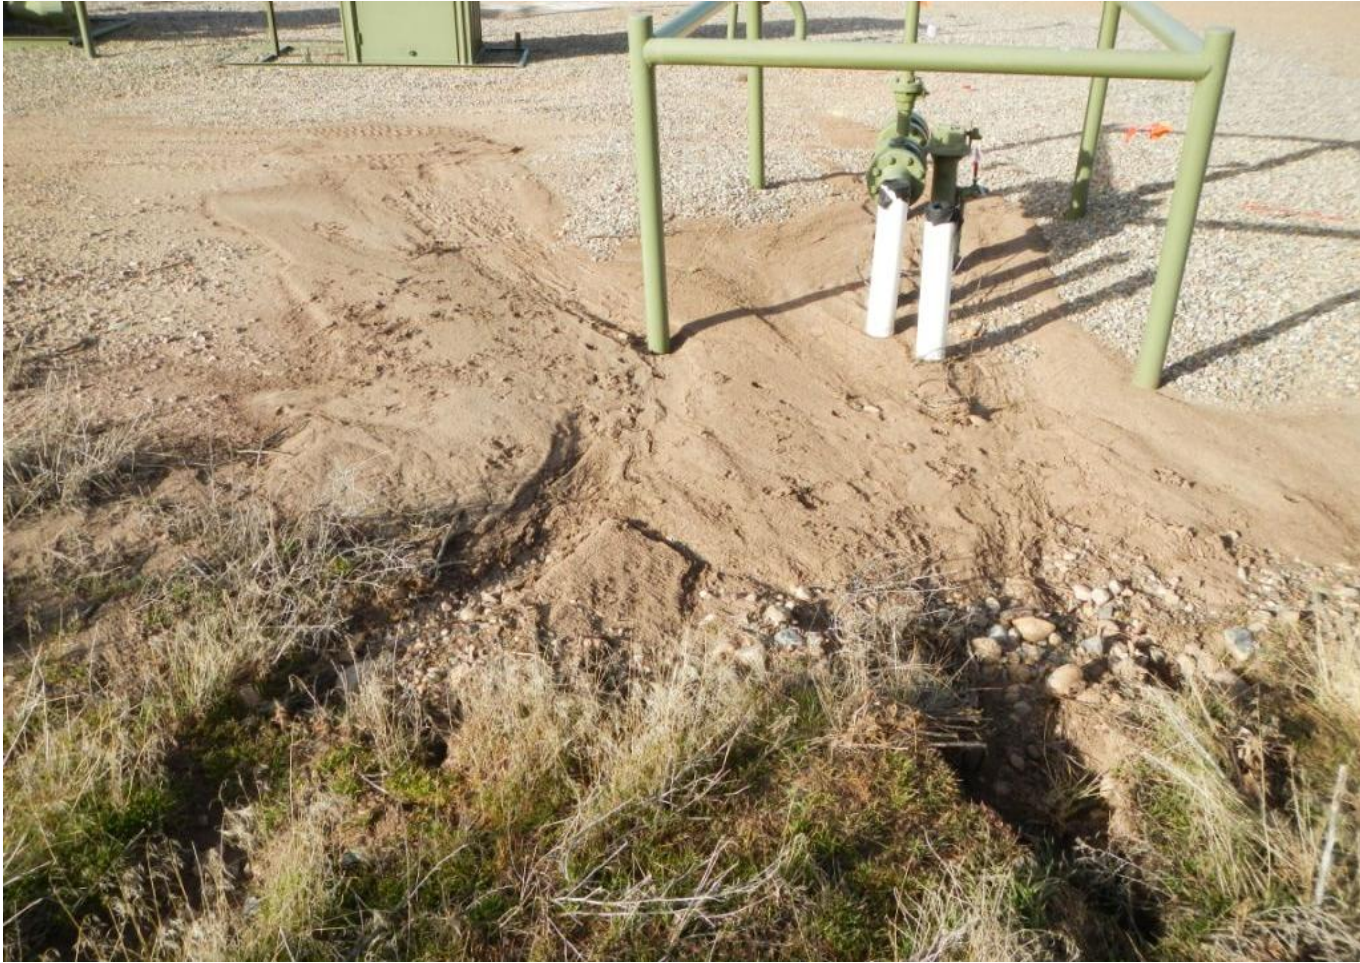
Photo 4. Sediment run-on to the well pad from erosion in the southern portion of the project area. This needs to be monitored and BMPs applied if erosion worsens.
