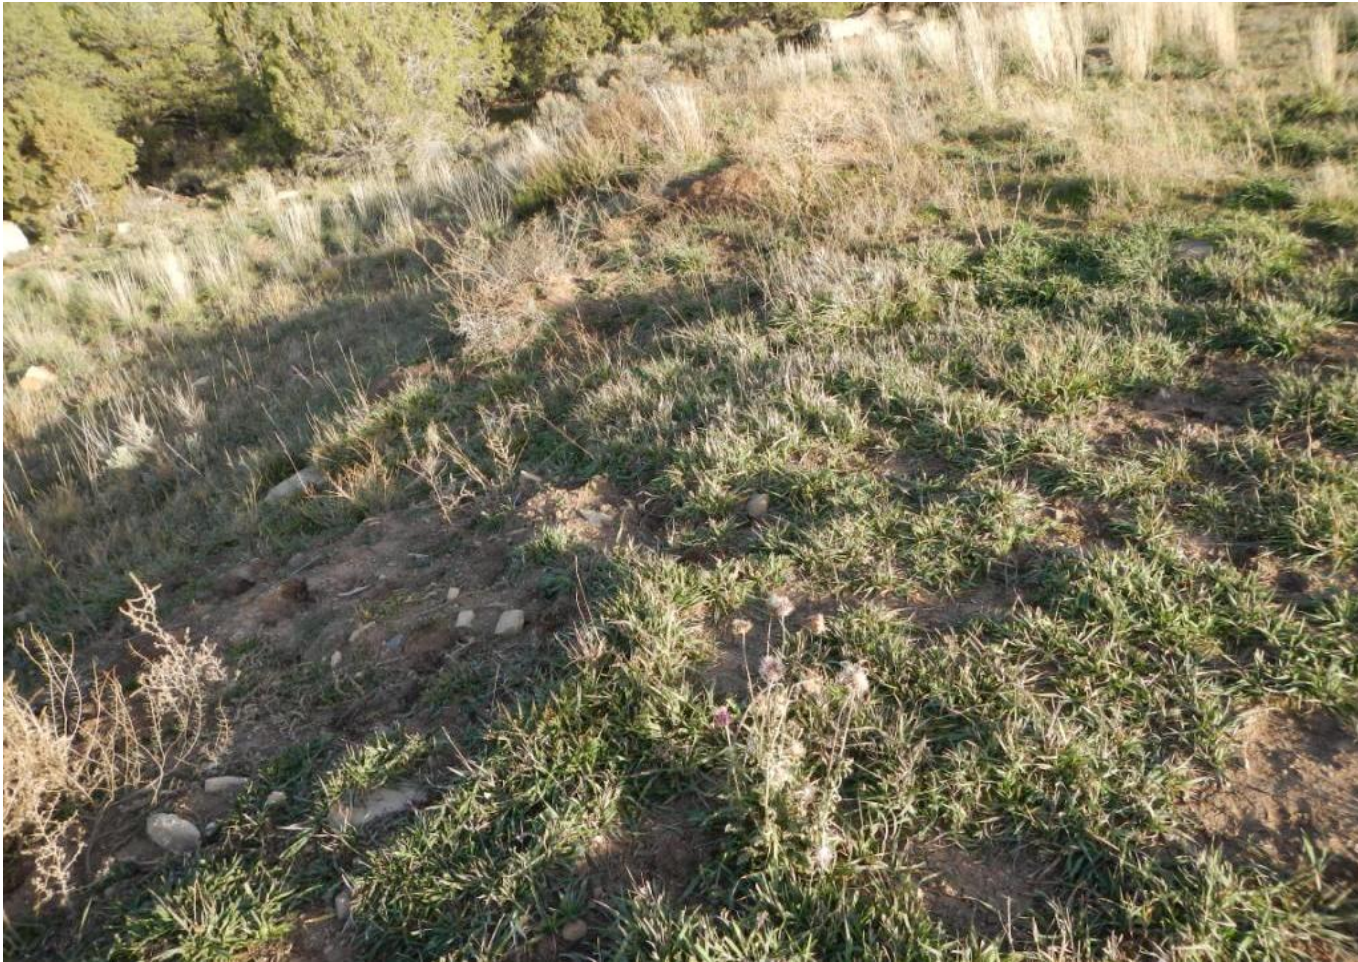
Photo 1. View of scotch thistle plant in foreground, within the eastern portion of the interim reclamation area.

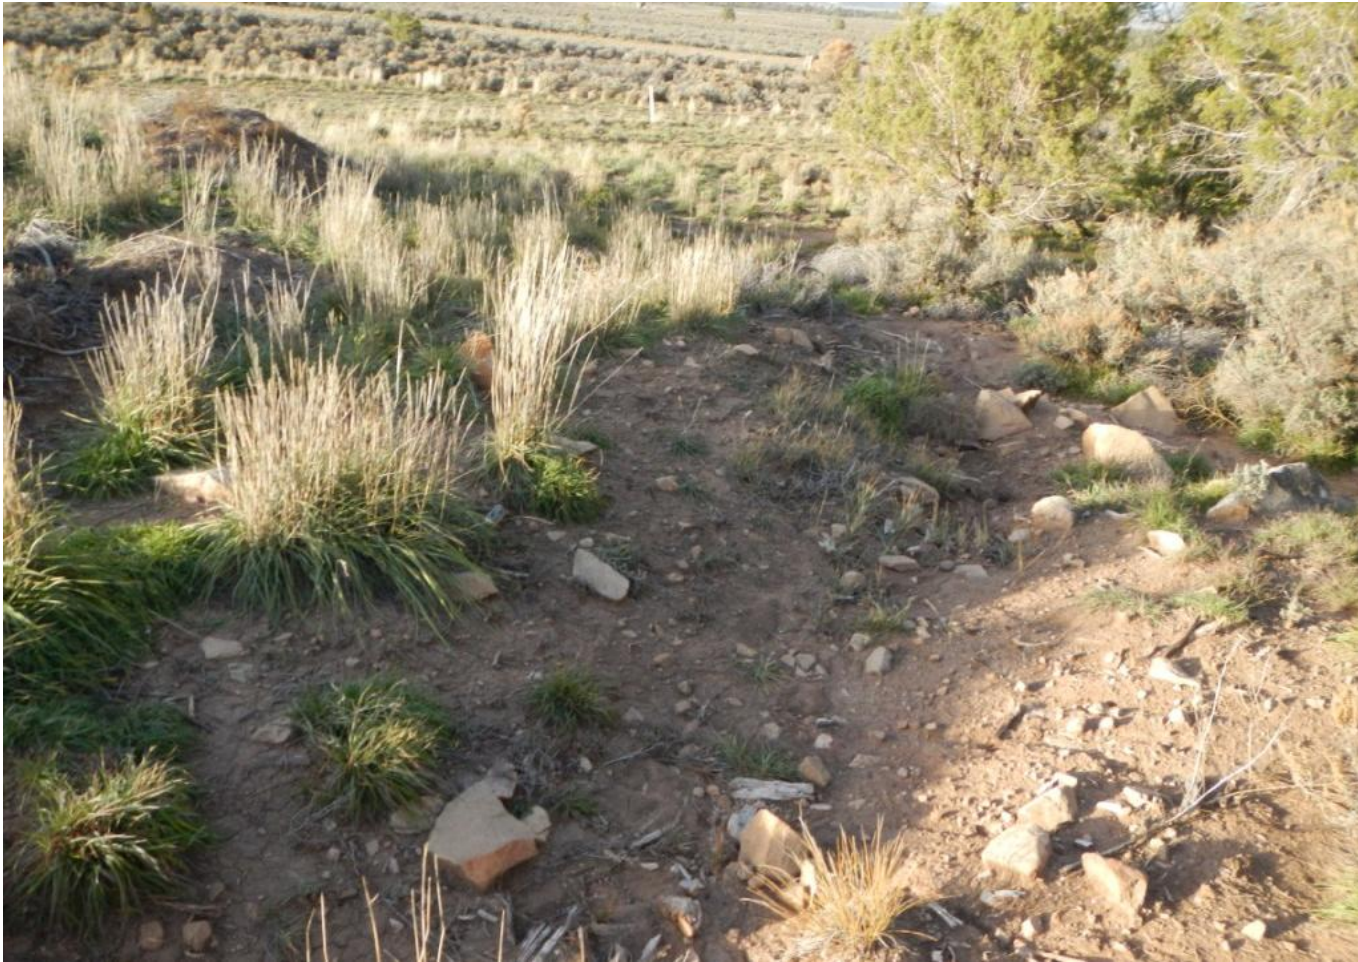
Photo 2. View of water diversion channel in southeastern portion of project area.

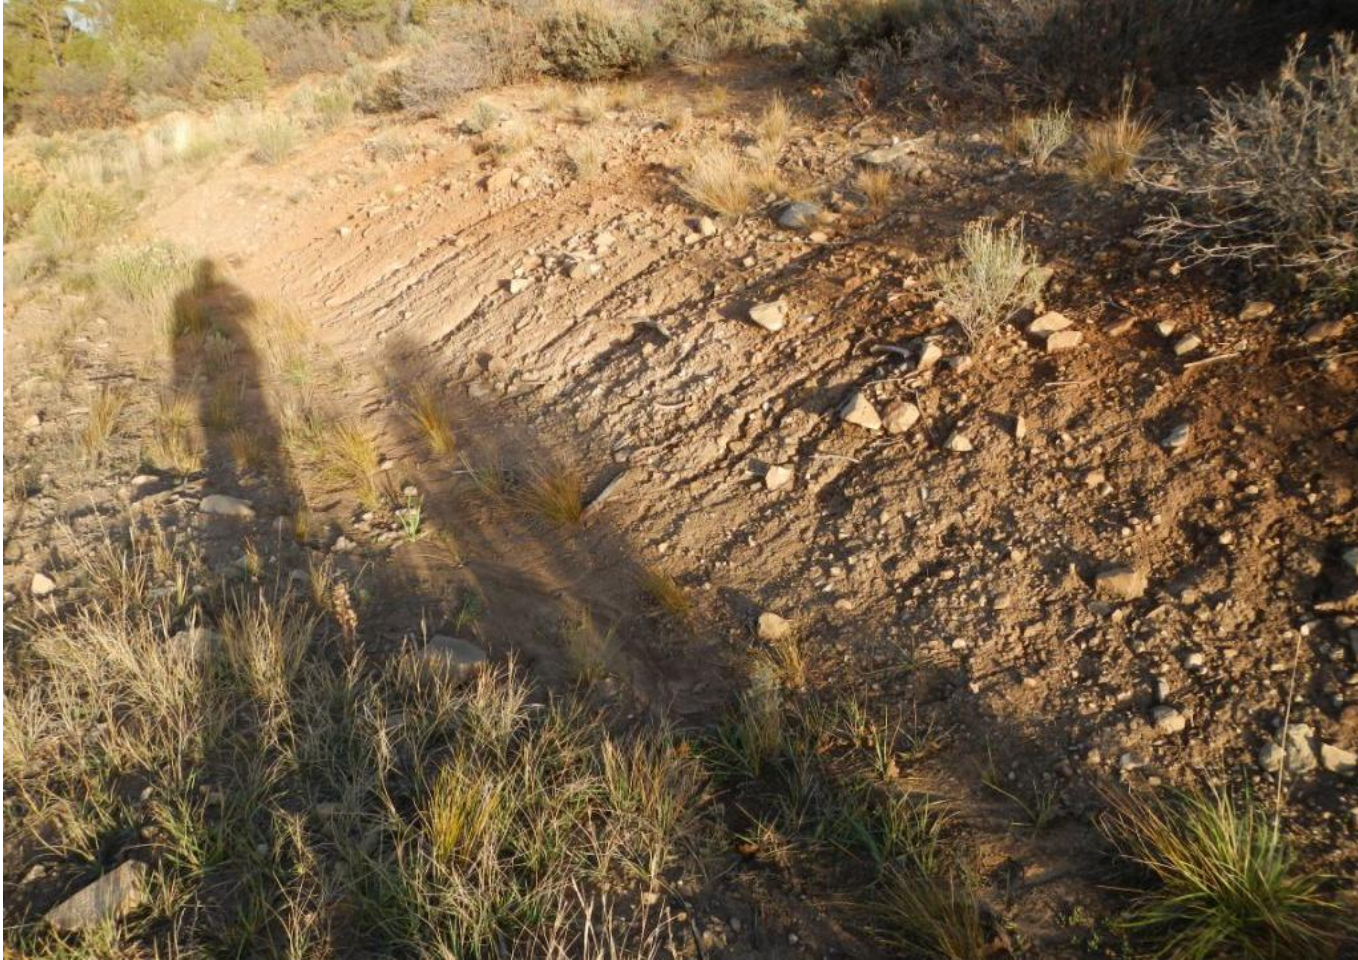
Photo 3. View of rill erosion along cut slope in southern portion of interim reclamation area.
