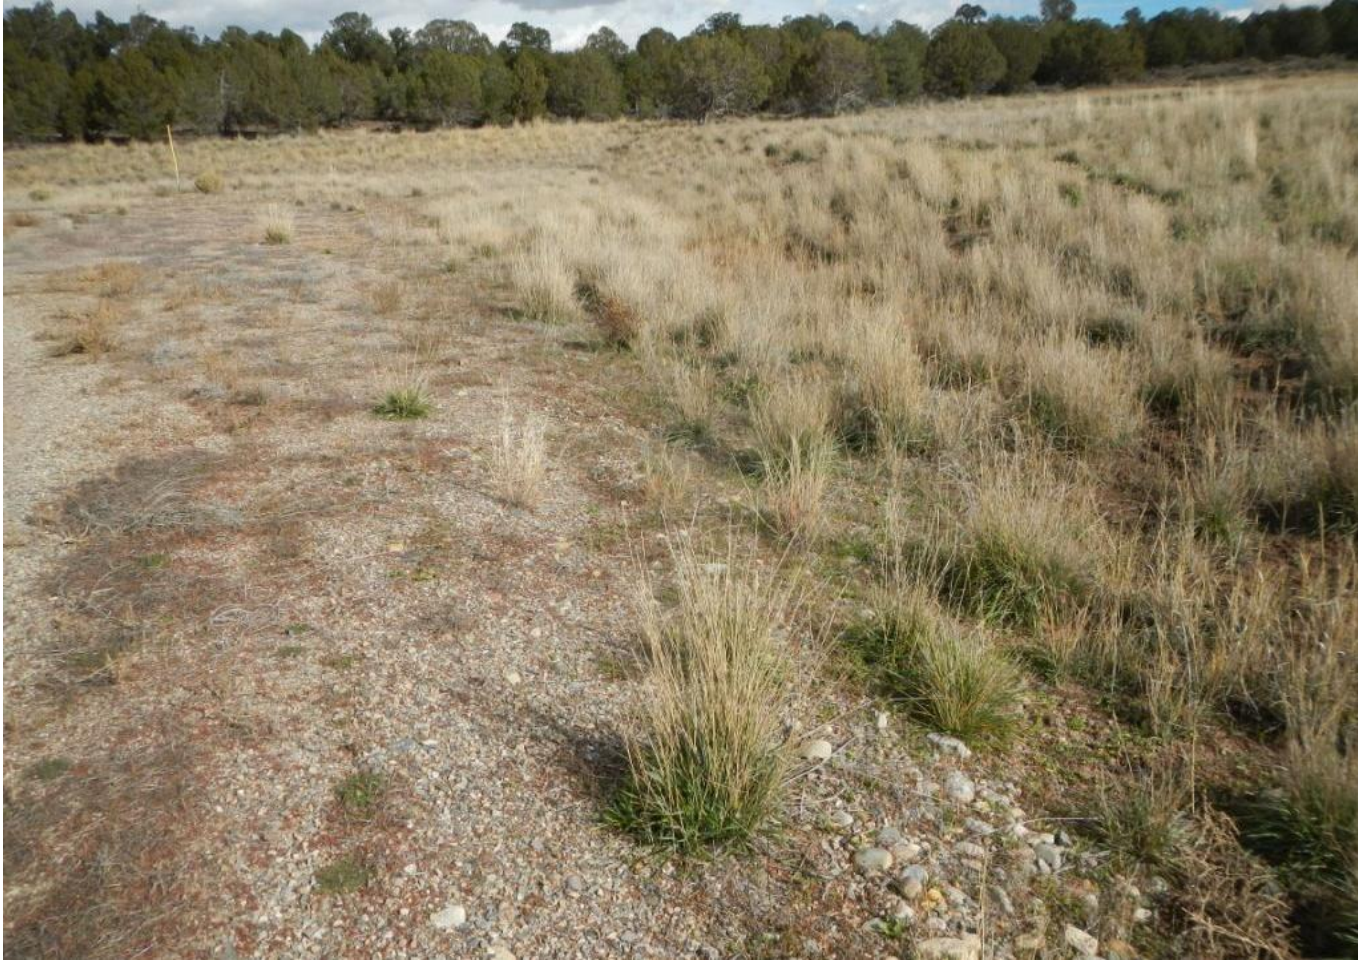
Photo 1. View of good revegetation in the southern (on right) and eastern (in background) portions of the project area.

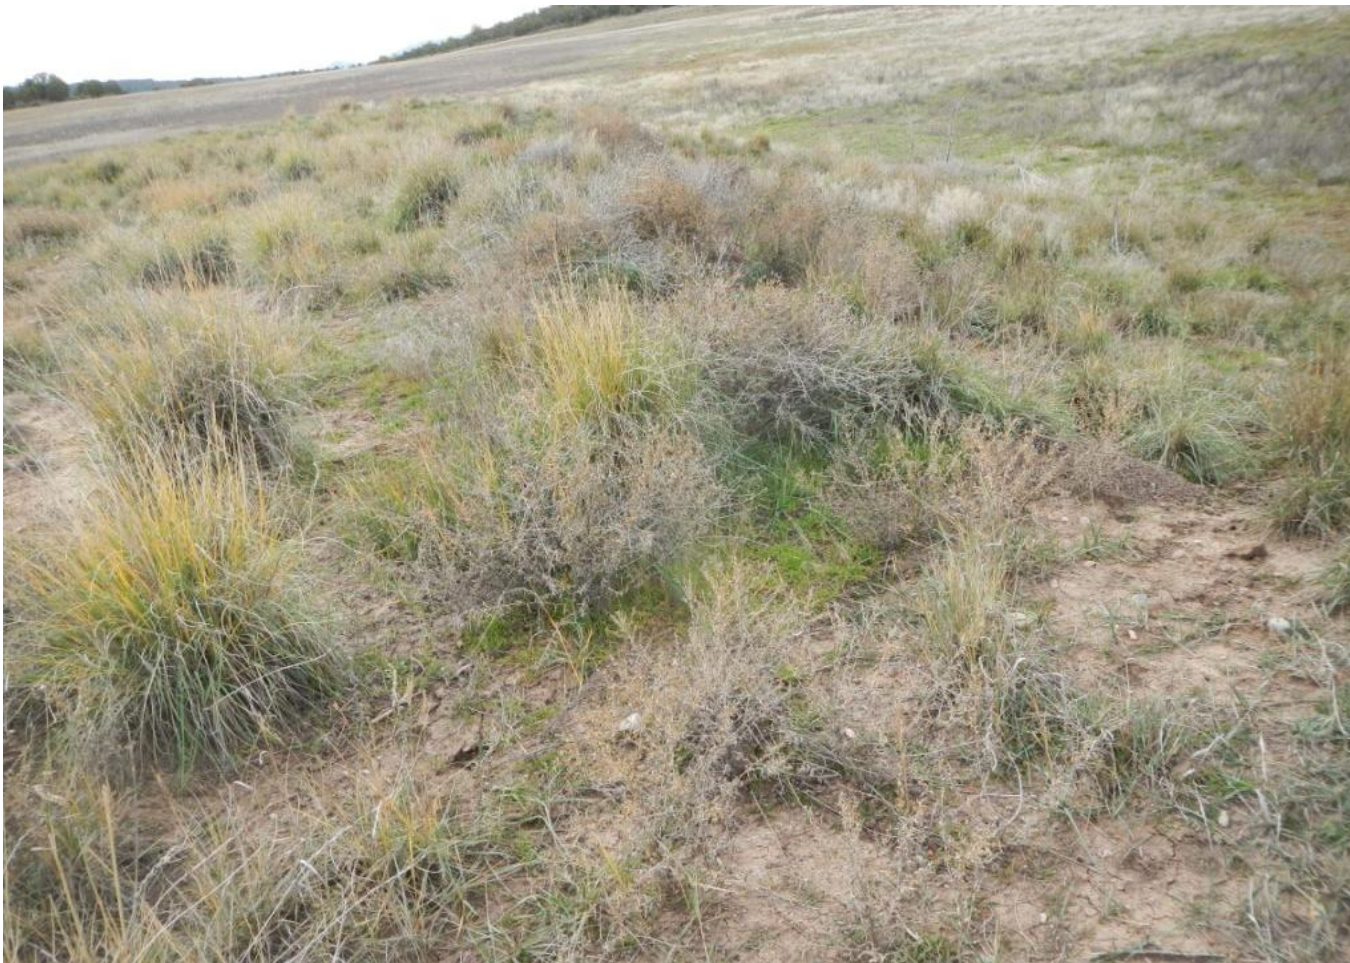
Photo 2. View of dried knapweed plants within the northern portion of the project area.

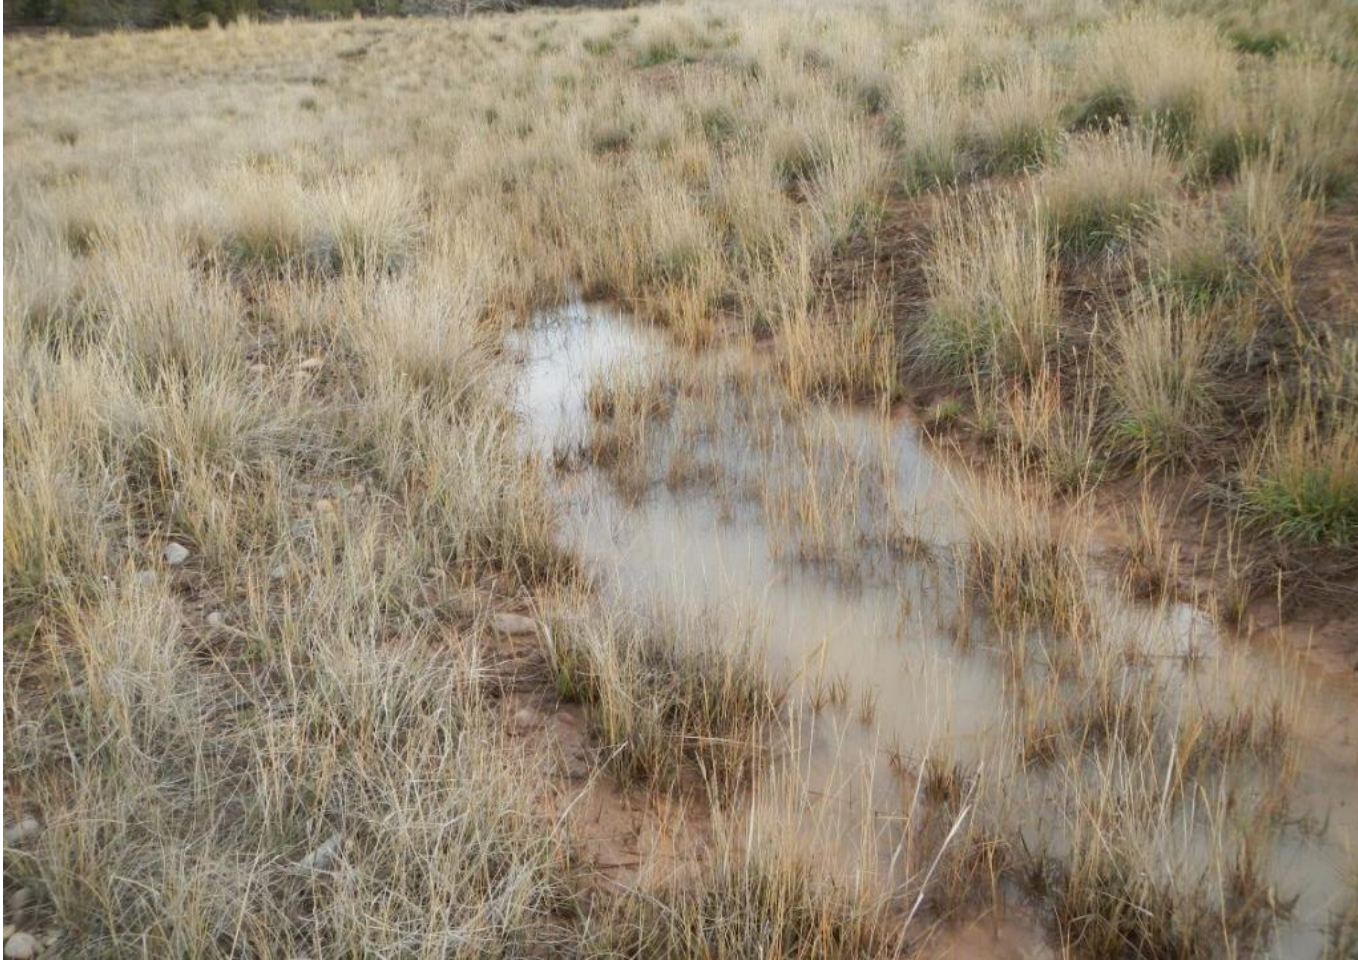
Photo 3. View of vegetated silt trap and vegetated swale functioning properly as a stormwater diversion.
