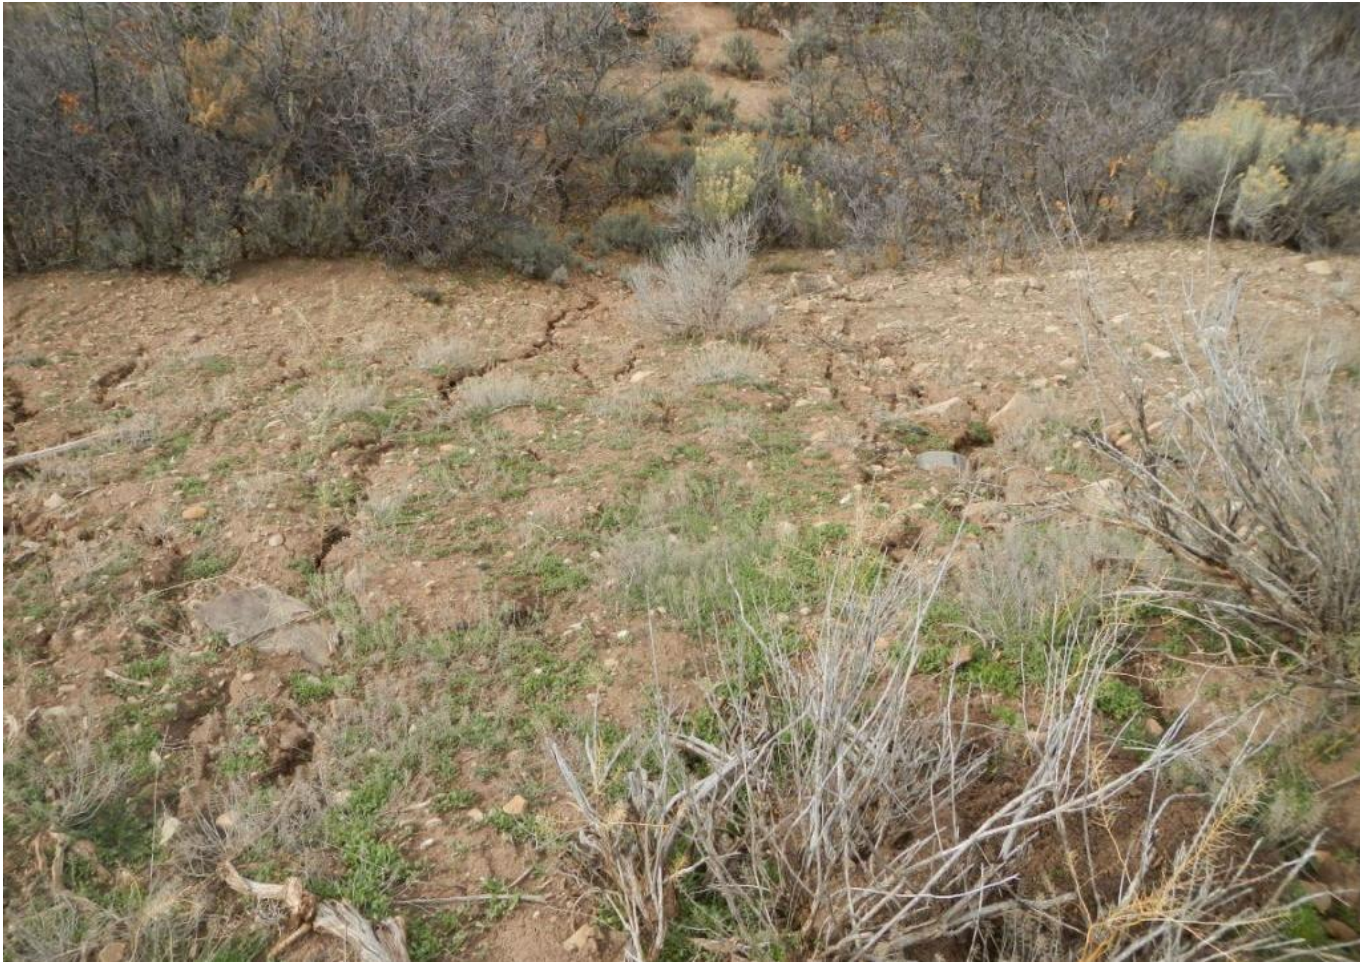
Photo 1. View of rill erosion in slope in western portion of project area.

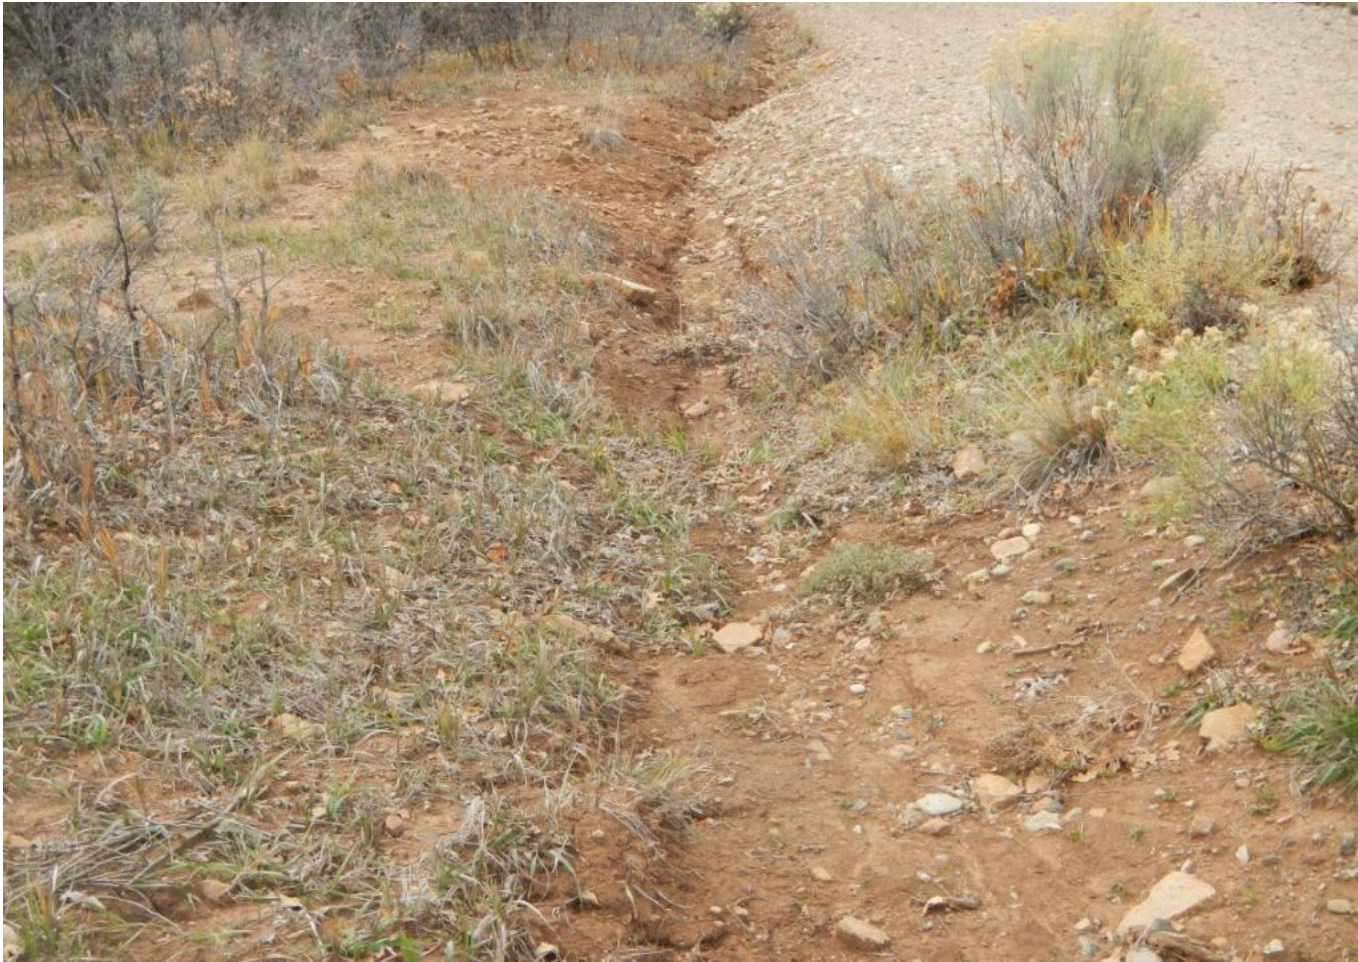
Photo 2. View of stormwater erosion and downcutting in roadside ditch along graveled portion of access road.

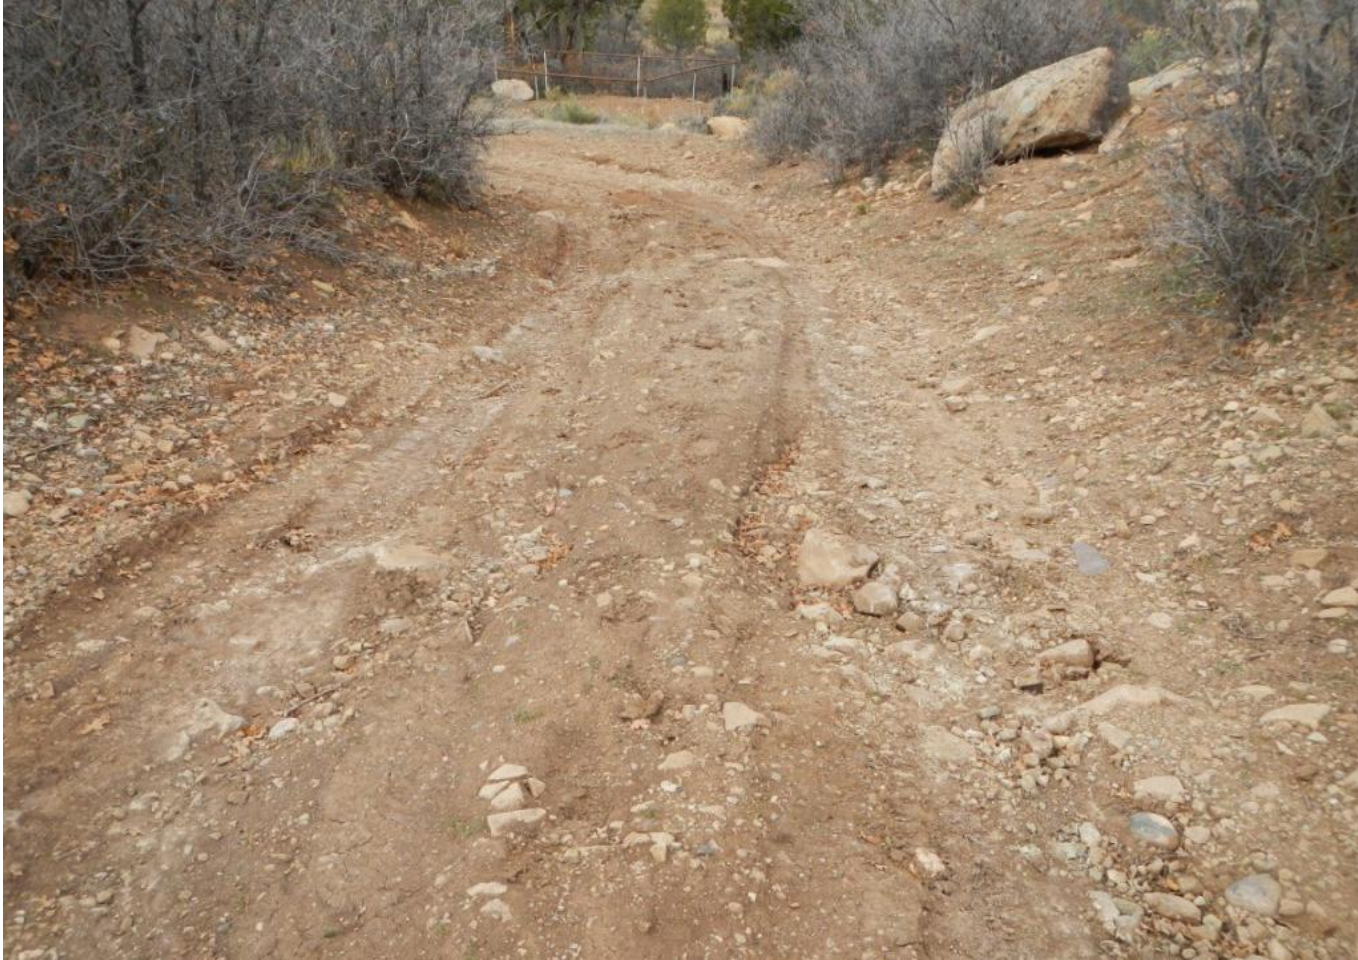
Photo 3. View of stormwater erosion on road surface of un-graveled portion of access road within project area upslope from project facilities.

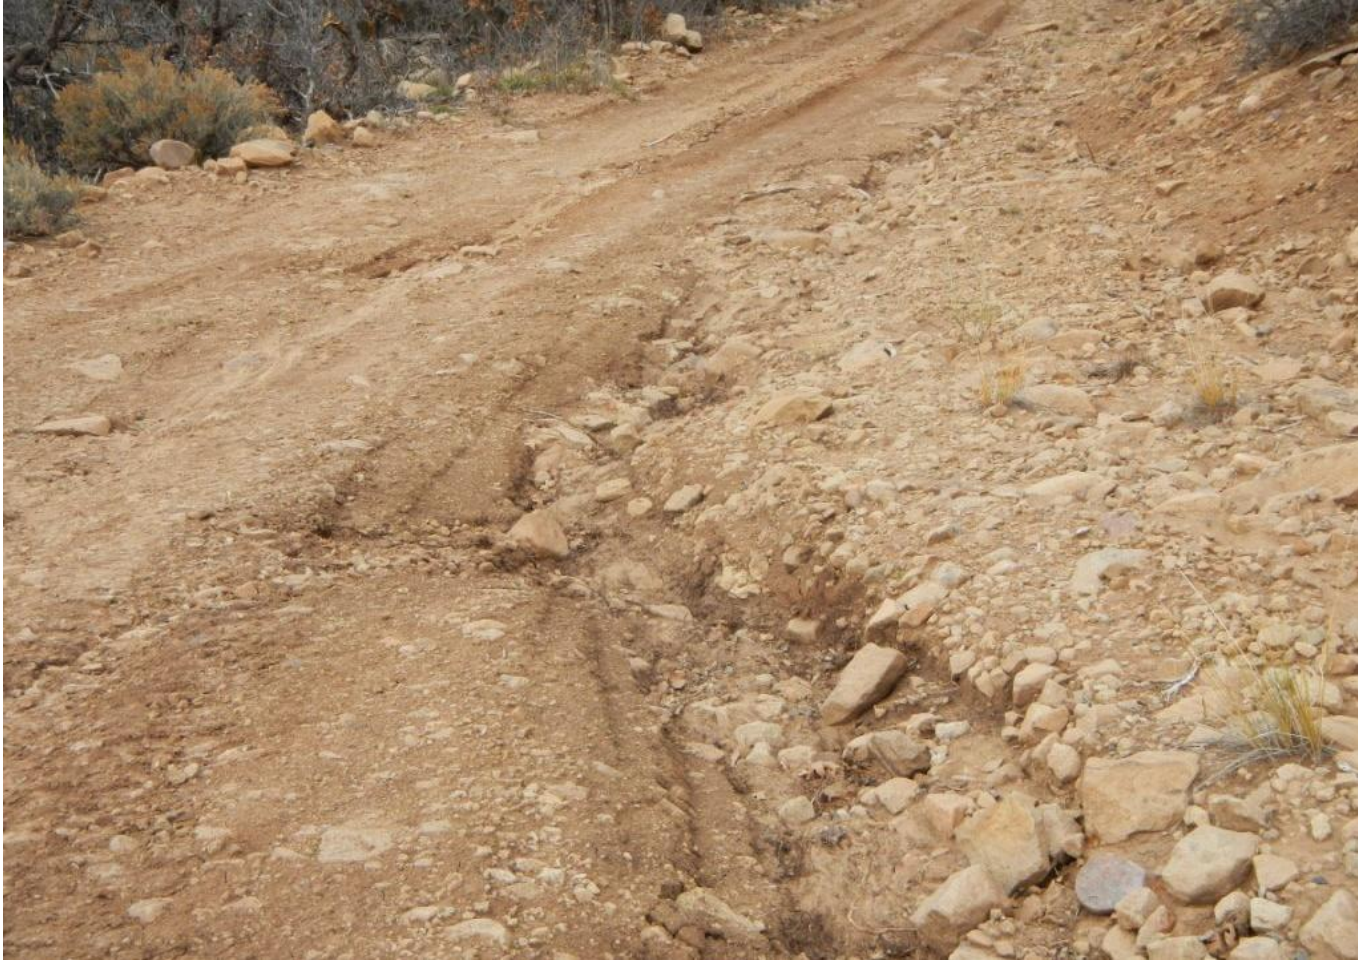
Photo 4. Another view of stormwater erosion and exposed rocks on surface of un-graveled access road near project facilities.
