Photo 1. View of revegetation within the project area from southeastern corner facing center.

Photo 2. View of Scotch thistle in project area.

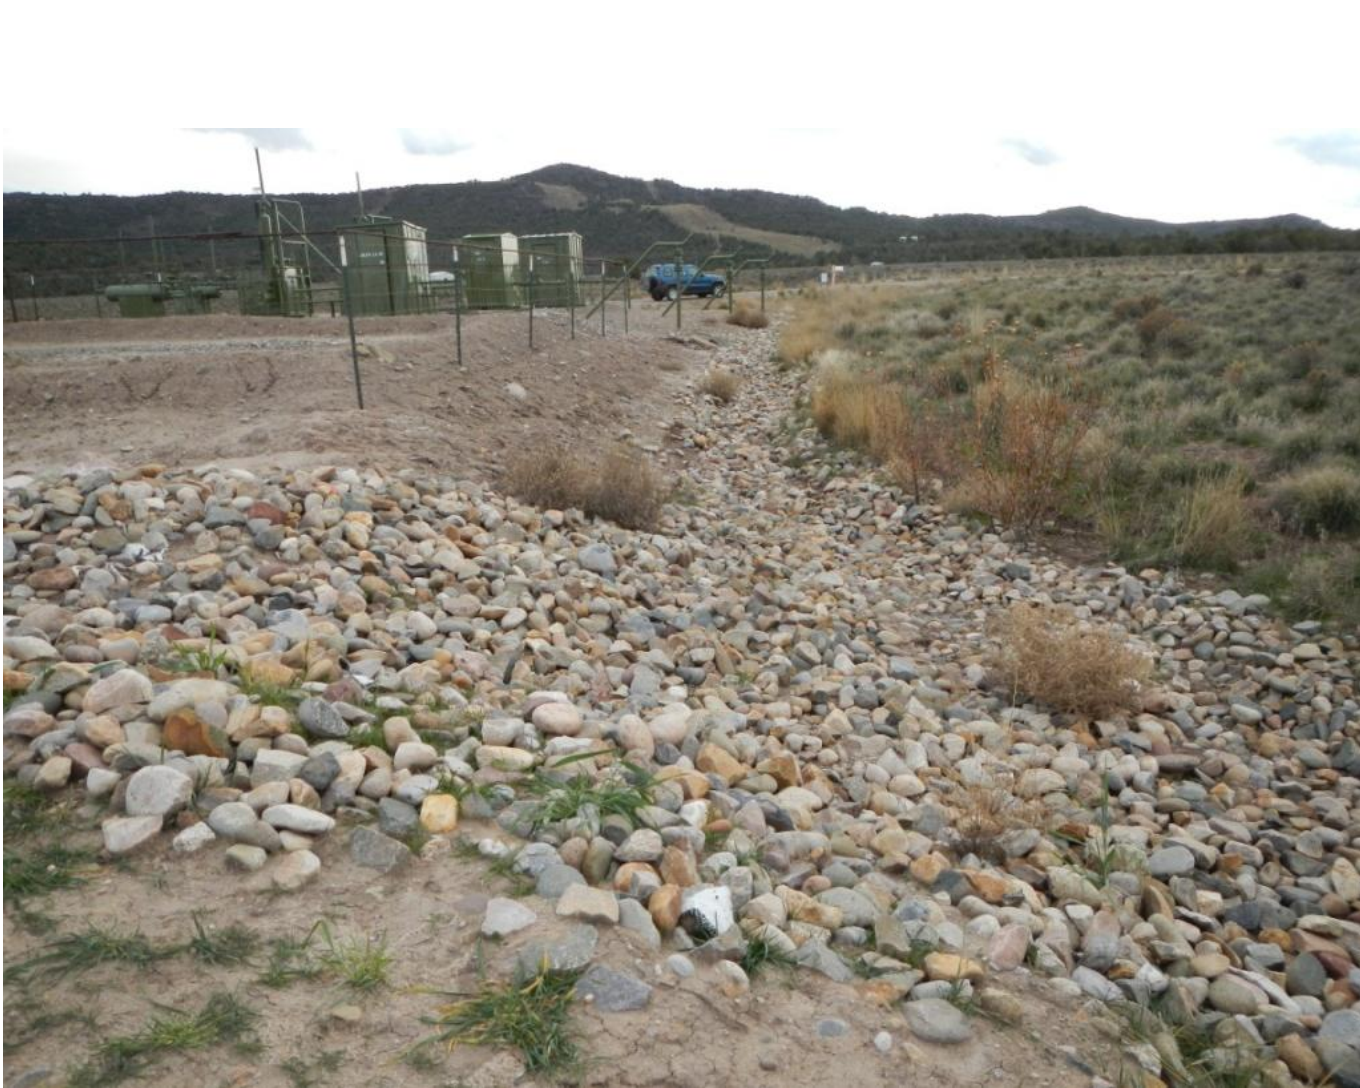
Photo 5. View of armored stormwater diversion channel in good condition.
