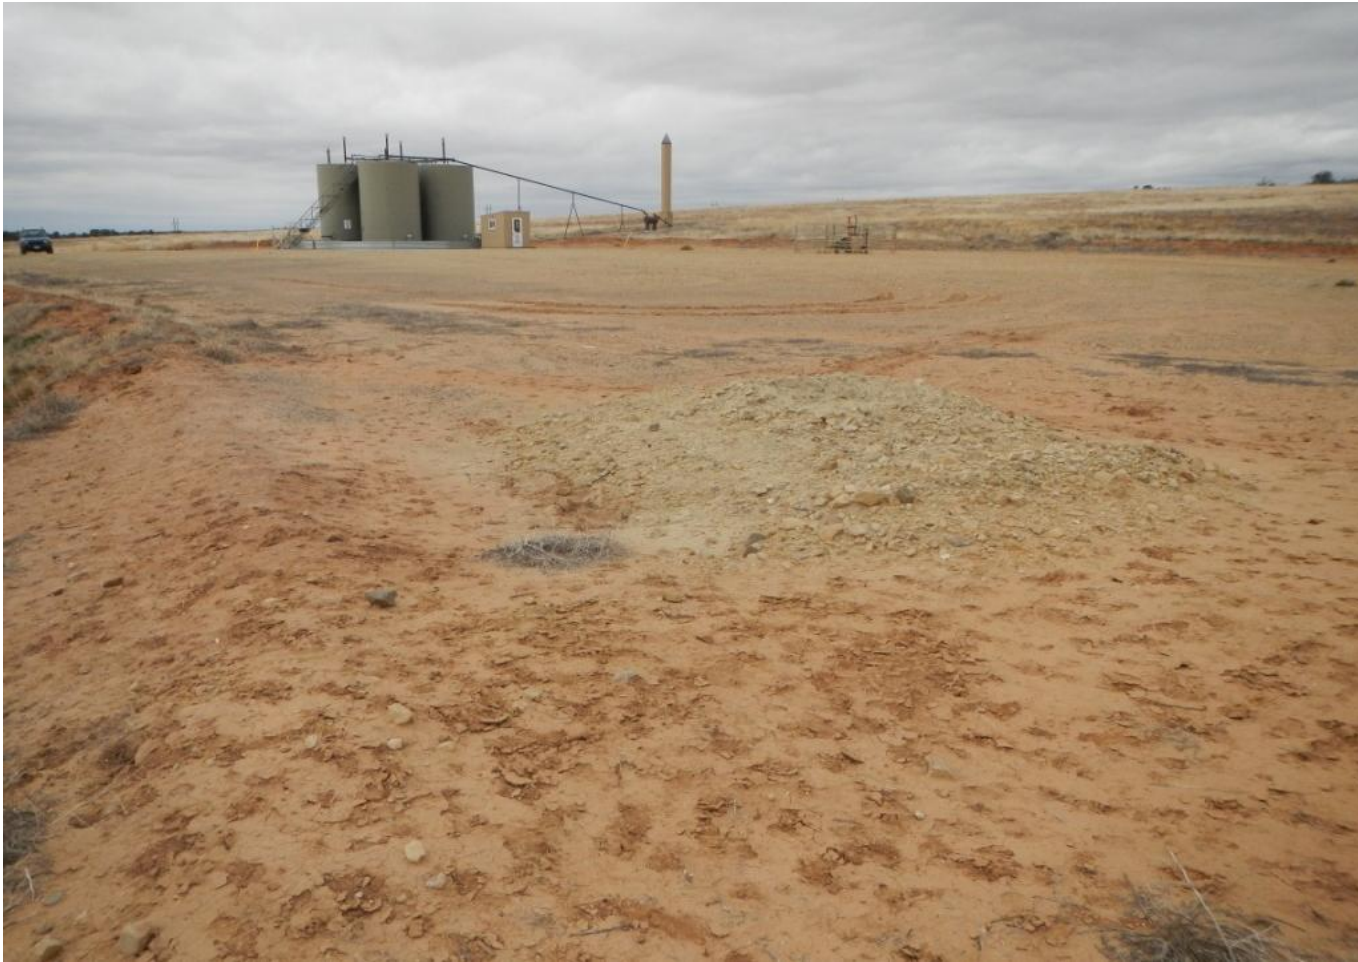
Photo 1. View from southeastern corner of project area facing center. Large area in foreground does not appear necessary for project activities and needs interim reclamation.

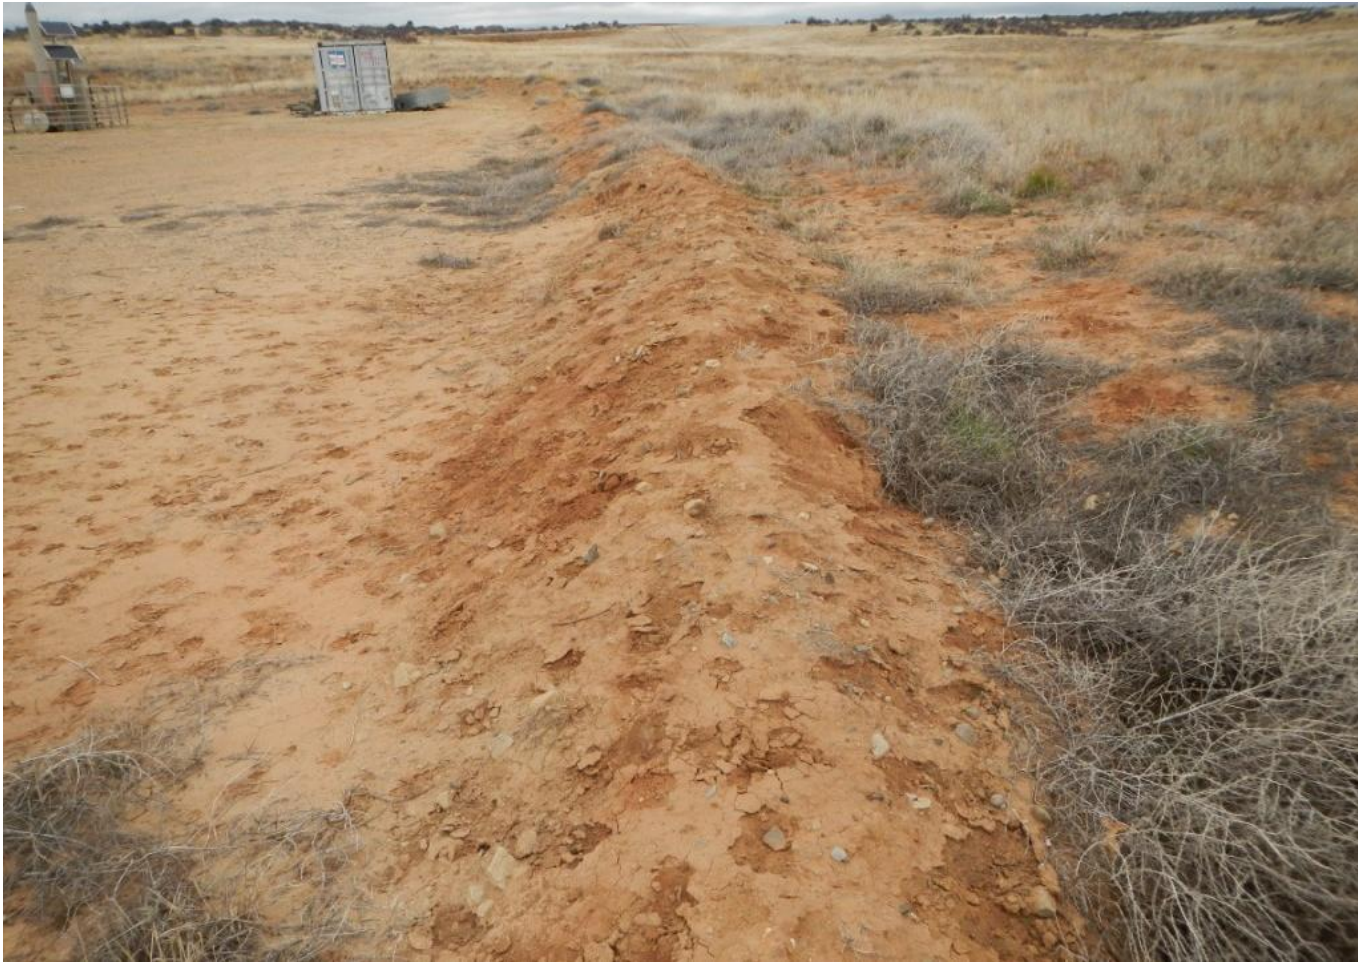
Photo 2. View of eastern edge of project area from southeastern corner facing northward.

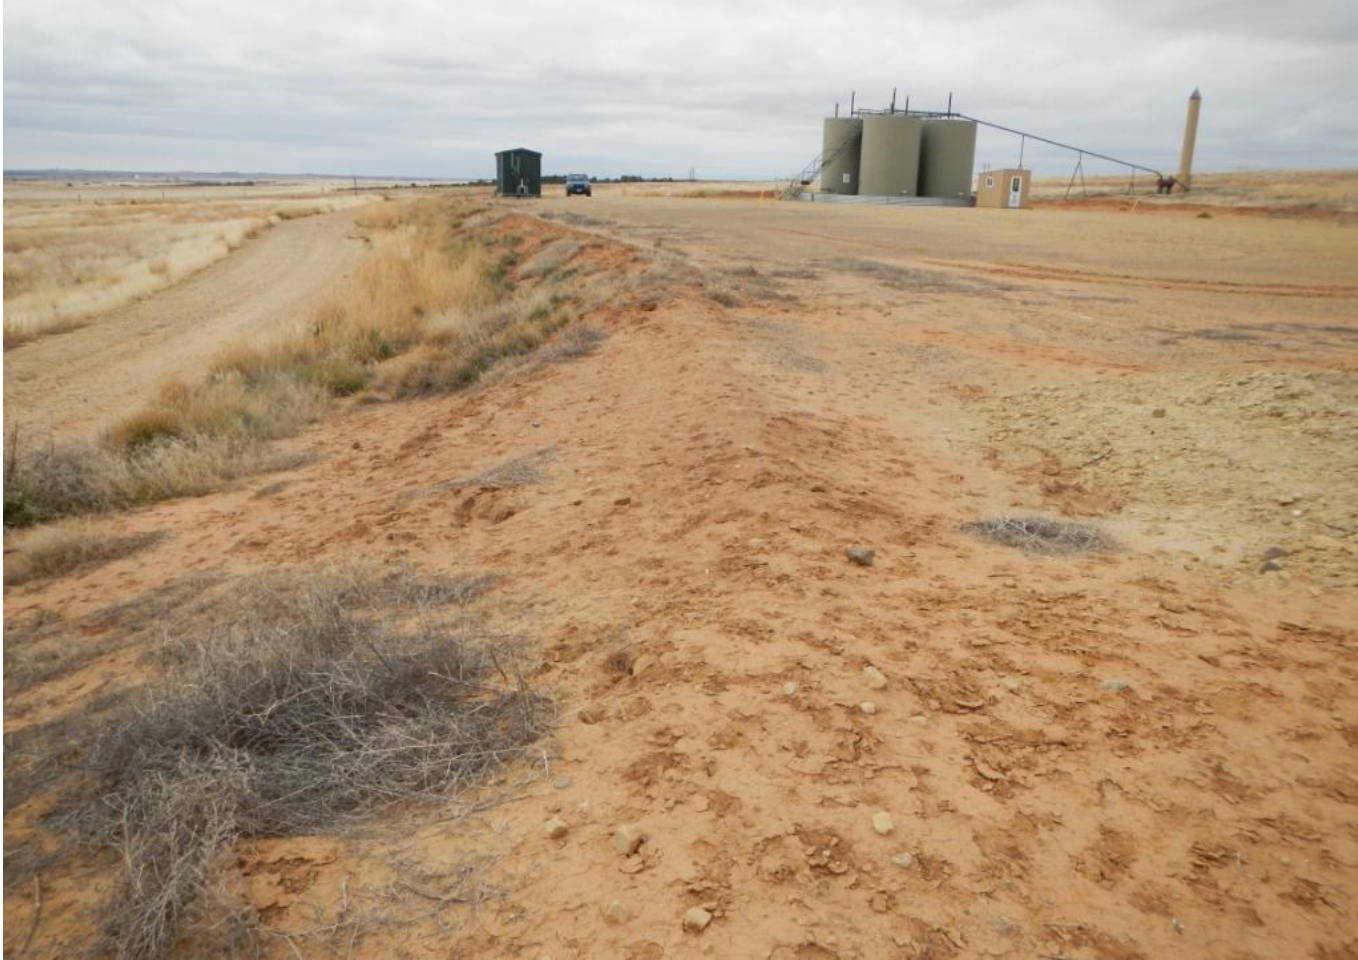
Photo 3. View of southern edge of project area from southeastern corner facing westward.

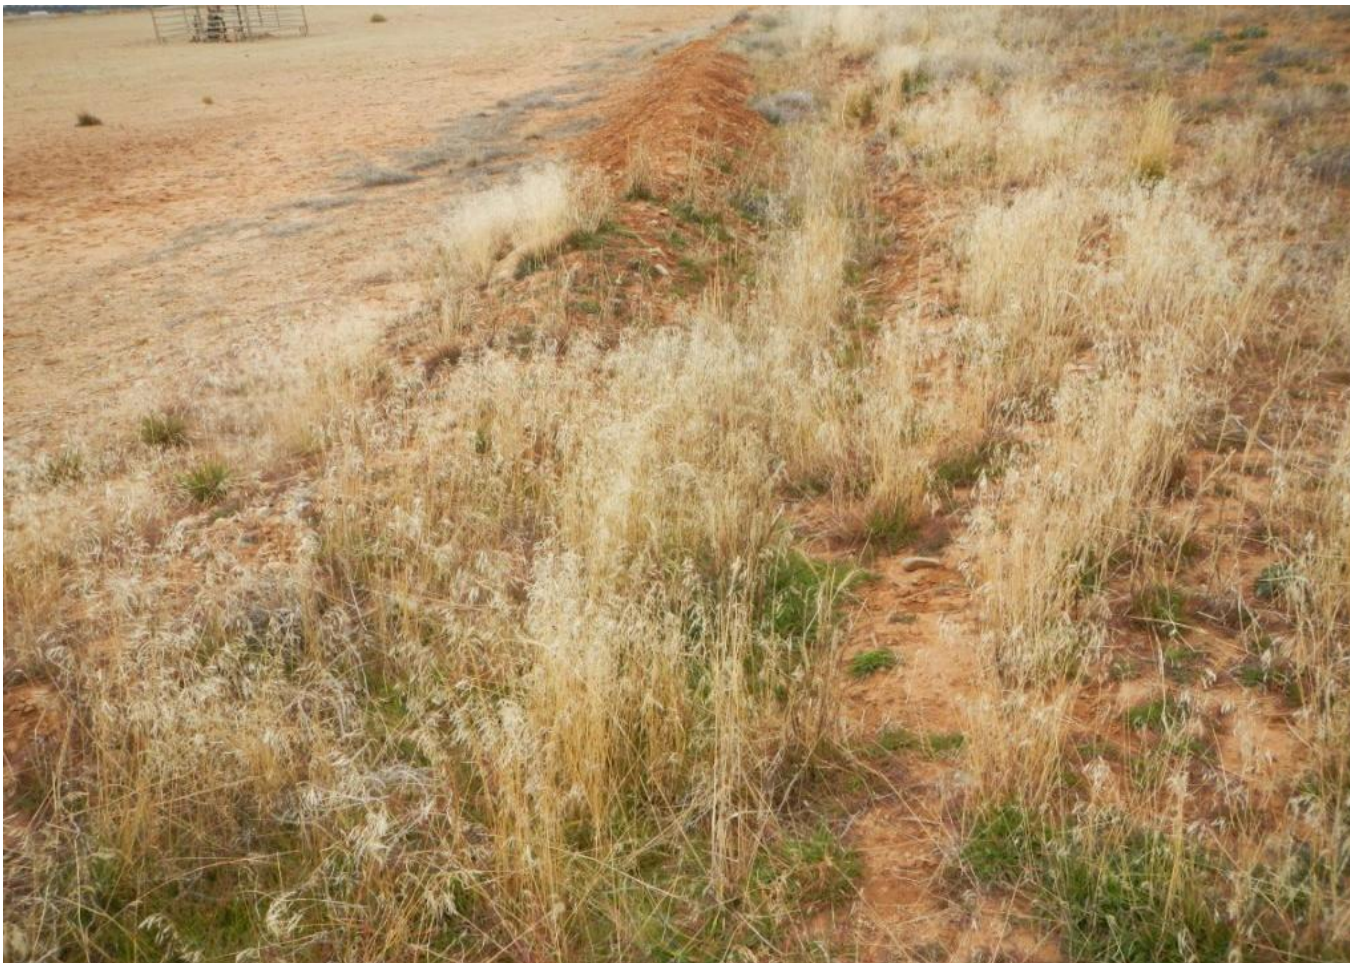
Photo 4. View of stormwater diversion along northern edge of project area.

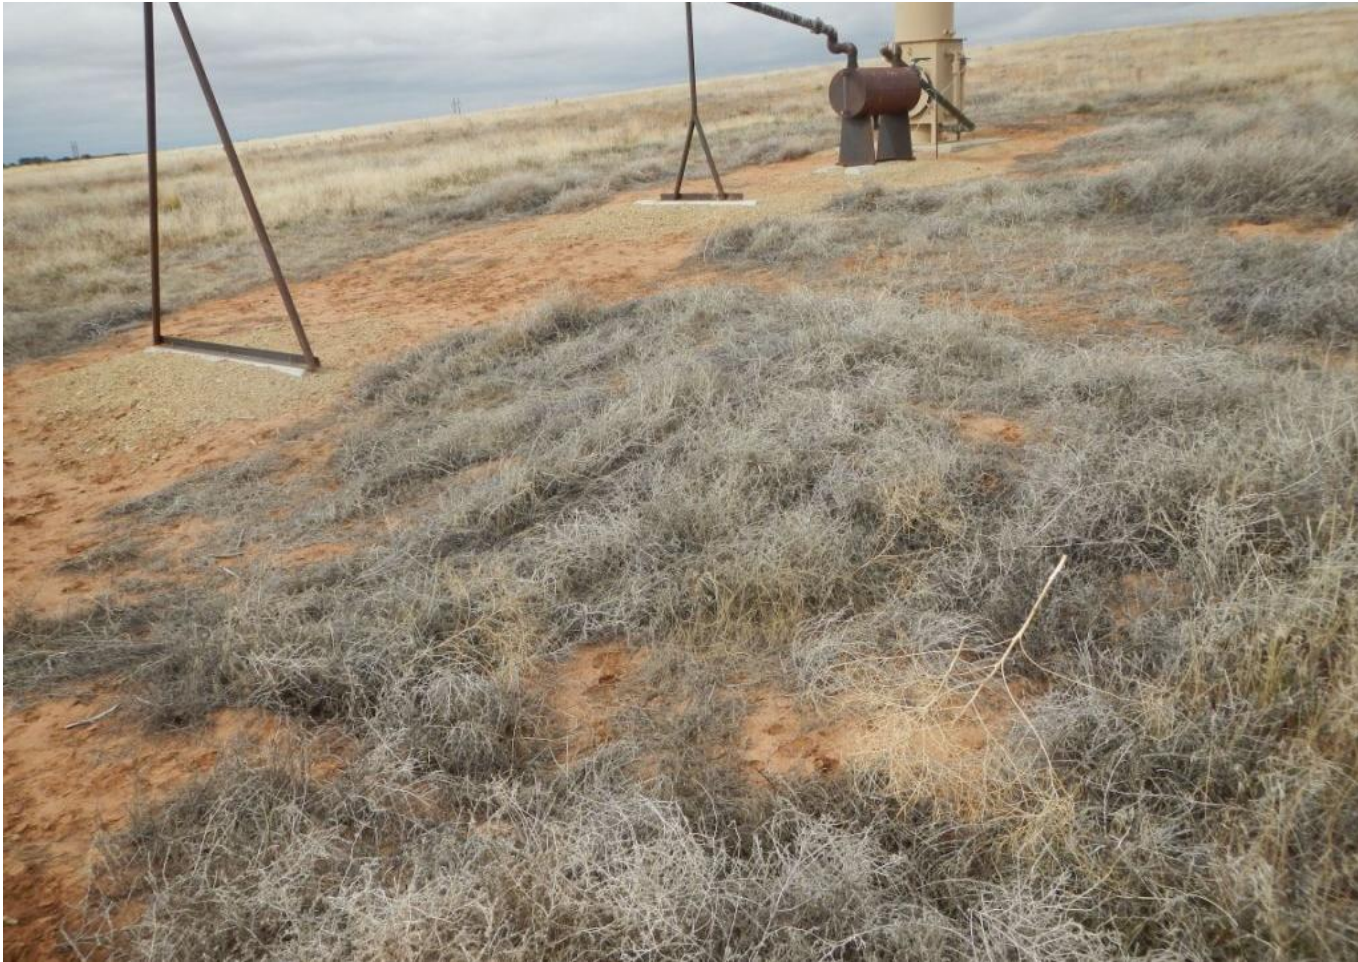
Photo 5. View of Russian thistle debris around project facilities. Unused portions of this area need revegetation and Russian thistle debris needs to be removed and disposed of properly.
