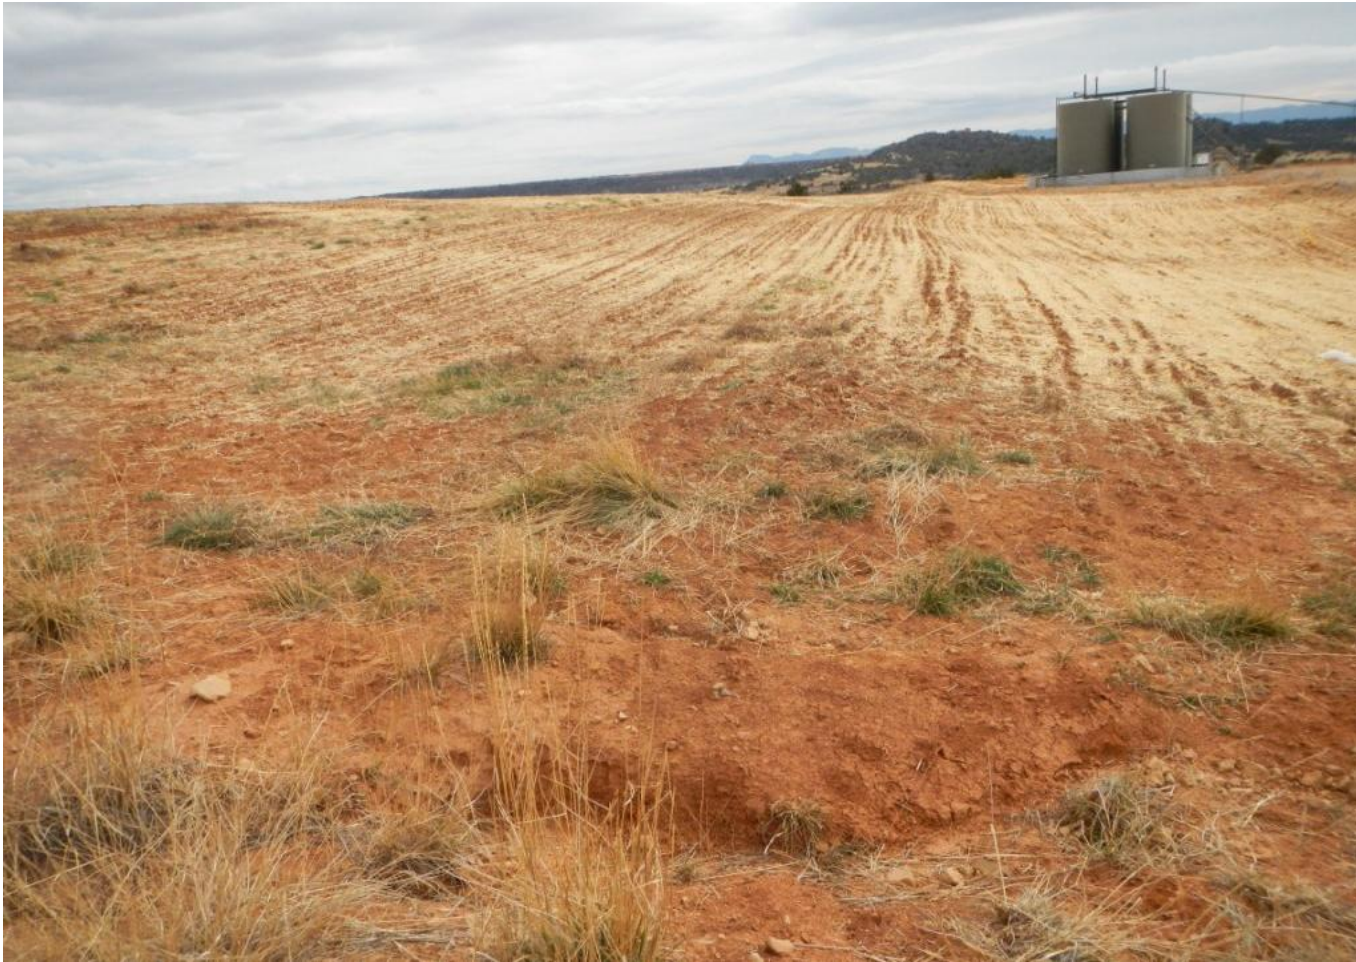
Photo 1. View of eastern portion of project area that appears to have recently undergone reclamation activities.

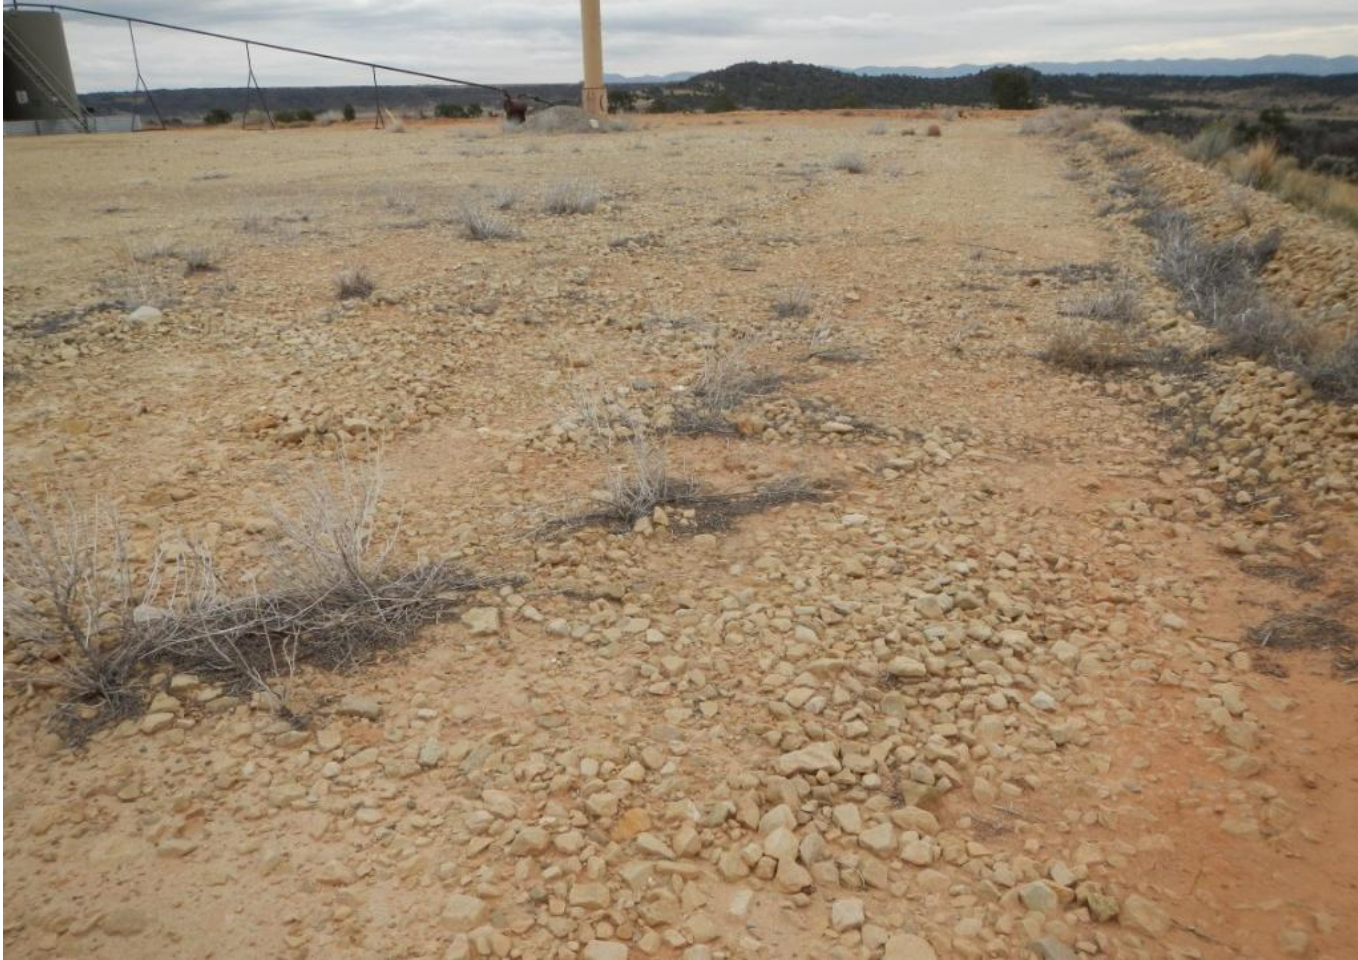
Photo 2. View of area in western portion of project area that does not appear necessary for production operations.

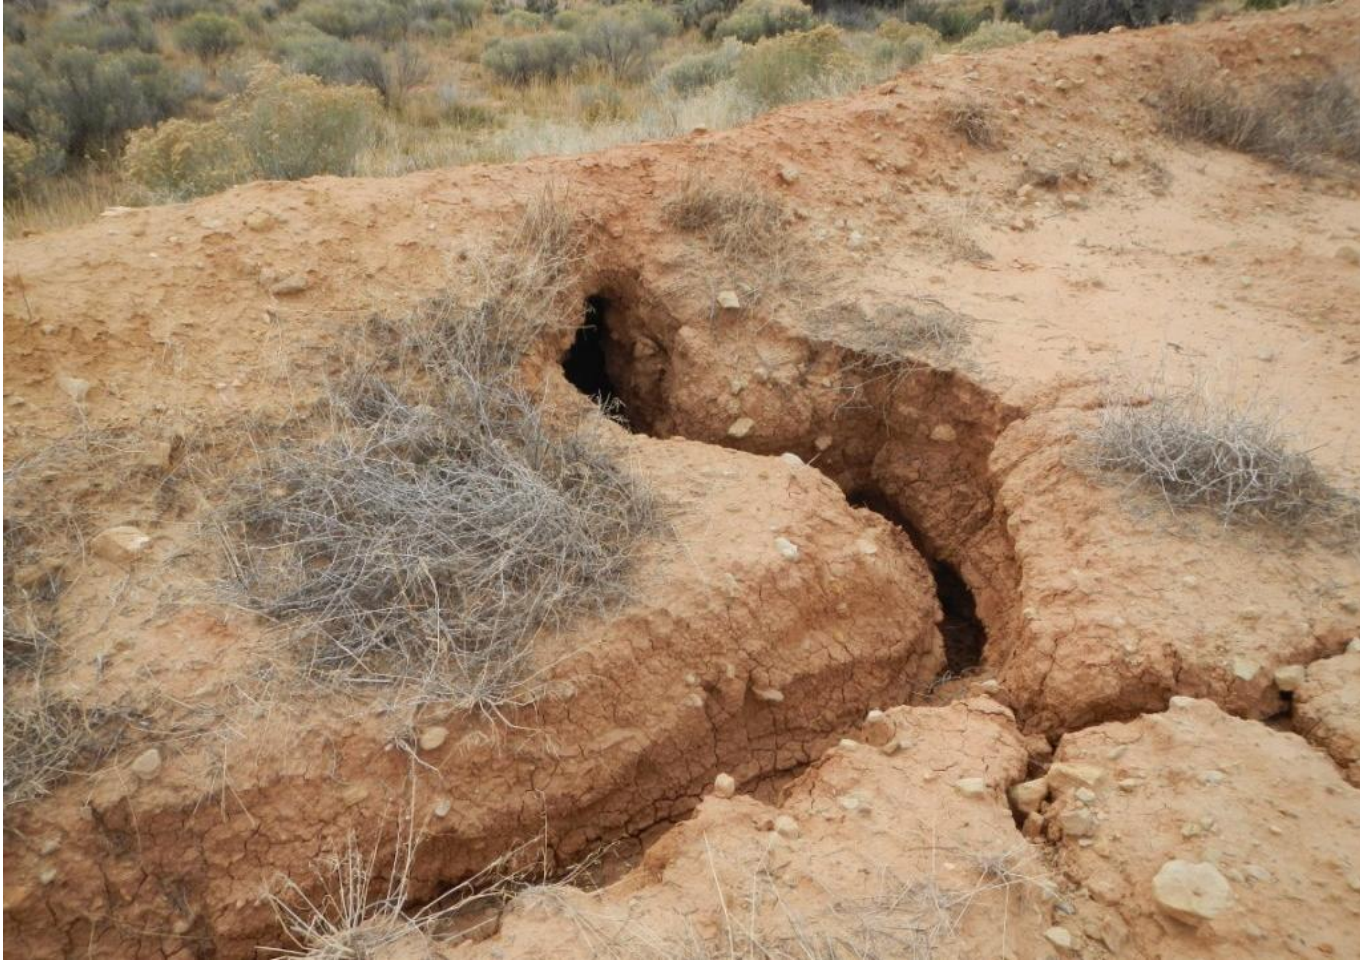
Photo 3. View of erosion in southwestern corner of project area.

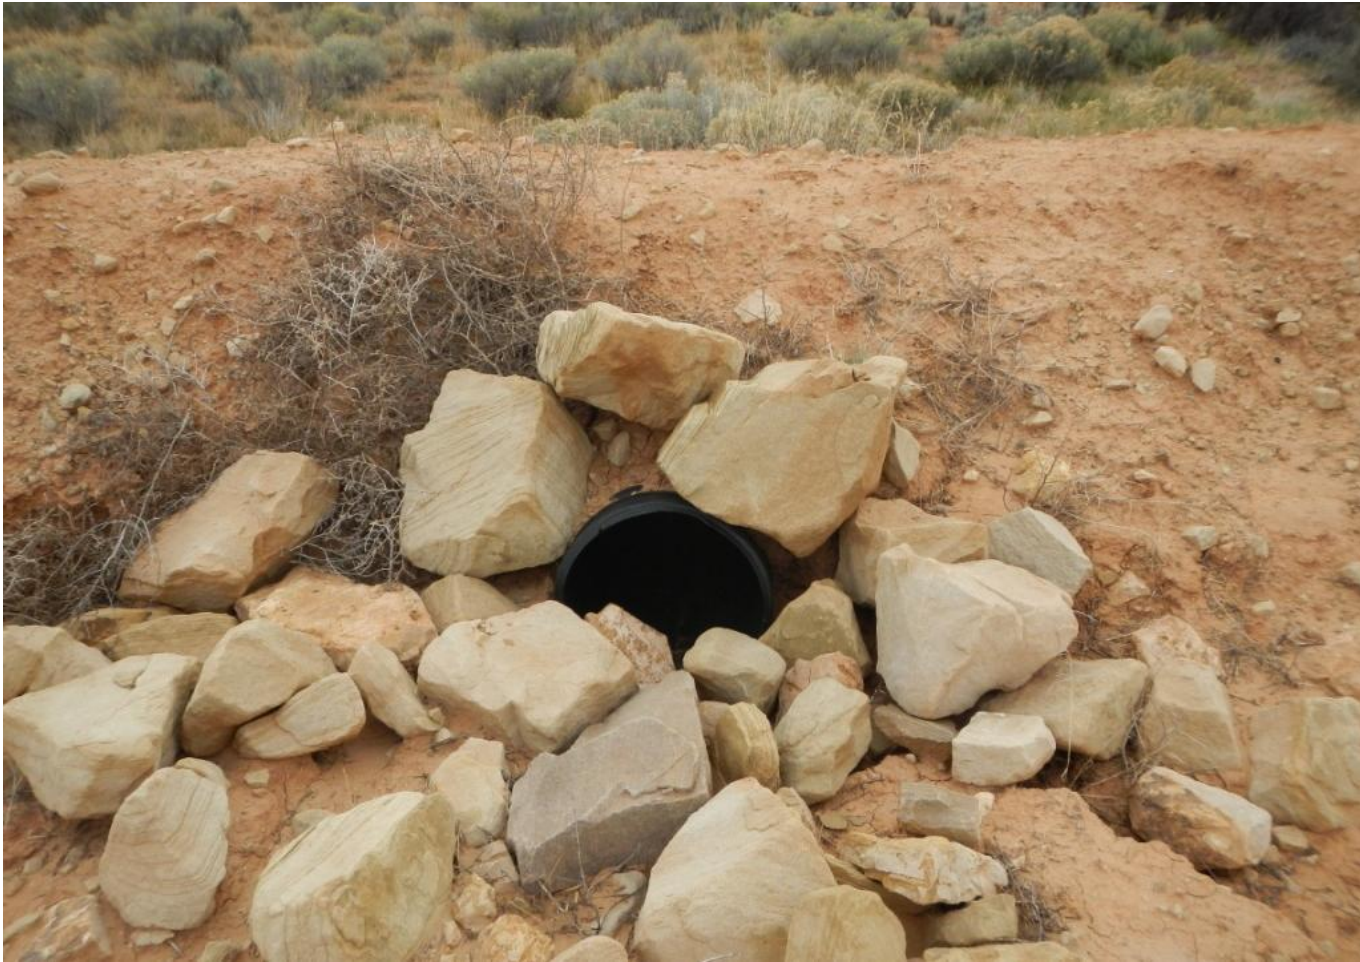
Photo 4. View of armored culvert in southwestern corner of project area.

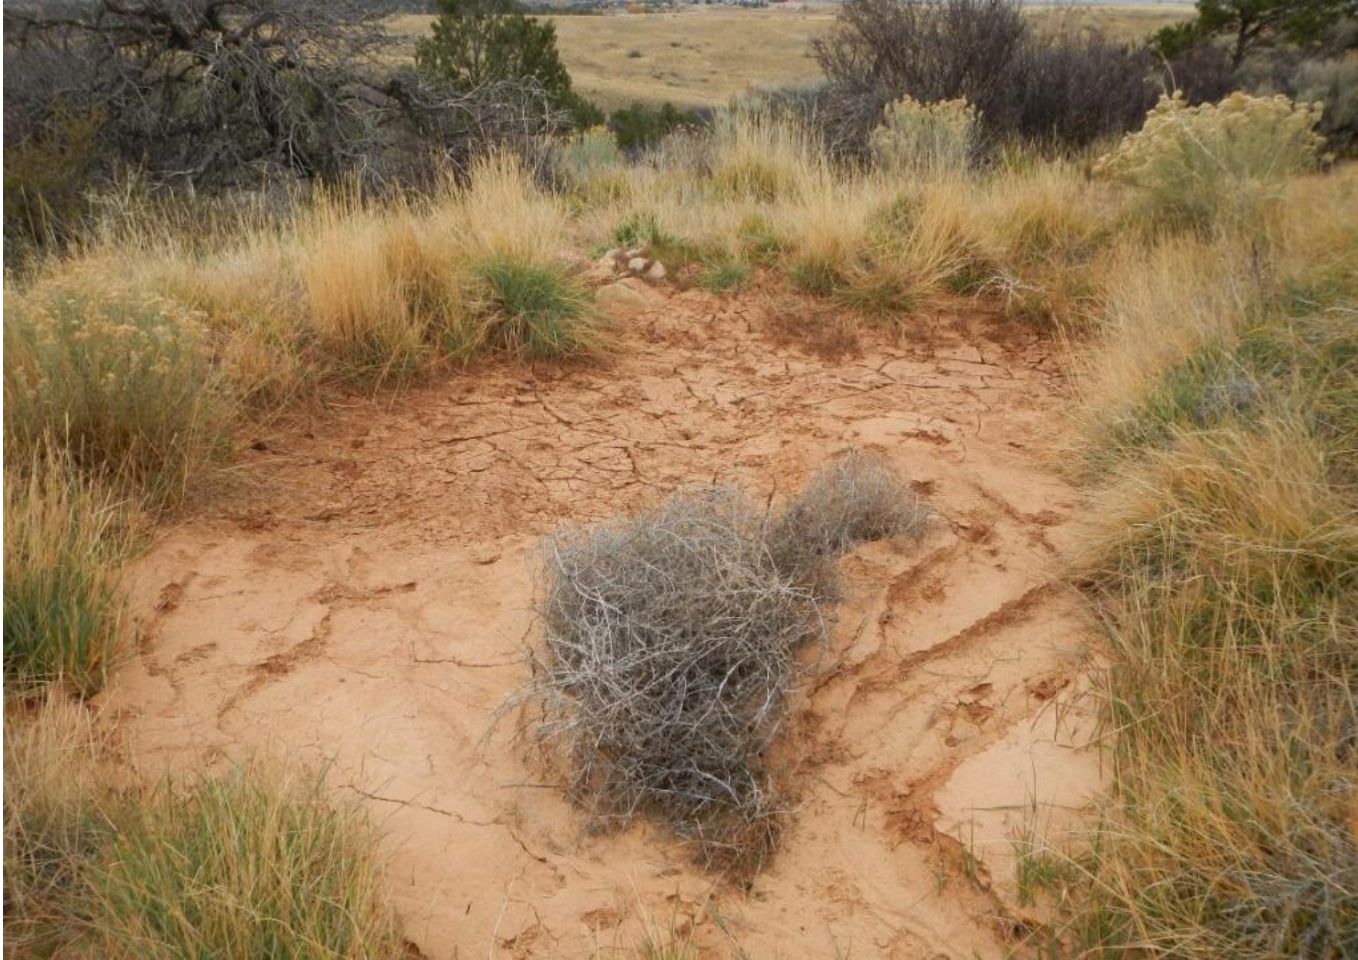
Photo 5. View of silt trap needing to be cleaned out in southwestern corner of project area.

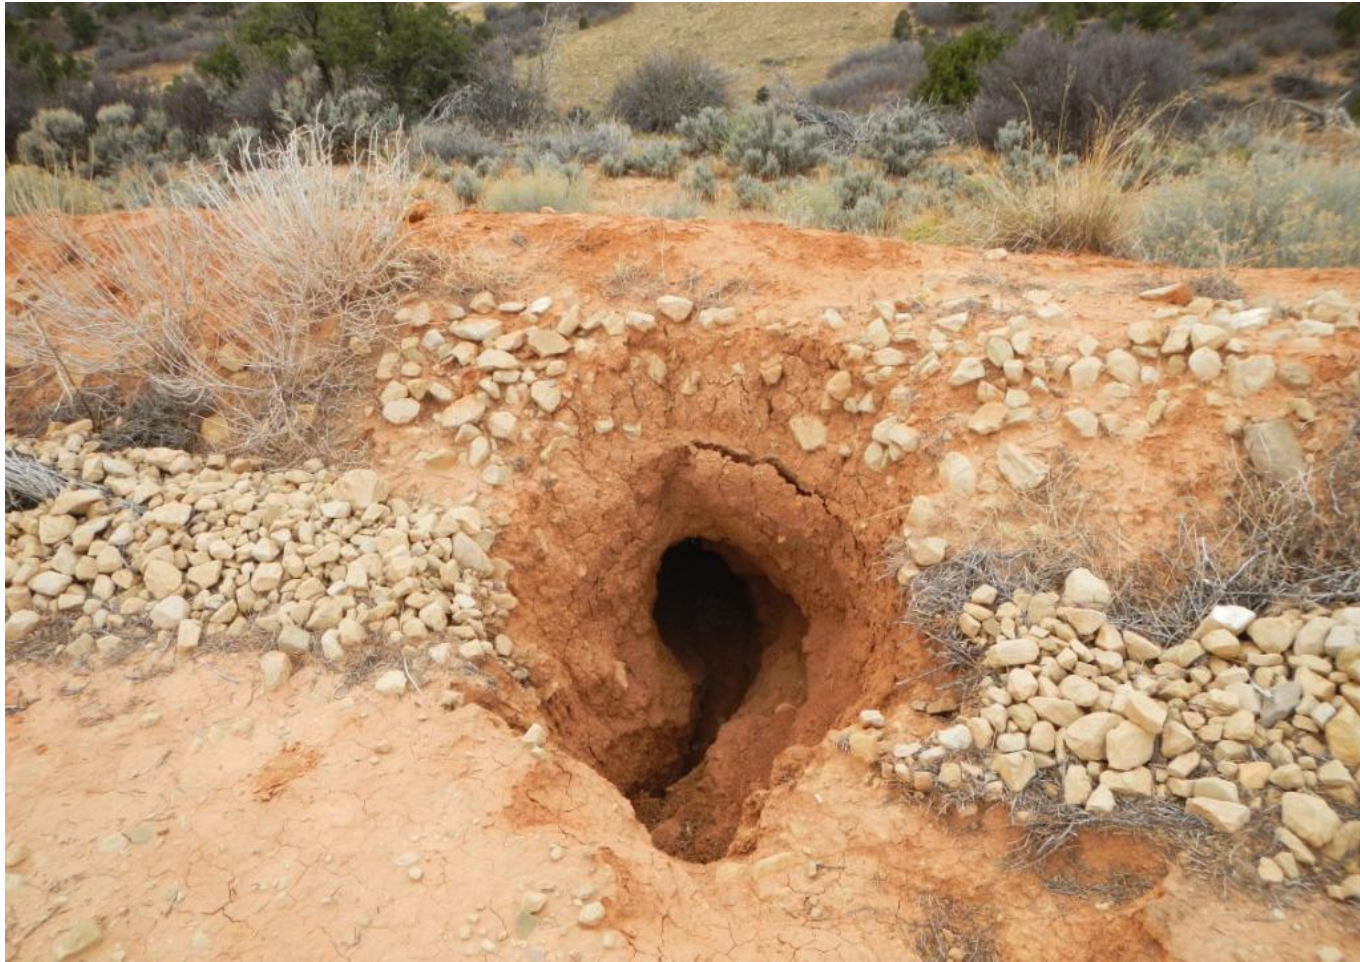
Photo 6. View of erosion along western edge of project area.
