**Dugan Production Co Operator #25250
Tiffany #1 API# 05-067-06498
Inspection #674601260**

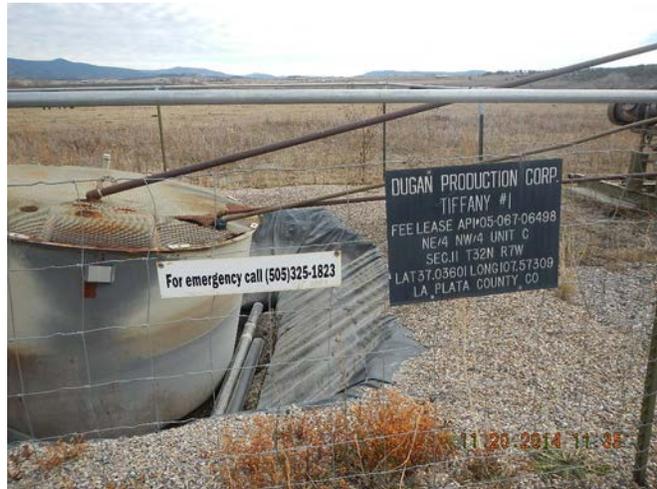
Existing Well Sign and Emergency
Contact Number

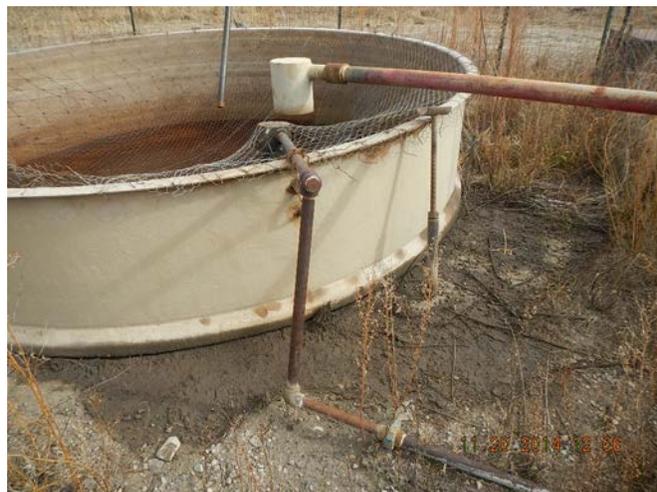
Spill/ saturated soils from unbermed
fiberglass open top tank; moving SW
toward production equipment.

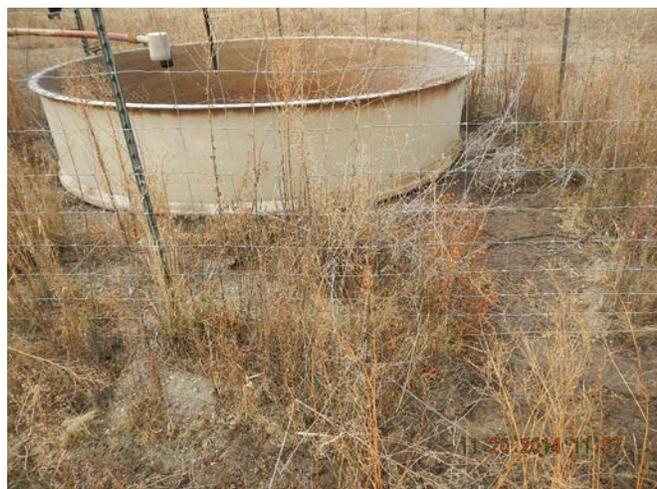
Spill/ saturated soils from unbermed
open to tank; Moving NE and away
from equipment.

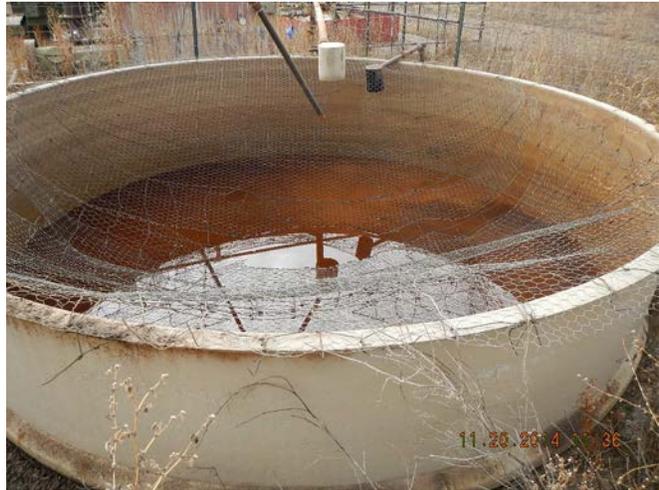
Damaged/ breached wildlife screen over fiberglass open top tank. No existing tank sign in place.

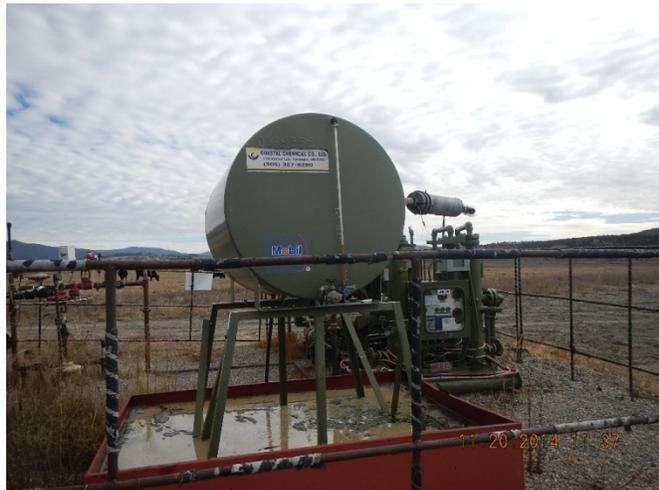
Chemical containment full of fluid, minimal freeboard, and without wildlife screen/ protection.

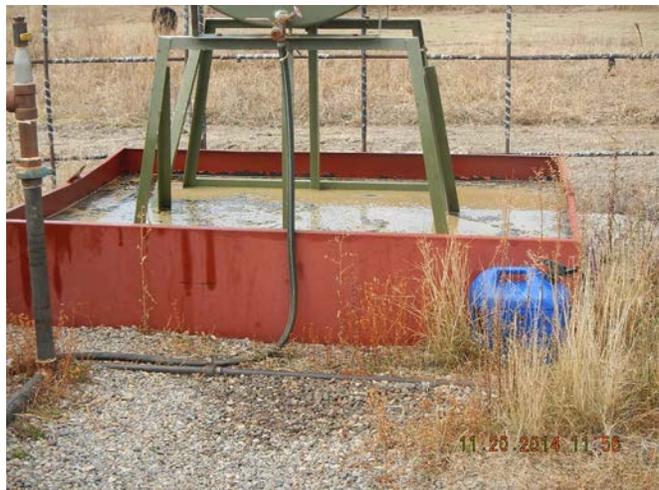
Chemical containment with fluid/ stained soils around equipment.

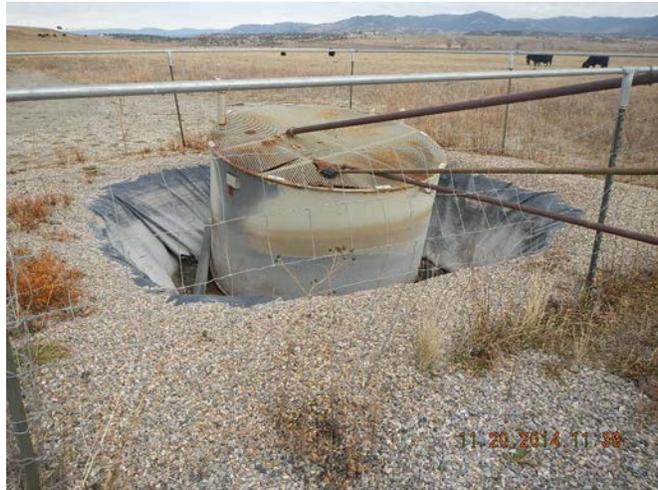
Steel open top tank (Near Dehydrator) with no sign; Integrity in question; Fluid in containment area; torn poly liner; unmaintained earthen berm.

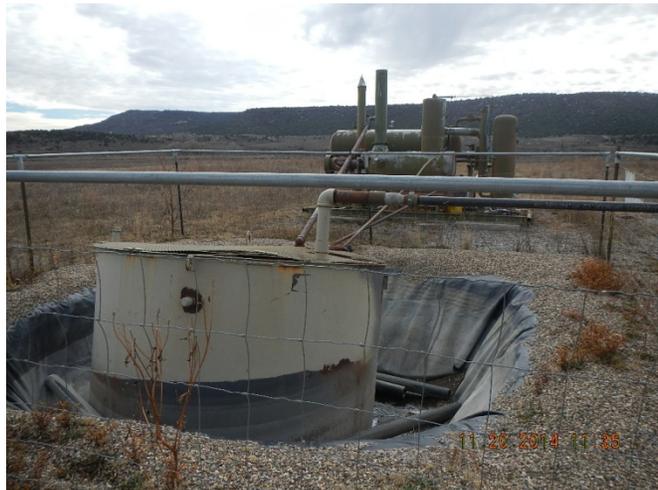
Damaged wildlife screen on steel open top tank; Trash in containment area.

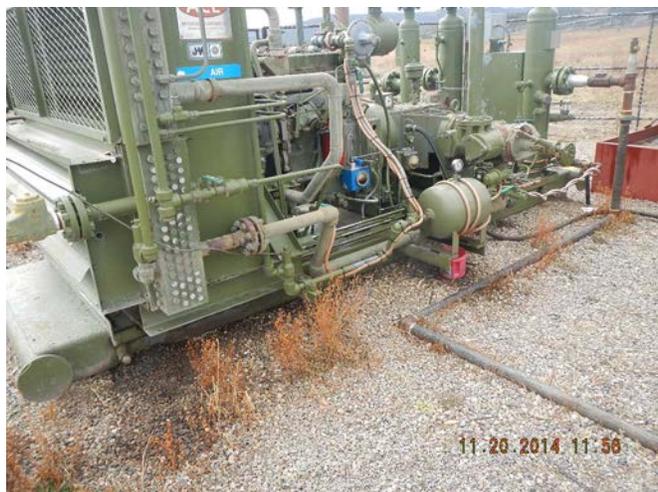
Free lube oils observed on compressor skid; Stained gravel/ soils on ground adjacent to equipment.

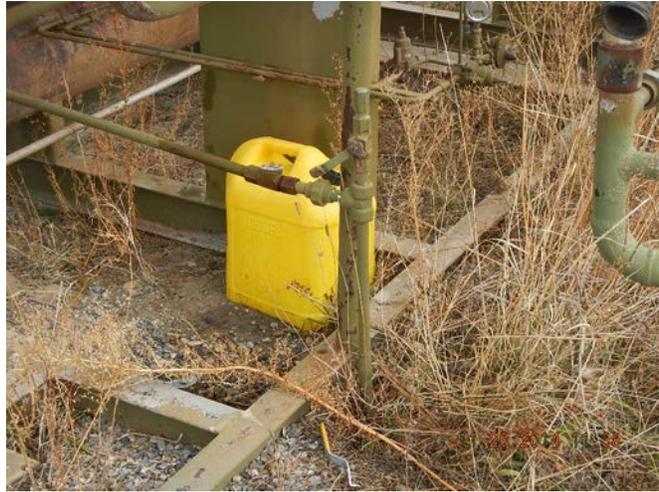
Inadequate storage of fuel containers;
No spill prevention/ covering in place;
Stained soils under equipment.

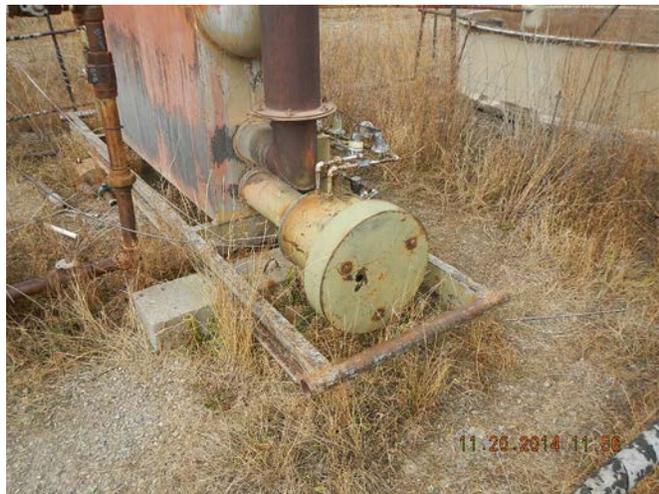
Undesirable vegetation under and
around heated/ fired equipment.

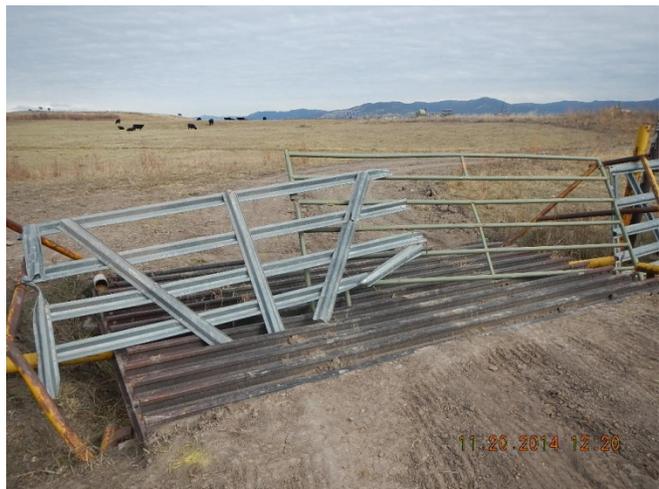
Heavily damaged/ non operable gate
on access road leading to well pad.

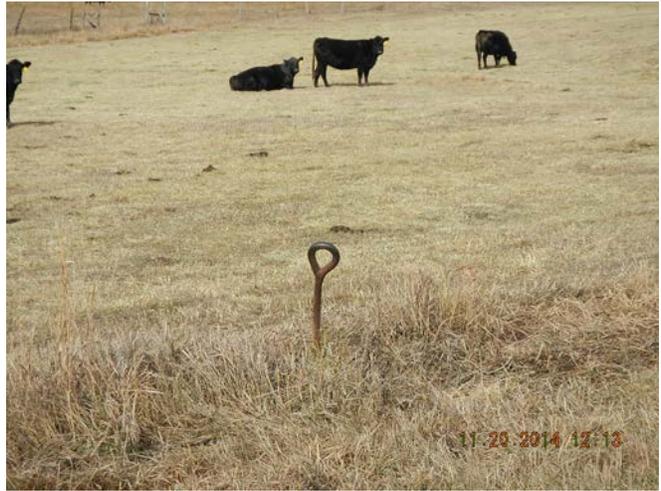
Unmarked Rig Anchor.
