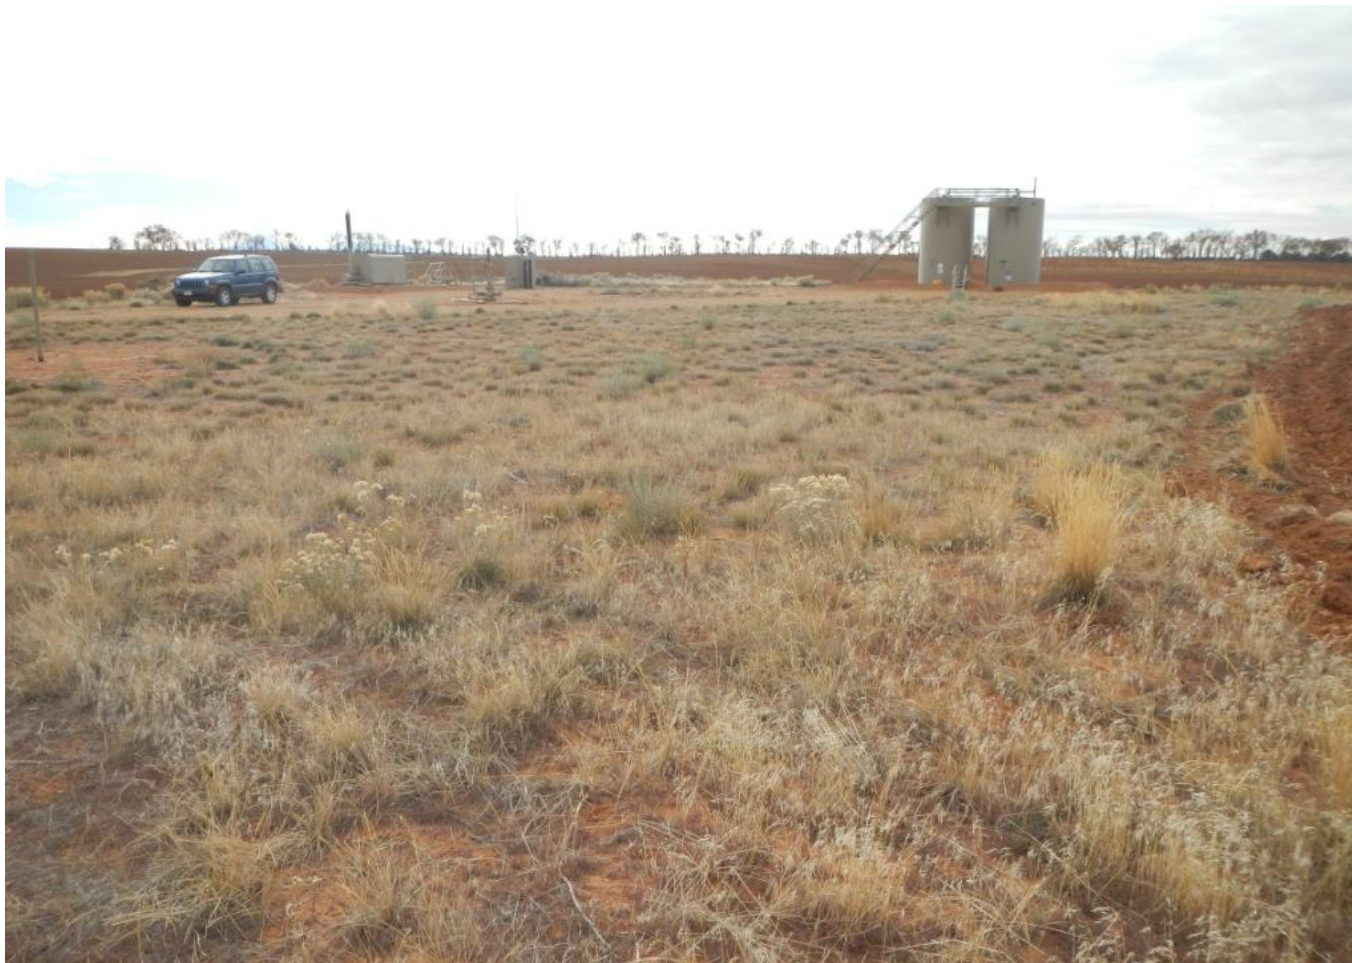
Photo 1. View from northwestern corner of project area facing center. Vegetation is progressing within the interim reclamation area.

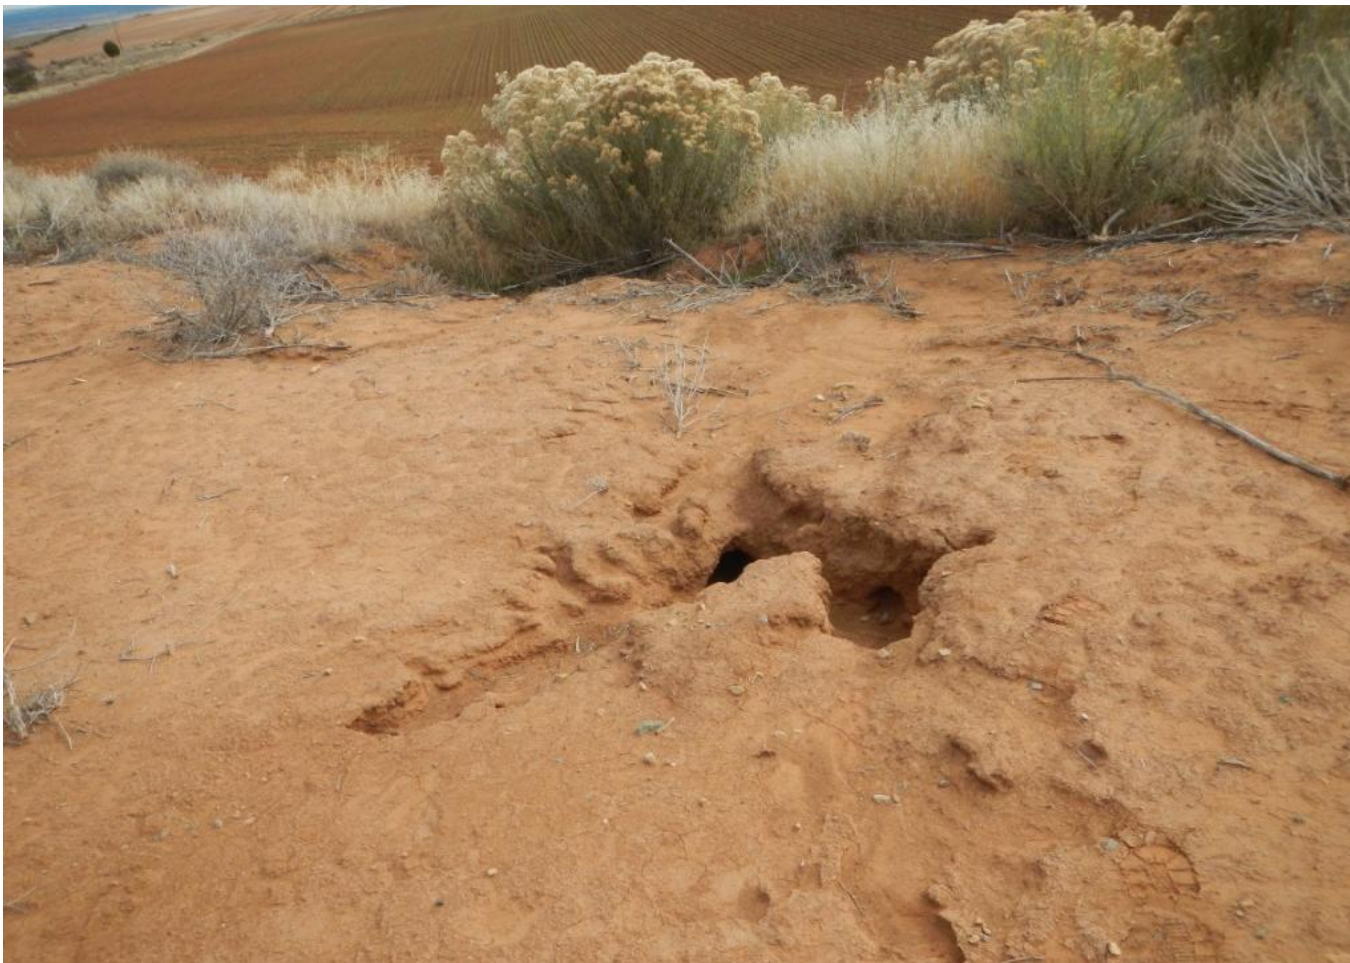
Photo 4. View of tunnel erosion forming within eastern portion of well pad.

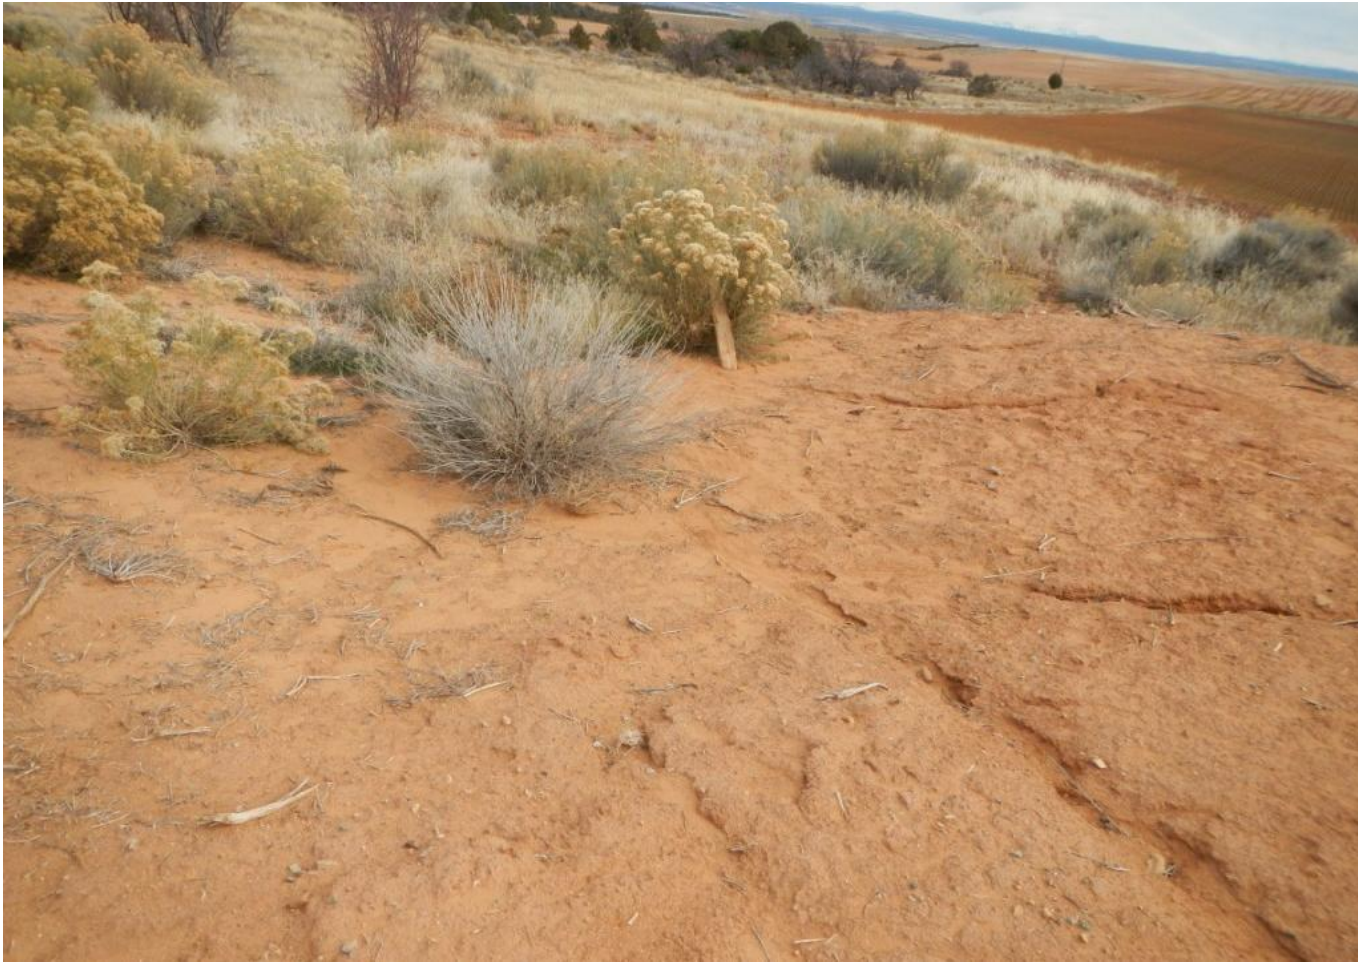
Photo 5. View of rill erosion in northeastern corner of well pad.
