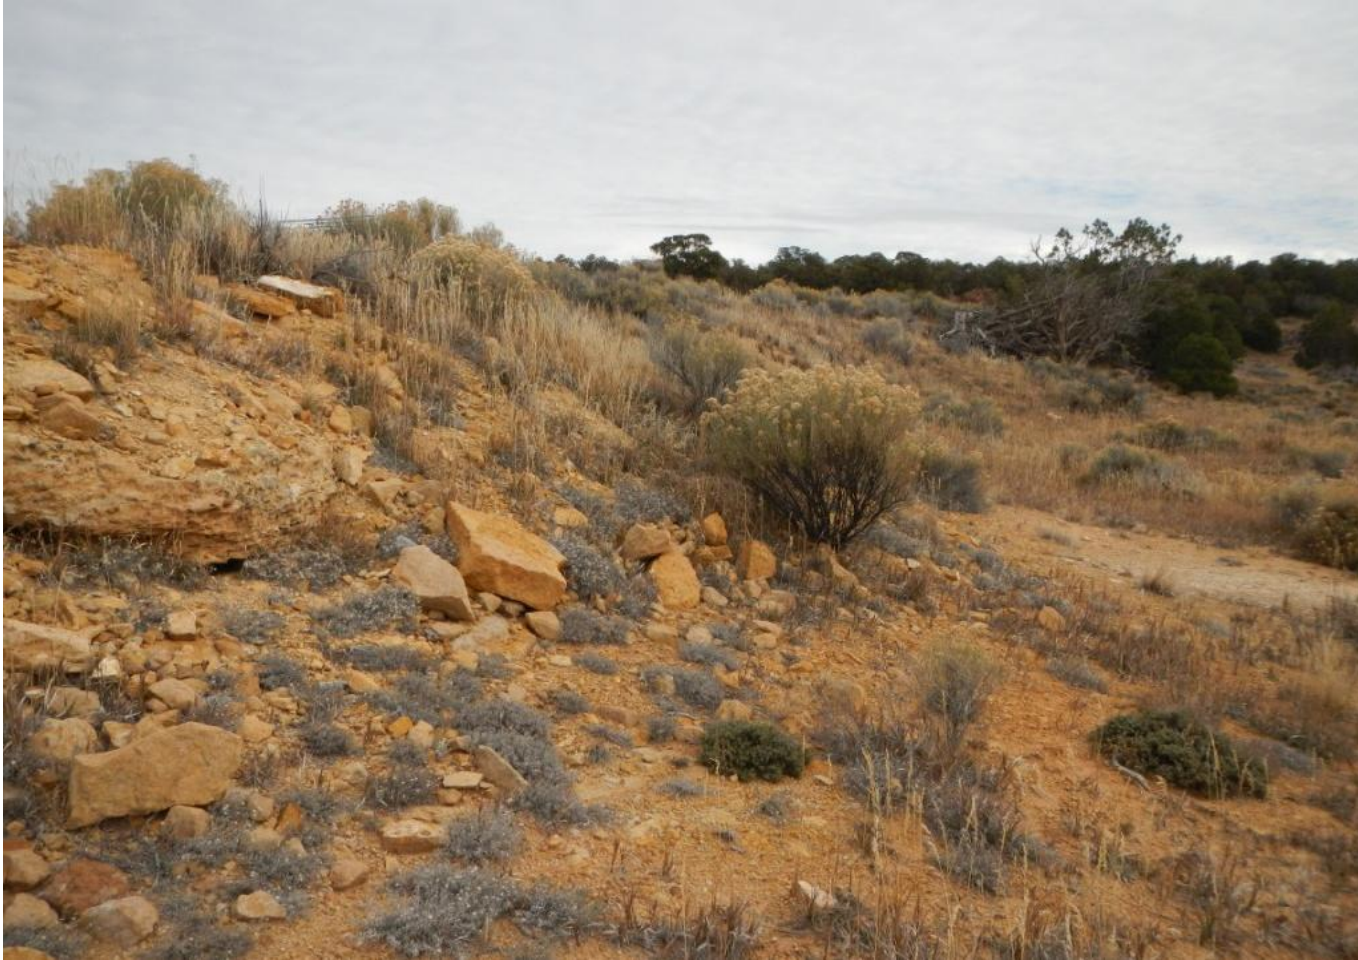
Photo 1. View of revegetation along the fill slope on the southern edge of the project area from the southwestern corner facing eastward.

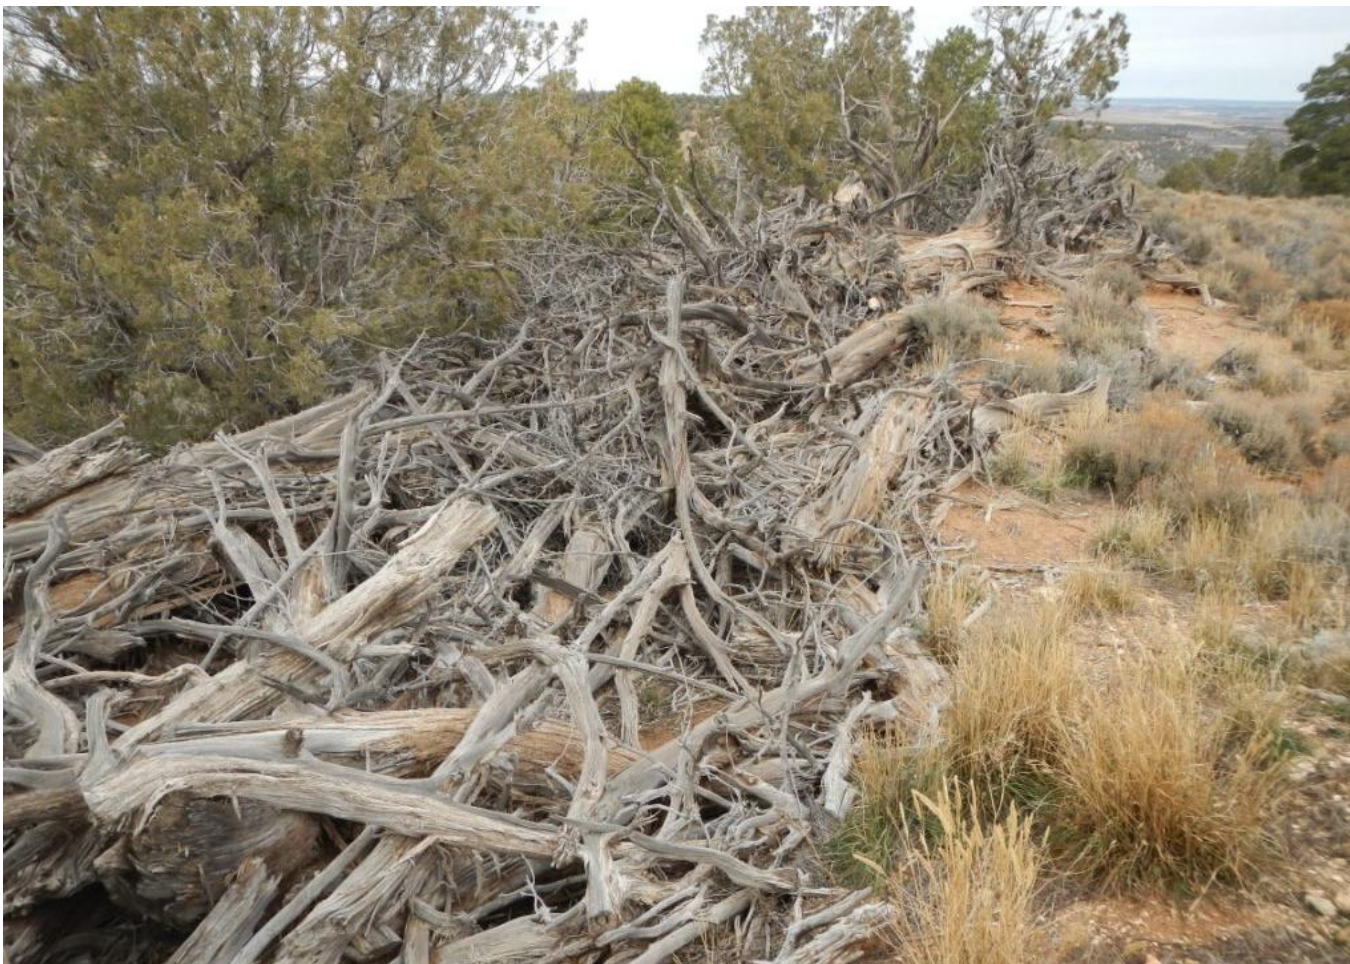
Photo 2. View of large slash pile along western edge of the project area.

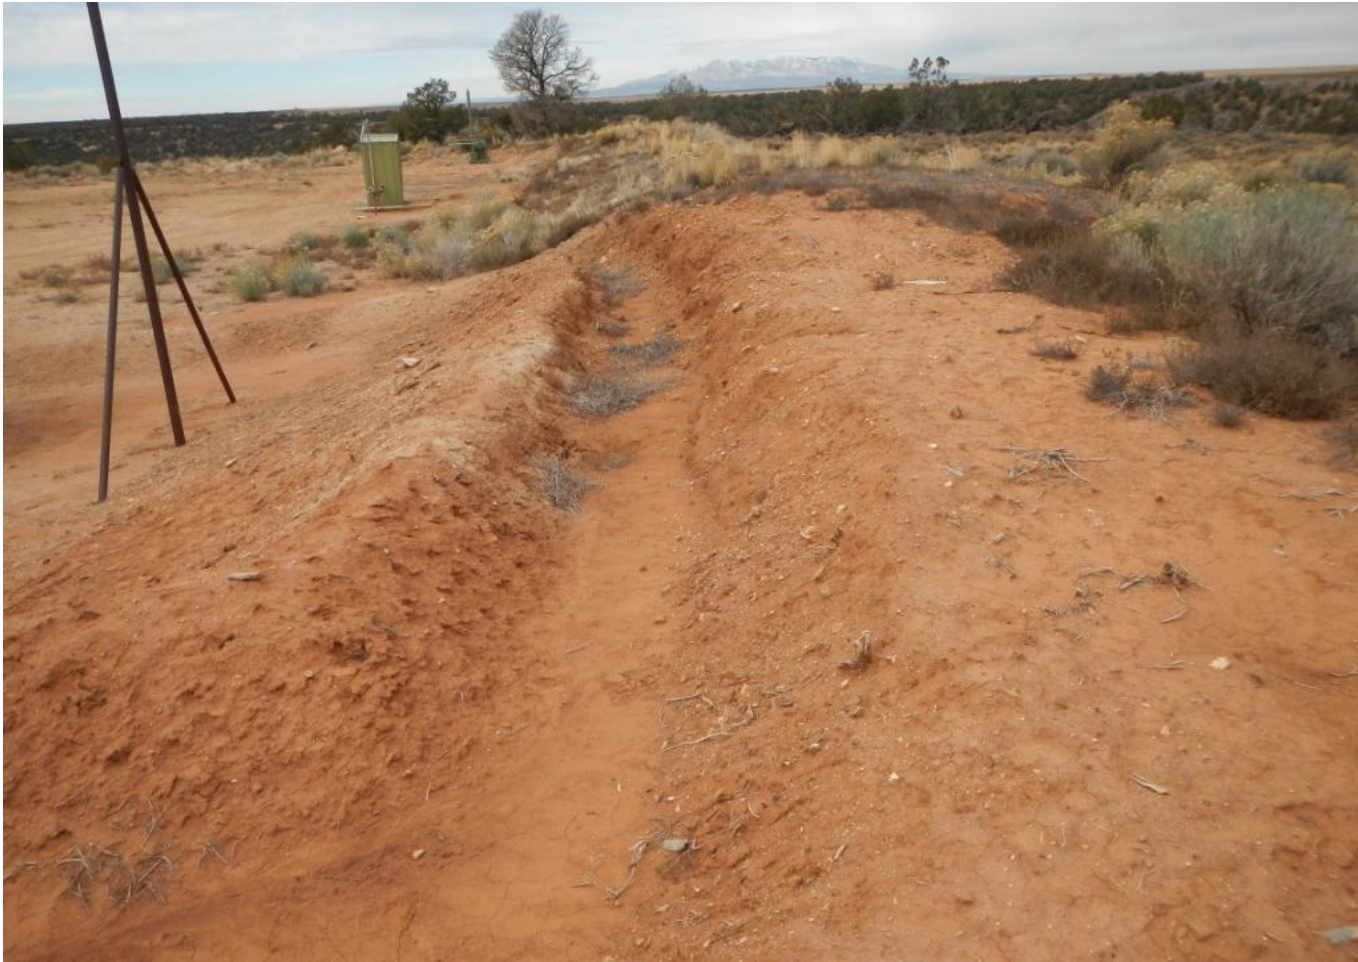
Photo 3. View of northern portion of project area from northeastern corner facing westward.

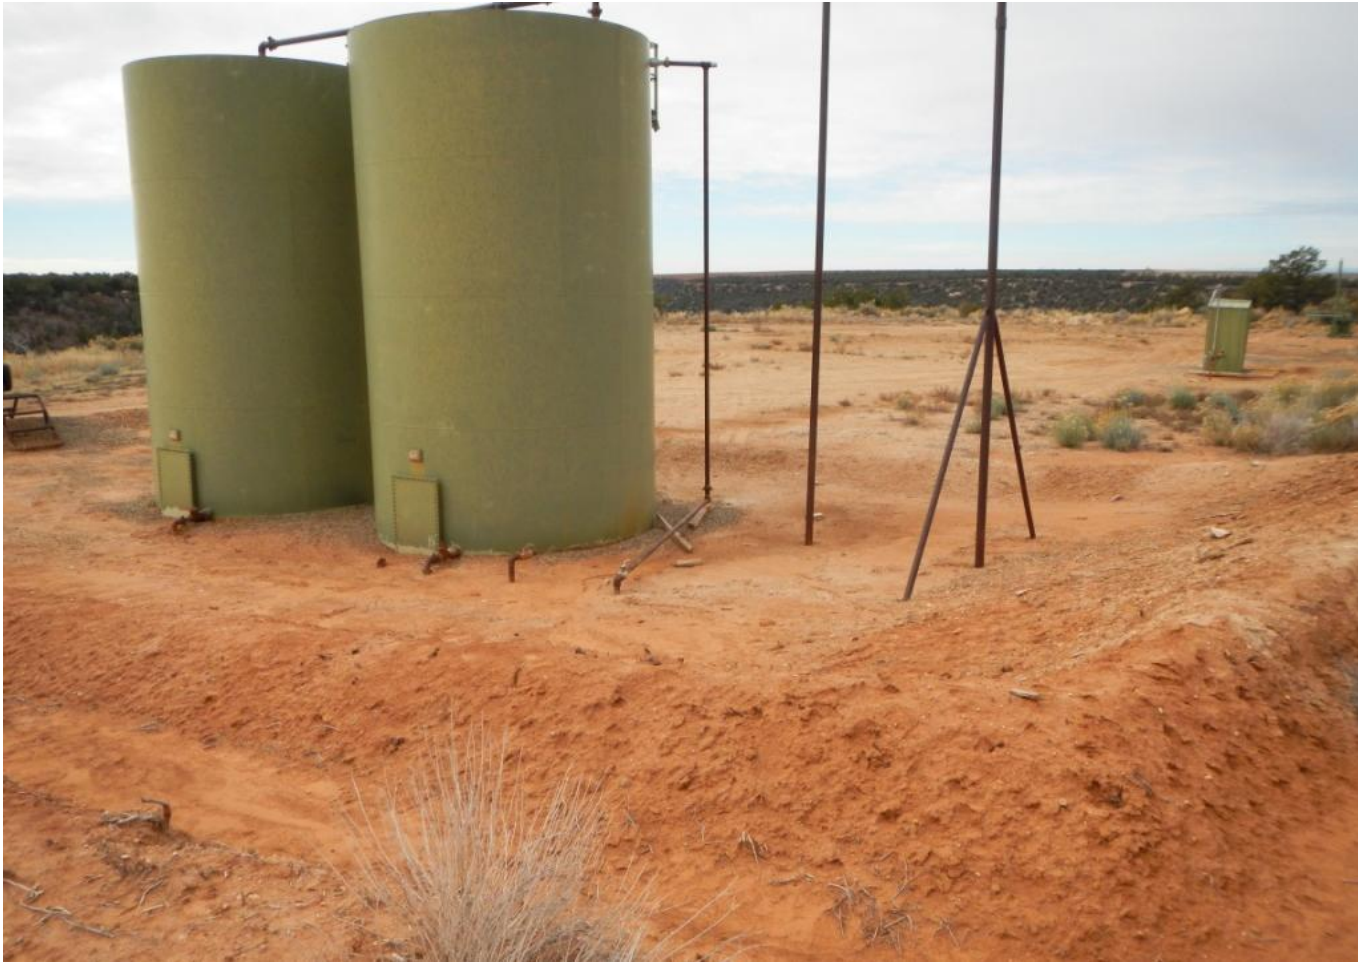
Photo 4. View from northeastern corner of project area toward center.

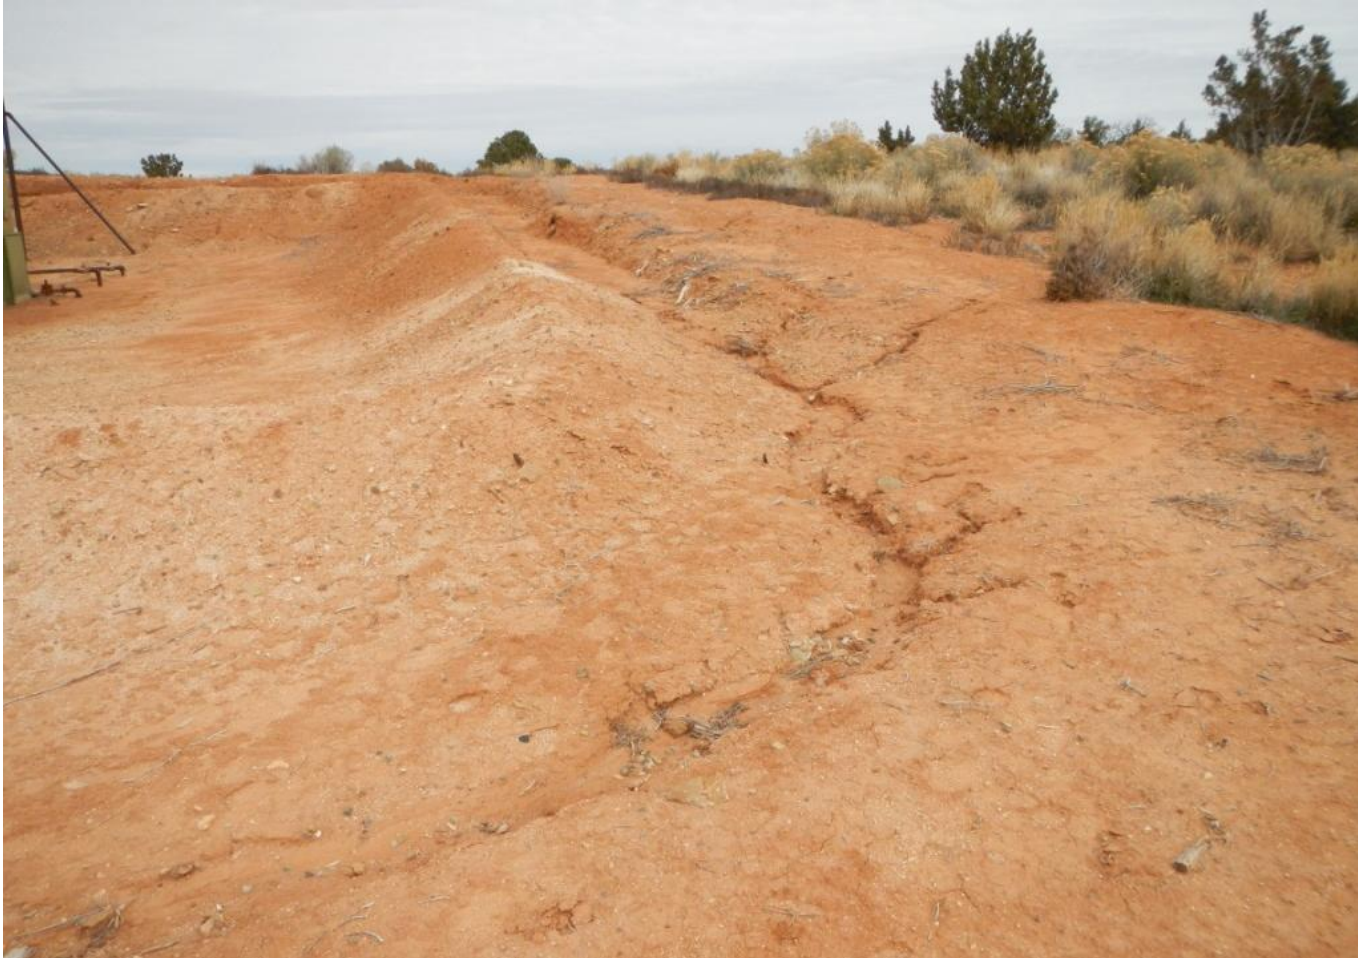
Photo 5. View of rill erosion along eastern edge of the project area from well pad entrance facing northward.
